**Conditions Study for  
Tejon and Costilla Partial Block  
Colorado Springs, Colorado**

FINAL  
February 2018

This report presents the conditions (“blight”) survey, analysis, findings and underlying rationale for the Tejon and Costilla Partial Block Conditions Study (“Conditions Study”, or “Study”), which was undertaken by DGC Community Planning and Design (“DGC”). DGC conducted the field survey in October, 2017.

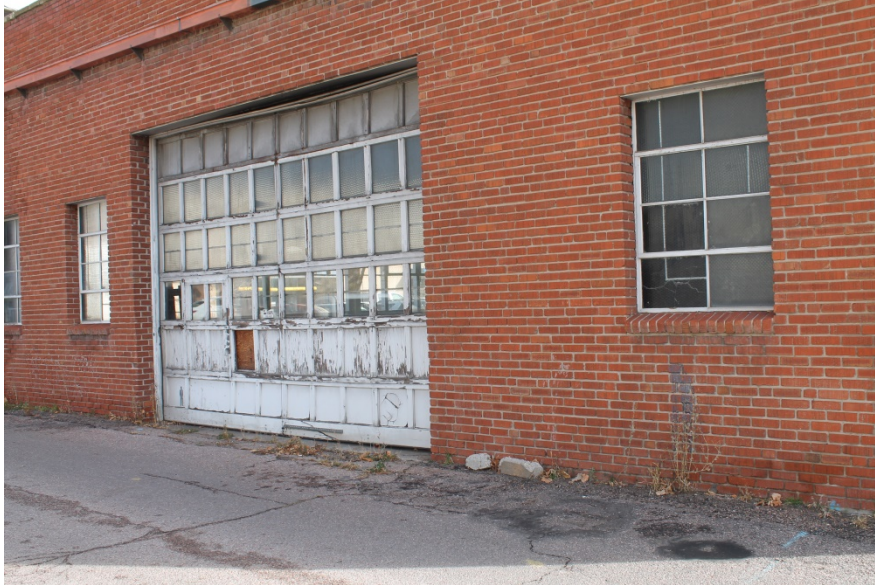
**Figure 2-1 Deteriorated exterior walls and finishes; deteriorated windows and doors; deteriorated loading areas; presence of debris adjacent to structure; debris near high traffic areas; Inadequate site maintenance; non-conformance to development regulations; presence of debris next to structures (Photo 1)**

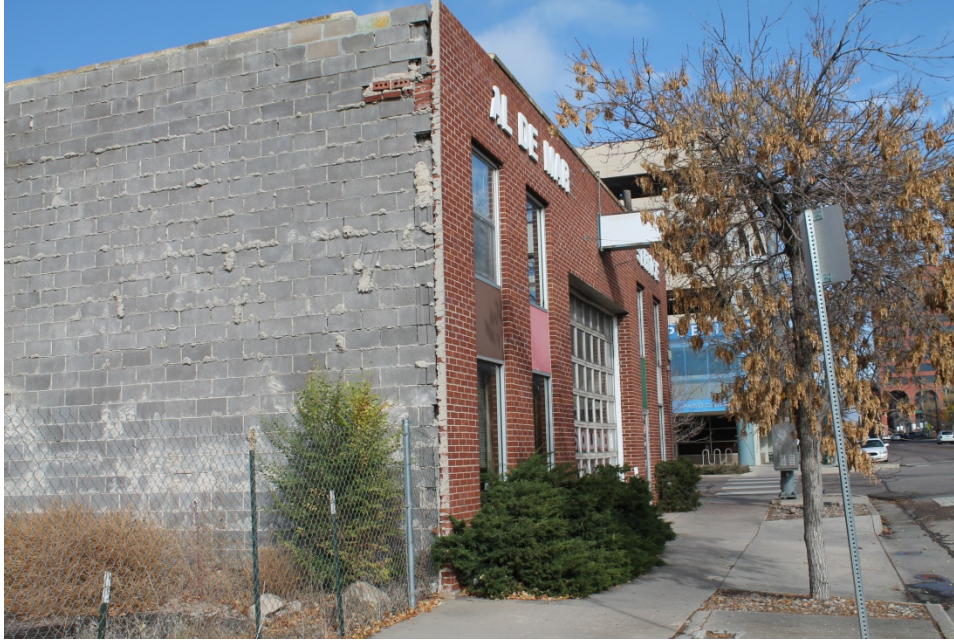
**Figure 2-3 Deteriorated exterior walls; deteriorated exterior finishes; deteriorated doors and windows; cracked or uneven pedestrian surfaces; presence of trash and debris; potentially hazardous materials and conditions; deterioration of signage; trees and shrubs in high traffic areas (Photo 5)**

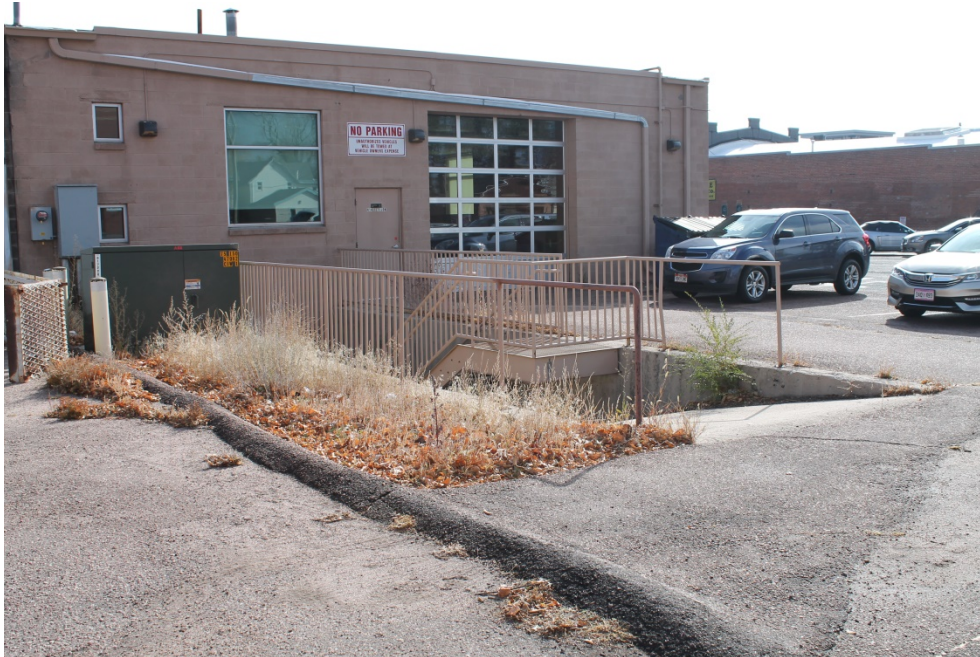
**Figure 2-5 Deteriorated loading areas/ramps; cracked or uneven pedestrian surfaces; poor drainage; presence of trash and debris; potentially hazardous conditions; unsafe level changes; deteriorated parking lot pavement; lack of sidewalks or pedestrian areas; deteriorated surface drainage; inadequate site maintenance; lack of conformance to site development regulations; dry debris near structures; unsafe level changes (Photo 9)**

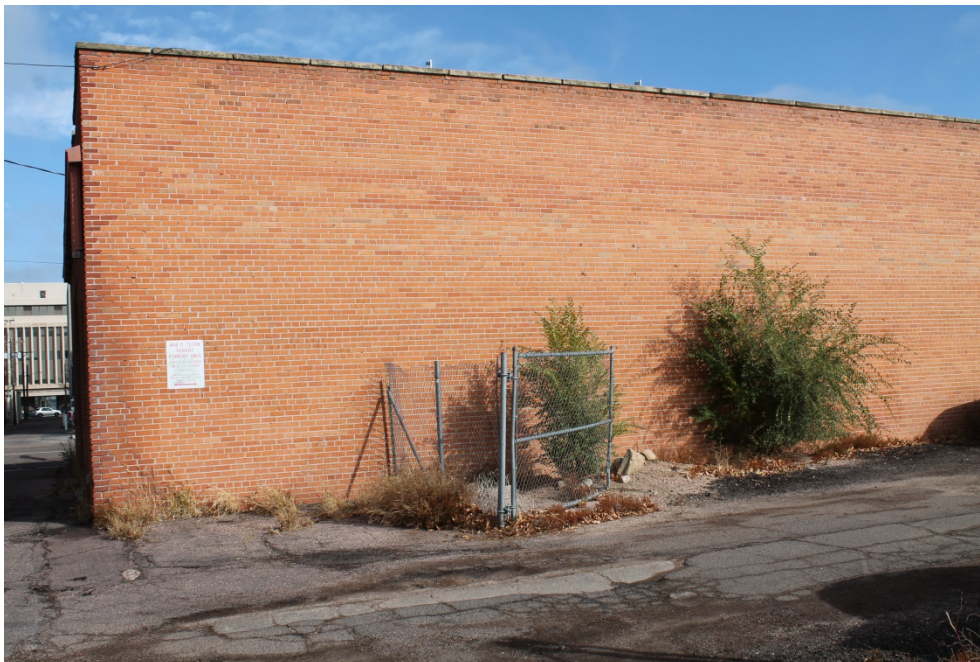
**Figure 2-6 Deteriorated external walls; deteriorated exterior finishes; deteriorated gutters/downspouts; deteriorated walls/fences/gates; cracked or uneven pedestrian surfaces; presence of trash and debris; deteriorated parking lot paving; inadequate site maintenance, non-conformance to development regulations (Photo 12)**
