**GEOLOGIC HAZARD INVESTIGATION
VILLAGES AT WATERVIEW NORTH
SOUTH POWERS BOULEVARD AND BRADLEY ROAD
EL PASO COUNTY, COLORADO**

May 15, 2020
Revised: October 1, 2020
Revised: July 15, 2022

Entech Job No. 200599
AAprojects/2020/200599 city geohaz-rev

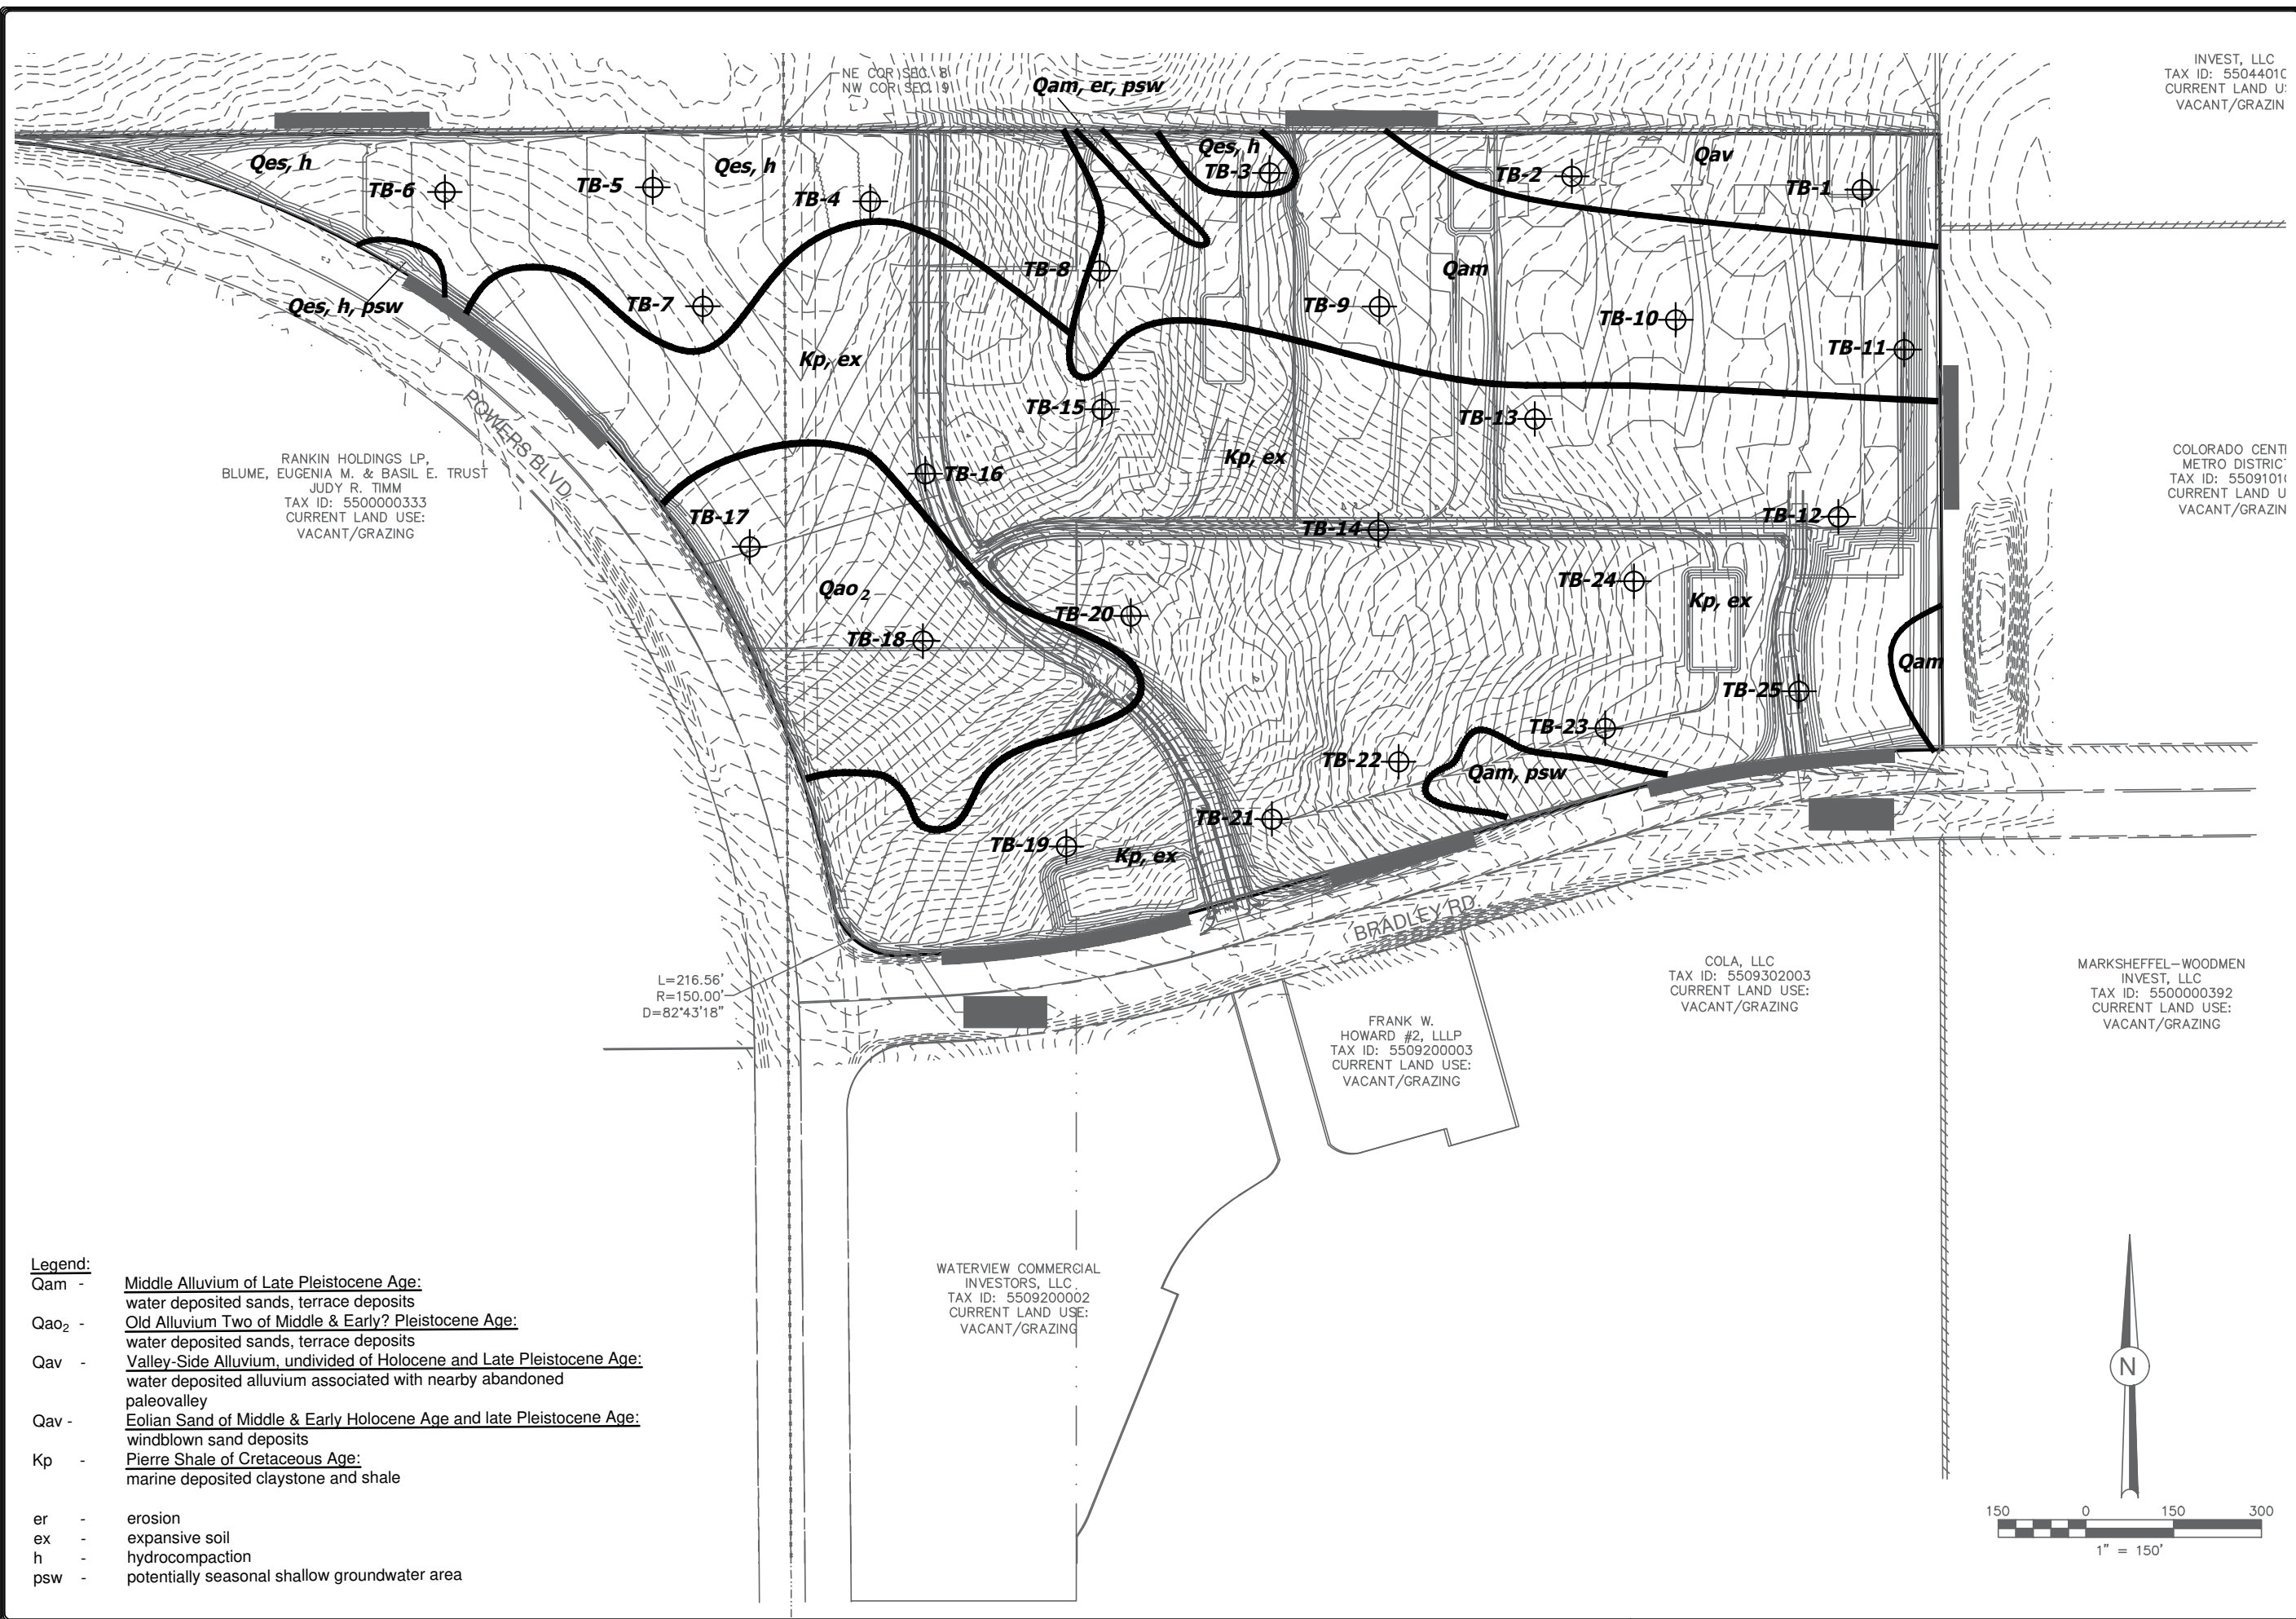
ENGINEERING GEOLOGY MAP
VILLAGES AT WATERVIEW NORTH ROAD
S POWERS BOULEVARD AND BRADLEY ROAD
EL PASO COUNTY, CO.
FOR: CPR ENTITLEMENTS, LLC

Detailed mapping has been performed on this site to produce an Engineering Geology Map Figure 7. This map shows the location of various geologic conditions of which the developers should be cognizant during the planning, design and construction stages of the project. Hazards include areas of collapsible soils/hydrocompaction, highly expansive soils, potential seasonal shallow groundwater, and shallow bedrock. Minor areas of erosion were also observed. These hazards and the recommended mitigation techniques are as follows:

Areas in which hydrocompaction have been identified are acceptable as building sites. In areas identified for this hazard classification, however, we anticipate a potential for settlement movements upon saturation of these surficial soils. The low density, uniform grain sized, windblown sand deposits are particularly susceptible to this type of phenomenon. Additionally, loose or collapsible soils may be encountered on this site. The majority of the soils encountered on-site do not exhibit collapsible characteristics; however, areas of soils with consolidation potential were encountered in the test borings drilled on site. Areas in the northwestern portion

Expansive soils are common in the area, and were encountered in the test borings drilled on site. Swells ranged from low to very high in the soils tested. The clay and claystone, if encountered beneath foundations, can cause differential movement in the structure foundation. These occurrences should be identified and dealt with on an individual basis or possibly mitigated during site grading.

The areas mapped with this hazard are located along the minor drainages in the northern and southern portion of the site, and in the low area in the northwestern portion of the site adjacent to the box culvert located under Powers Boulevard. In these areas, we would anticipate the potential for periodically high subsurface moisture conditions and possible frost heave potential, depending on the soil conditions.

Mitigation: The potential for settlement movement is directly related to saturation of the soils below the foundation areas. Therefore, good surface and subsurface drainage is extremely critical in these areas in order to minimize the potential for saturation of these soils. The ground surface around all permanent structures should be positively sloped away from the structure to all points, and water must not be allowed to stand or pond anywhere on the site. We recommend that the ground surface within 10 feet of the structures be sloped away with a minimum gradient of five percent. If this is not possible on the upslope side of the structures, then a well-defined swale should be created to intercept the surface water and carry it quickly and safely around and away from the structures. Roof drains should be made to discharge well away from the structures and into areas of positive drainage. Where several structures are involved, the overall drainage design should be such that water directed away from one structure is not directed against an adjacent building. Planting and watering in the immediate vicinity of the structures, as well as general lawn irrigation, should be minimized.

Should loose or collapsible soils be encountered beneath foundations, recompaction and moisture conditioning of the upper 2 to 3 feet of soil at 95 percent of its maximum Modified Proctor Dry Density ASTM D-1557 will be required. Exterior flatwork and parking areas may also experience movement. Proofrolling and recompaction of soft areas should be performed during site work.

Mitigation Should expansive soils be encountered beneath the foundation; mitigation will be necessary. Mitigation of expansive soils will require special foundation design. Overexcavation and replacement with non-expansive soils at a minimum of 95 percent of its maximum Modified Proctor Dry Density, ASTM D-1557 is a suitable mitigation, which is common in the area. Floor slabs on expansive soils should be expected to experience movement. Overexcavation and replacement has been successful in minimizing slab movements. Overexcavation depths of 4 to

6 feet are anticipated for the site. Mitigation may also include moisture conditioning and recompaction of the clay soils. The use of structural floors should be considered for basement construction on highly expansive clays.

Drilled piers are another option that is used in areas where highly expansive soils are encountered. Typical minimum pier depths are on the order of 25 feet or more and require penetration into the bedrock material a minimum of 4 to 6 feet, depending upon building loads. Final recommendations should be determined after additional investigation of the lots.

Mitigation: In these locations, foundations in areas subject to severe frost heave potential should penetrate sufficient depth so as to discourage the formation of ice lenses beneath foundations. At this location and elevation, a foundation depth for frost protection of 2.5 feet is recommended. In areas where high subsurface moisture conditions are anticipated periodically, a subsurface perimeter drain will be necessary to help prevent the intrusion of water into areas located below grade. A typical perimeter drain detail is presented in Figure 9. Additionally, swales should be created to intercept surface runoff and carry it safely around and away from structures. It is anticipated that the site grading will likely mitigate the dry drainages on the site, and a detention pond is proposed in the northwestern portion of the site. Lots adjacent to the detention pond may also require drains to help prevent the intrusion of water into areas below grade during periods of high moisture. Several detention ponds are proposed across the site.
