Gold Hill Mesa Commercial Area Conditions Survey

City of Colorado Springs, Colorado

January 2015

Conditions Survey

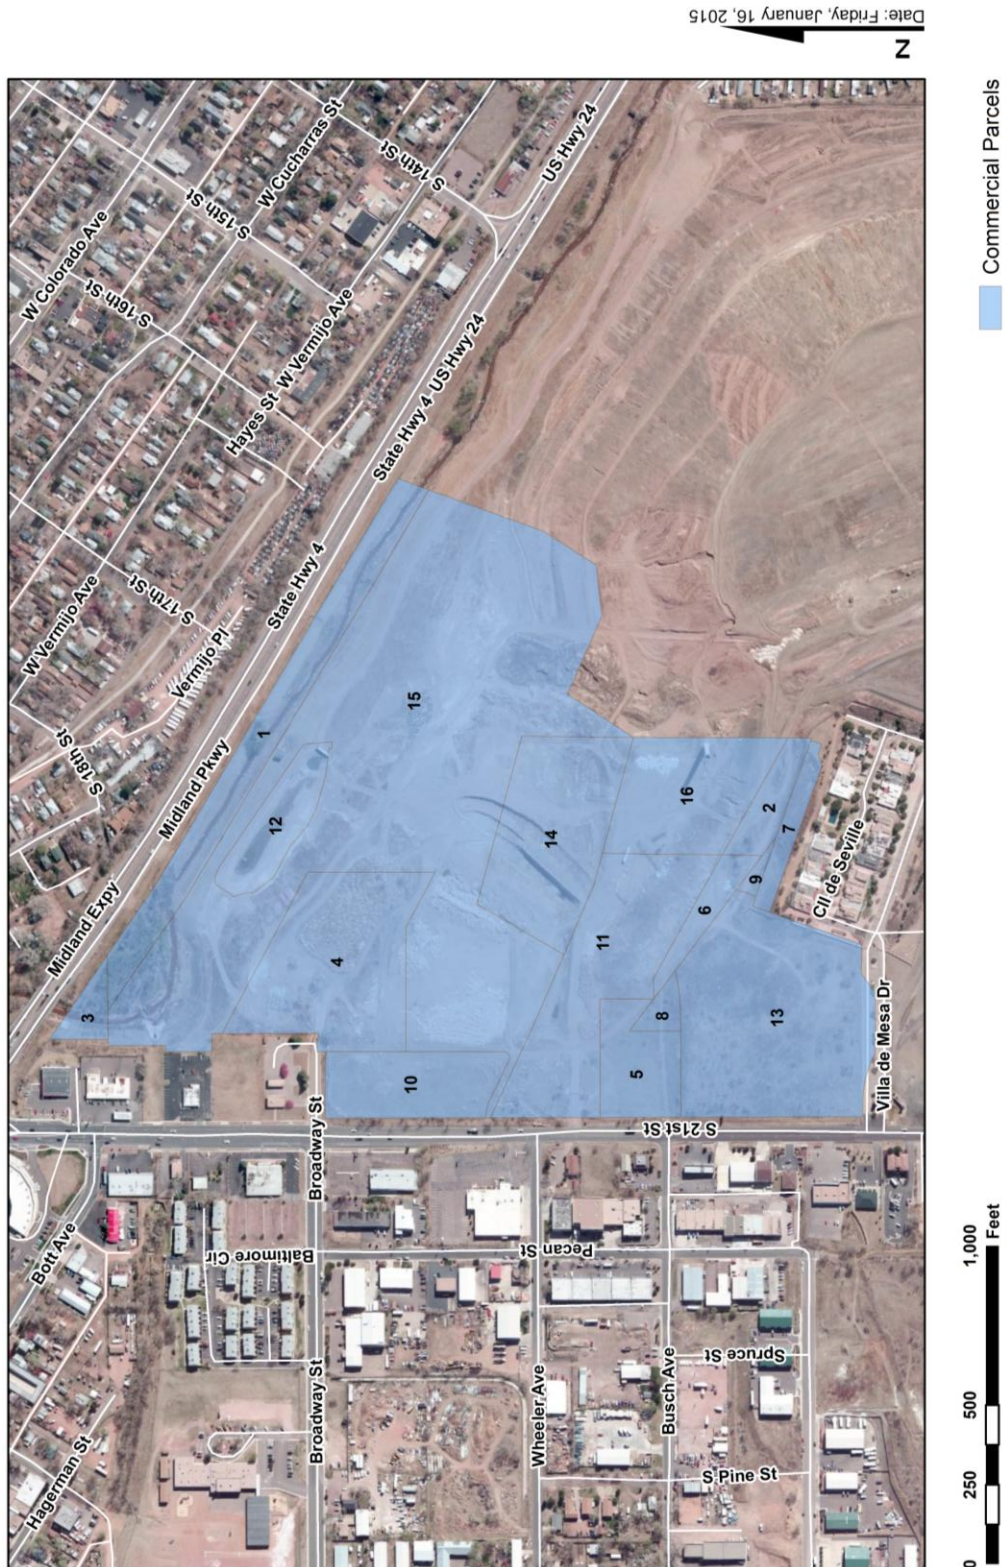
Figure 1: Survey Area Boundaries

In addition to limited access to and within the Area, other parcel-related conditions which negatively impact the ability of properties within its boundaries to develop include size and shape. As evidenced in **Figure 1**, several properties are either too small or too irregular in shape to be developed to City-standards without being part of a larger assemblage. Size relative to zoning is a particular concern whereas site coverage, density, and parking ratios are dictated by use, irrespective of parcel size, thereby rendering some properties economically "useless." Similarly, many of those parcels with an irregular shape also suffer from a significant lack of utility, rendering them unmarketable. A parcel with limited usefulness due to shape is one that when developed leaves substantial portions either under-utilized or with limited access or visibility.

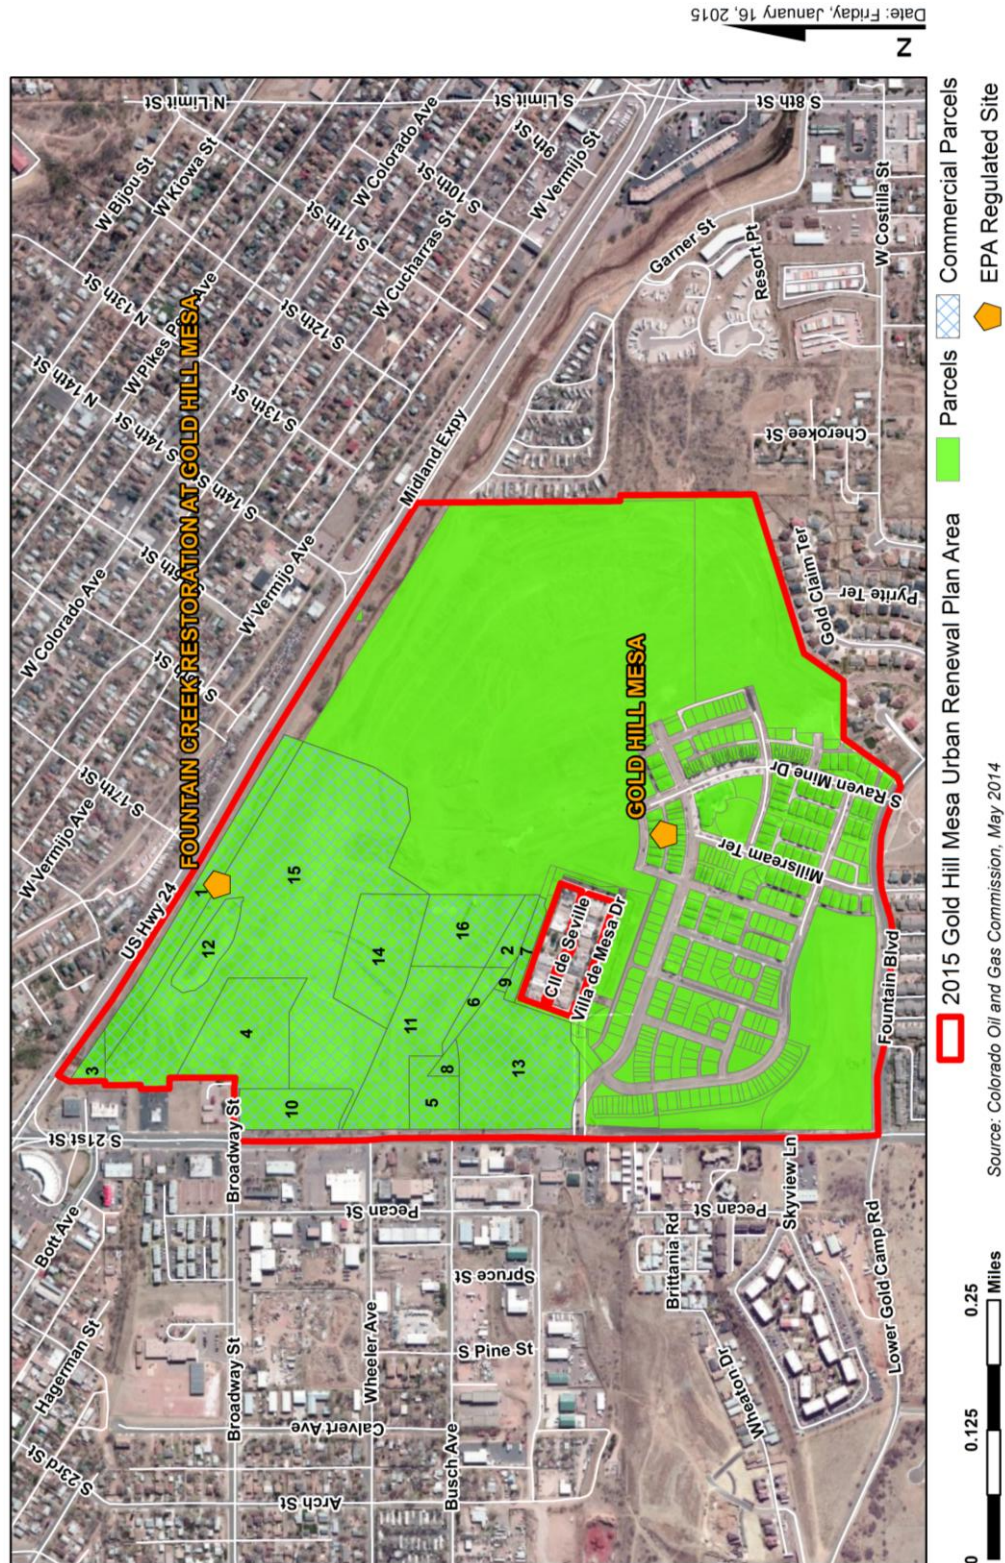
Figure 5: Facilities Subject to EPA Oversight

A review of materials published by the State of Colorado on behalf of the Federal Government related to properties that are presently under the oversight of the EPA, revealed that there are two locations under review within the existing Gold Hill Mesa Urban Renewal Area, one of which is within the Survey Area. **Figure 5** illustrates their location.

Properties within the Area and larger urban renewal area are impacted by environmental contamination stemming from the accumulation of tailings from the ore refinement process that took place at the Golden Cycle Mill from 1905 to 1949. Specifically, both lead and arsenic have been detected in the soils.
