Geologic Hazards Study

**Wilson Tank Replacement
Colorado Springs, Colorado**

July 27, 2021 (Revised November 18, 2021)

Terracon Project No. 23215020

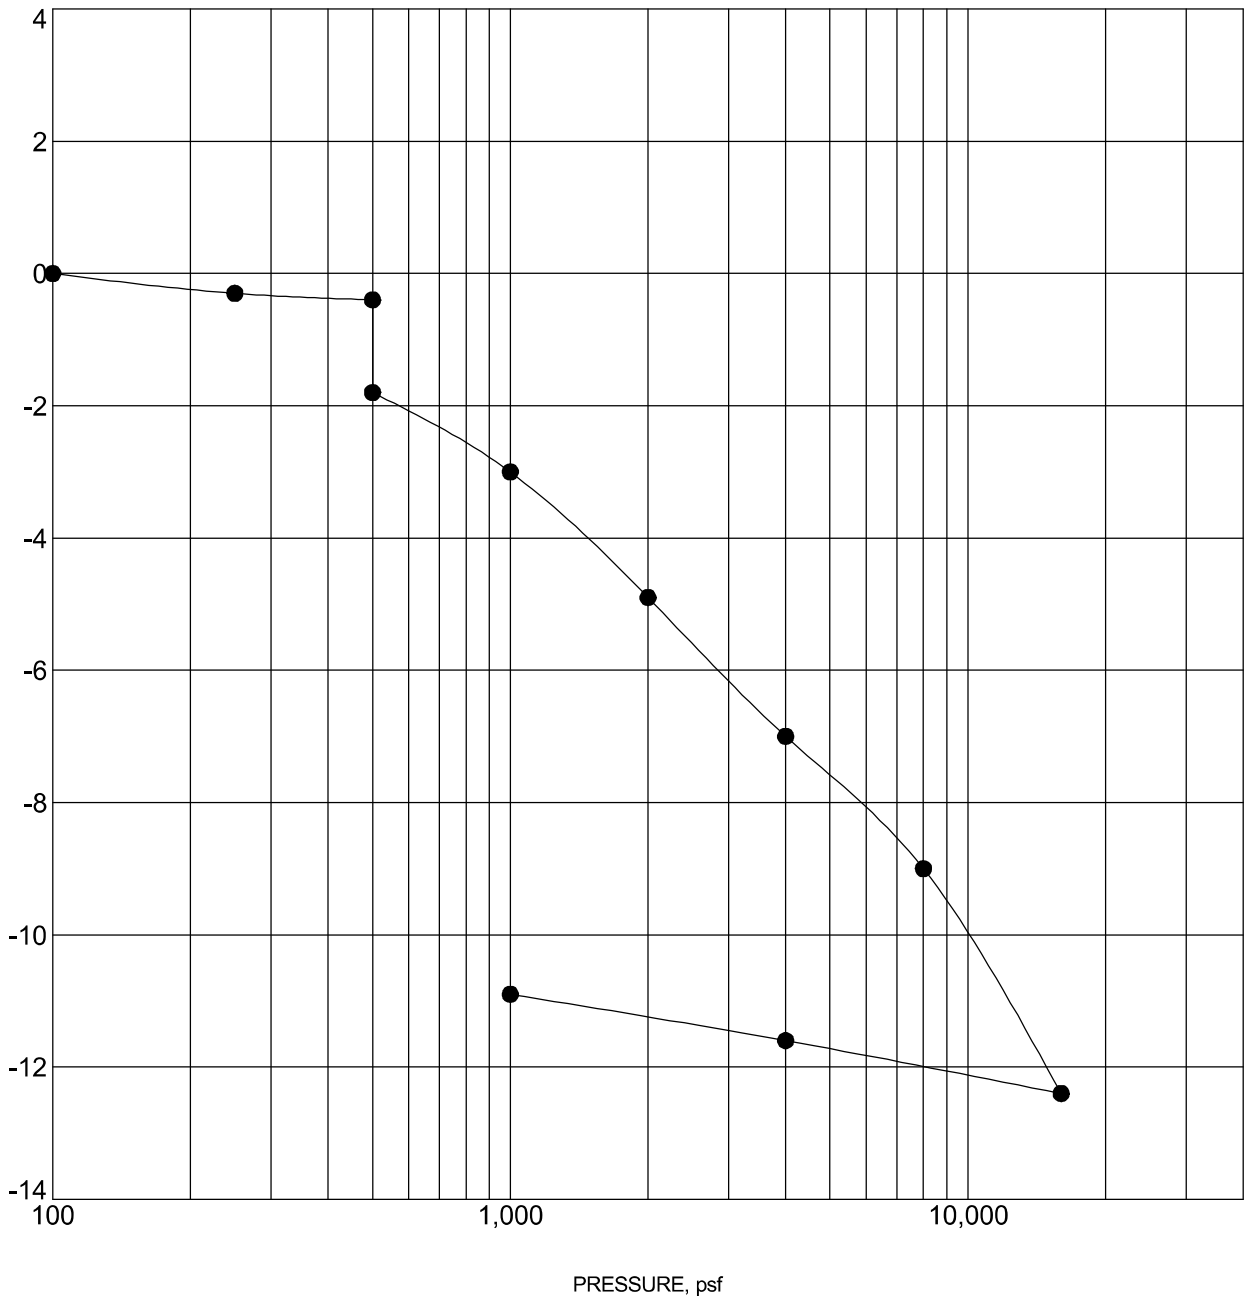
Specimen Identification		Classification	γ_d , pcf	WC, %
●	B-103 9 - 10 ft	SILTY SAND(SM)	119	2

to increases in moisture content at an applied load of 500 psf, the sand soils tested exhibit negligible to low compression followed by low to very high compression at increased loadings. It is our opinion that the sample of sand soils tested was disturbed either during sampling or sample preparation and the observed moderate to very high compression is not representative of the in-situ conditions of the on-site sand soils. Based on our experience, the on-site sand soils would be considered to exhibit low to moderate compression when subjected to increased moisture and loading conditions.

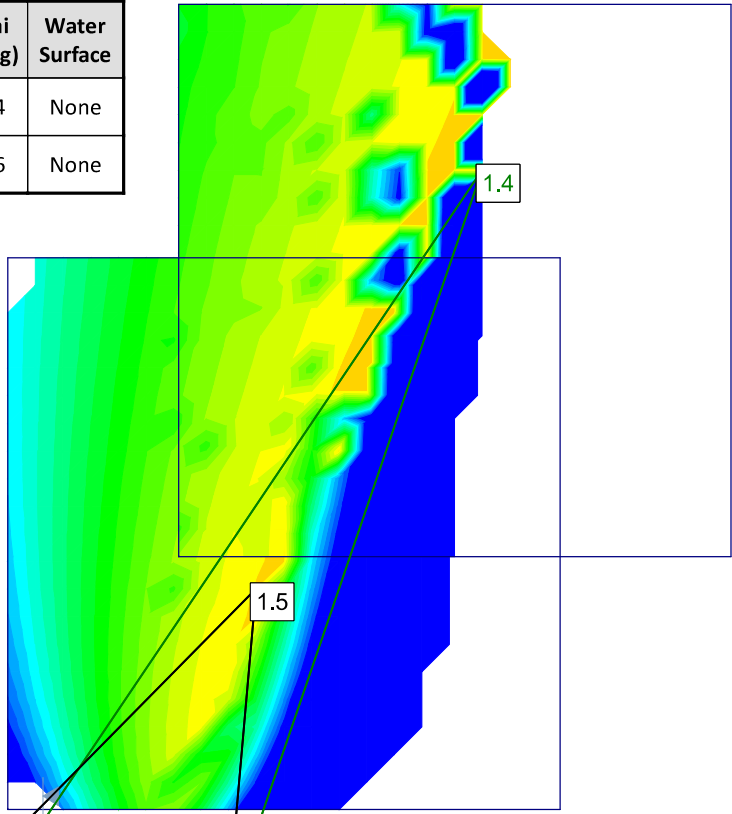
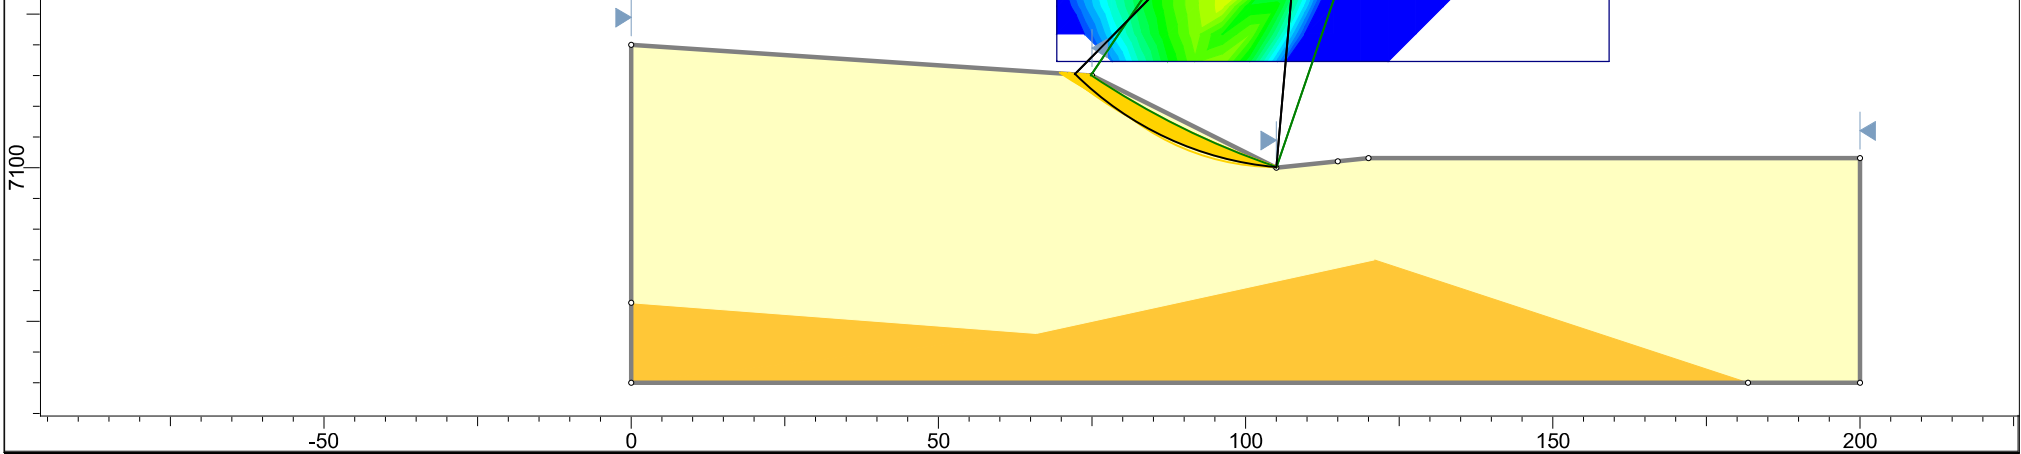
Project			23215020 - Wilson Tank Replacement		
	Analysis Description			Section A-A', 50 percent slope		
	Drawn By	TAC	Scale	1:375	Company	Terracon
	Date	10/21/2021, 9:07:43 PM

Slope Stability Analysis: As noted on page 5 of Terracon's report, "The existing and proposed relatively steep slopes along the west and south sides of the proposed tank create a risk for localized man-made unstable slopes at this location." CGS agrees with Terracon's recommendation that "a slope stability analysis be performed to confirm the long term stability of the slopes." The slope stability analysis *must* be based on soil/bedrock geometry along the length of the slope section, shear strength values measured from site-specific samples and laboratory testing, and groundwater levels that may be anticipated in the area (perched conditions). Also, seismic factors should be included in the analysis that considers the Rampart Range Fault zone.
