Geologic Hazards Study

**Wilson Tank Replacement
Colorado Springs, Colorado**

July 27, 2021 (Revised November 18, 2021)

Terracon Project No. 23215020

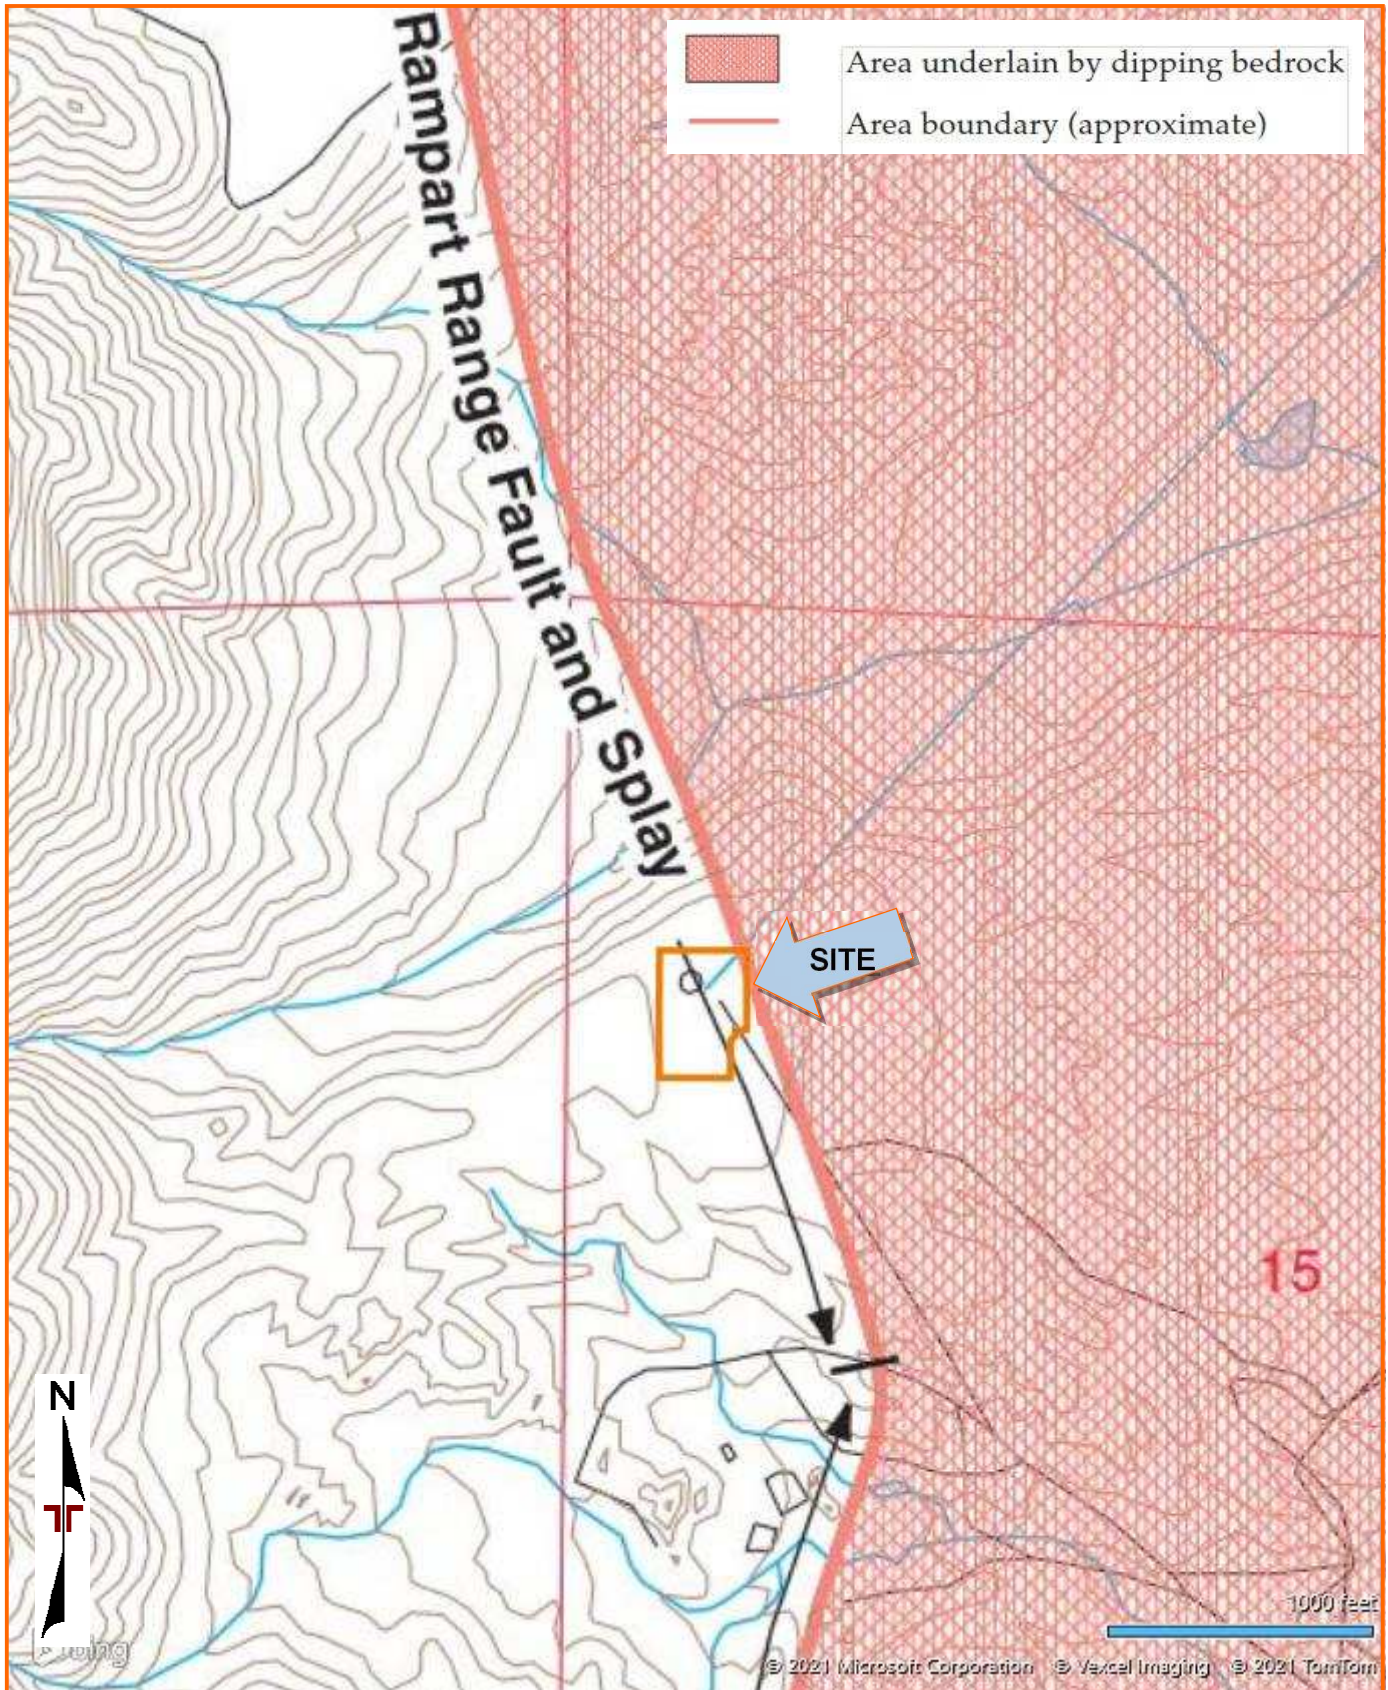
Dipping Bedrock: The site is located within the Hillside Overlay and is mapped about 150 feet west of an area mapped as susceptible to differential heave in expansive, steeply dipping bedrock (>30°). Terracon encountered bedrock at depths ranging from 3½ to 37 feet below the existing grade. CGS agrees with Terracon's assessment that "Although not observed in the bedrock samples obtained from our borings, it is our opinion that dipping bedrock is likely present at this site." We also agree with Terracon's recommendation "The proposed tank should be constructed on shallow foundations supported on a minimum 10-foot thick zone of structural fill, such that a minimum 10-foot separation exists between the lowest foundation element and the top of bedrock." **CGS recommends that Terracon provide material properties (gradation specifications, use of on-site vs. import materials, etc.), earthwork recommendations for the structural fill material, and potential movement estimates (total and differential) if not provided in the Geotechnical Engineering Report. In addition, the project team and contractor should anticipate difficult excavation conditions within the on-site bedrock.**

- The proposed tank should not be constructed on deep foundations supported on bedrock.
- The proposed tank should be constructed on shallow foundations supported on a minimum 10-foot thick zone of structural fill, such that a minimum 10-foot separation exists between the lowest foundation element and the top of bedrock. This is anticipated to require excavation of existing bedrock within portions of the tank footprint.

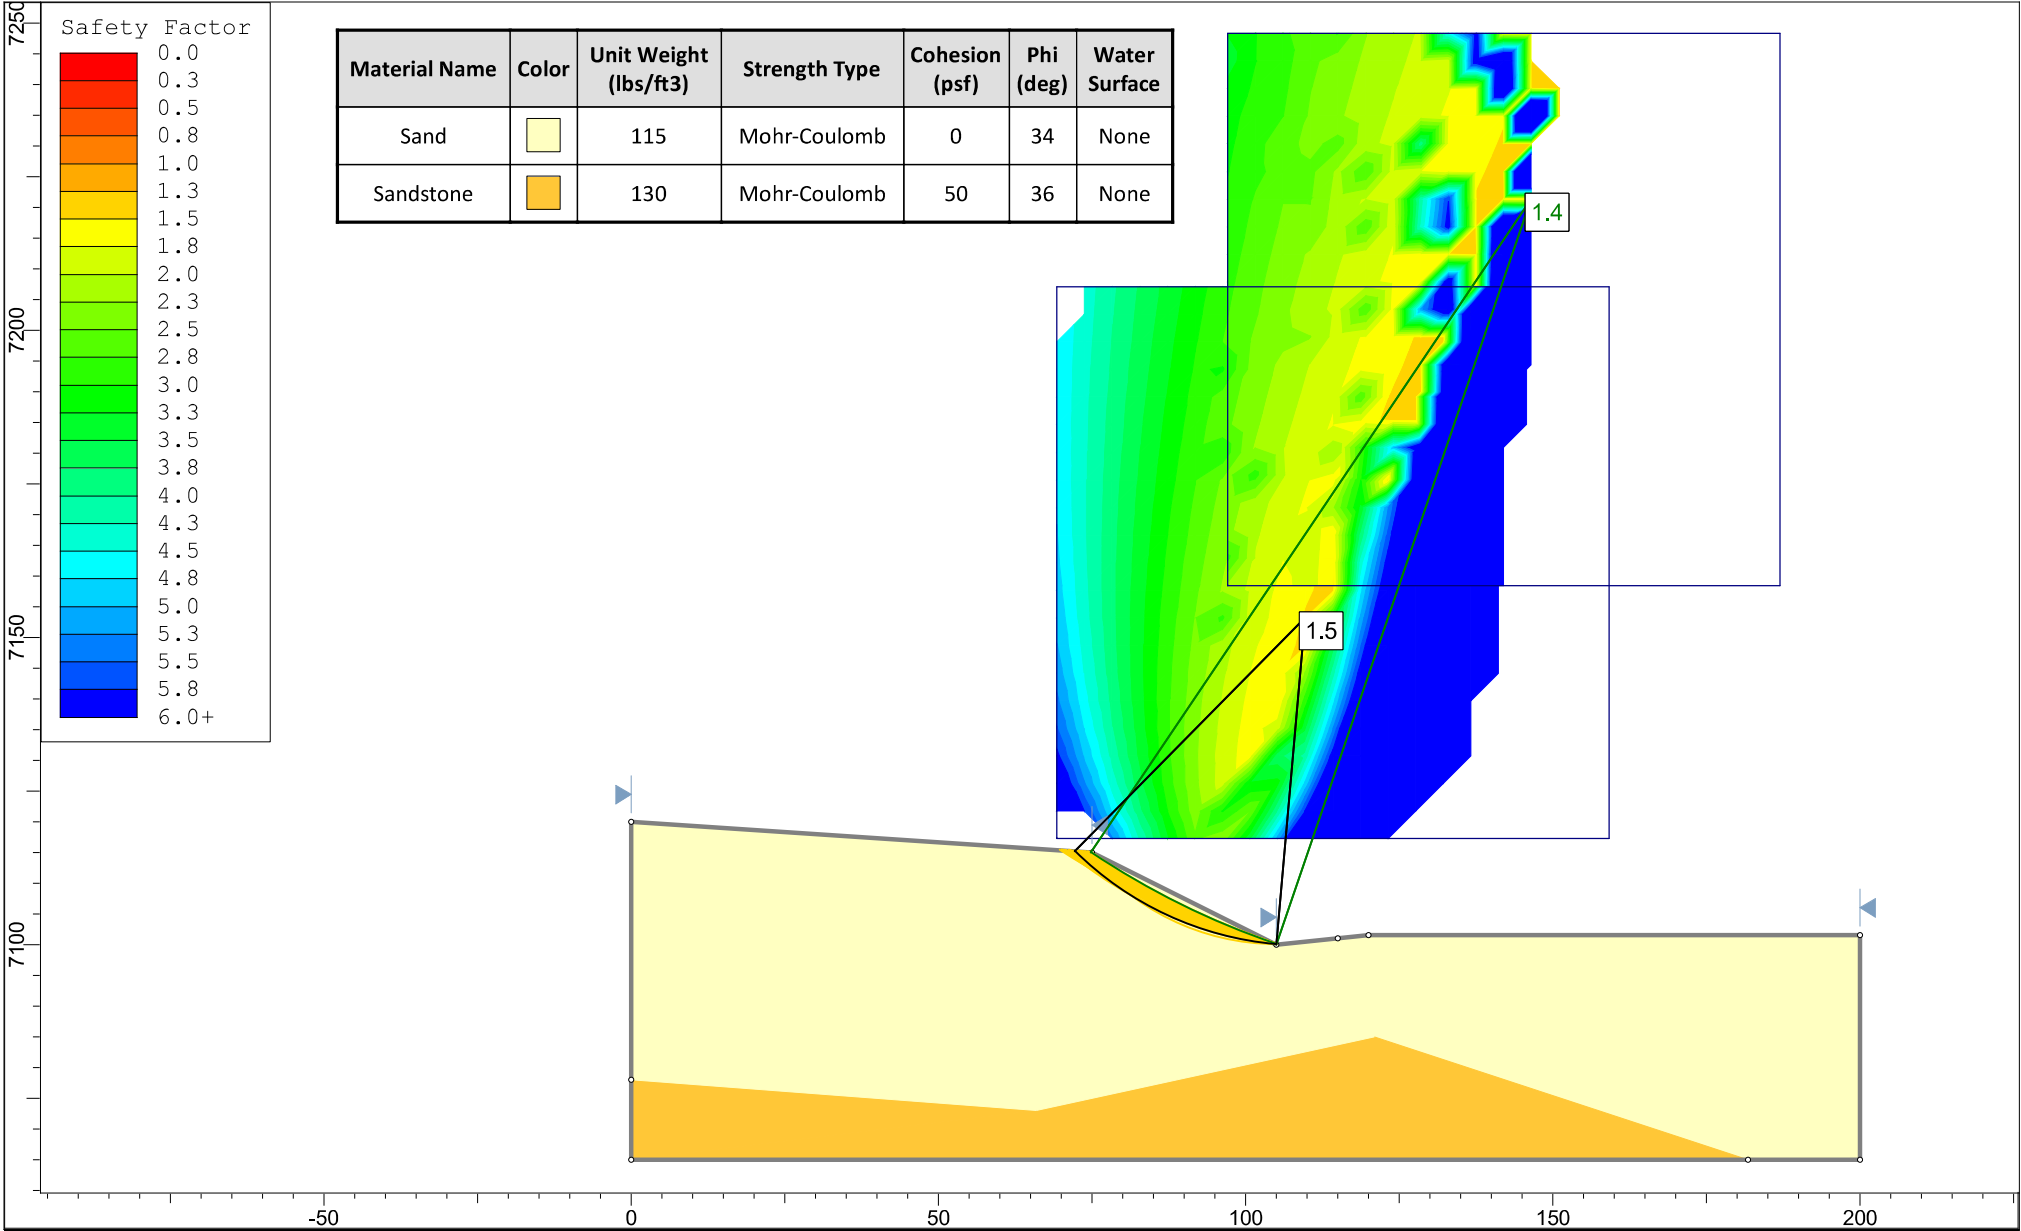
Project			23215020 - Wilson Tank Replacement		
	Analysis Description			Section A-A', 50 percent slope		
	Drawn By	TAC	Scale	1:375	Company	Terracon
	Date	10/21/2021, 9:07:43 PM

stability of the slope is sufficient for the subsurface conditions encountered and proposed slope geometry.

Slope Stability Analysis: As noted on page 5 of Terracon's report, "The existing and proposed relatively steep slopes along the west and south sides of the proposed tank create a risk for localized man-made unstable slopes at this location." CGS agrees with Terracon's recommendation that "a slope stability analysis be performed to confirm the long term stability of the slopes." The slope stability analysis *must* be based on soil/bedrock geometry along the length of the slope section, shear strength values measured from site-specific samples and laboratory testing, and groundwater levels that may be anticipated in the area (perched conditions). Also, seismic factors should be included in the analysis that considers the Rampart Range Fault zone.
