June 24, 2015

Re: CGS Response Letter and Proposed Phase II Scope of Geotechnical Services
Bates Student Housing Project
702 Cragmor Road
Colorado Springs, Colorado
Terracon Project Number: 23155012

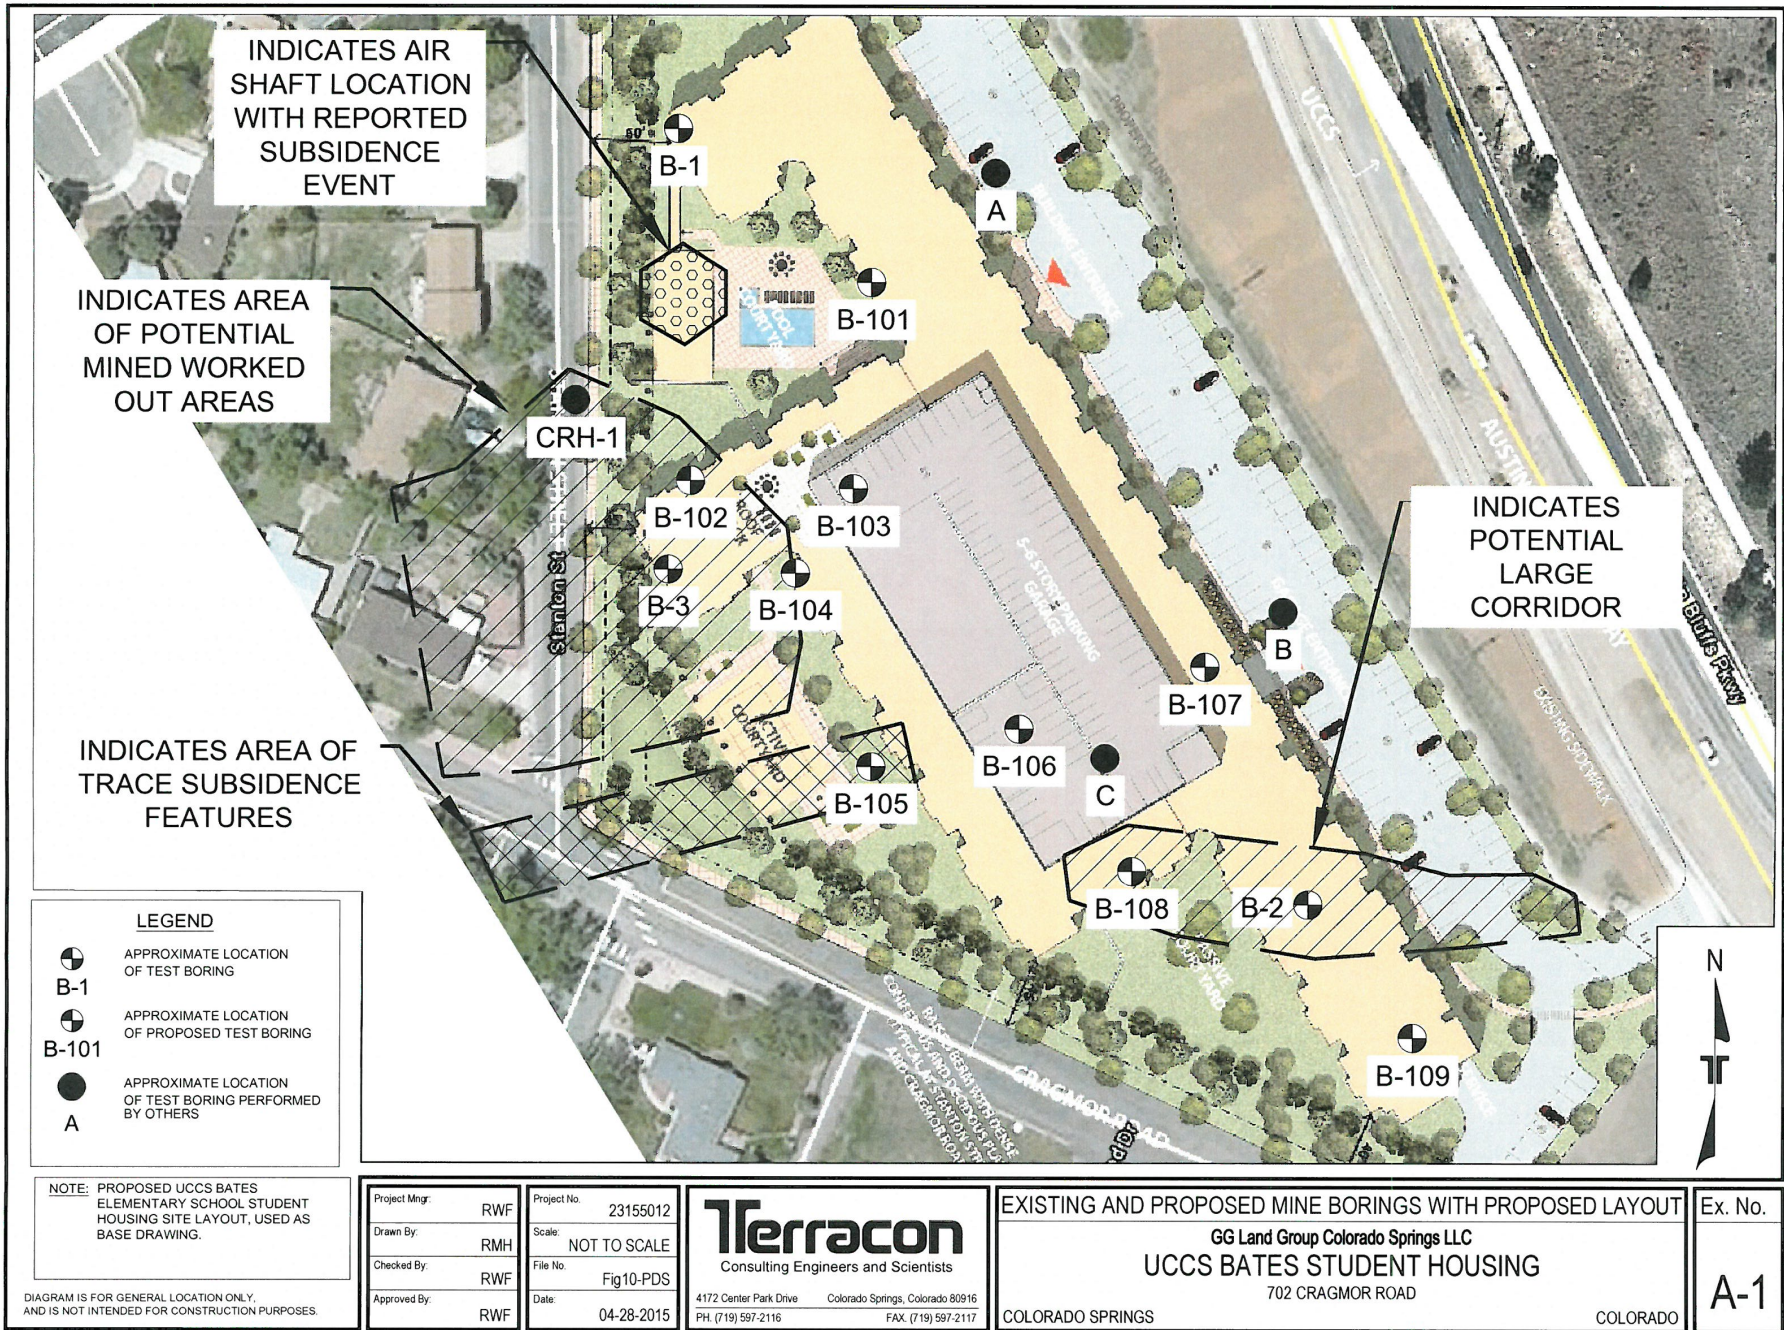
We concur with CGS that three borings are not sufficient to characterize the site with respect to mine activity. The borings were part of our initial phase of exploration with the intention of performing supplemental borings at a later time. We do not agree with the 40 to 50-foot spacing of borings within all building footprints. As indicated in our report, it is our intention to perform relatively closely spaced borings, at about 50 feet apart, at the locations where the designated worked out mine areas overlap the proposed building improvements only. If the supplemental borings indicate unfavorable results, we will recommend additional borings. We are proposing to perform approximately 8 to 10 supplemental mine borings as shown on the attached Exhibits A-

1 through A-4. Similarly to the initial three borings, we plan on performing gamma, caliper, and density logging of the borings.

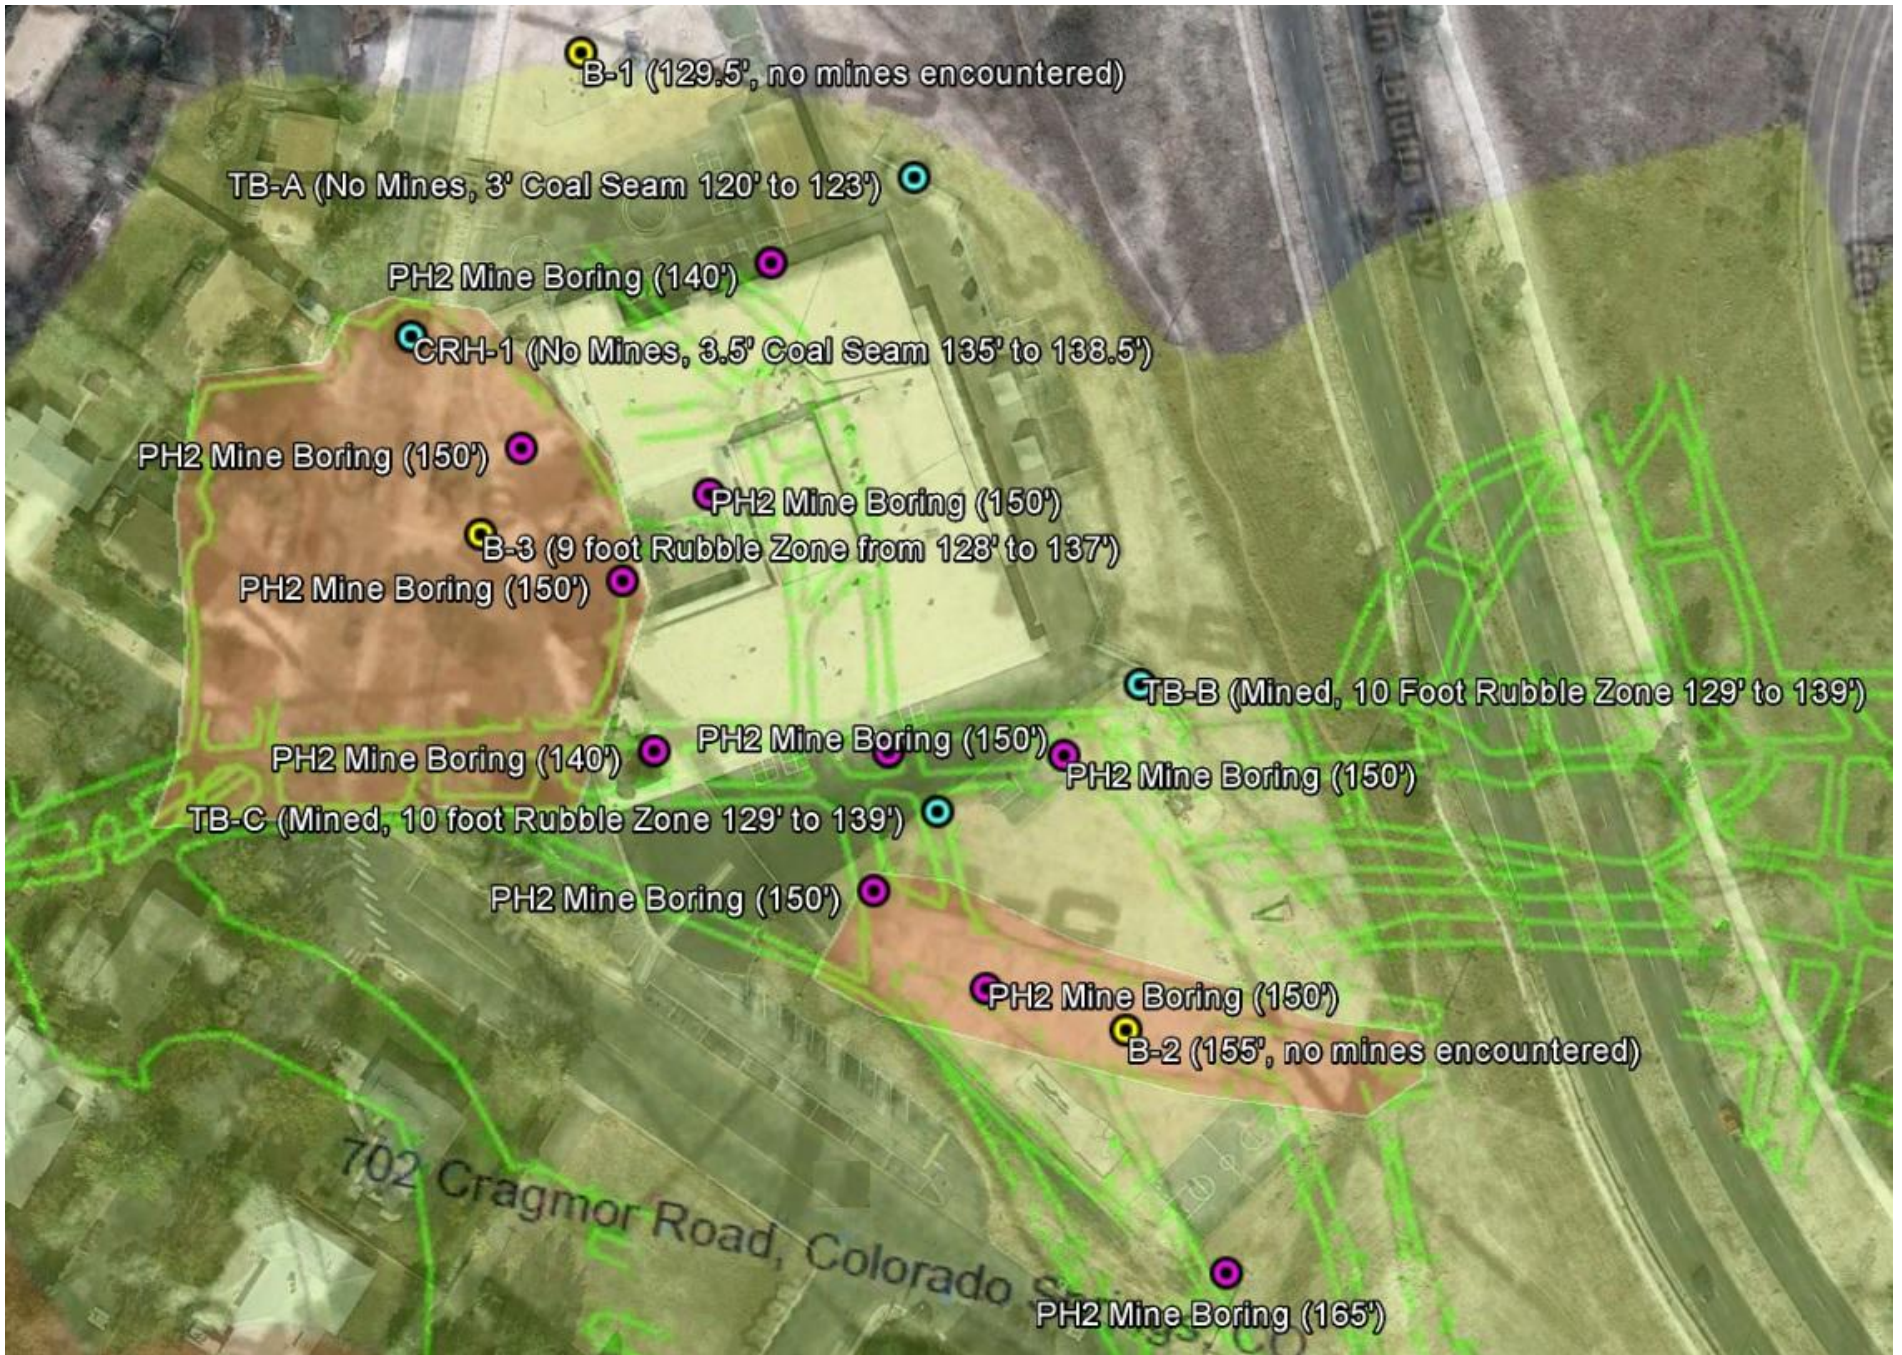
Exhibit A-2, Existing and Proposed Borings with Mine Map

Terracon Response: In general, mining maps overlaid with aeriels provide a general location of the mined areas and should not be considered to be accurate in plan view. However, this particular site is unique such that the mine "haul road", or the main corridor tunnel lines up relatively well with documented surface subsidence. The attached Exhibit A-1, shows the documented surface subsidence associated with the "haul road". Due to this identifier, it is our opinion that the mine maps and worked out areas may correlate relatively well the aerial overlays.
