Final Report

OneVeLa Existing Conditions Survey

City of Colorado Springs Urban Renewal Authority

July 15, 2024

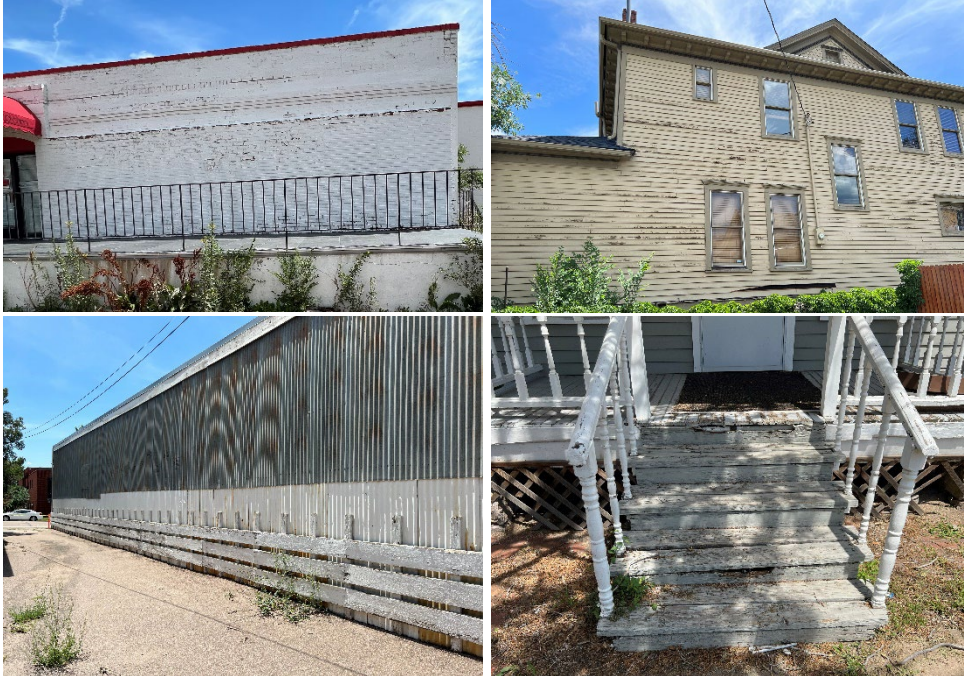
Figure 2. Deteriorated Exterior Finishes and Stairways

Multiple buildings in the Study Area have deteriorated exterior finishes with chipped paint, exposed brick, and rusted and worn-out metal siding, shown in **Figure 2**. The single family home on Parcel 3 has a deteriorated wooden stairway to the front porch as well as chipped paint.

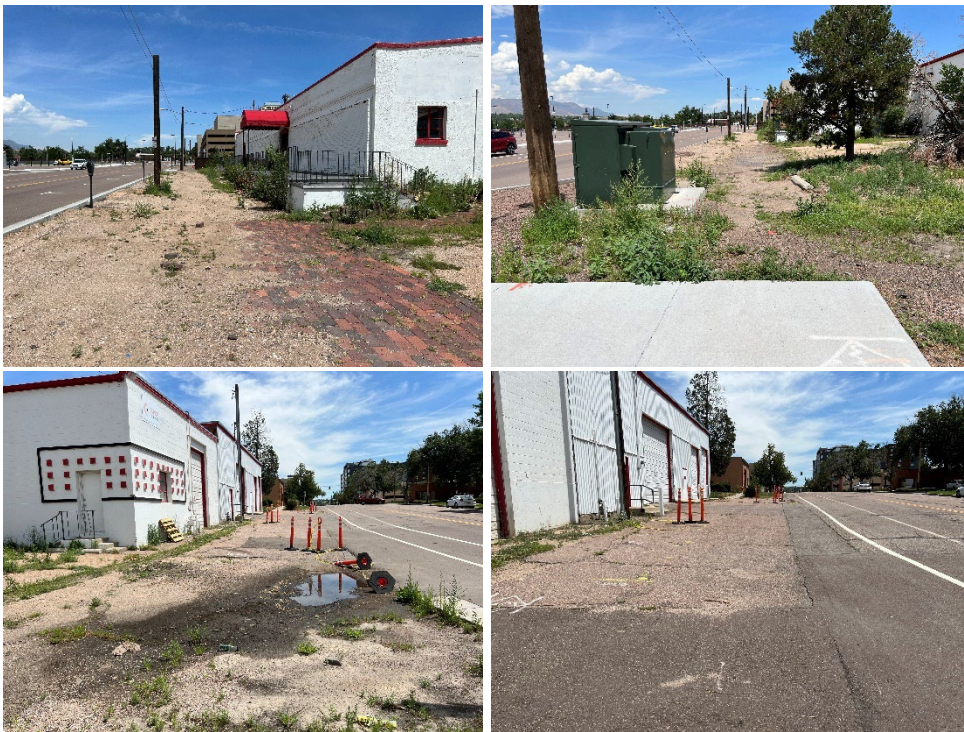
Figure 3. Poor Provision of Street Improvements for Pedestrians

Poor provisions of street improvements for pedestrians were observed in the form of lack of sidewalks along Sahwatch Street on parcel 1 and along Costilla Street on parcels 1 and 2, as shown in **Figure 3**. Along Sahwatch Street there is a defined curb but no sidewalk and along Costilla Street there is dirt and a large driveway for commercial vehicles. It is important to note at the corner of Sahwatch and Costilla Street pedestrian improvements were made with curb cuts and a small portion of sidewalk. These are extensions of the sidewalk improvements on the opposite sides of the streets and illustrates the disconnect the Study Area has within the existing pedestrian network.

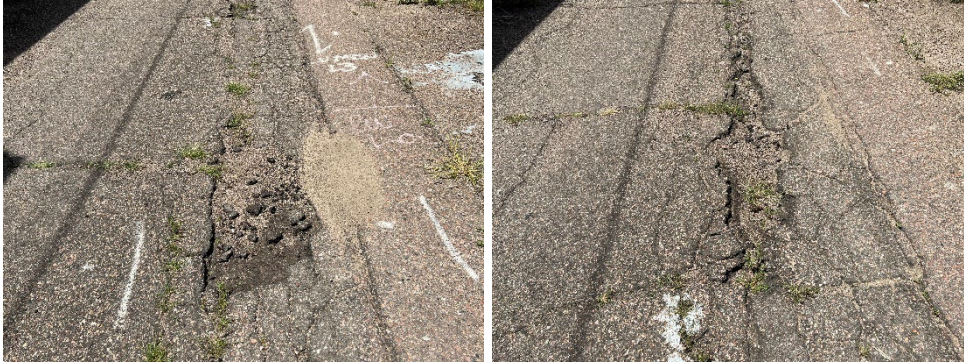
Figure 4. Poor Provision of Street Improvements for Vehicles

Additionally, poor provisions of street improvements for vehicles were observed in the form of potholes and cracked pavement in the alley on the northside of the Study Area, shown below in **Figure 4**.

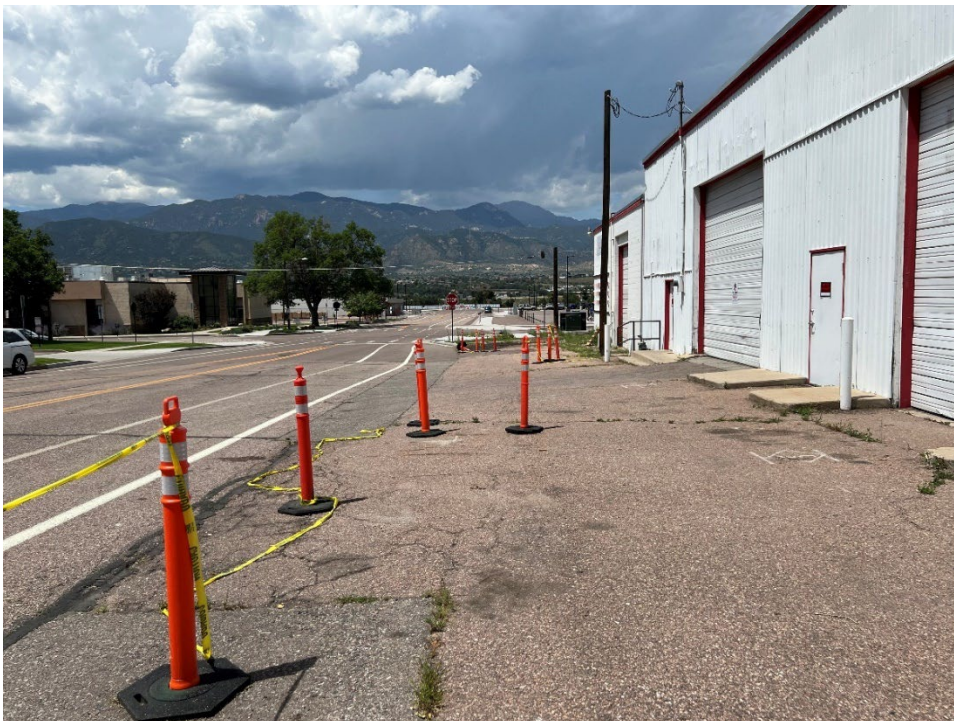
Figure 5. Excessive Curb Cuts Along Commercial Blocks

There is an excessive driveway along Costilla Street for the existing warehouse/storage facilities on parcels 1 and 2, shown in **Figure 5**. The drive covers approximately a third of the block and does not include curb cuts or a sidewalk.

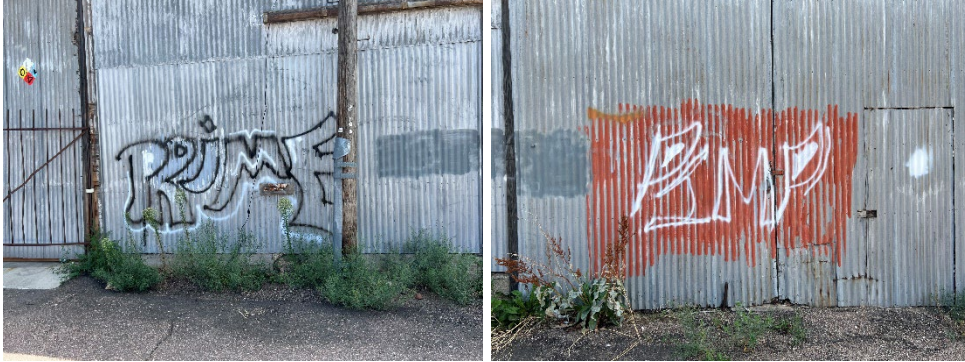
Figure 6. Vandalism/Graffiti

Throughout the Study Area unsafe and unsanitary conditions were documented, including vandalism/graffiti, excessive litter, and evidence of vagrants. Vandalism/graffiti was observed in alley on the backside of the building on parcel 2, shown in **Figure 6**.

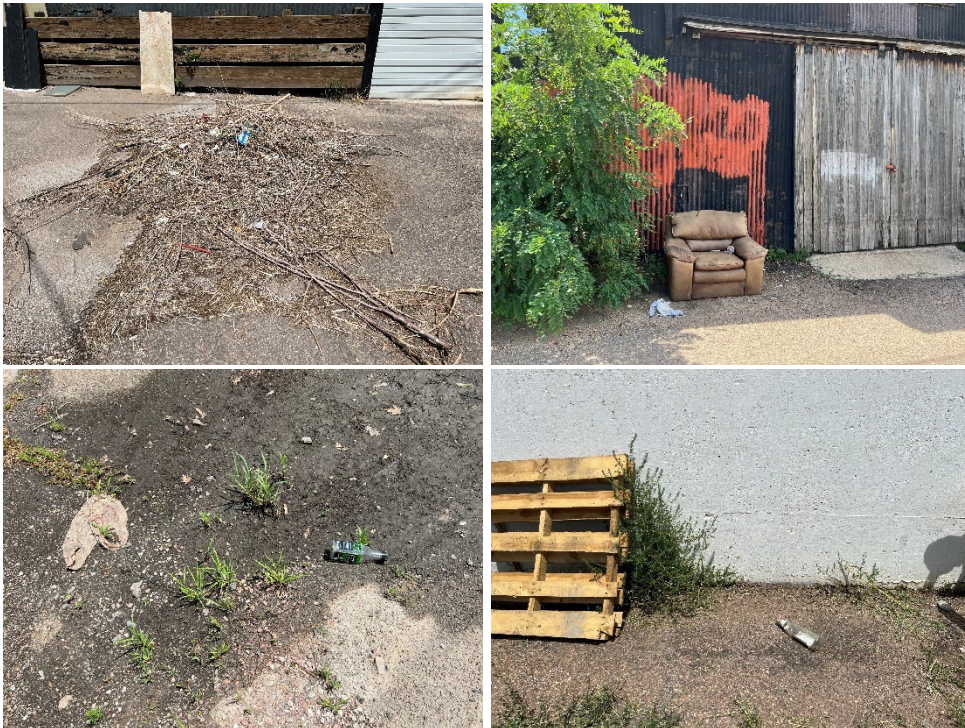
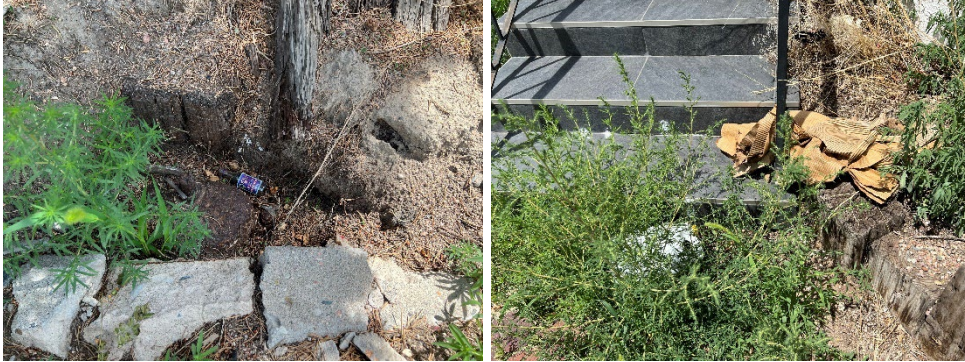
Figure 7. Excessive Litter

Excessive litter was observed and documented throughout the Study Area, shown in **Figure 7**.

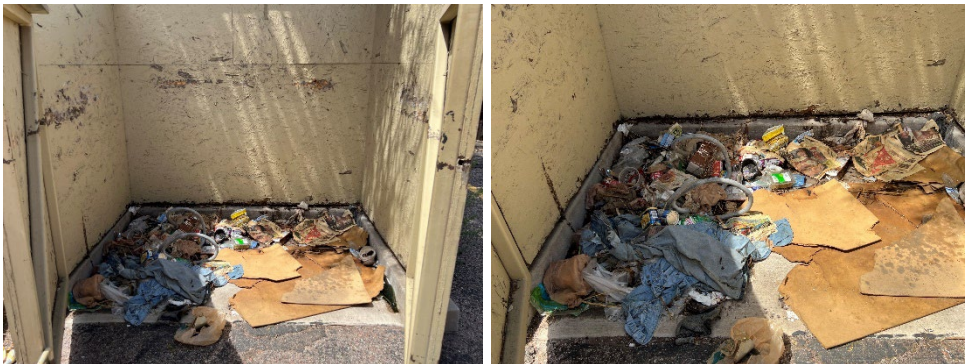
Figure 8. Evidence of Vagrants

Evidence of vagrant(s) was observed on parcel 4 in the gated area for the dumpster. The dumpster was removed and there was evidence that a person had been sleeping and hanging out there, shown in **Figure 8**.

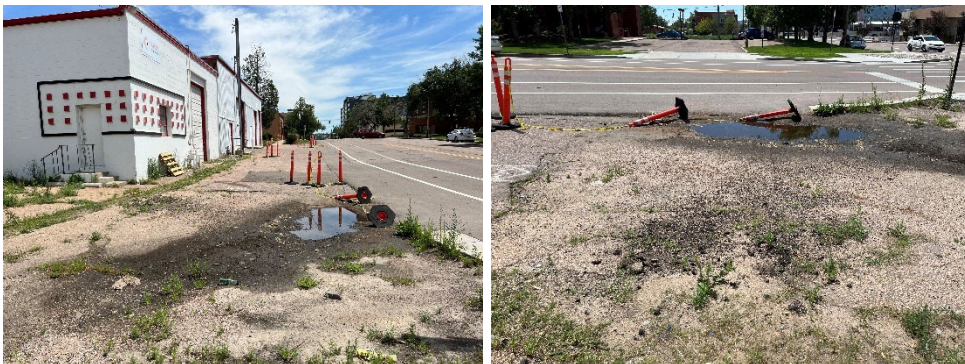
Figure 9. Evidence of Standing Water

Additionally, standing water was observed on parcel 1 along Costilla Street, shown below in **Figure 9**, which may indicate inadequate stormwater drainage.

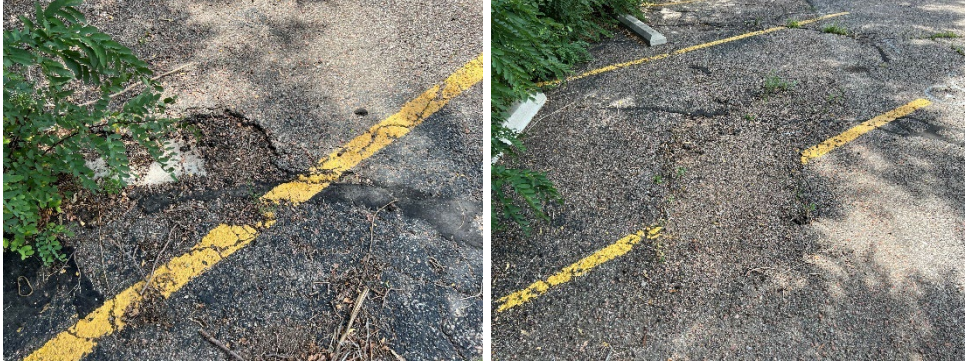
Figure 10. Deteriorated On-Site Parking Surfaces

Deterioration of site improvements were observed throughout the Study Area and overall the site shows signs of neglect. The small parking lot on parcel 4 showed signs of deterioration with missing sections of pavement and pot holes, shown in **Figure 10**.

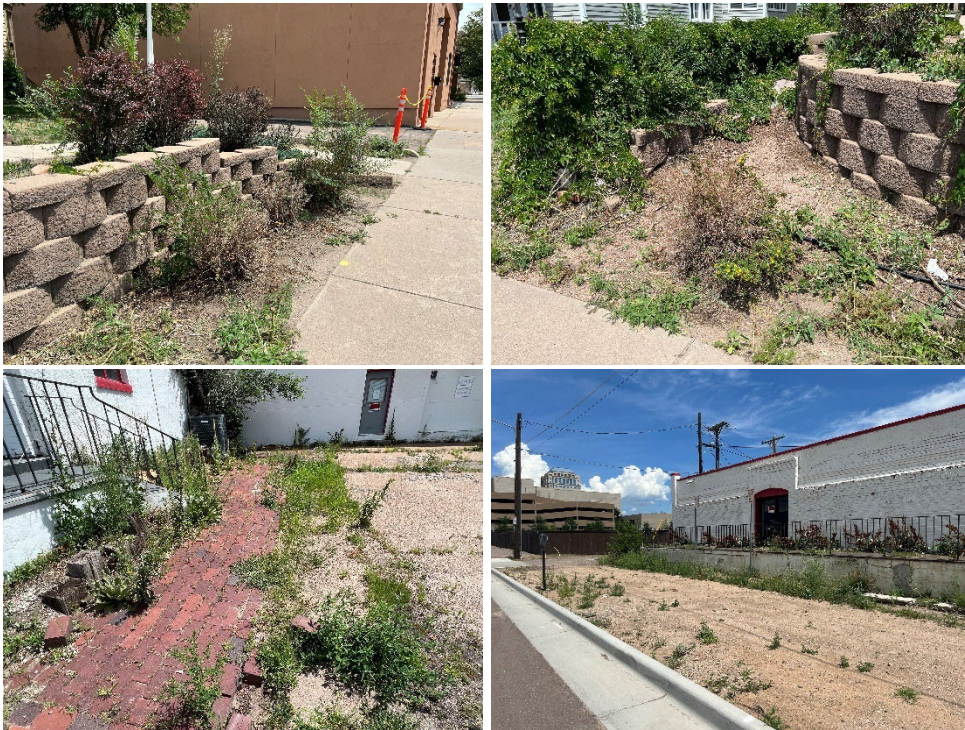
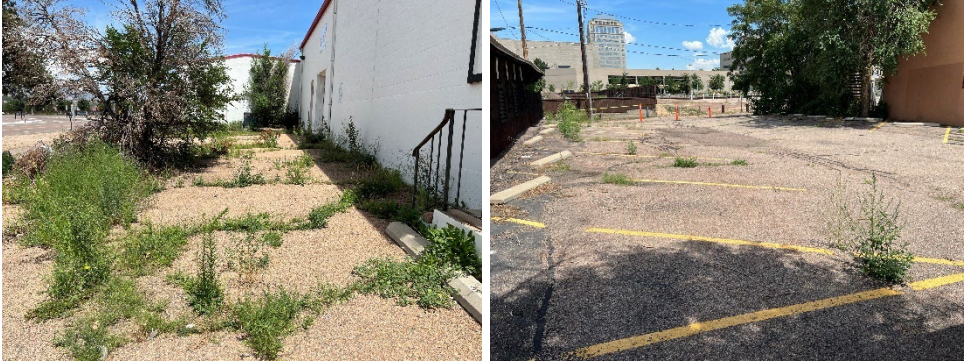
Figure 11. Overgrown Vegetation

Overgrown vegetation and poorly maintained landscaping was observed throughout the Study Area, shown in **Figure 11**.

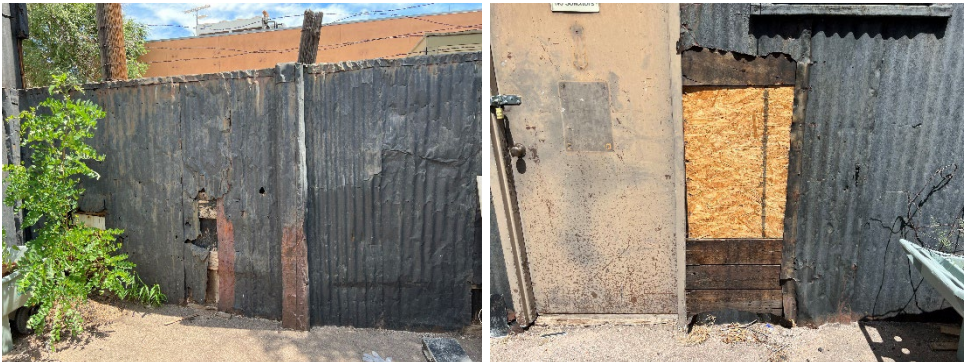
Figure 12. Deteriorated Fences and Walls

On parcel 3 a deteriorated portion of fence and exterior wall of the shed was observed, shown below in **Figure 12**.

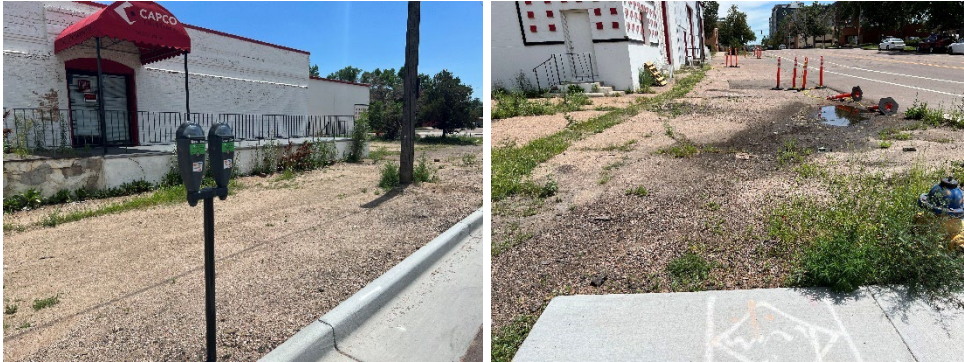
Figure 13. Lack of Sidewalks and Curb

Inadequate infrastructure was observed throughout the Study Area, predominately in the form of deteriorated pavement and lack of curbs and sidewalks. As previously mentioned, there is no sidewalk along Sahwatch Street and Costilla Street on parcels 1 and 2, shown in **Figure 13**.

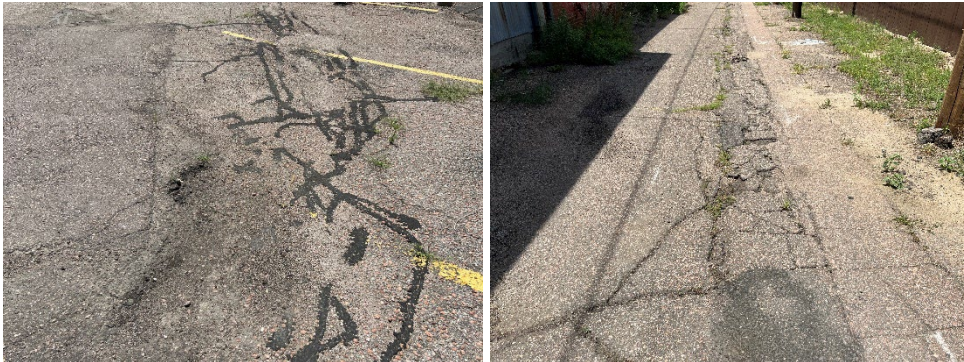
Figure 14. Deteriorated Pavement

In addition, the section along Costilla Street is also missing a curb. Deteriorated pavement was observed on the parking lot on parcel 4 and along the alley behind all the parcels, as shown in **Figure 14**.

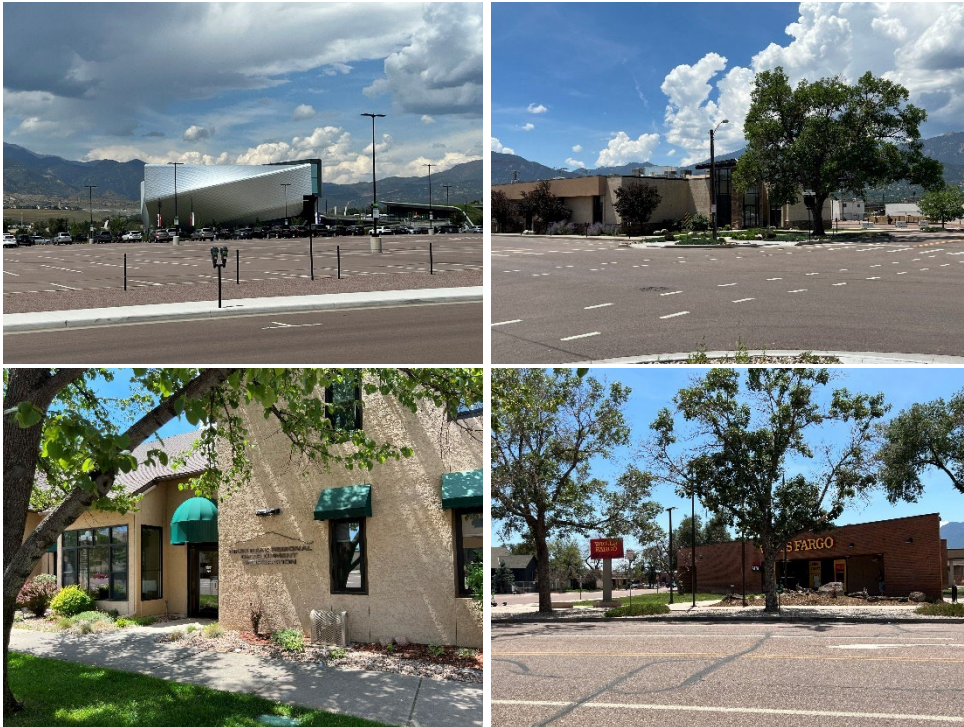
Figure 15. Underdeveloped Parcels in an Urbanized Area

The Study Area is comprised of parcels that are underdeveloped and underutilized in the urban location. The surrounding context of the Study Area is largely developed with commercial uses, shown in **Figure 15**, with the U.S. Olympic and Paralympic Muesum to the west, Colorado Springs Conservatory and Wells Fargo Bank to the south, Pikes Peak Regional Development Corporation to the east, and government buildings on the block to the north. The Study Area is in Downtown Colorado Springs and currently underutilized with older industrial uses and single family residences, all of which are currently vacant.
