N.E.S., Inc.
Geologic Hazard Investigation
Tax Schedule No. 63200-00-122
4785 Stanton Road
Newman Center
Colorado Springs, Colorado

Entech Job No. 180571
AAprojects/2018/180571 GeoHaz letter - City

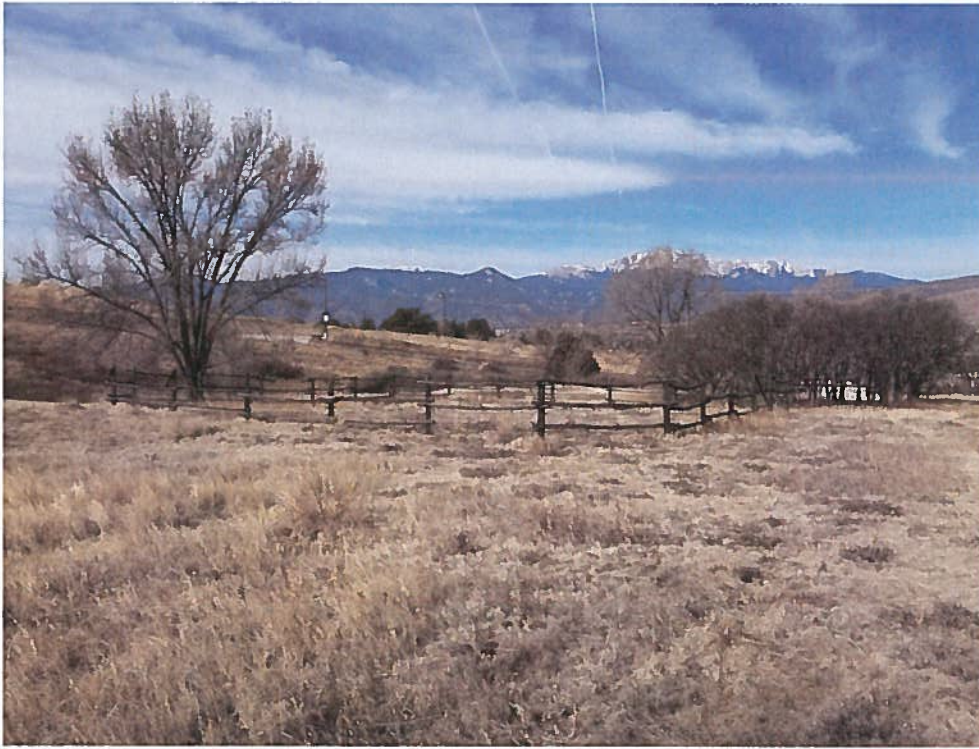
Looking west from the central portion of the site.

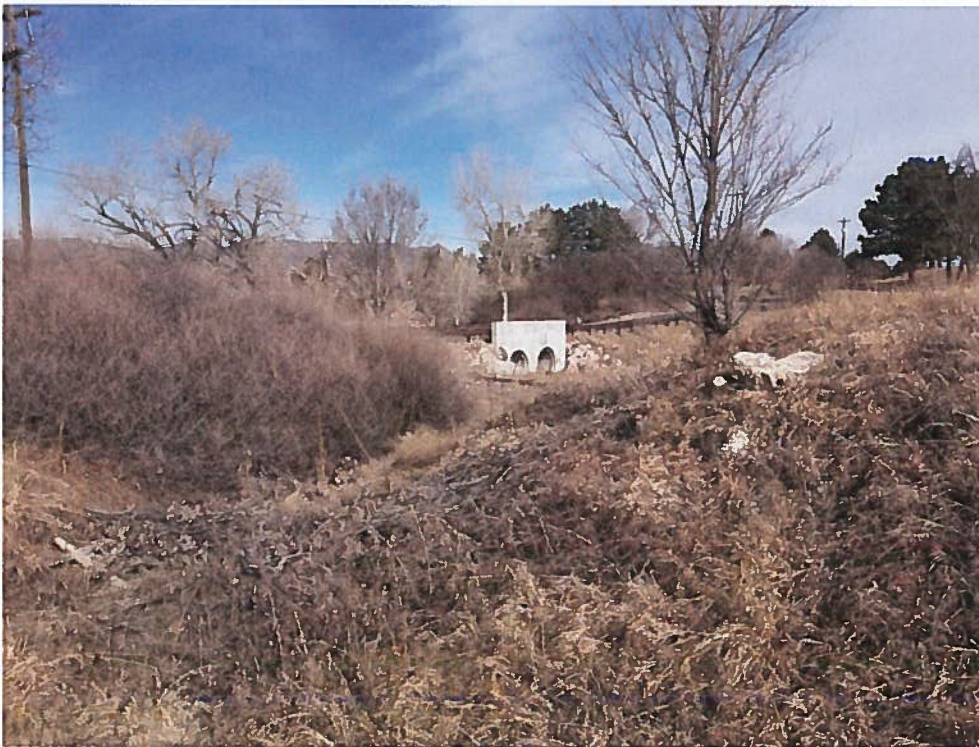
A drainage is located in the southern portion of the site that flows in a southwesterly direction. At the time of our site observations the drainage was dry. The site does not lie within any FEMA floodplain zones according to the FIRM Map No. 08041CO518F. Specific floodplain locations and drainage studies are beyond the scope of this report. Evidence of past debris or hyperconcentrated flows were observed in historical photos of the area. The potential for debris or hyperconcentrated flows exist in the drainage in the southern portion of the site. It is our opinion, that based on current site conditions and proposed grading the proposed building is located at sufficient distance away and topographically higher than the drainage that it should not affect the proposed structure. Proper erosion control should be implemented to protect the banks of the drainage from significant erosion in the future. The proposed finish floor elevation of the building is 6,331 feet, and the elevation of the roadway at the location of the two 60-inch concrete culverts are located is 6,318 feet. If the culverts were to become clogged with debris during a flooding event, it is anticipated the drainage would overflow at Stanton Road before the proposed structure could be potentially affected.

Looking northwest along drainage that is located to the southwestern portion of the site.

Mitigation: Mitigation will be required along the drainage channel to protect the site from damaging effect of future hyperconcentrated flows. These flows could have the potential to cause severe erosion and have the potential to cause blockages in downstream culverts. The 100-year flow potential for the drainages that flow into the site is 332 cfs. The planned drainage improvements should account for these quantities of flows and also account for the increased sediment and debris transported in the hyperconcentrated flows.

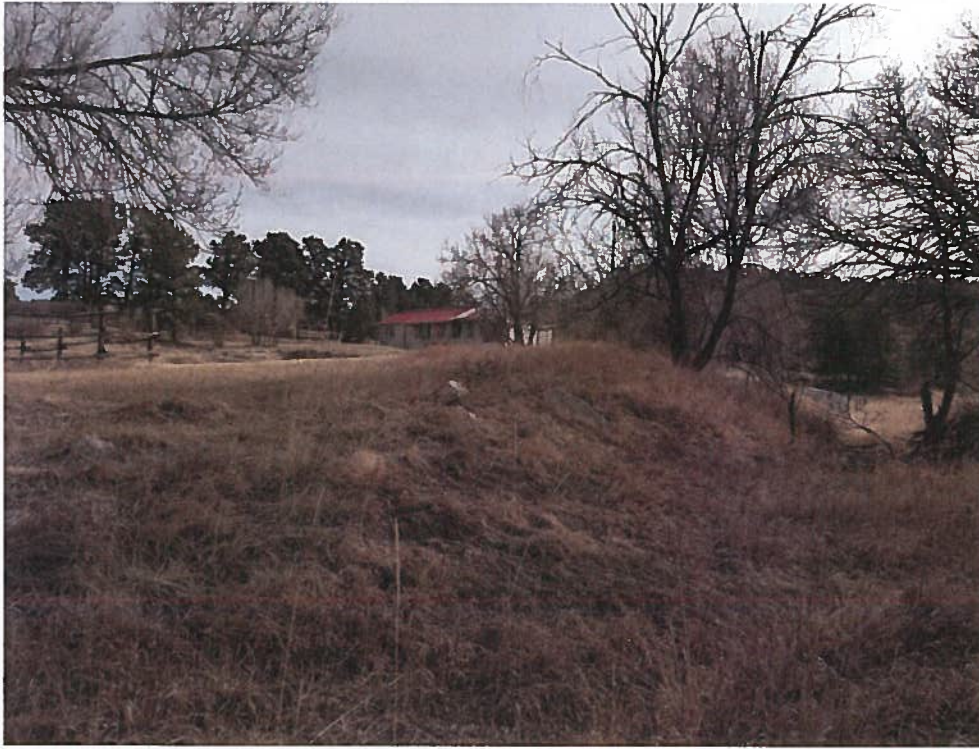
Looking north from the southeastern portion of the site.

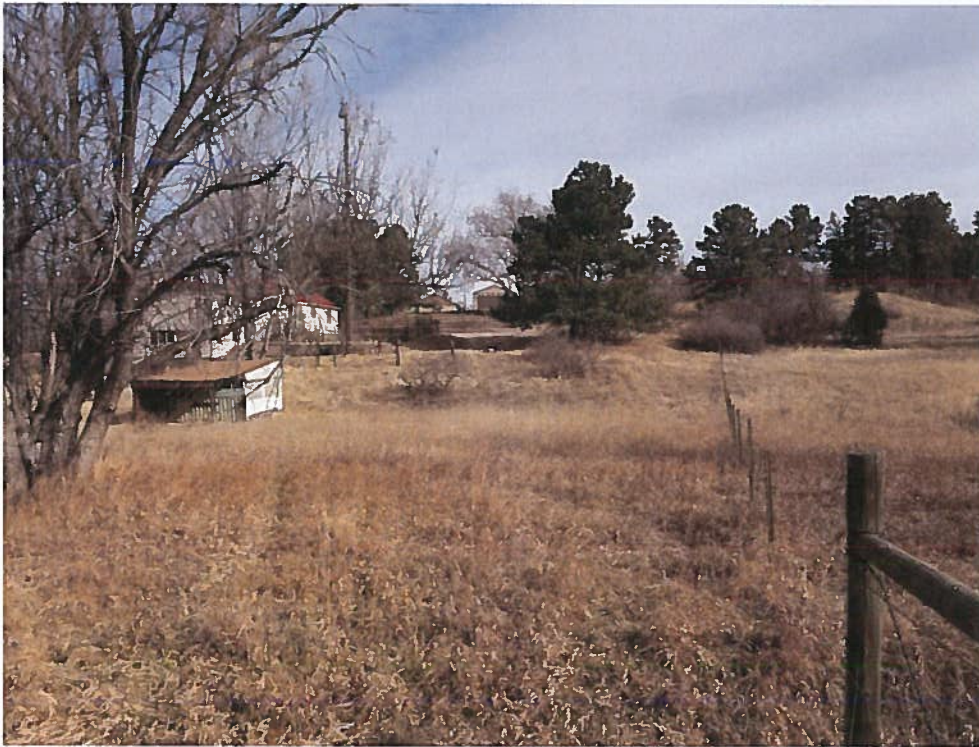
Looking north from the southeast corner of the site.

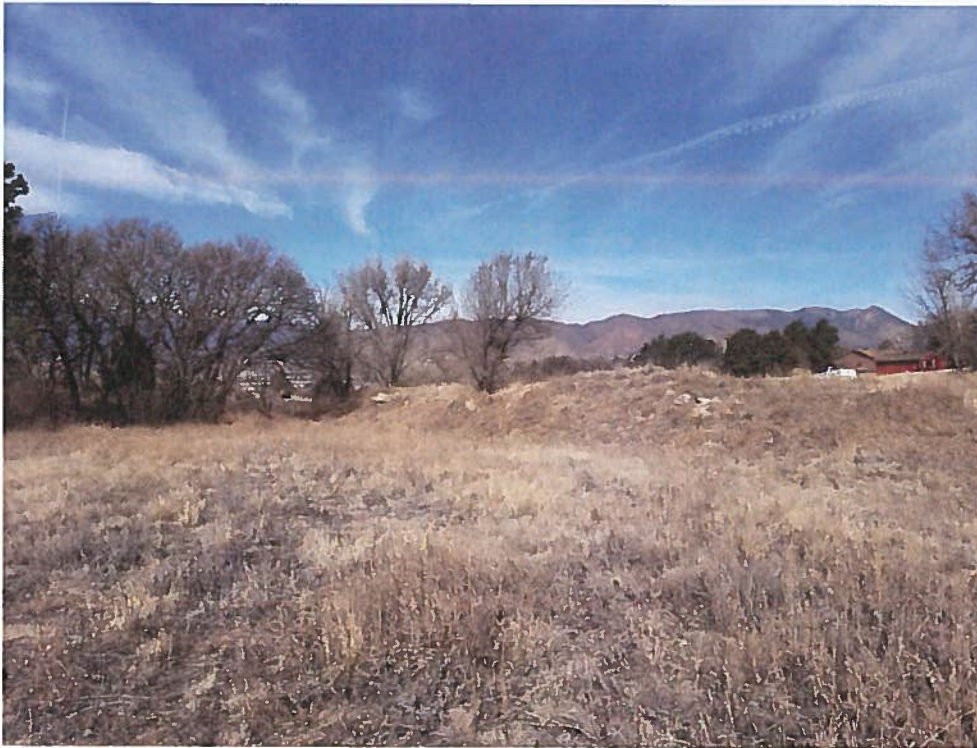
Looking west from the southeastern portion of the site.

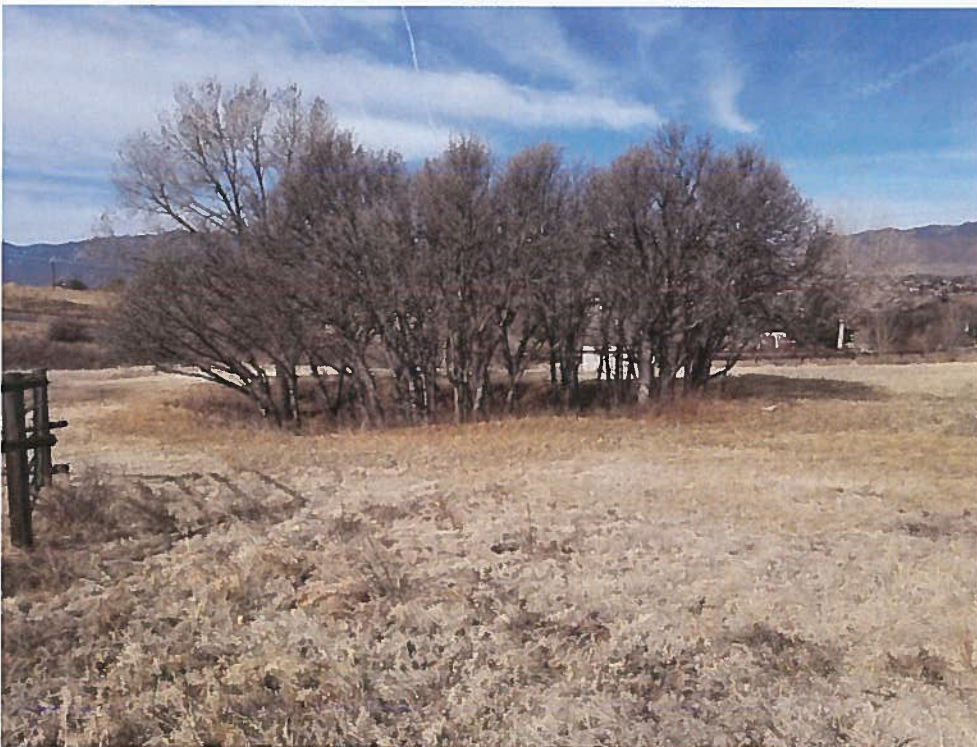
Looking west towards depression in the proposed building area.
