APPLICATION FORM FOR GEOLOGIC HAZARD REPORT

Premises Involved: Development Plan/Subdivision Plat Name: 205 Yale Avenue, Colorado Springs, Colorado

Job No. 175767

GEOLOGIC HAZARD STUDY

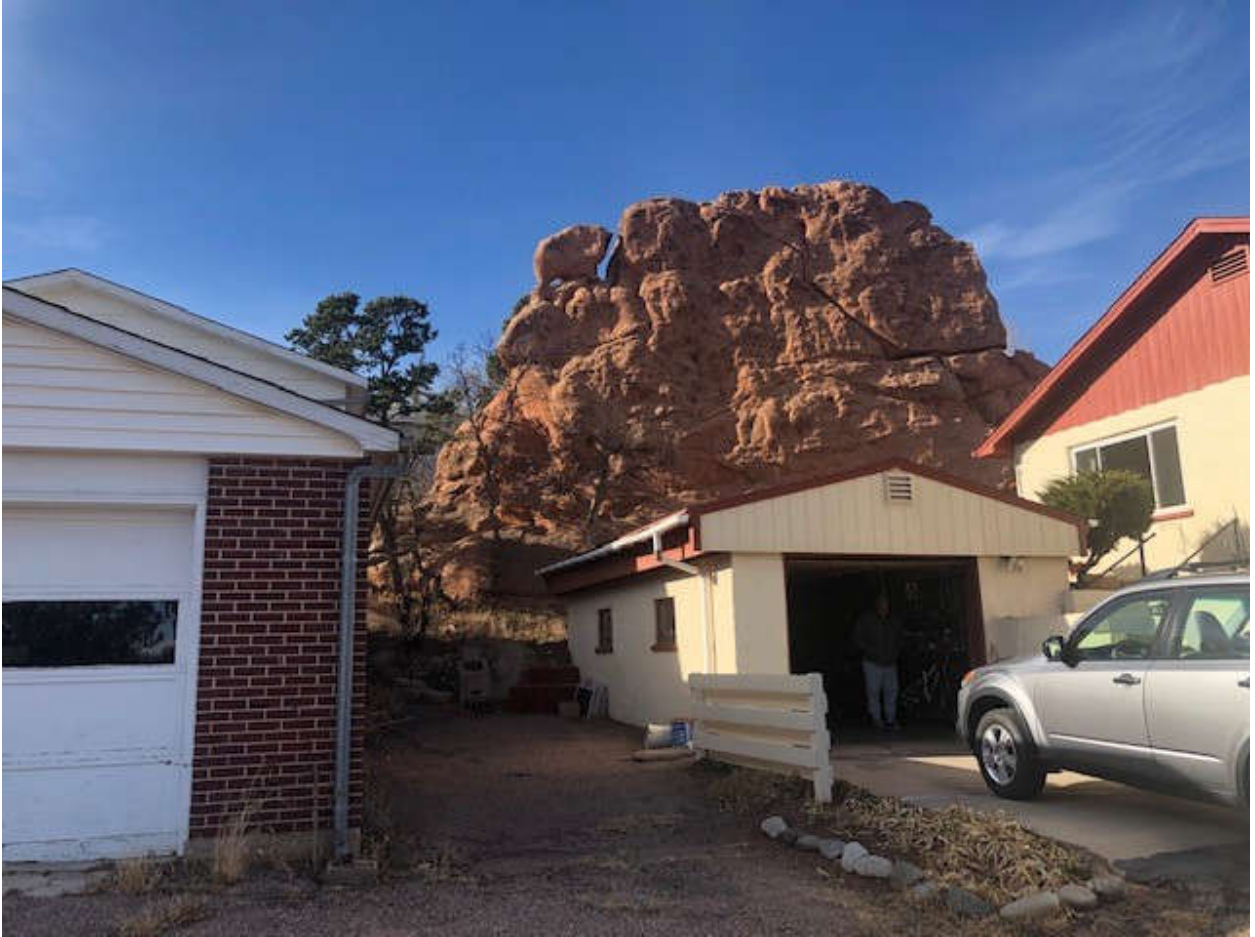
Left of photo, detached garage. Right of photo, 204 Red Rock Ave.

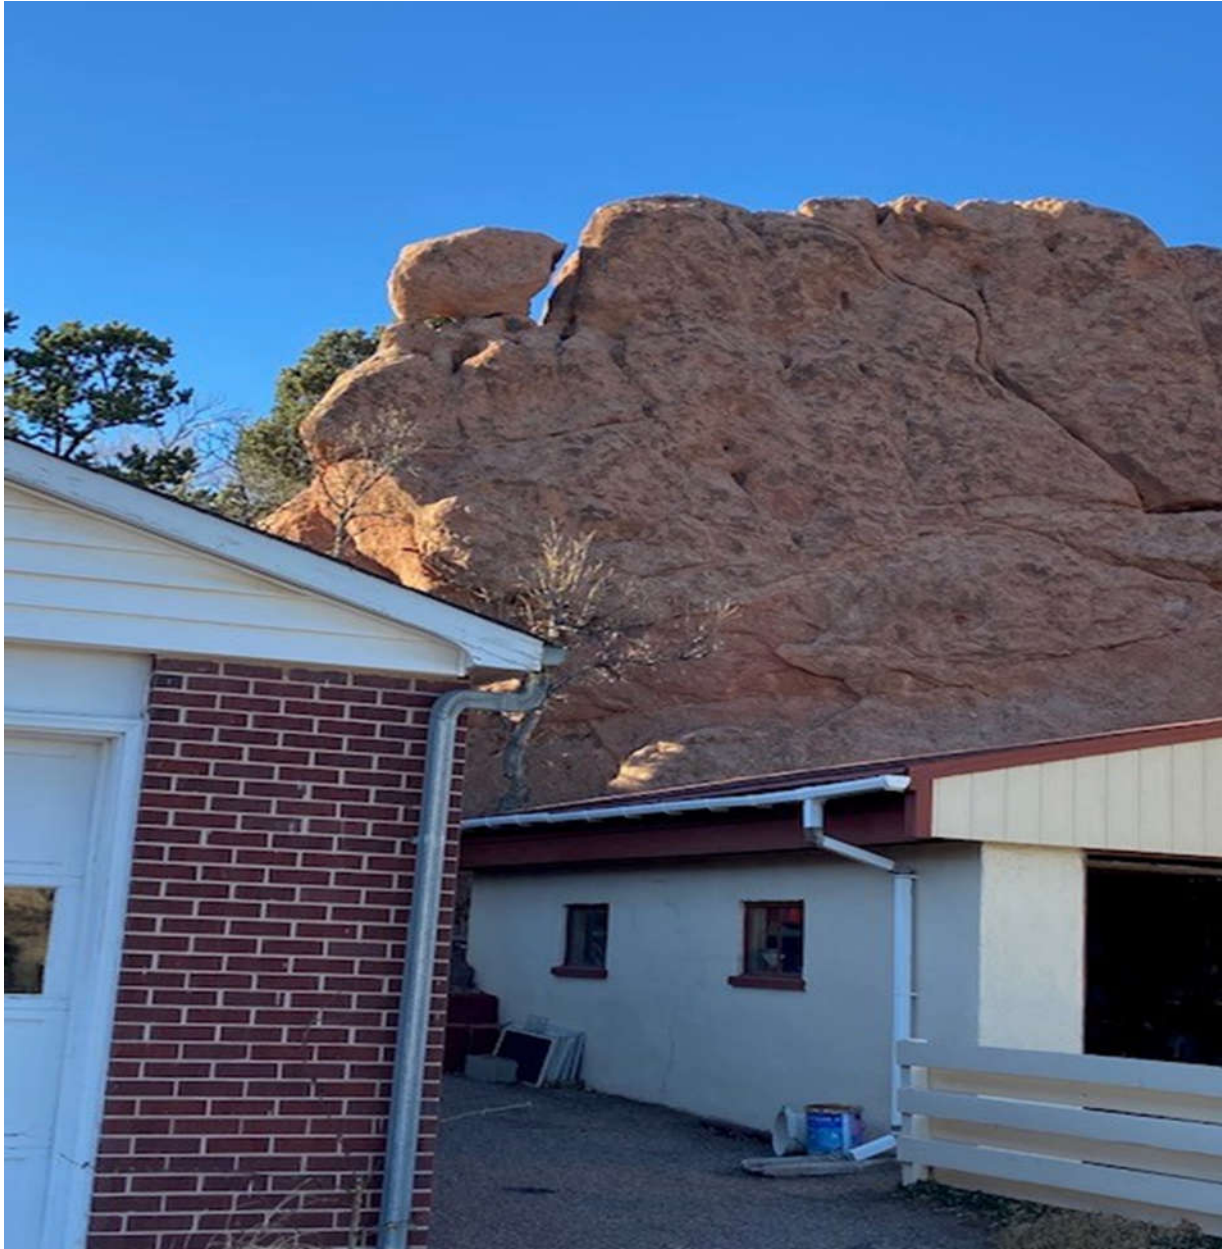
Neither free-standing boulders nor freshly calved sandstone wedges were observed on or around the sandstone "fin". Based on the lack of free standing boulders, absence of any indications of recent rockfall, the general resistance of this and similar formations to weathering due to their strong cementation and thickly bedded grains, and the orientation of the majority of the fractures, it is our opinion that the sandstone "fin" is not considered an imminent rockfall hazard. Photos of the sandstone "fin" are included in Appendix C. Furthermore, as the anticipated ground vibrations from the proposed construction are anticipated to be at least 50 times lower than the levels generally considered "safe" for sensitive historic structures or structures in a poor or deteriorated state of maintenance (which we judge to be weaker than the subject sandstone "fin"). While this does not guarantee that a portion of the sandstone "fin" won't detach during the proposed construction (nor could such a guarantee be reasonably expected), it is our opinion that the risk of rockfall directly resulting from the vibrations caused by the proposed construction activities (as described above) is suitably low that rockfall hazard is not anticipated to preclude the proposed construction.

Sandstone "fin" formation west of 204 Red Rock Ave.

Blasting and ripping at the sandstone face are not currently proposed, and shall be prohibited. It is our understanding based on conversations with Mr. Robertson that demolition of the existing detached garage, concrete slab and asphalt paving is to incorporate reasonable measures to reduce the frequency and intensity of ground vibrations to a level that is not anticipated to adversely impact the sandstone “fin”, including limiting the use of “heavy” construction equipment to a “skid-steer” style loader. We recommend that the equipment be further limited to a rubber-tired “skid-steer”, which produces significantly lower ground vibration than the tracked version.

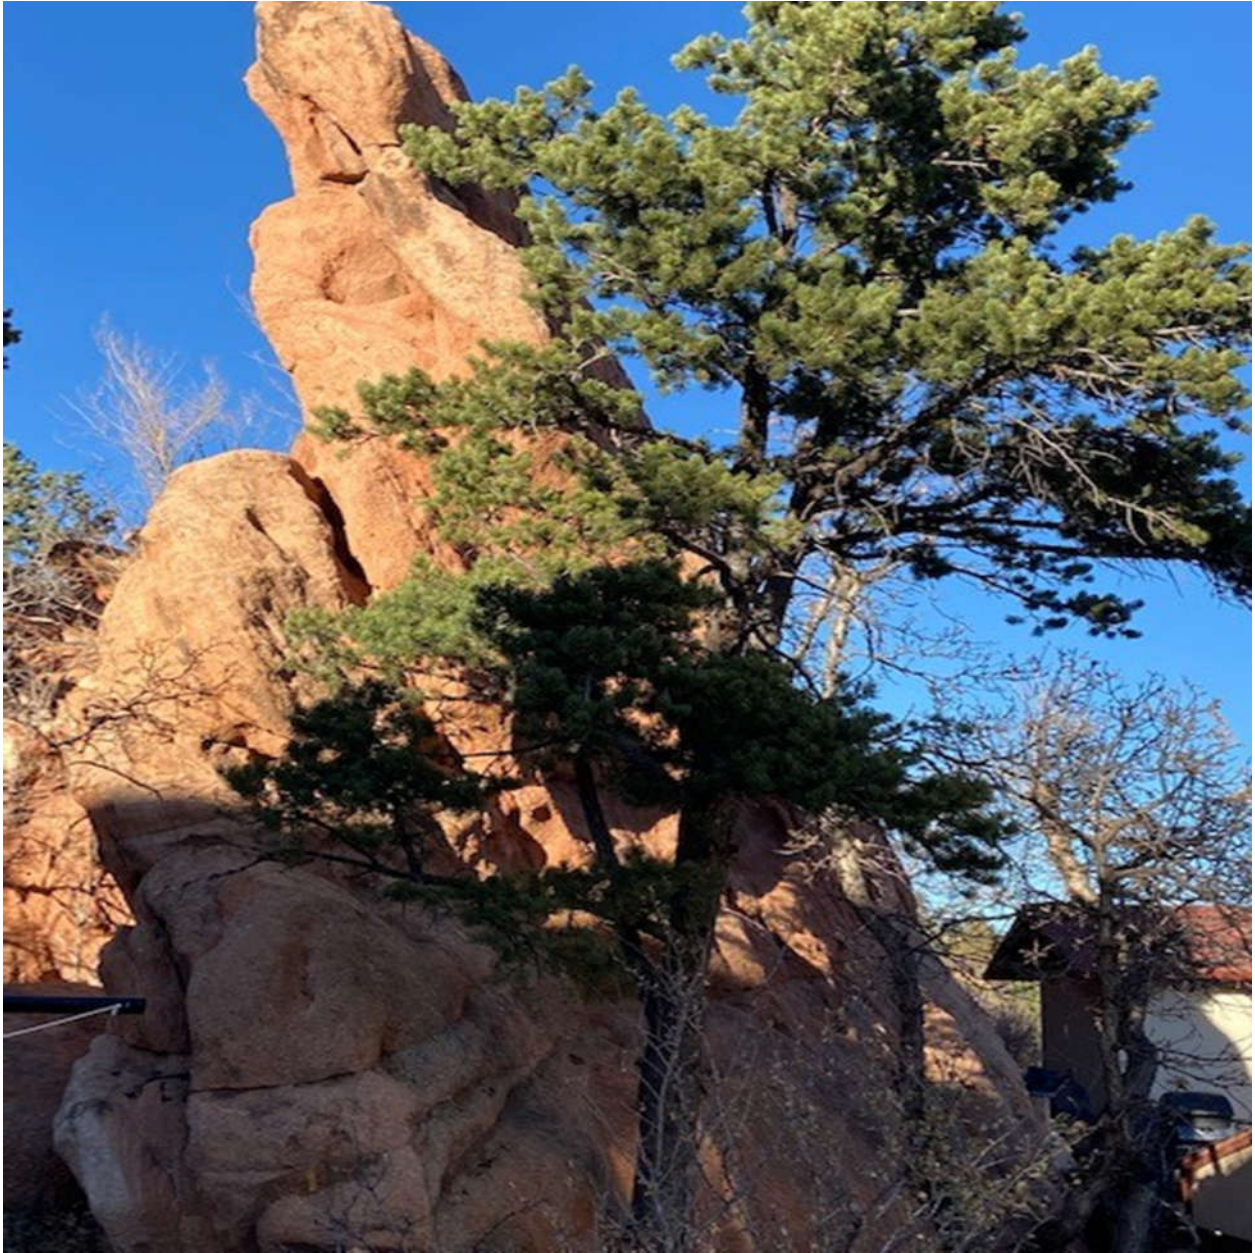
West of detached garage, looking north

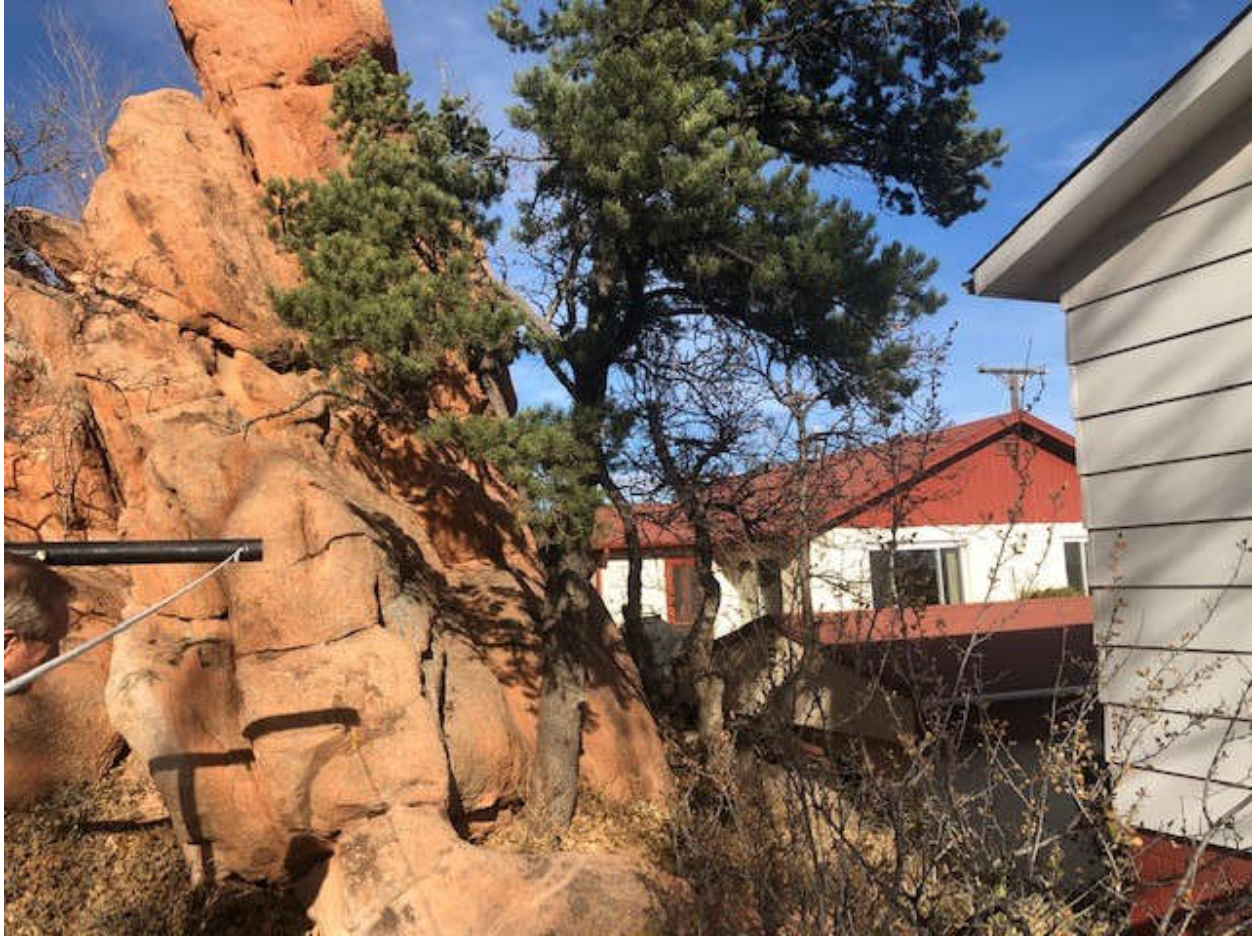
West of detached garage, looking north

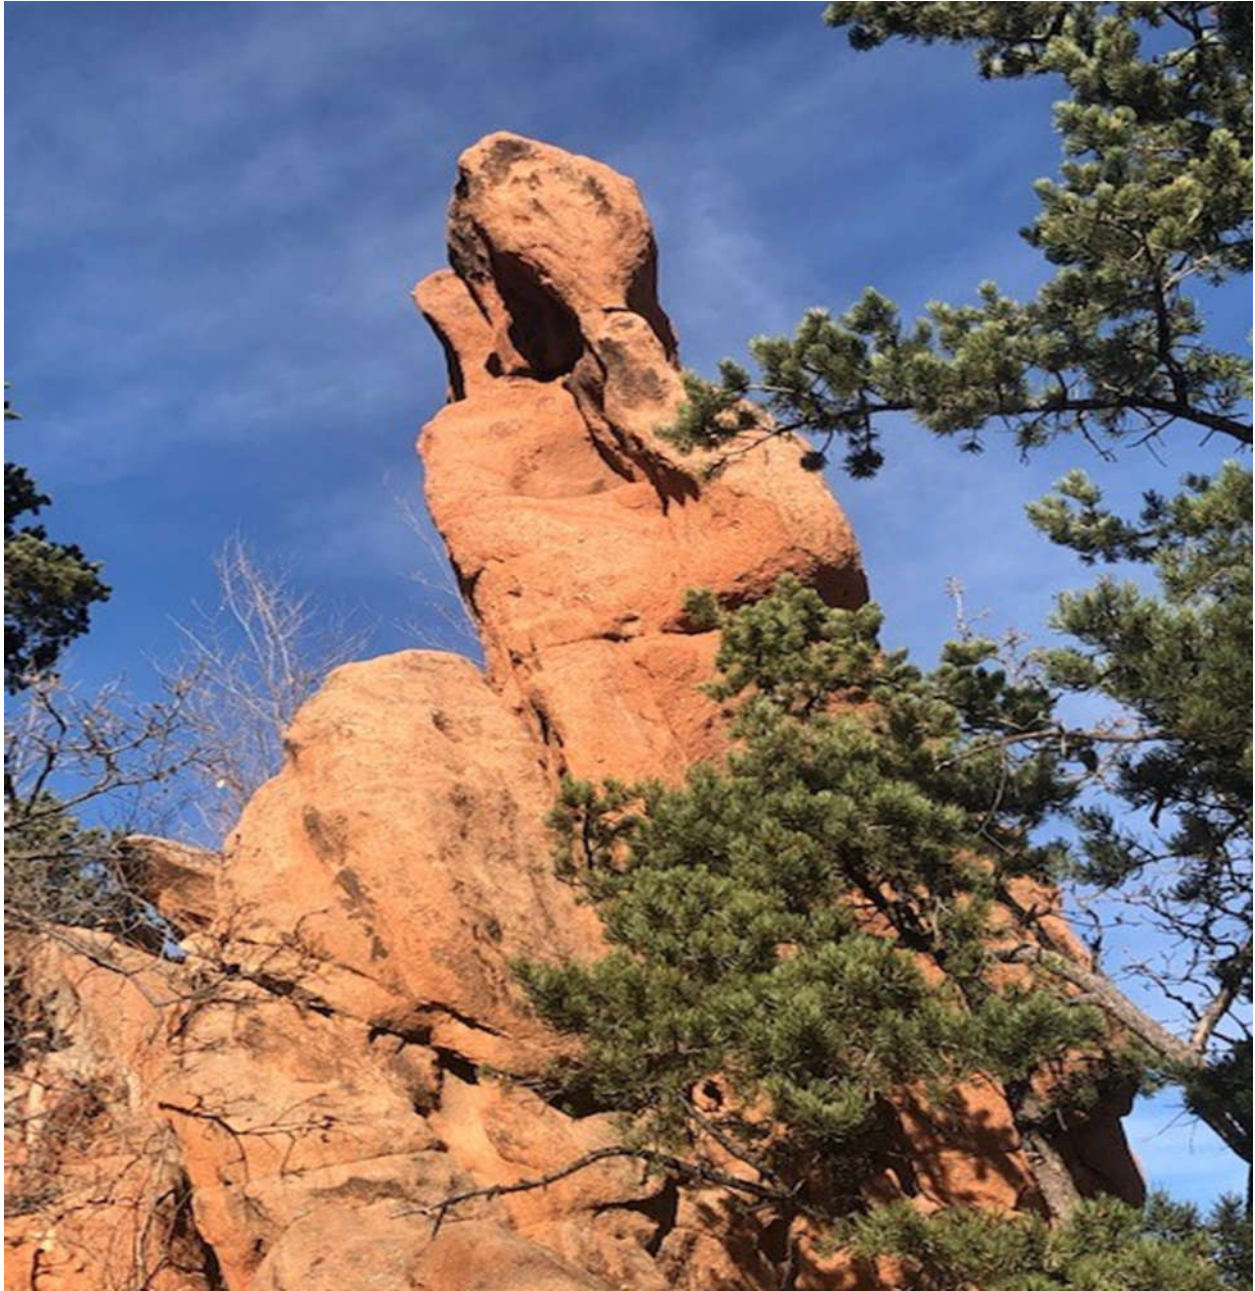
The steeply dipping sedimentary rock formation (sandstone “fin”) is mapped within the Rockfall Hazard Susceptibility map, referenced in Appendix A. According to the Rockfall Hazard map; *the mapped areas represent the maximum extent of possible rockfall hazard based on a “worst-case scenario” for a probably volume of falling rock. This includes effects following wildfires, modest earthquakes, and extreme weathering.*”

Steeply dipping sandstone formation

Use of specialized heavy equipment to facilitate rock removal and breakup is not anticipated, but could be necessary if substantial sandstone is to be removed. RMG recommends **blasting should be prohibited on the site due to the close proximity of other structures and the rock outcroppings.**

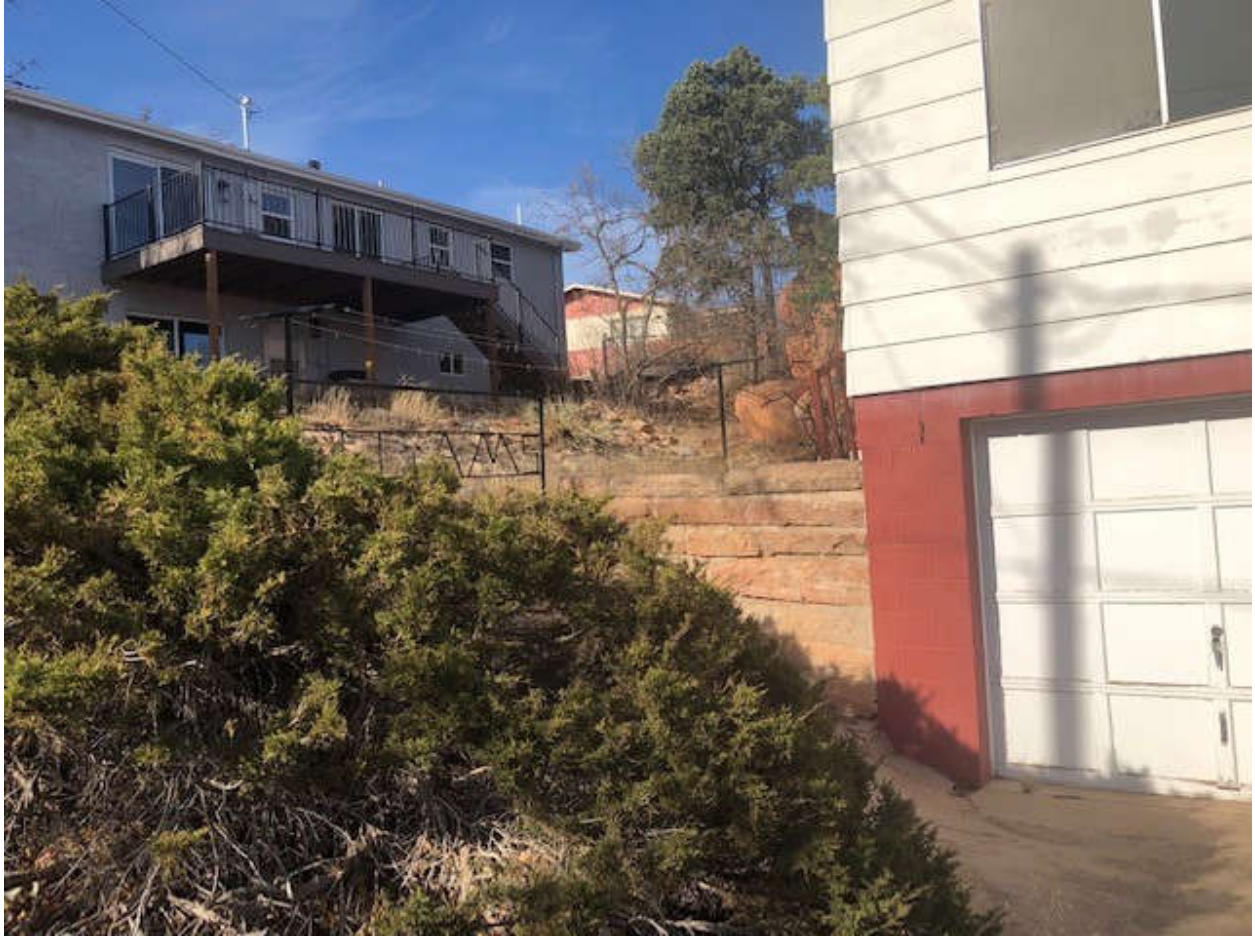
Retaining wall, west of detached garage to remain

Mr. Robertson is proposing to leave the rear wall of the existing garage and existing retaining wall in place. These walls will continue to support the "hillside" to the west. We recommend that a portion of the northern wall be left in place as well, to provide support for the "hillside" to the north. Note, one or both of these walls may require modifications to reinforce the severed ends of these existing (unpermitted, and presumably non-engineered) walls.

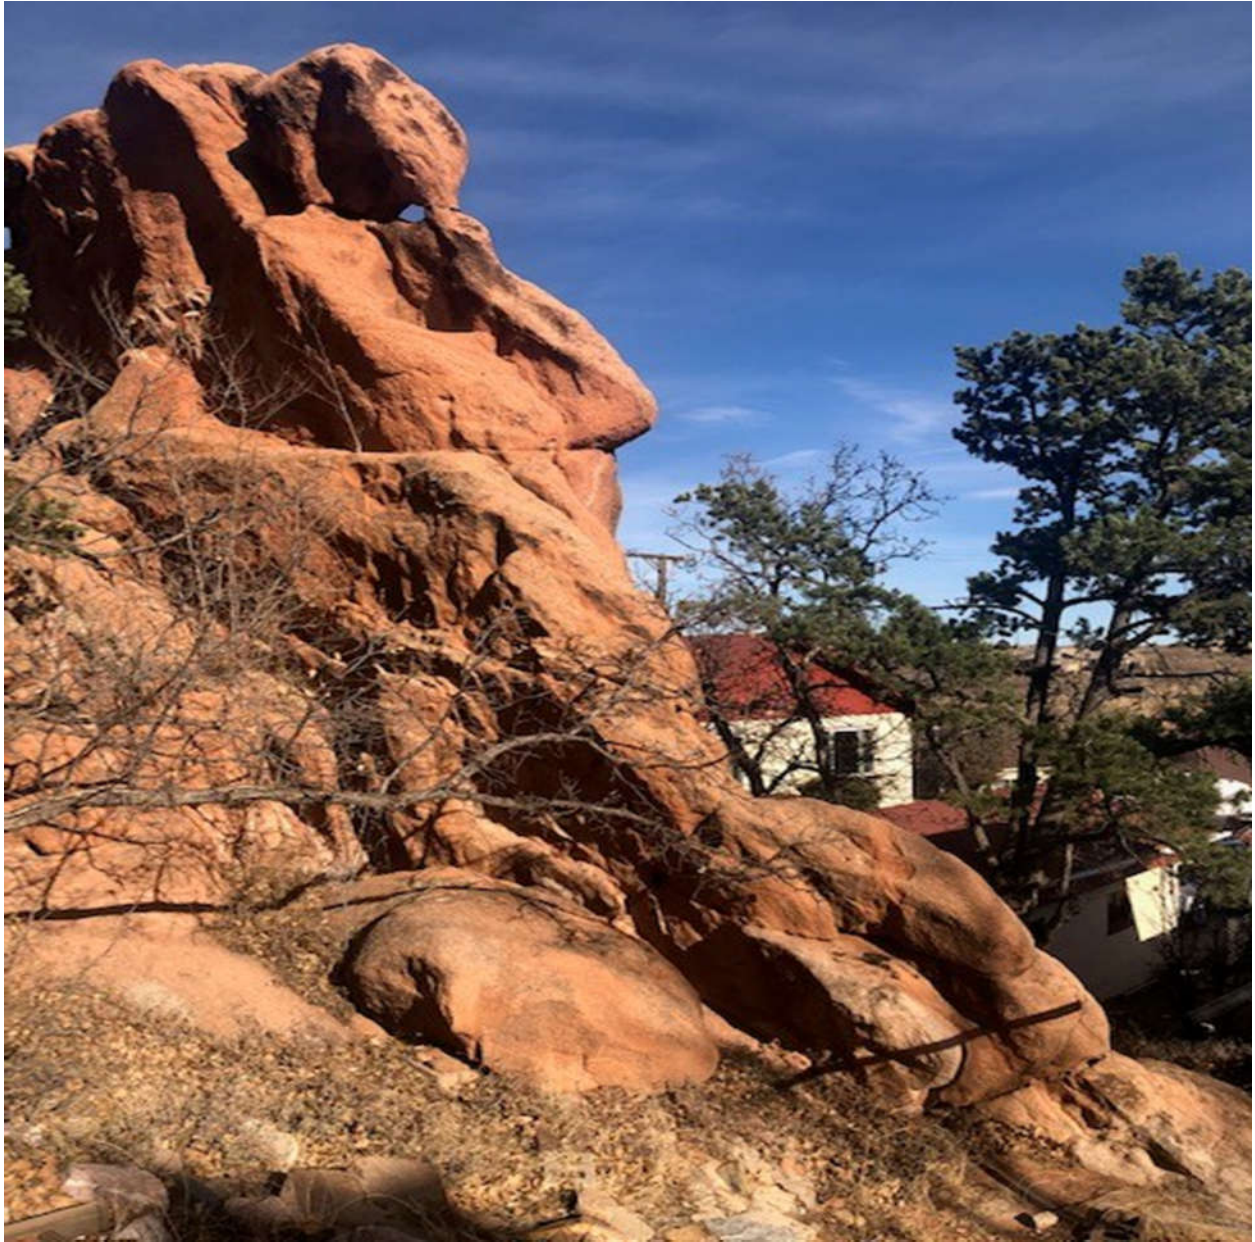
Looking northeast, towards 204 Red Rock Ave.

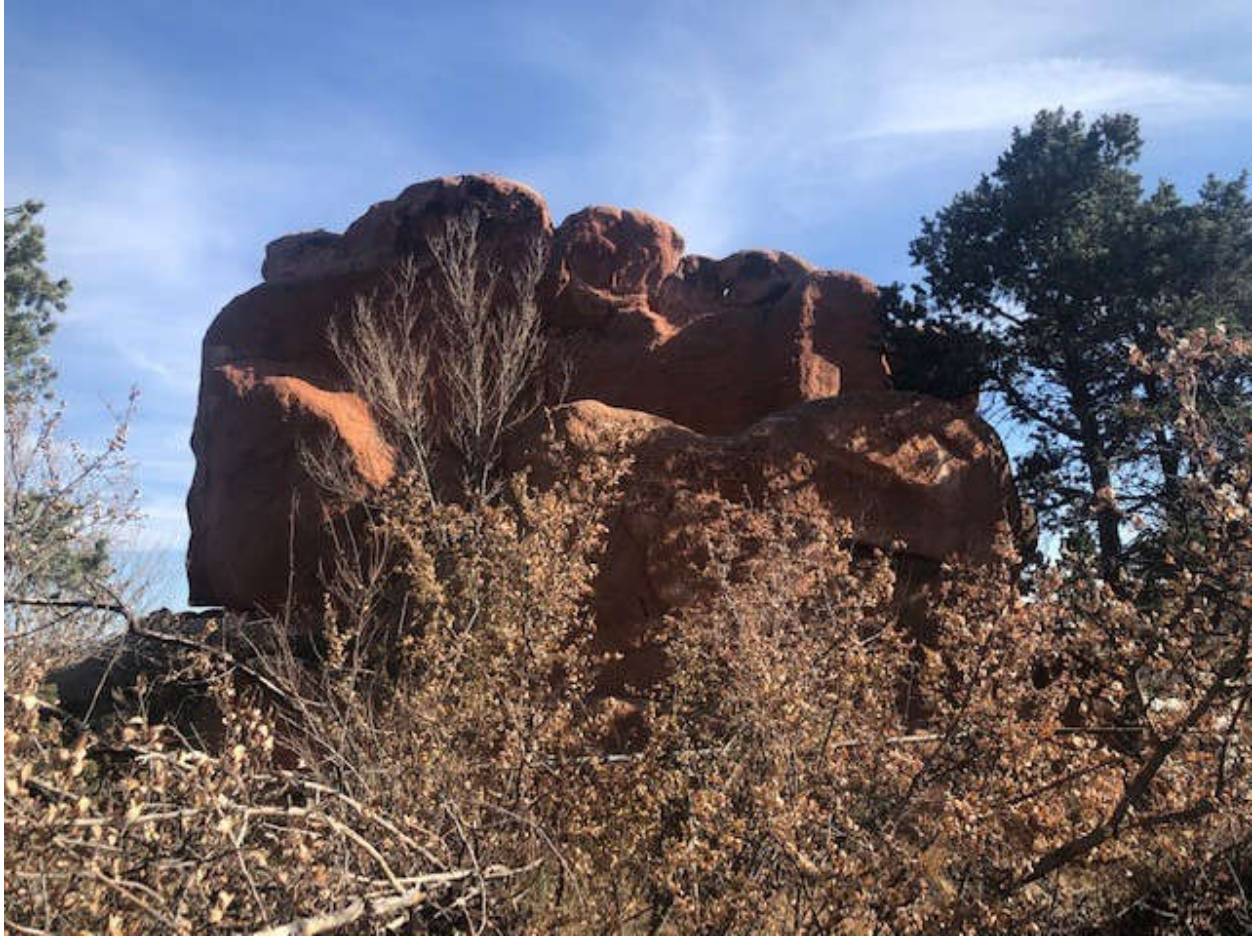
Looking east towards sandstone formation
