GEOLOGIC HAZARD ASSESSMENT PARCEL NOS. 74111-24-137 and 74111-24-206 SUN MOUNTAIN TOWNHOMES WEST UINTAH STREET AND NORTH 21ST STREET COLORADO SPRINGS, COLORADO

Re: Geologic Hazard Assessment

Sun Mountain Townhomes

Entech Job No. 221101

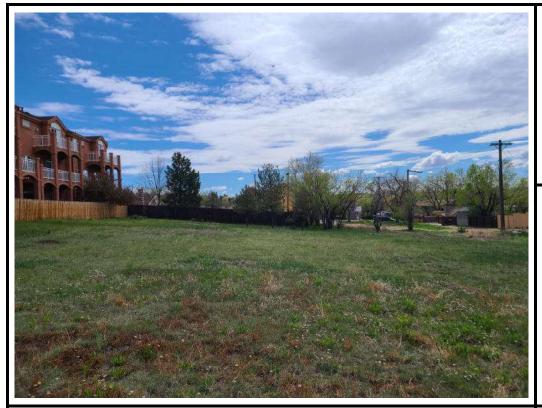
Looking east the north-central portion of the site.

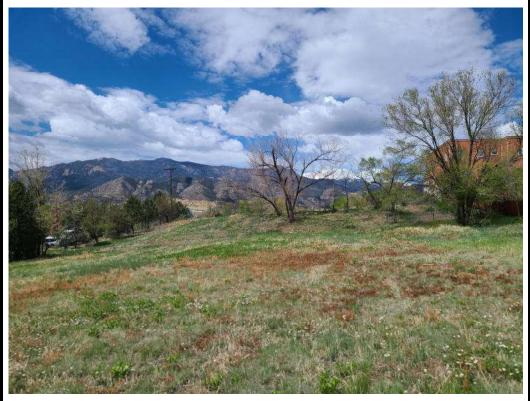
Looking west the north-central portion of the site.

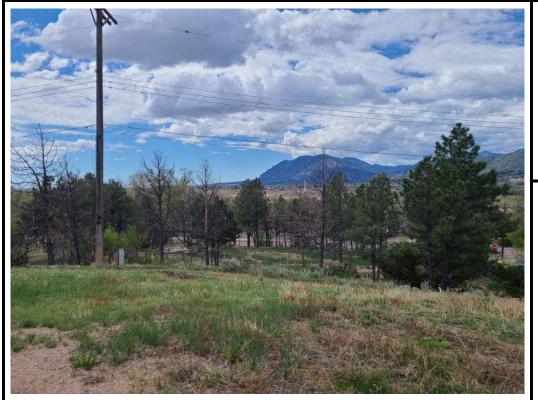
Looking south from the western portion of the site.

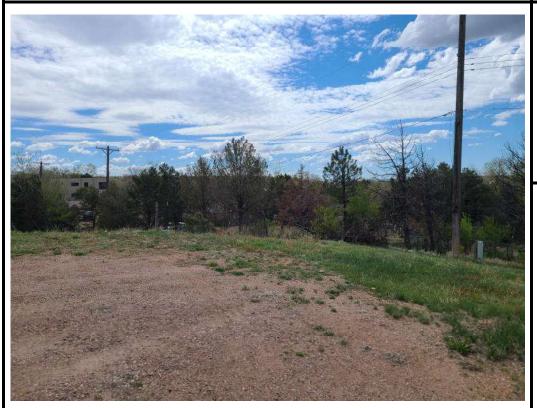
Looking southeast from the western portion of the site.
