Subject: Geologic Hazard Evaluation Update  
1615 High Tech Way  
Colorado Springs, Colorado  
Project Number CS20056-105

CTL|Thompson, Inc. (CTL|T) presents this Geologic Hazards Evaluation Update for the property located at 1615 High Tech Way in Colorado Springs, Colorado. The purpose of this letter is to update a previous geologic hazards report prepared by John Himmelreich & Associates that covered the subject project area. This was completed by reviewing existing information, including more recent reports in the immediate vicinity, and published geologic maps and aerial photographs.

Subject: Summary Report of Geologic Hazards  
Intel Subdivision No. 1  
Colorado Springs, Colorado  
Project No. 00-132

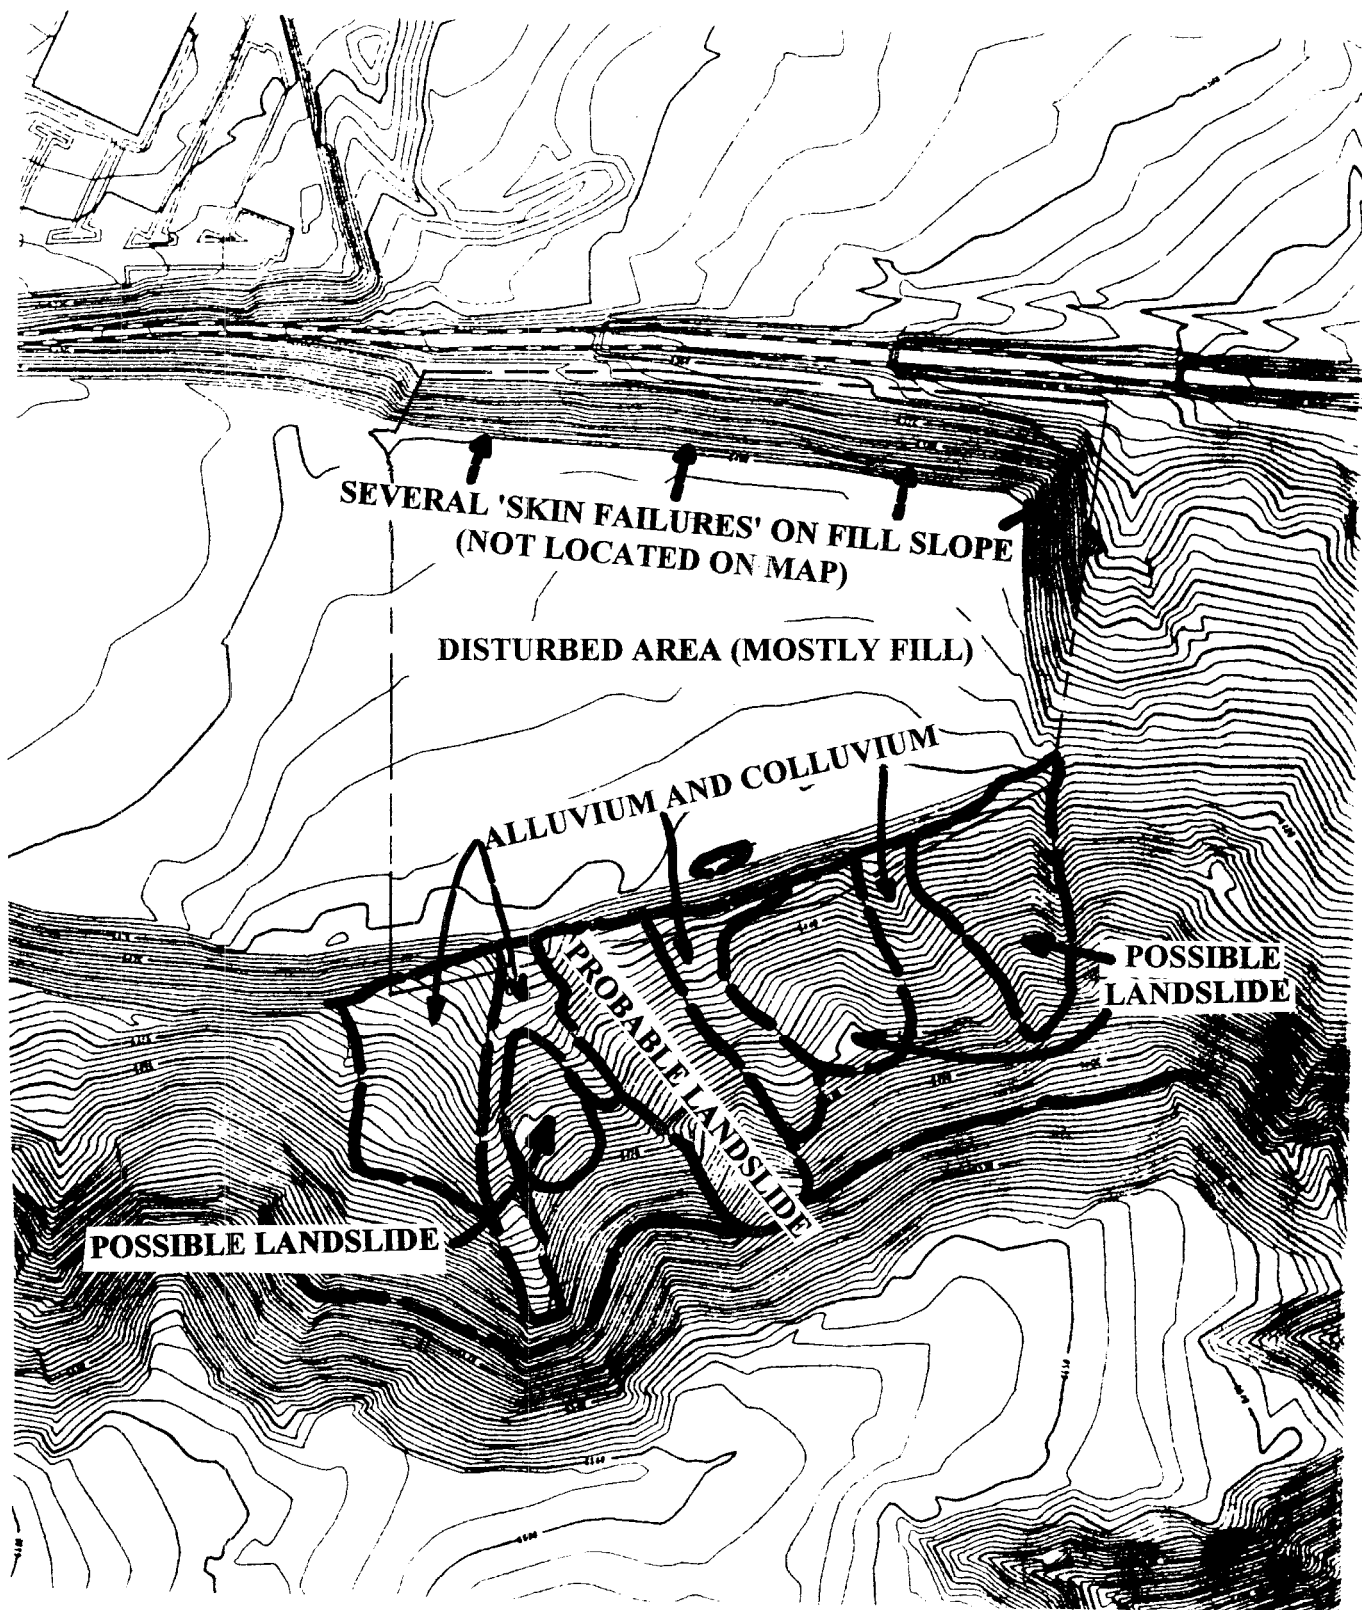
SURFICIAL GEOLOGIC MAP      FIGURE 2

Older landslides were mapped along the slope adjacent to the south boundary of the site (see Figure 2). Recent landslides have occurred on the site and adjacent site to the west. The recent landslides that occurred on the site in the spring of 1999 appear to be 'skin failures' associated with failure of the upper 1 to 3 feet of the fill slope surface (see attached Figure 3). Some of these failures slumped into the Douglas Creek channel.

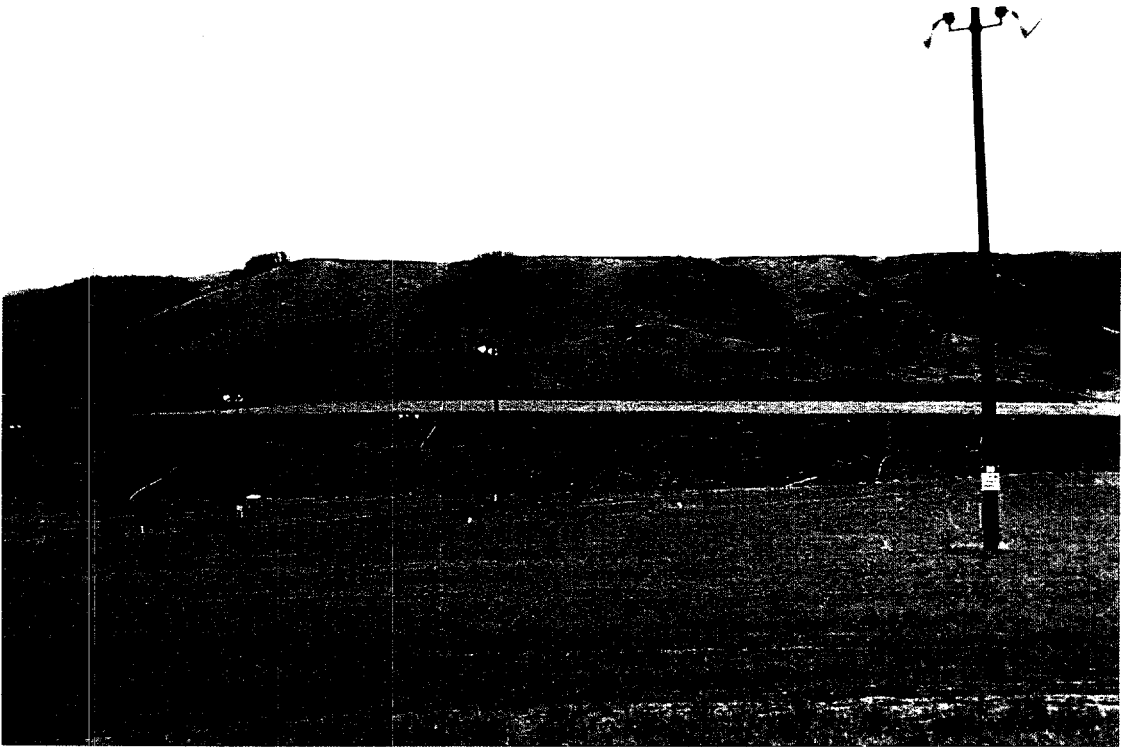
Several shallow 'skin failures' have occurred on the fill slopes south of Douglas Creek. The potential for additional skin failures has been mitigated (reduced) by the construction of the curb and gutter and drainage facilities for the south parking lot. The slope along the east part of the parking lot has also been flattened and re-vegetated.

Photos of 'skin failures' after 1999 storms.

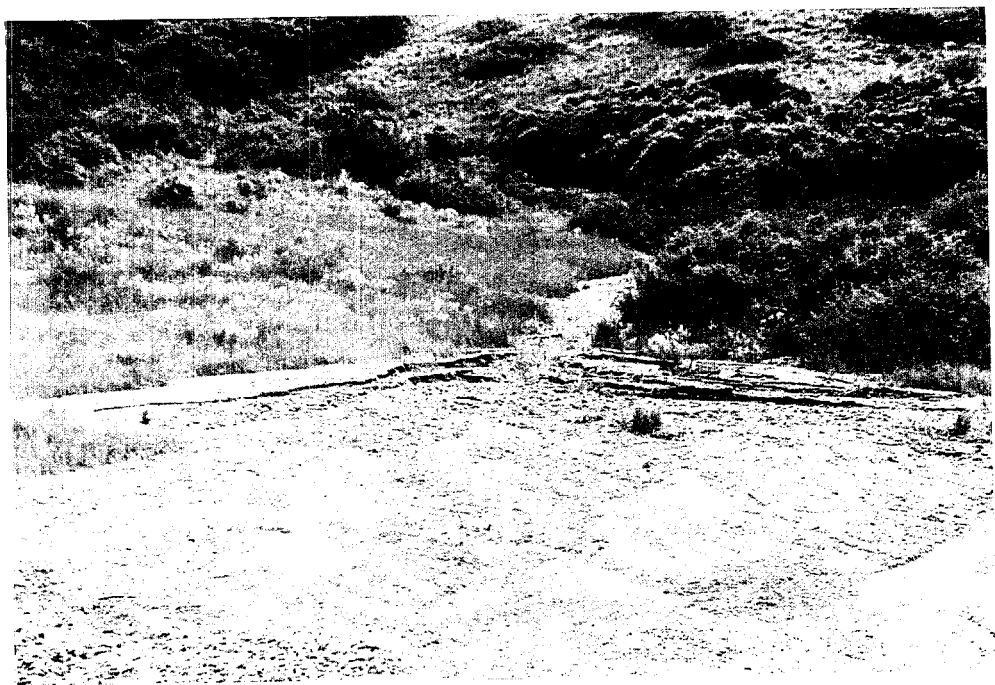
**Photo of sediment deposition near the southwest corner of the site (from 1999 storms).**
