Final Report

Gold Hill Mesa Commercial Existing Conditions Survey

City of Colorado Springs Urban Renewal Authority

February 18, 2022

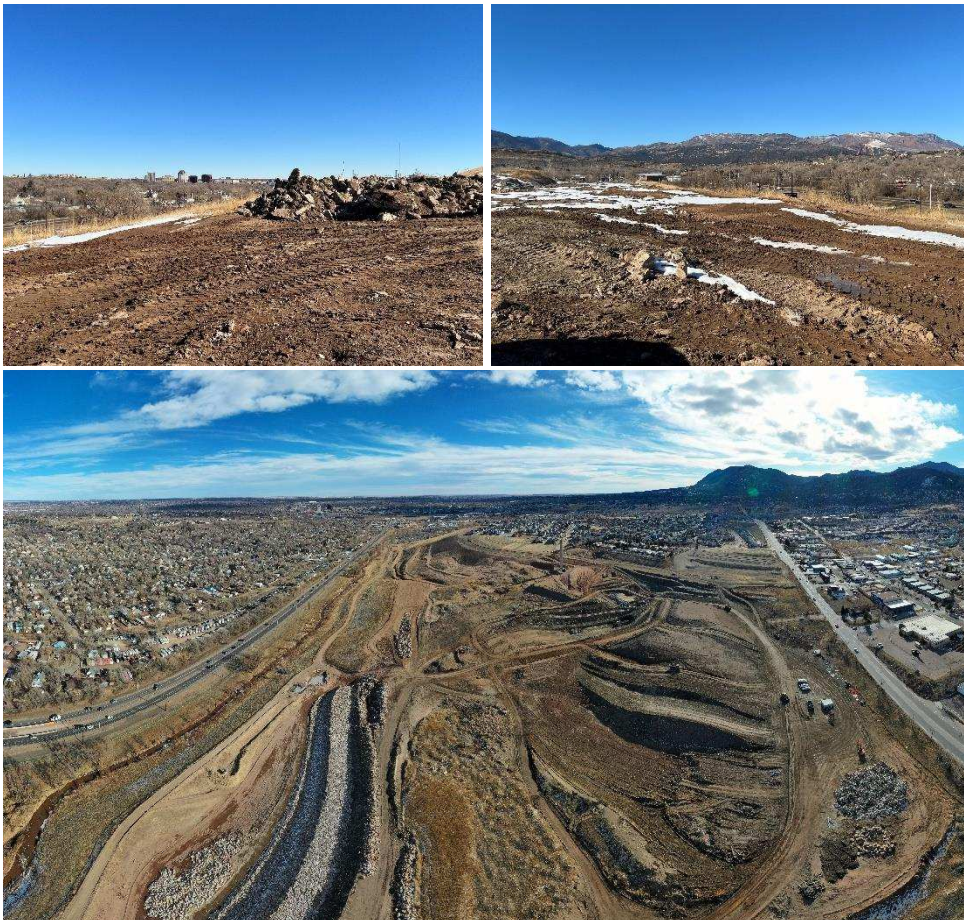
The Study Area includes a large area, over 100 acres, with 19 parcels. Many of these parcels are located within the interior of the site without street access due to lack of internal streets on site. This lack of connectivity is shown below in **Figure 3** as well as the progress of forming roadways and connections throughout the site to resolve this issue. This lack of connectivity also inhibits access to the existing residential homes and commercial buildings in Gold Hill Mesa to the major thoroughfares of Highway 24 and 21st Street. Additionally, this lack of street layout in the Study Area creates poor provision for vehicular traffic. Poor provisions of street improvements for pedestrians were observed in lack of sidewalks and lighting along the east side of South 21st Street, north side of Gold Hill Mesa Drive, and north side of Villa de Mesa Drive, as shown below in **Figure 4**.

Figure 3. Poor Internal Vehicular or Pedestrian Circulation

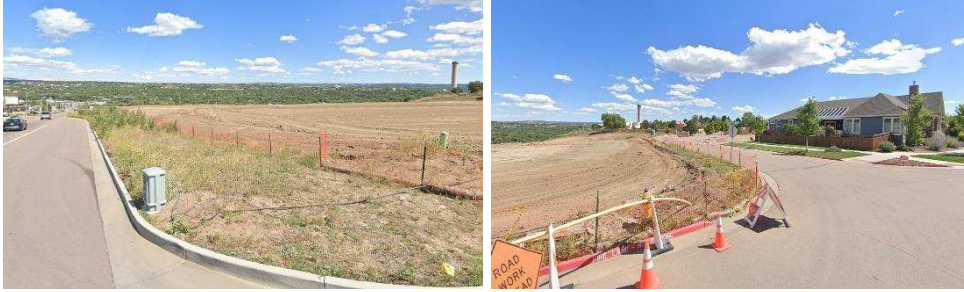
Figure 4. Poor Provision of Street Improvements for Pedestrians

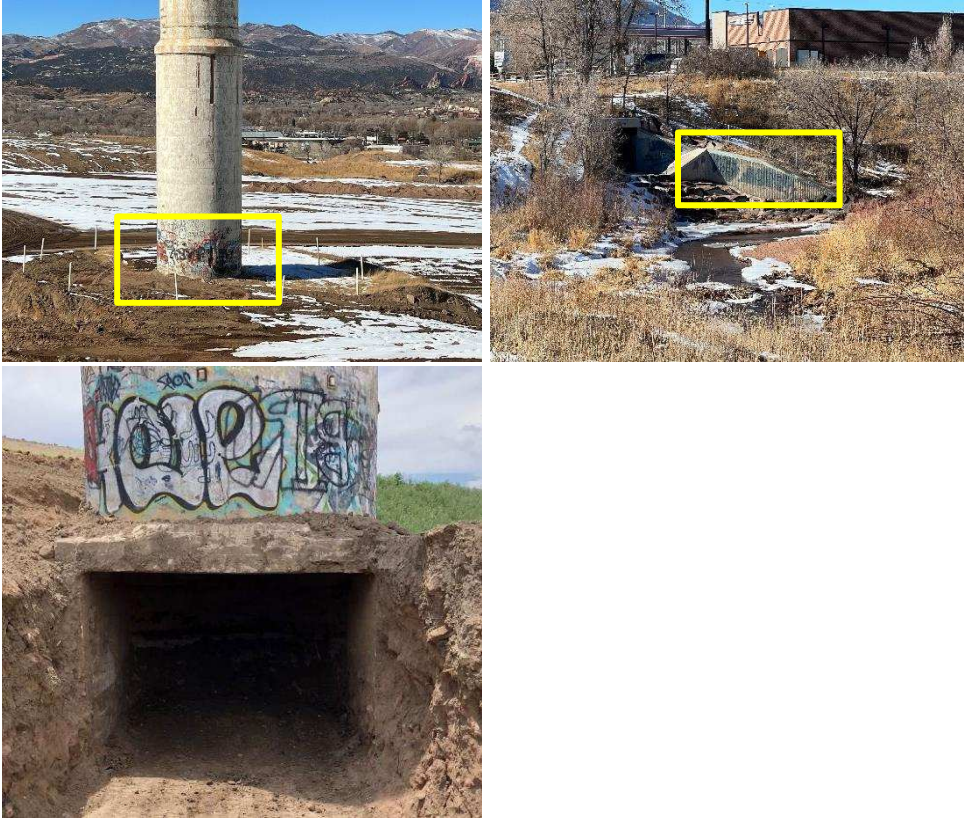
Throughout the Study Area unsafe and unsanitary conditions were documented, including contaminant/hazardous materials, litter and dumping, vandalism/graffiti, and inadequate stormdrainage system. Vandalism/graffiti was observed on the historic smokestack and new drainage infrastructure, shown in **Figure 5**.

Figure 5. Vandalism/Graffiti

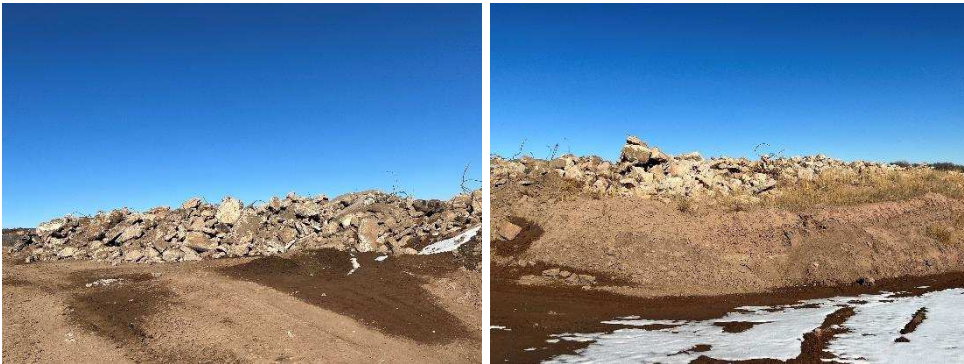
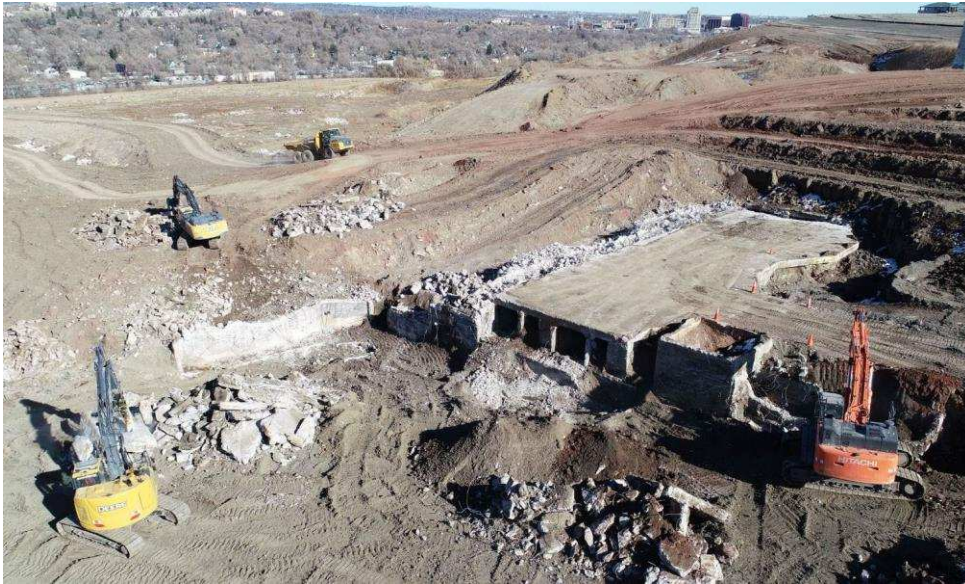
Large amounts of containinants have been found throughout the Study Area and require substantial work to remove. In additon to the tailings from the gold processing, the concrete foundations and substructures remained burried underground following the removal of the mill buildings in the 1960s, shown in **Figure 6**. In the 1990s, the Study Area was used as a dump site for dirt and an estimated 600,000 cubic yards of additional material was brought onto the Study Area. While at the time dirt was permitted to be dumped in the Study Area, illegal dumping also took place and brought concrete and other undesriable materials. Large amounts of concrete, rebar, and organics (yard waste, trash, wood, trees, etc.), shown in **Figure 7**, must be removed and mitigated before development can occur.

Figure 6. Evidence of Contaminants or Hazardous Materials

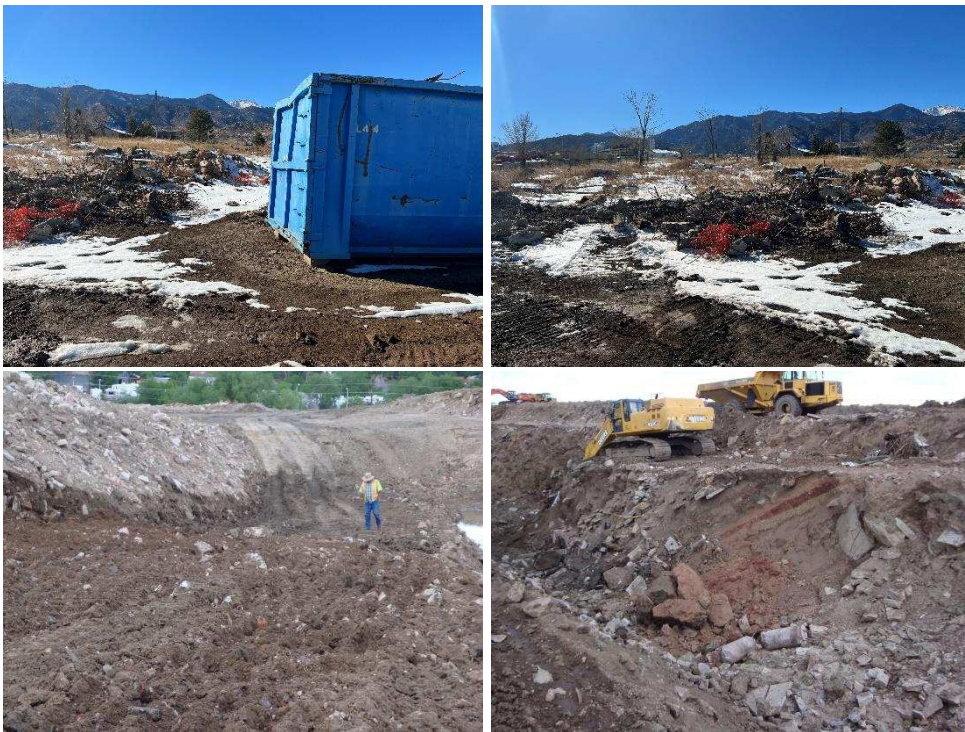
Figure 7. Excessive Litter/Illegal Dumping

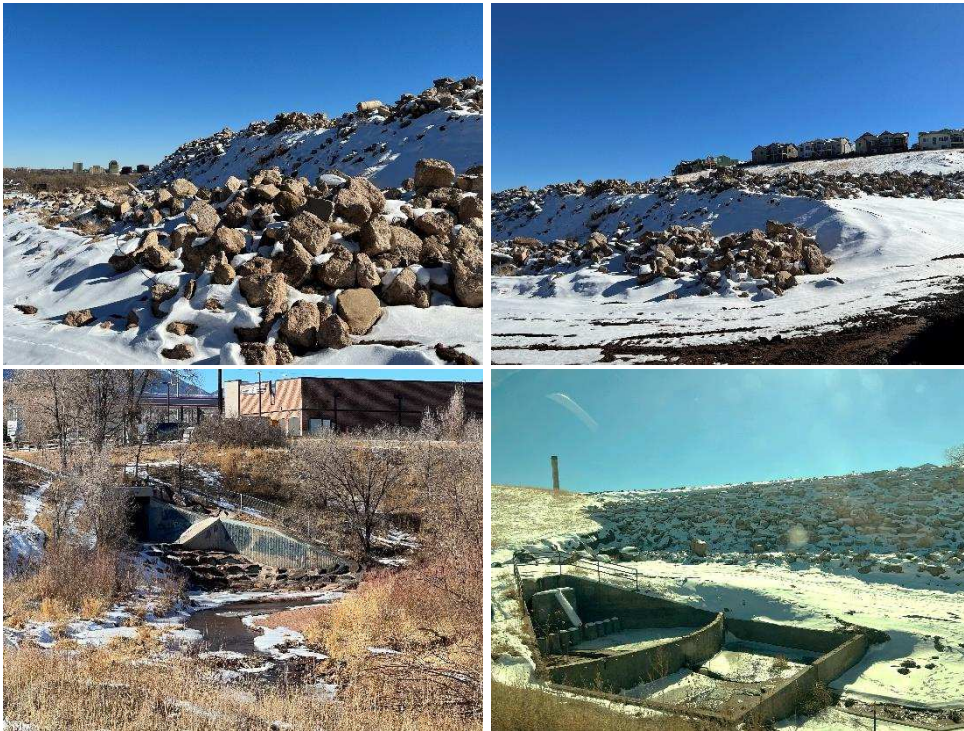
The Study Area lacks strom drainage infrastructure and a regional storm dention system is required to serve the capacity of the Study Area, existing Gold Hill Mesa residential development, and Villa de Mesa neighborhood. This infrastructure is more expensive and difficult to construct due to the steep slopes in the Study Area. The Gold Hill Mesa Development Group has found a sustainable solution of repurposing concrete from on-site mitigation to make a buttress slope condition, which aids in having the correct size detention pond, shown below in **Figure 8**. New storm drainage infrastructure has also been built along the northwest and northeast corners of the Study Area.

Figure 8. Inadequate Storm Drainage System

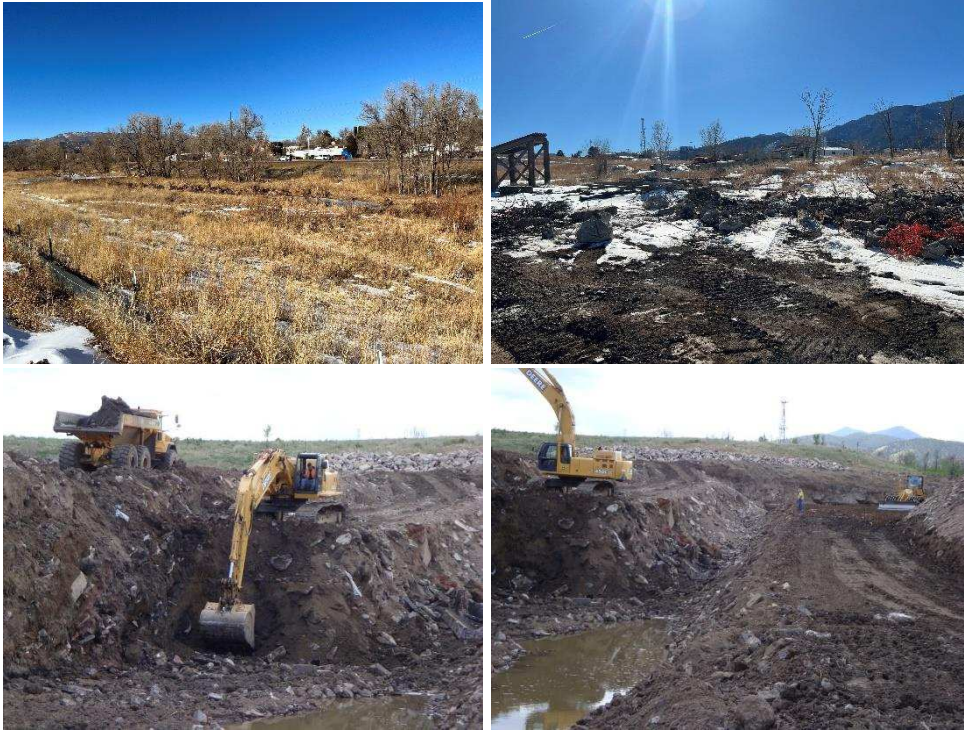
Deterioration of the site was observed throughout the Study Area under the conditions of neglected properties and poorly maintained landscaping, as shown in Error! Reference source not found.. Tailings from the gold production were left on the Study Area under a thin layer of dirt after the mill was closed in the 1940s to prevent wind erosion. This impeded the growth for most vegetation and only a limited amount of grass and some brush could survive. Over the decades, the Study Area was sparse and did not support plant growth. Furthermore, dirt, concrete, and trash were dumped in the Study Area in the 1990s. The bottom two images below show the existing conditions during remediation in 2009.

Figure 9. Neglected Properties

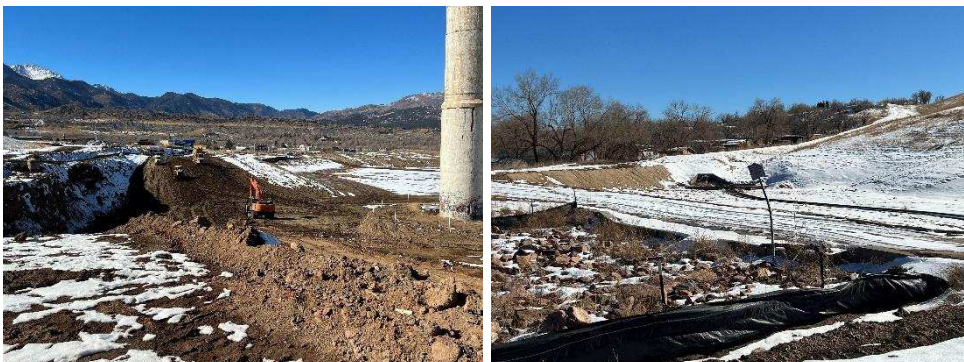
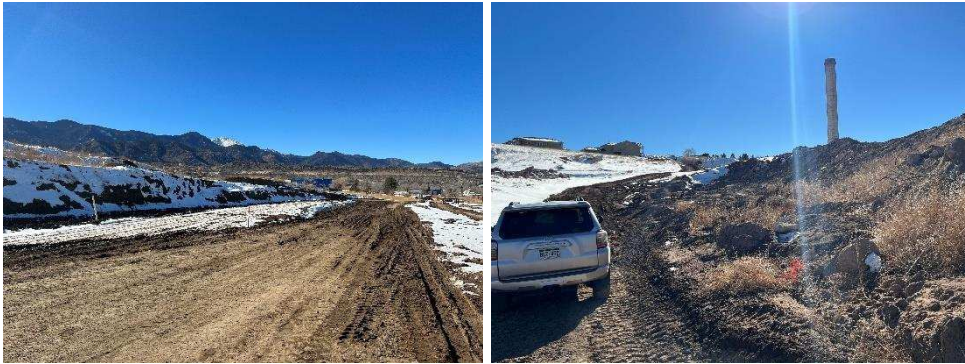
Unusual topography was observed throughout the Study Area and creates the need for significant grading, as shown in **Figure 10**. The Study Area has steep slopes with the highest elevation at the southern portion of the site and declines towards the northeast. Elevations vary from 6,250 to 6,000 feet above sea level. Along Highway 24 and the northeast side of the Study Area there is a billboard and overhead utility lines, as shown in **Figure 11**. Additionally, the lack of site infrastructure including pavement, curb, sidewalks, lighting, drainage, and inadequate sanitation or water systems are previously documented and described in **Figure 3**, **Figure 4**, and **Figure 8**.

Figure 10. Unusual Topography

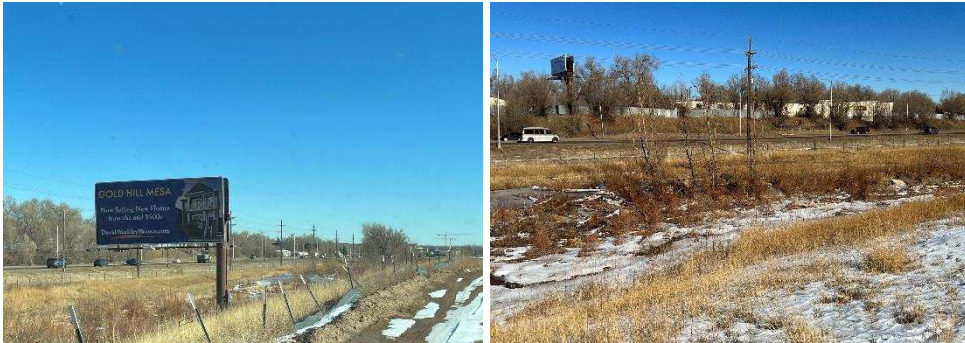
Figure 11. Presence of Overhead Utilities or Billboards

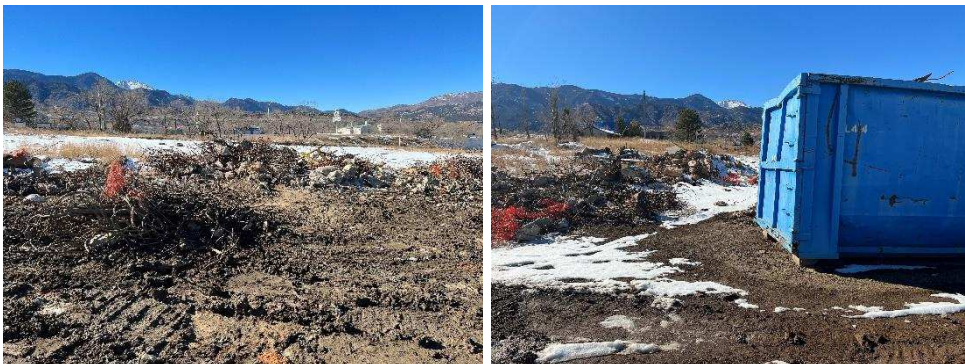
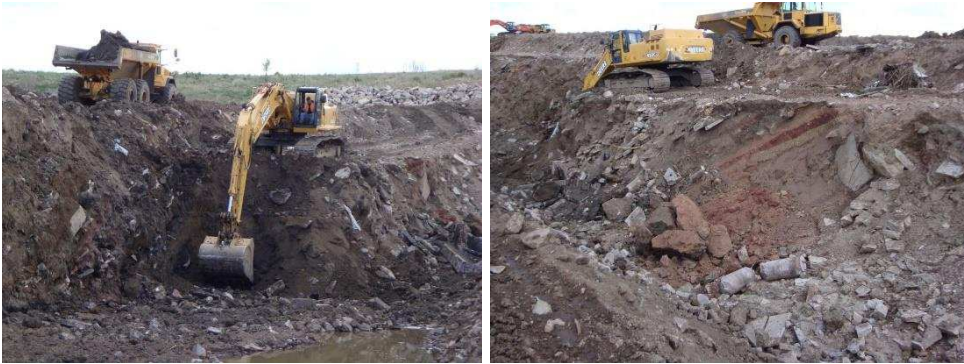
As perviously noted, environmental contamination was indentified throughout the Study Area with gold tailings, concrete and rebar from old foundations and structures, dumping of concrete, trash, and other materials, shown in **Figure 12.**

Figure 12. Environmental Contamination of Property

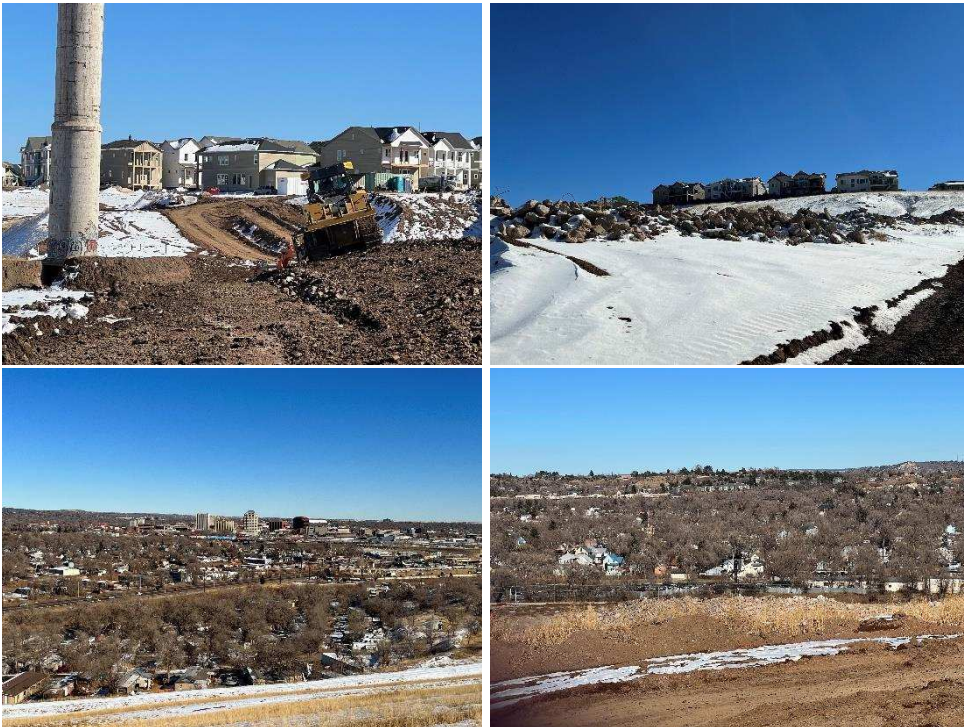
The Study Area is comprised of parcels that are undeveloped/vacant and it is a brownfield site with former industrial activity from the Golden Cycle Mill. The surrounding area is largely developed and urbanized with residential development to the south, mobile home and RV parks to the east, commercial development along 21st Street to the west, and development along the north side of Highway 24 to the north, shown in **Figure 13**.

Figure 13. Undeveloped/Underdeveloped Parcels in a Generally Urbanized Area
