**GEOLOGIC HAZARD REPORT VALIDTION
PARCEL NO. 63200-03-002
1210 EAGLE ROCK ROAD
LOT 1, RILEY SUBDIVISION
COLORADO SPRINGS, COLORADO**

Subject: 1210 Eagle Rock Road, STM-REV25-0558
Colorado Springs, El Paso County, CO, CGS Unique No. EP-25-0079

Re: Geologic Hazards Report Validation
Parcel No. 63200-03-002
1210 Eagle Rock Road
Lot 1, Riley Subdivision
Colorado Springs, Colorado
Entech Job No. 250184

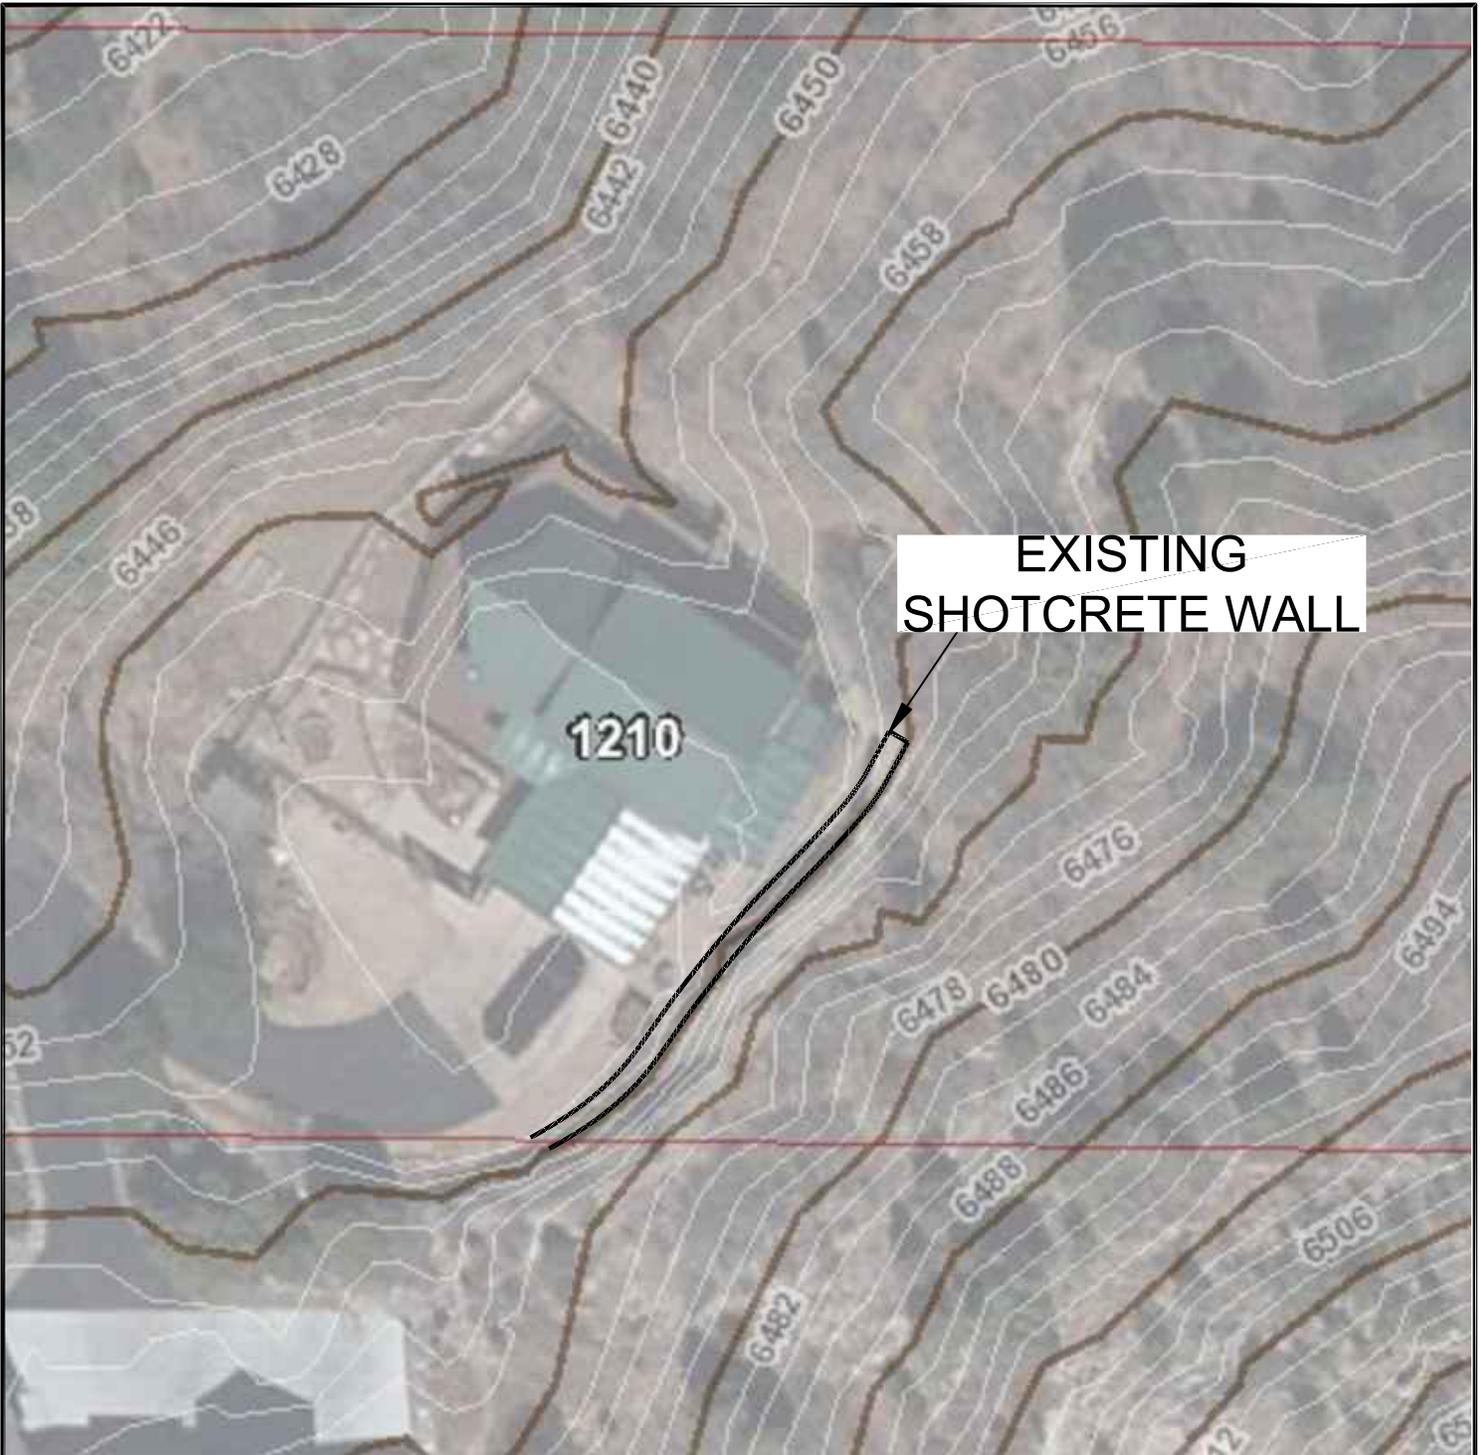
FIG. 3

EXISTING
SHOTCRETE WALL

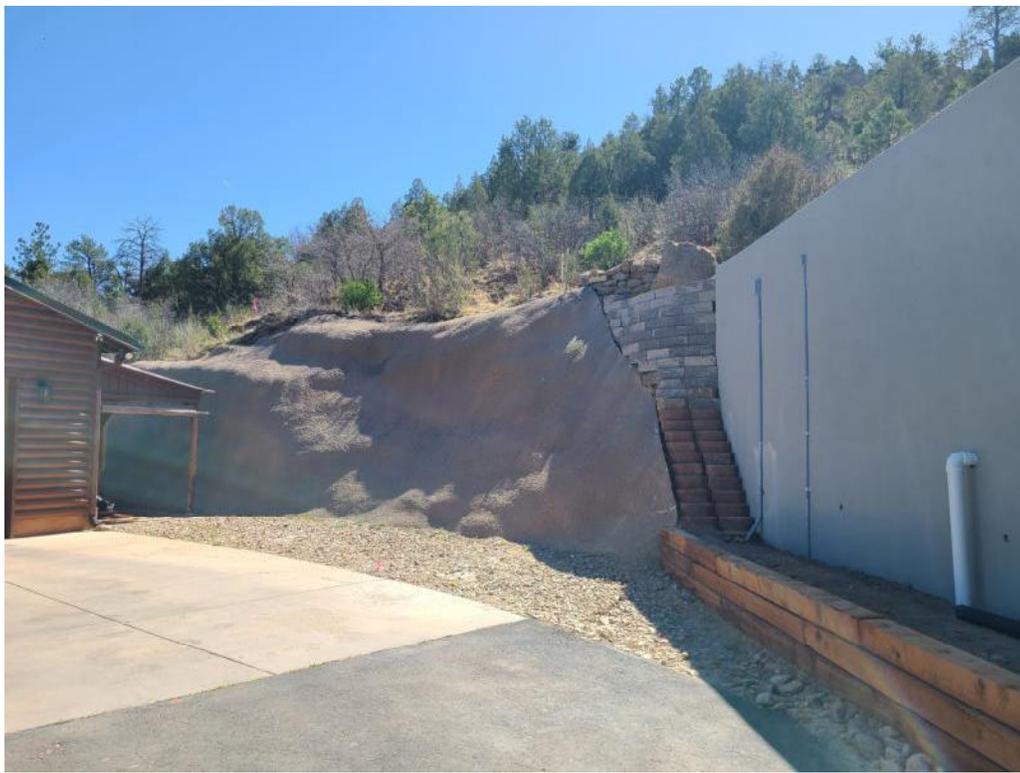
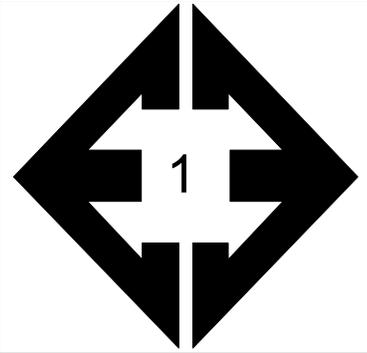
Looking east towards the southwestern end of the shotcrete stabilized slope from the driveway.

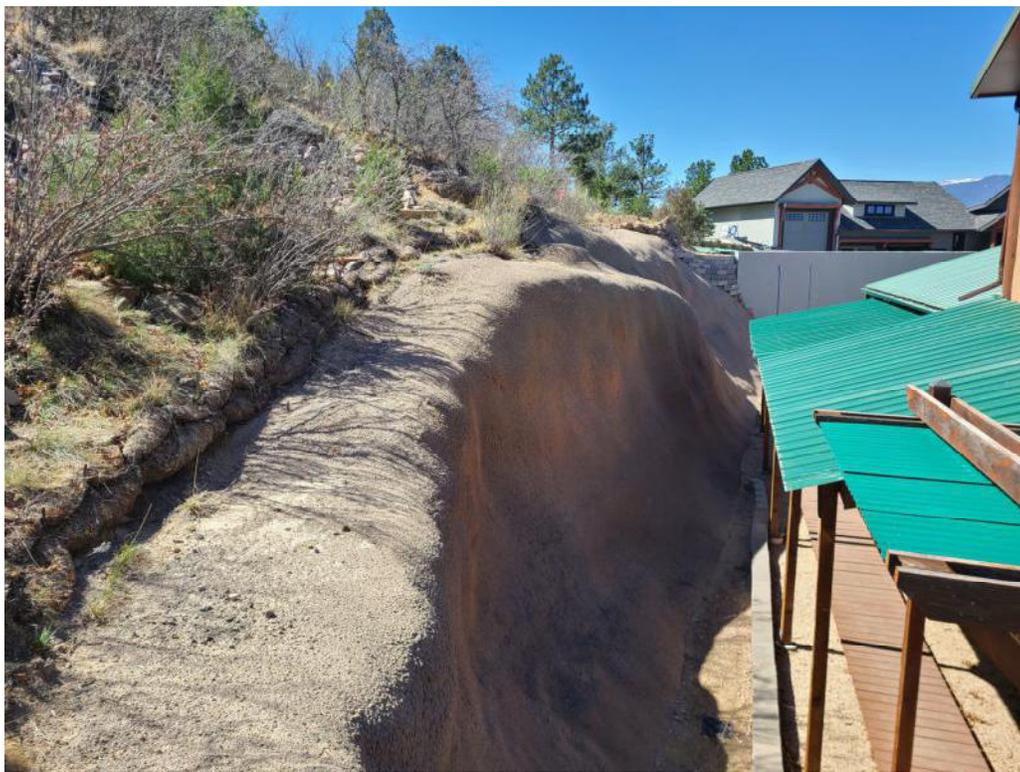
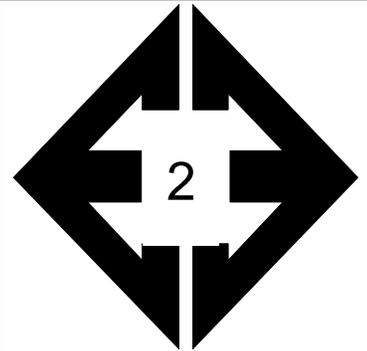
Looking southwest along the top of the shotcrete stabilized slope.

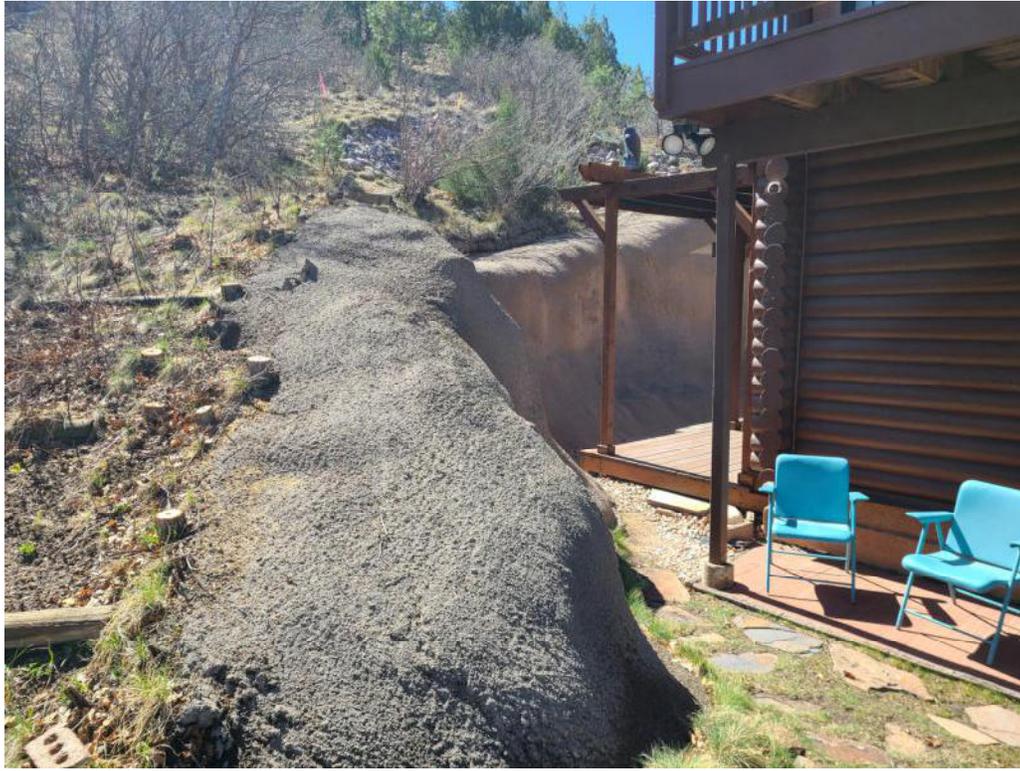
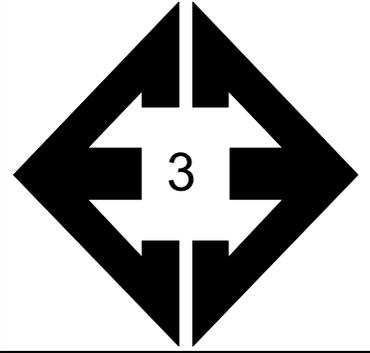
Looking southeast towards the northeastern end of the shotcrete stabilized slope.

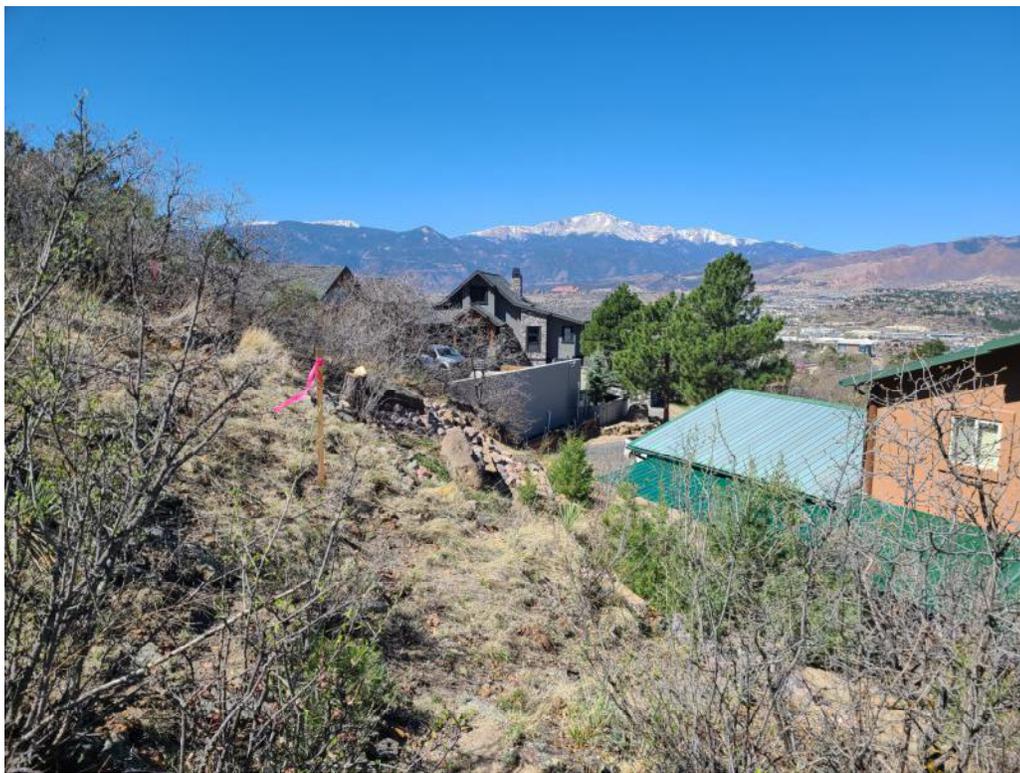
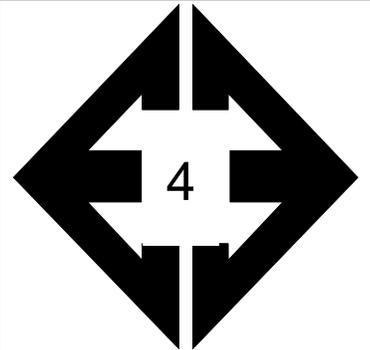
Looking west along steep slope above the shotcrete stabilization.
