**GEOLOGIC HAZARDS EVALUATION AND
GEOTECHNICAL INVESTIGATION
THE LAUNCHPAD – YOUTH HOUSING
810 NORTH 19th STREET
COLORADO SPRINGS, COLORADO**

CTL|T Project No. CS19543-125

September 8, 2022
Revised December 20, 2022

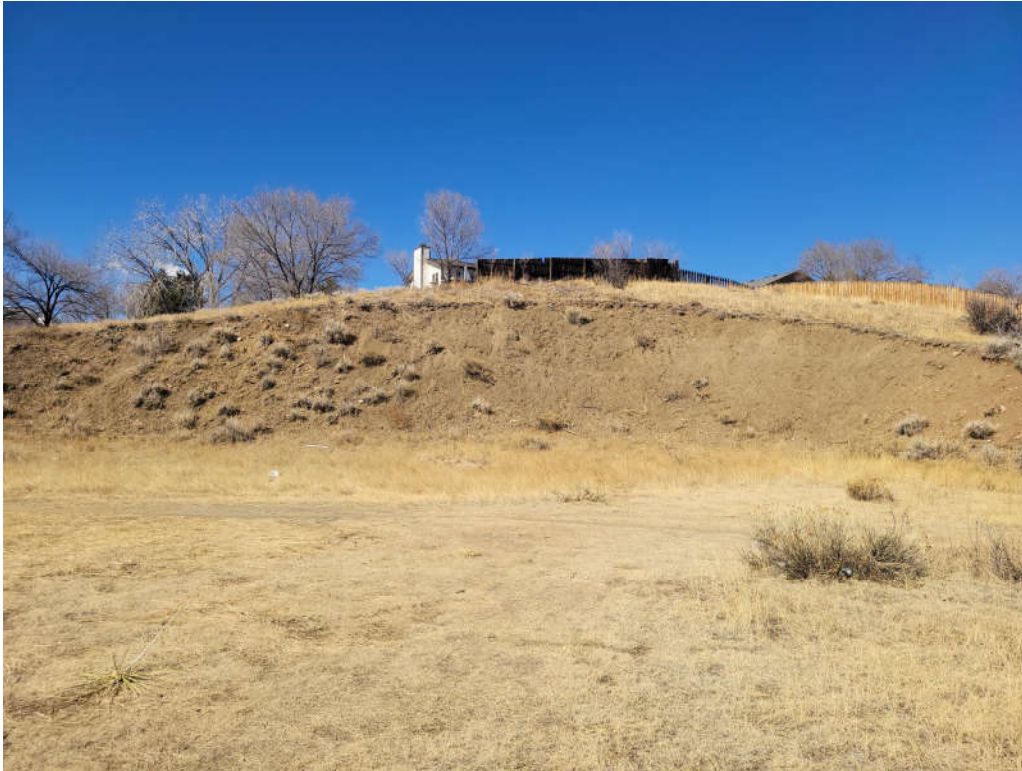
The site is dominated by a steep slope within the western half that descends from the adjacent residential community to the west. Photographs of the slope are presented below. The high point of the slope is located in the northwest corner of the site at approximately 6174 feet above mean sea level (msl). The slope descends steeply to the east and southeast at gradients between approximately 1:1 (horizontal to vertical) and 3:1. The slope appears to have been partially excavated. Aerial photography and previous mapping confirm the slope formerly descended at a gentler gradient and extended further into the parcel. Below the slope, a generally level area is present before becoming gently sloping as the site approaches North 19th Street. Vegetation consists of scattered shrubs and grasses and a couple trees around the perimeter.

Photo 1 - View to the west toward steep slope

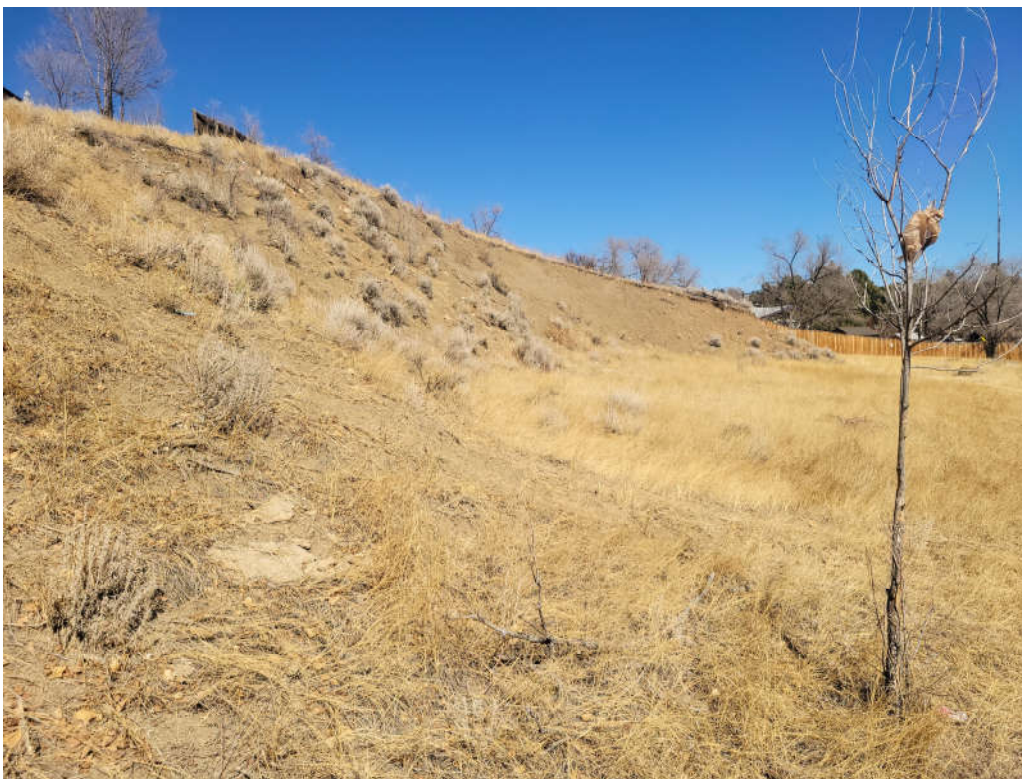
Photo 2 - View to the north toward steep slope

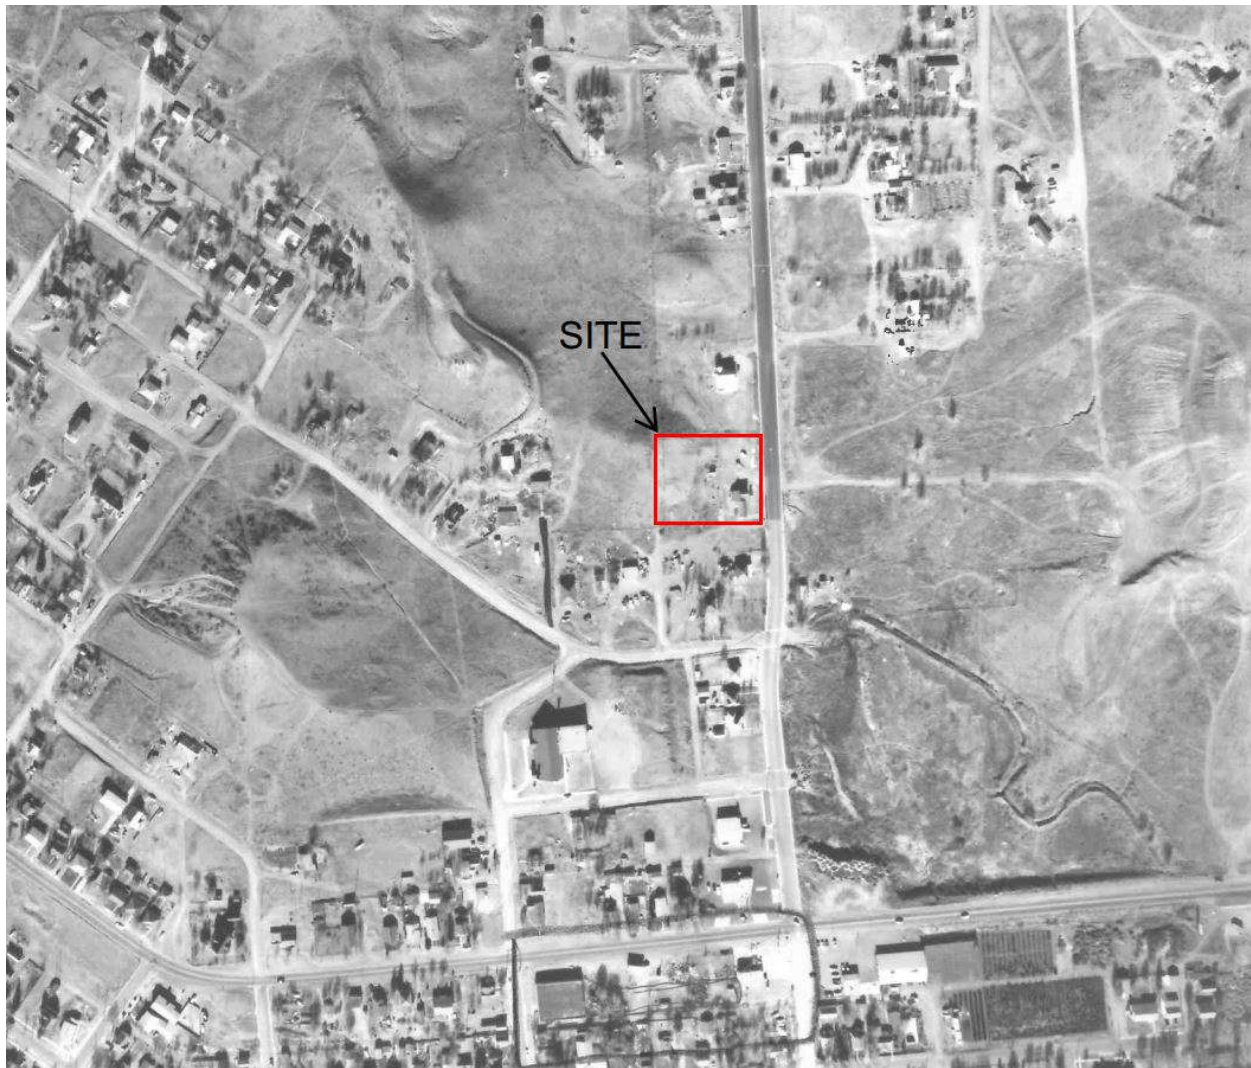
1966 Aerial Photo

The 1966 aerial photo shown above indicates a structure was present at the site. We believe it was likely a single-family residence. The structure is not shown on the September 1999 Google Earth® aerial image.

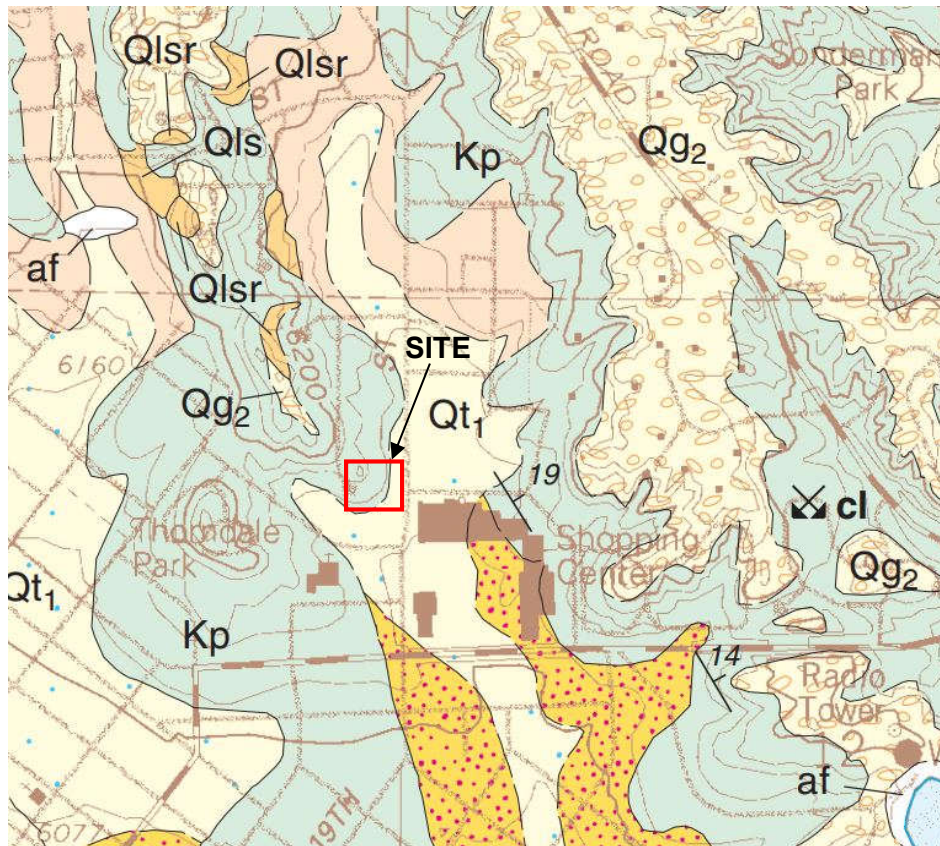
Excerpt from Geologic Map

The eastern portion of the site adjacent to North 19th Street is mapped as Qt₁, denoted as Terrace alluvium one. This map unit is comprised of Holocene-age, poorly to moderately sorted, unconsolidated, matrix-supported cobble gravel in a sandy, silty, or clayey matrix.

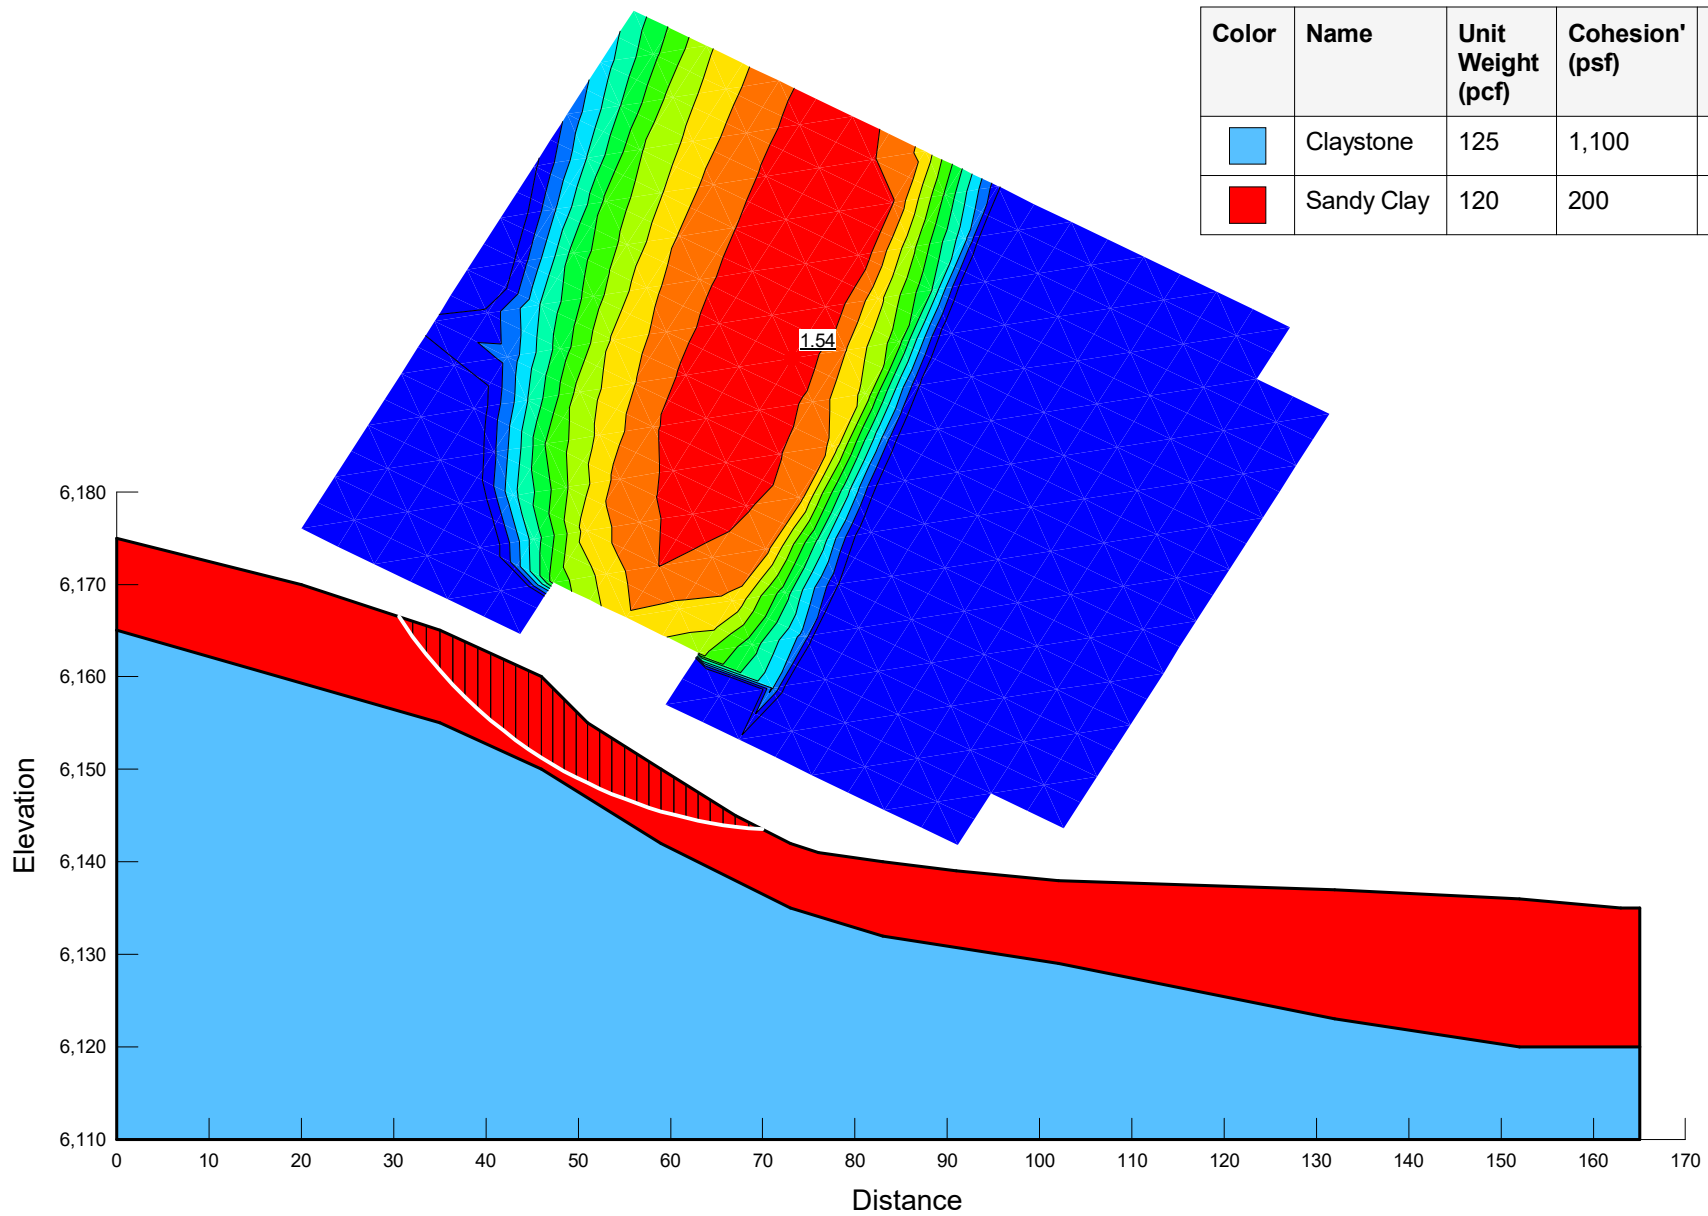
EXISTING CONDITIONS (SECTION A-A')

Our analysis (Section A-A') indicates the current condition of the slope is stable from the standpoint of global stability; however, the slope is susceptible to erosion and surficial sloughing that may cause the slope to become unstable. Our analysis (Section B-B') indicates the proposed grading and retaining walls will result in an acceptable factor of safety. Further discussion of our analysis is included in the slope stability section of our report.
