**GEOLOGIC HAZARD INVESTIGATION
VILLAGES AT WATERVIEW NORTH
SOUTH POWERS BOULEVARD AND BRADLEY ROAD
EL PASO COUNTY, COLORADO**

May 15, 2020
Revised: October 1, 2020
Revised: July 15, 2022

Entech Job No. 200599
AAprojects/2020/200599 city geohaz-rev

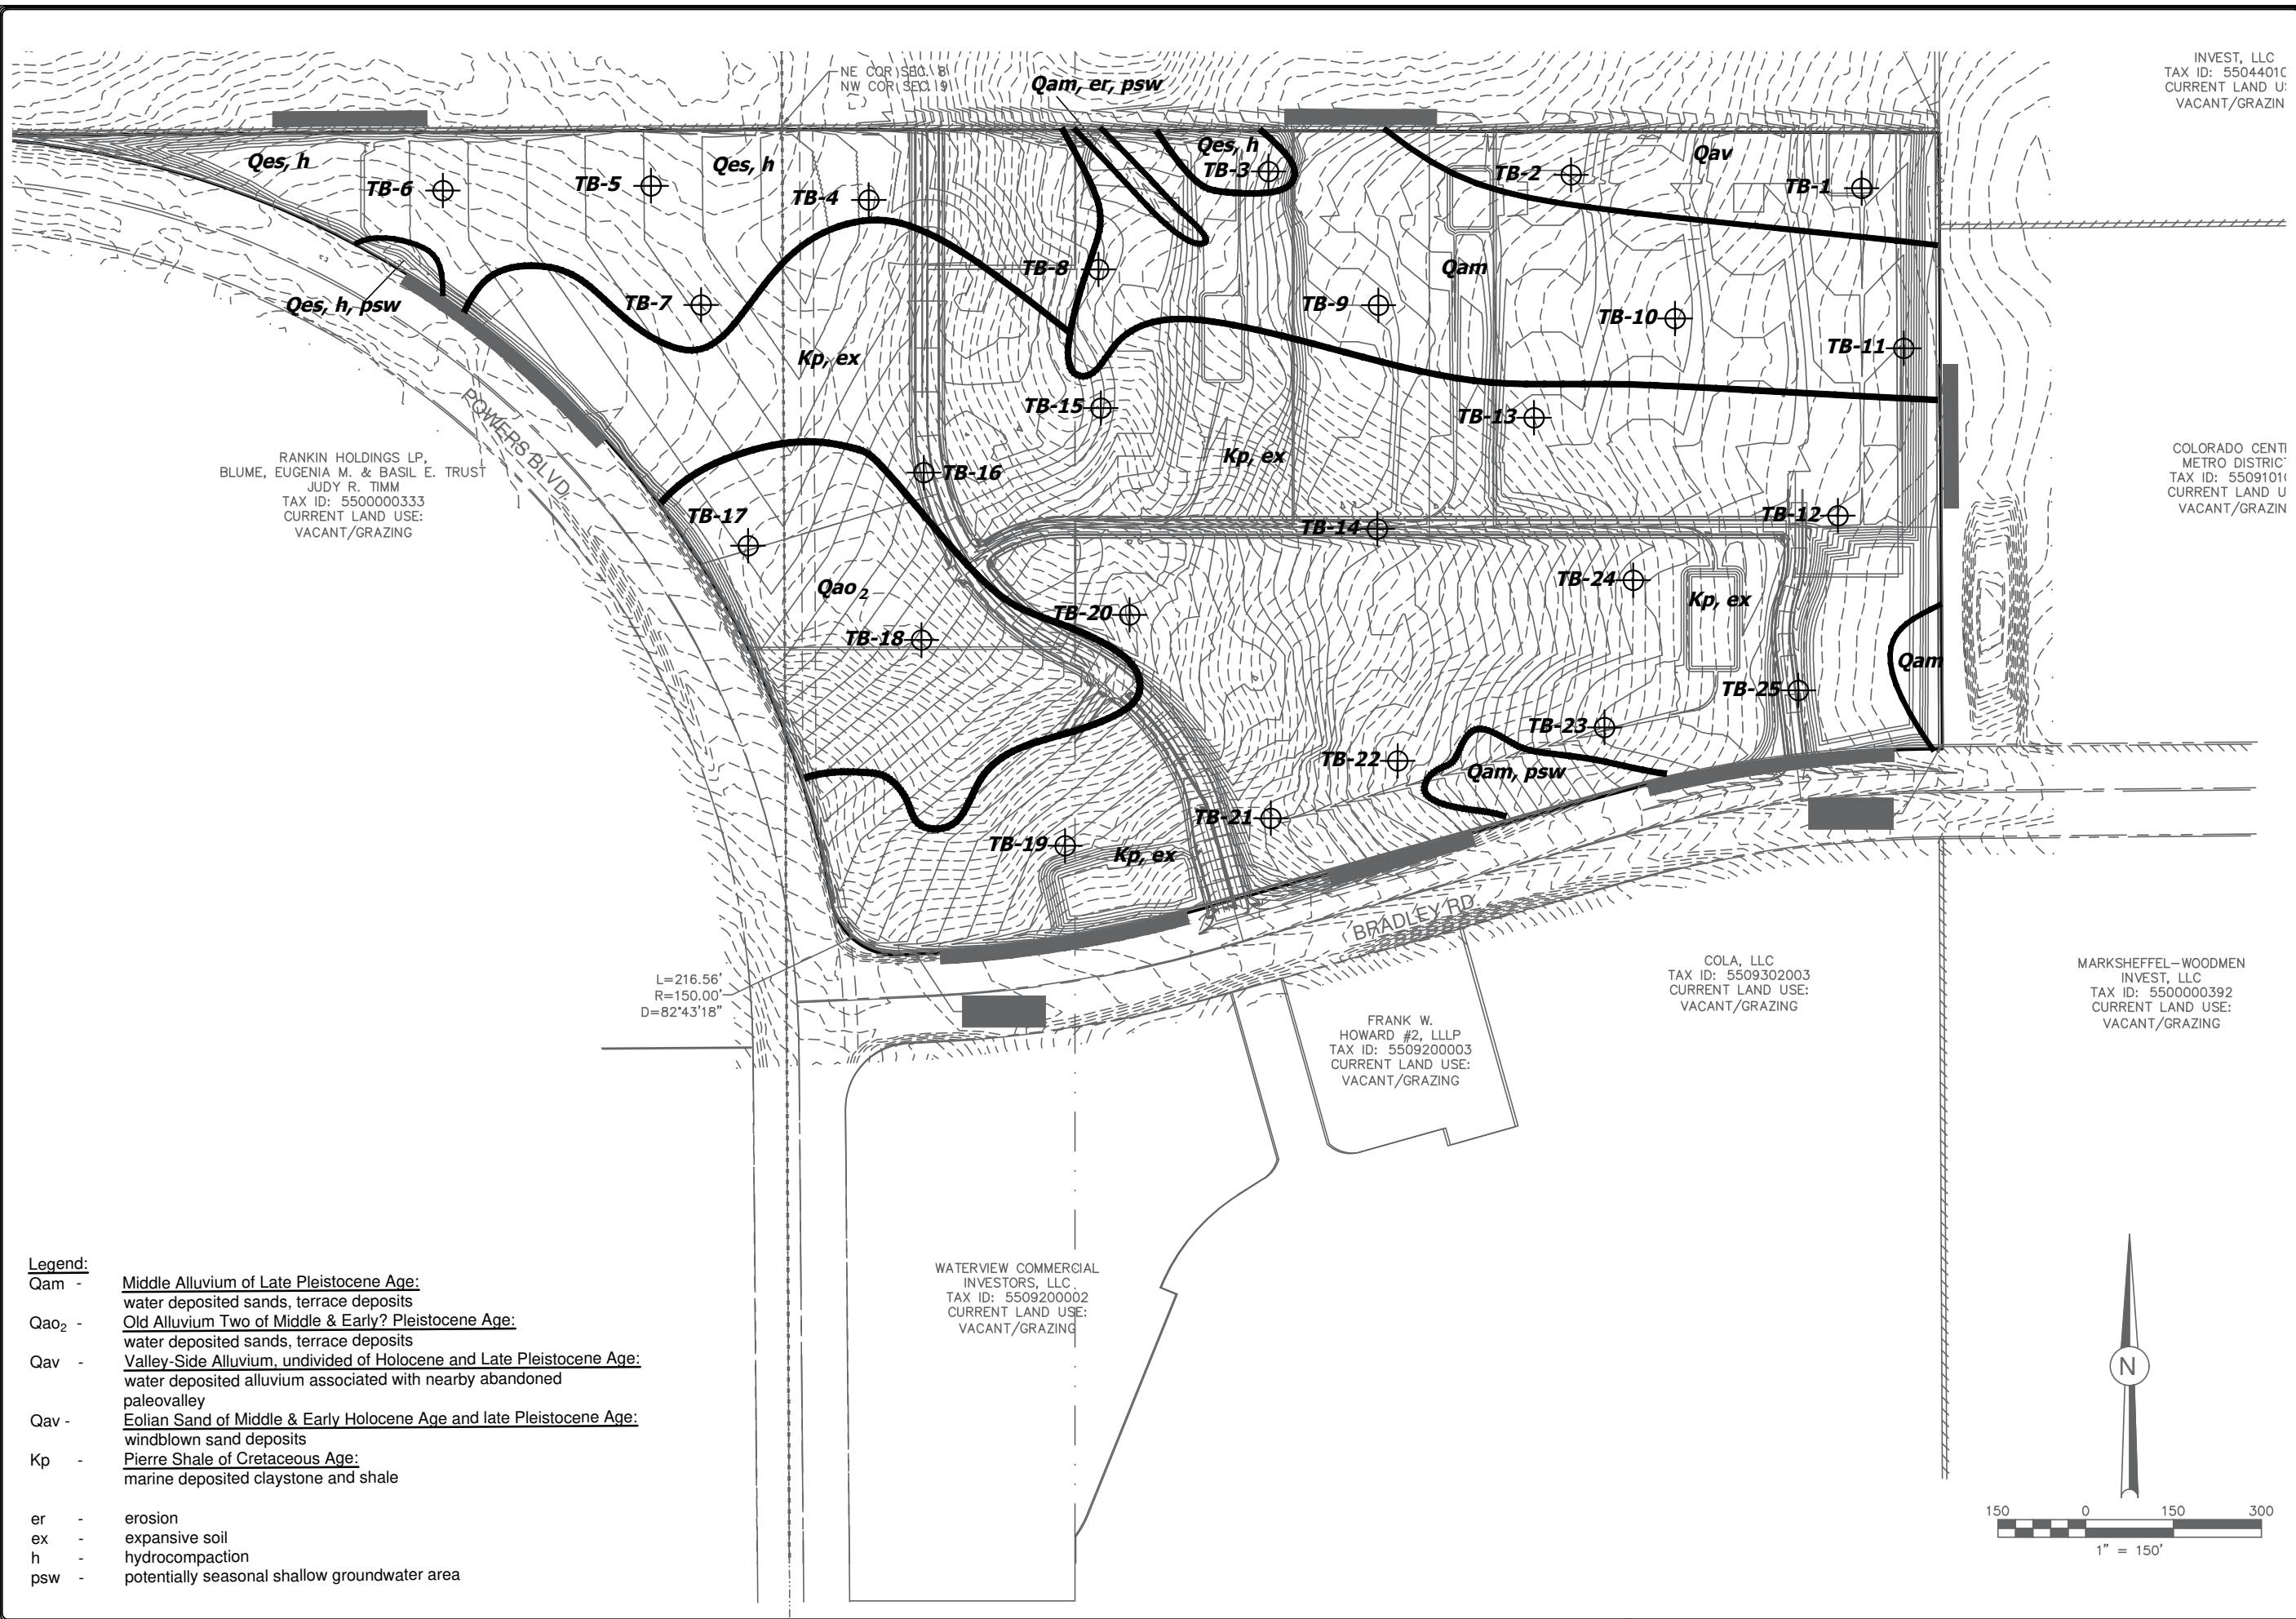
DRAWN L.L.
CHECKED
DATE 7/11/22
SCALE AS SHOWN
JOB NO. 200599
FIGURE No. 7

Detailed mapping has been performed on this site to produce an Engineering Geology Map Figure 7. This map shows the location of various geologic conditions of which the developers should be cognizant during the planning, design and construction stages of the project. Hazards include areas of collapsible soils/hydrocompaction, highly expansive soils, potential seasonal shallow groundwater, and shallow bedrock. Minor areas of erosion were also observed. These hazards and the recommended mitigation techniques are as follows:

Areas in which hydrocompaction have been identified are acceptable as building sites. In areas identified for this hazard classification, however, we anticipate a potential for settlement movements upon saturation of these surficial soils. The low density, uniform grain sized, windblown sand deposits are particularly susceptible to this type of phenomenon. Additionally, loose or collapsible soils may be encountered on this site. The majority of the soils encountered on-site do not exhibit collapsible characteristics; however, areas of soils with consolidation potential were encountered in the test borings drilled on site. Areas in the northwestern portion

Expansive soils are common in the area, and were encountered in the test borings drilled on site. Swells ranged from low to very high in the soils tested. The clay and claystone, if encountered beneath foundations, can cause differential movement in the structure foundation. These occurrences should be identified and dealt with on an individual basis or possibly mitigated during site grading.

The areas mapped with this hazard are located along the minor drainages in the northern and southern portion of the site, and in the low area in the northwestern portion of the site adjacent to the box culvert located under Powers Boulevard. In these areas, we would anticipate the potential for periodically high subsurface moisture conditions and possible frost heave potential, depending on the soil conditions.

Mitigation: The potential for settlement movement is directly related to saturation of the soils below the foundation areas. Therefore, good surface and subsurface drainage is extremely critical in these areas in order to minimize the potential for saturation of these soils. The ground surface around all permanent structures should be positively sloped away from the structure to all points, and water must not be allowed to stand or pond anywhere on the site. We recommend that the ground surface within 10 feet of the structures be sloped away with a minimum gradient of five percent. If this is not possible on the upslope side of the structures, then a well-defined swale should be created to intercept the surface water and carry it quickly and safely around and away from the structures. Roof drains should be made to discharge well away from the structures and into areas of positive drainage. Where several structures are involved, the overall drainage design should be such that water directed away from one structure is not directed against an adjacent building. Planting and watering in the immediate vicinity of the structures, as well as general lawn irrigation, should be minimized.

Should loose or collapsible soils be encountered beneath foundations, recompaction and moisture conditioning of the upper 2 to 3 feet of soil at 95 percent of its maximum Modified Proctor Dry Density ASTM D-1557 will be required. Exterior flatwork and parking areas may also experience movement. Proofrolling and recompaction of soft areas should be performed during site work.

Mitigation Should expansive soils be encountered beneath the foundation; mitigation will be necessary. Mitigation of expansive soils will require special foundation design. Overexcavation and replacement with non-expansive soils at a minimum of 95 percent of its maximum Modified Proctor Dry Density, ASTM D-1557 is a suitable mitigation, which is common in the area. Floor slabs on expansive soils should be expected to experience movement. Overexcavation and replacement has been successful in minimizing slab movements. Overexcavation depths of 4 to

6 feet are anticipated for the site. Mitigation may also include moisture conditioning and recompaction of the clay soils. The use of structural floors should be considered for basement construction on highly expansive clays.

Drilled piers are another option that is used in areas where highly expansive soils are encountered. Typical minimum pier depths are on the order of 25 feet or more and require penetration into the bedrock material a minimum of 4 to 6 feet, depending upon building loads. Final recommendations should be determined after additional investigation of the lots.

Mitigation: In these locations, foundations in areas subject to severe frost heave potential should penetrate sufficient depth so as to discourage the formation of ice lenses beneath foundations. At this location and elevation, a foundation depth for frost protection of 2.5 feet is recommended. In areas where high subsurface moisture conditions are anticipated periodically, a subsurface perimeter drain will be necessary to help prevent the intrusion of water into areas located below grade. A typical perimeter drain detail is presented in Figure 9. Additionally, swales should be created to intercept surface runoff and carry it safely around and away from structures. It is anticipated that the site grading will likely mitigate the dry drainages on the site, and a detention pond is proposed in the northwestern portion of the site. Lots adjacent to the detention pond may also require drains to help prevent the intrusion of water into areas below grade during periods of high moisture. Several detention ponds are proposed across the site.
