**GEOLOGIC HAZARD INVESTIGATION
VILLAGES AT WATERVIEW NORTH
SOUTH POWERS BOULEVARD AND BRADLEY ROAD
EL PASO COUNTY, COLORADO**

May 15, 2020
Revised: October 1, 2020
Revised: July 15, 2022

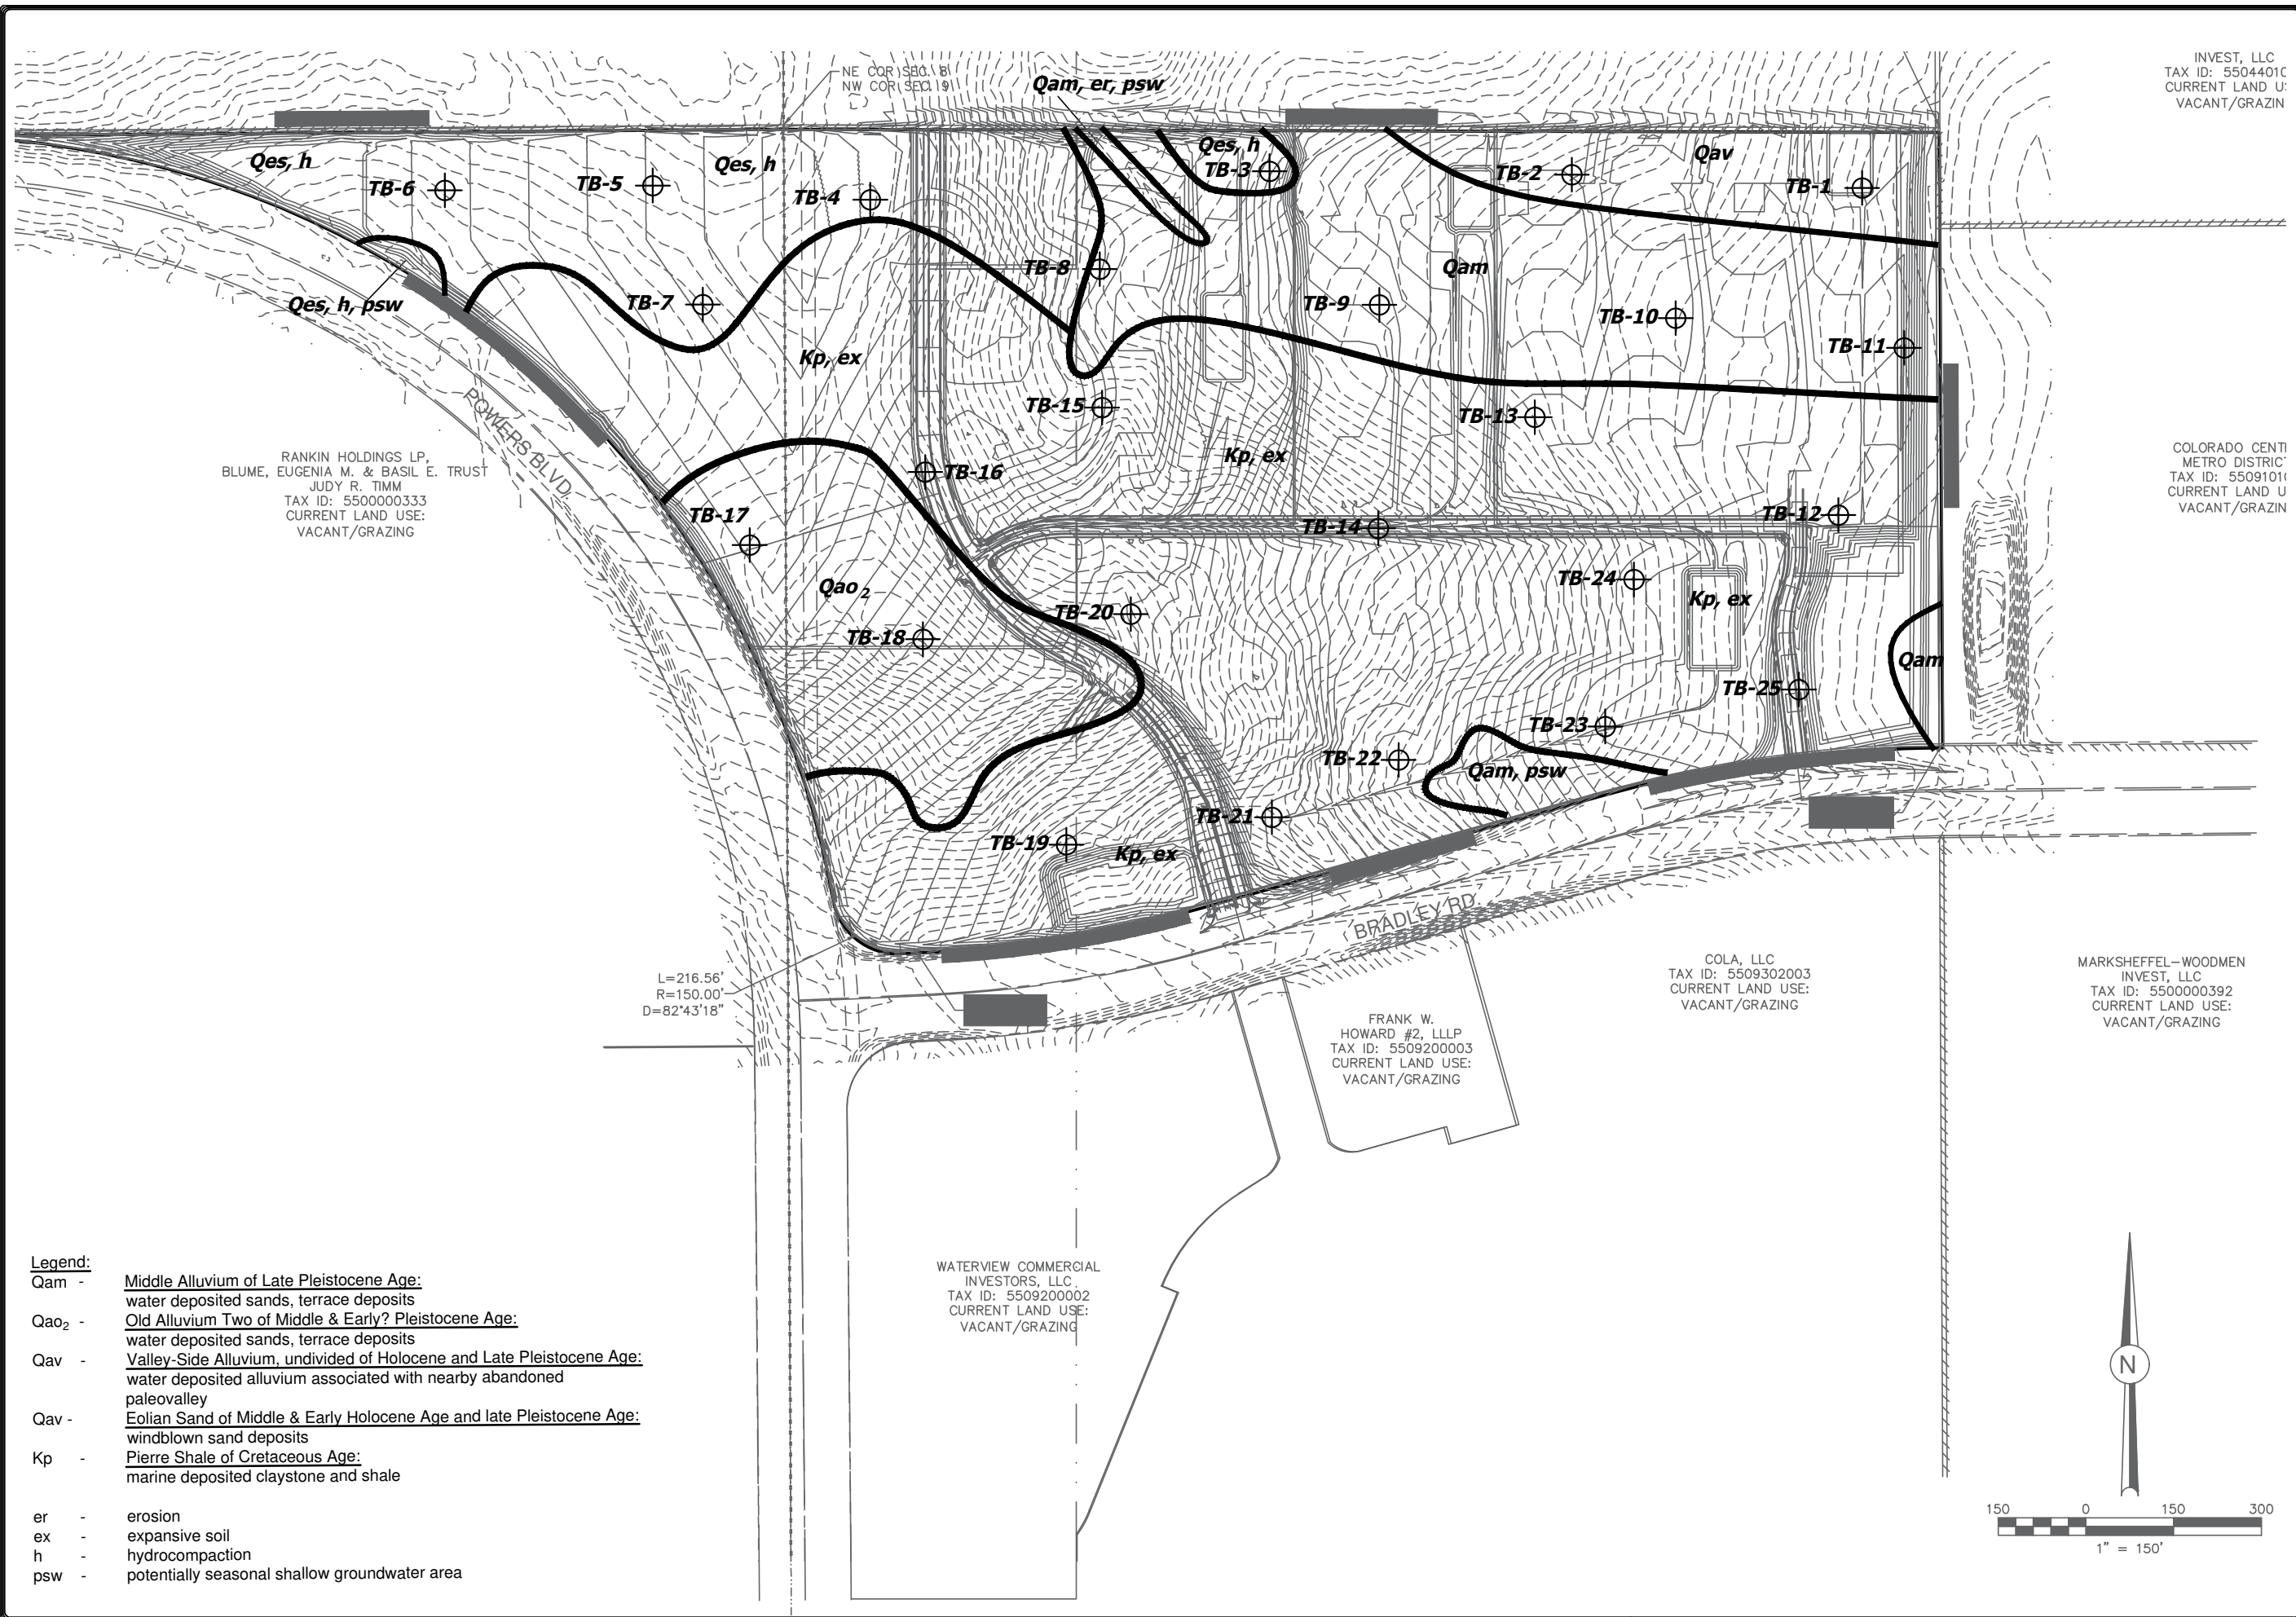
| FIGURE No. 7 |

Detailed mapping has been performed on this site to produce an Engineering Geology Map Figure 7. This map shows the location of various geologic conditions of which the developers should be cognizant during the planning, design and construction stages of the project. Hazards include areas of collapsible soils/hydrocompaction, highly expansive soils, potential seasonal shallow groundwater, and shallow bedrock. Minor areas of erosion were also observed. These hazards and the recommended mitigation techniques are as follows:

Areas in which hydrocompaction have been identified are acceptable as building sites. In areas identified for this hazard classification, however, we anticipate a potential for settlement movements upon saturation of these surficial soils. The low density, uniform grain sized, windblown sand deposits are particularly susceptible to this type of phenomenon. Additionally, loose or collapsible soils may be encountered on this site. The majority of the soils encountered on-site do not exhibit collapsible characteristics; however, areas of soils with consolidation potential were encountered in the test borings drilled on site. Areas in the northwestern portion

Expansive soils are common in the area, and were encountered in the test borings drilled on site. Swells ranged from low to very high in the soils tested. The clay and claystone, if encountered beneath foundations, can cause differential movement in the structure foundation. These occurrences should be identified and dealt with on an individual basis or possibly mitigated during site grading.

The areas mapped with this hazard are located along the minor drainages in the northern and southern portion of the site, and in the low area in the northwestern portion of the site adjacent to the box culvert located under Powers Boulevard. In these areas, we would anticipate the potential for periodically high subsurface moisture conditions and possible frost heave potential, depending on the soil conditions.

Mitigation: The potential for settlement movement is directly related to saturation of the soils below the foundation areas. Therefore, good surface and subsurface drainage is extremely critical in these areas in order to minimize the potential for saturation of these soils. The ground surface around all permanent structures should be positively sloped away from the structure to all points, and water must not be allowed to stand or pond anywhere on the site. We recommend that the ground surface within 10 feet of the structures be sloped away with a minimum gradient of five percent. If this is not possible on the upslope side of the structures, then a well-defined swale should be created to intercept the surface water and carry it quickly and safely around and away from the structures. Roof drains should be made to discharge well away from the structures and into areas of positive drainage. Where several structures are involved, the overall drainage design should be such that water directed away from one structure is not directed against an adjacent building. Planting and watering in the immediate vicinity of the structures, as well as general lawn irrigation, should be minimized.

Should loose or collapsible soils be encountered beneath foundations, recompaction and moisture conditioning of the upper 2 to 3 feet of soil at 95 percent of its maximum Modified Proctor Dry Density ASTM D-1557 will be required. Exterior flatwork and parking areas may also experience movement. Proofrolling and recompaction of soft areas should be performed during site work.

Mitigation Should expansive soils be encountered beneath the foundation; mitigation will be necessary. Mitigation of expansive soils will require special foundation design. Overexcavation and replacement with non-expansive soils at a minimum of 95 percent of its maximum Modified Proctor Dry Density, ASTM D-1557 is a suitable mitigation, which is common in the area. Floor slabs on expansive soils should be expected to experience movement. Overexcavation and replacement has been successful in minimizing slab movements. Overexcavation depths of 4 to

Mitigation: In these locations, foundations in areas subject to severe frost heave potential should penetrate sufficient depth so as to discourage the formation of ice lenses beneath foundations. At this location and elevation, a foundation depth for frost protection of 2.5 feet is recommended. In areas where high subsurface moisture conditions are anticipated periodically, a subsurface perimeter drain will be necessary to help prevent the intrusion of water into areas located below grade. A typical perimeter drain detail is presented in Figure 9. Additionally, swales should be created to intercept surface runoff and carry it safely around and away from structures. It is anticipated that the site grading will likely mitigate the dry drainages on the site, and a detention pond is proposed in the northwestern portion of the site. Lots adjacent to the detention pond may also require drains to help prevent the intrusion of water into areas below grade during periods of high moisture. Several detention ponds are proposed across the site.
