## GEOLOGIC HAZARD STUDY APPLICATION

**Subject: Kettle Creek, Addition No. 1**  
**Colorado Springs, El Paso County, CO**  
**City Number STM-REV25-0916; CGS Unique No. EP-26-0033**

# **PRELIMINARY SUBSURFACE SOIL INVESTIGATION AND GEOLOGIC HAZARD STUDY**

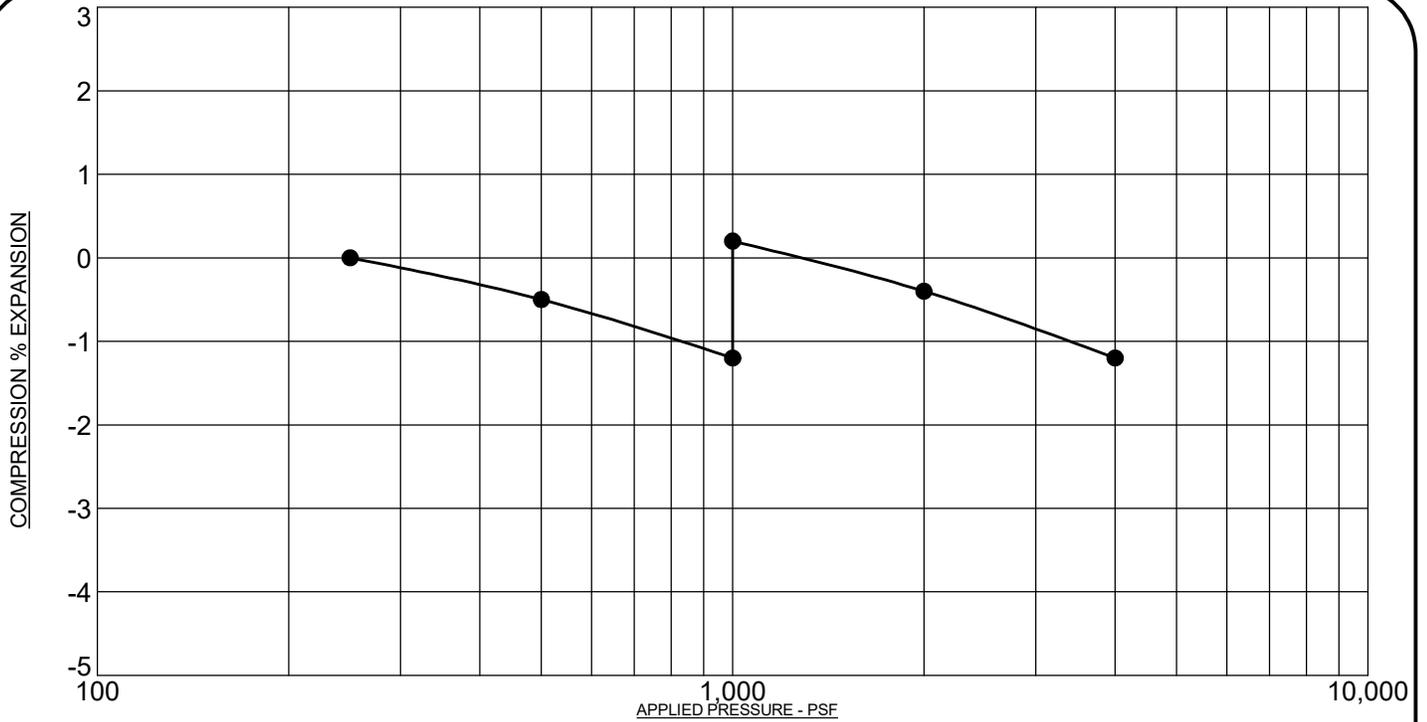
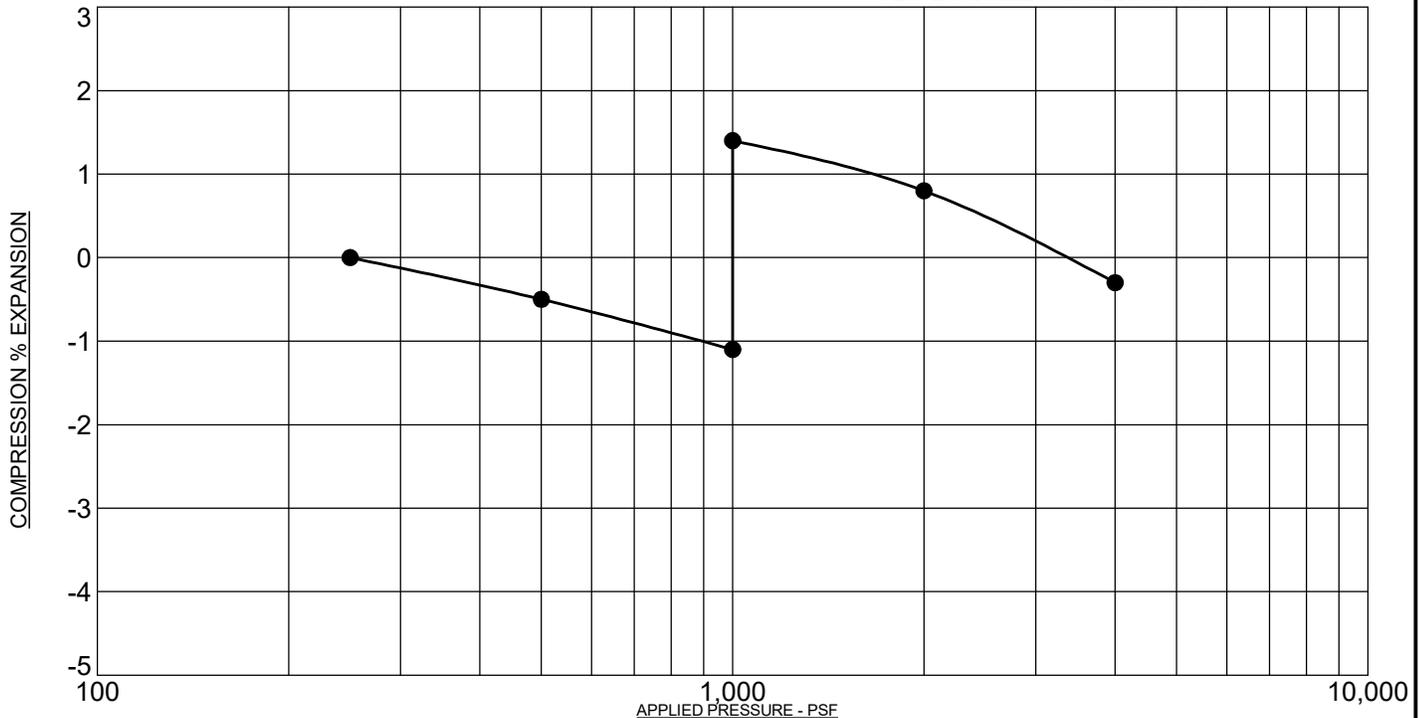
FIGURE No. 8

PROJECT: Kettle Creek Rd, Colorado Springs, Colorado  
 SAMPLE DESCRIPTION: SANDSTONE, CLAYEY  
 NOTE: SAMPLE WAS INUNDATED WITH WATER AT 1,000 PSF

SAMPLE LOCATION: 1 @ 14 FT  
 NATURAL DRY UNIT WEIGHT: 108.4 PCF  
 NATURAL MOISTURE CONTENT: 27.0%  
 PERCENT SWELL/COMPRESSION: 1.4

PROJECT: Kettle Creek Rd, Colorado Springs, Colorado  
 SAMPLE DESCRIPTION: CLAYSTONE, SANDY  
 NOTE: SAMPLE WAS INUNDATED WITH WATER AT 1,000 PSF

SAMPLE LOCATION: 2 @ 14 FT  
 NATURAL DRY UNIT WEIGHT: 102.2 PCF  
 NATURAL MOISTURE CONTENT: 21.5%  
 PERCENT SWELL/COMPRESSION: 2.5

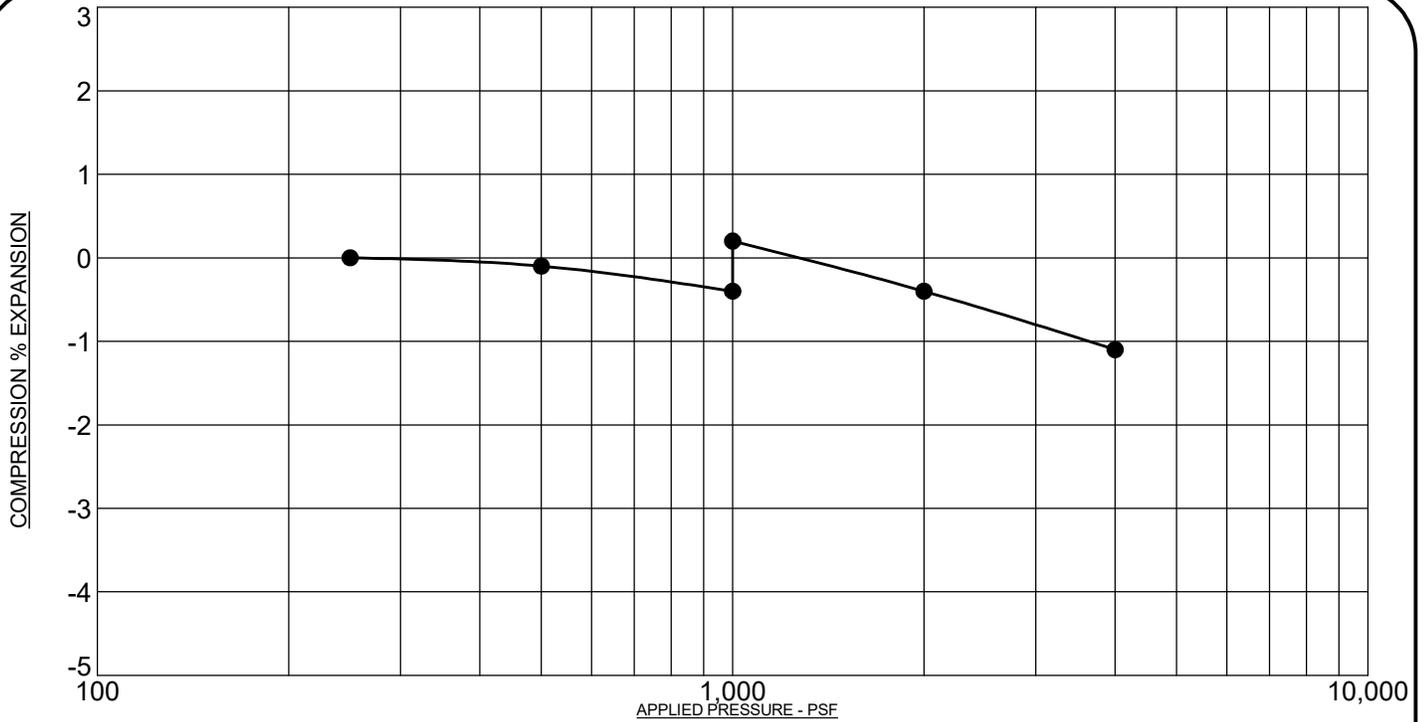
FIGURE No. 9

PROJECT: Kettle Creek Rd, Colorado Springs, Colorado  
 SAMPLE DESCRIPTION: SAND, CLAYEY  
 NOTE: SAMPLE WAS INUNDATED WITH WATER AT 1,000 PSF

SAMPLE LOCATION: 3 @ 9 FT  
 NATURAL DRY UNIT WEIGHT: 100.2 PCF  
 NATURAL MOISTURE CONTENT: 26.3%  
 PERCENT SWELL/COMPRESSION: 0.6
