**GEOLOGIC HAZARD INVESTIGATION
VILLAGES AT WATERVIEW NORTH
SOUTH POWERS BOULEVARD AND BRADLEY ROAD
EL PASO COUNTY, COLORADO**

May 15, 2020
Revised: October 1, 2020
Revised: July 15, 2022

Entech Job No. 200599
AAprojects/2020/200599 city geohaz-rev

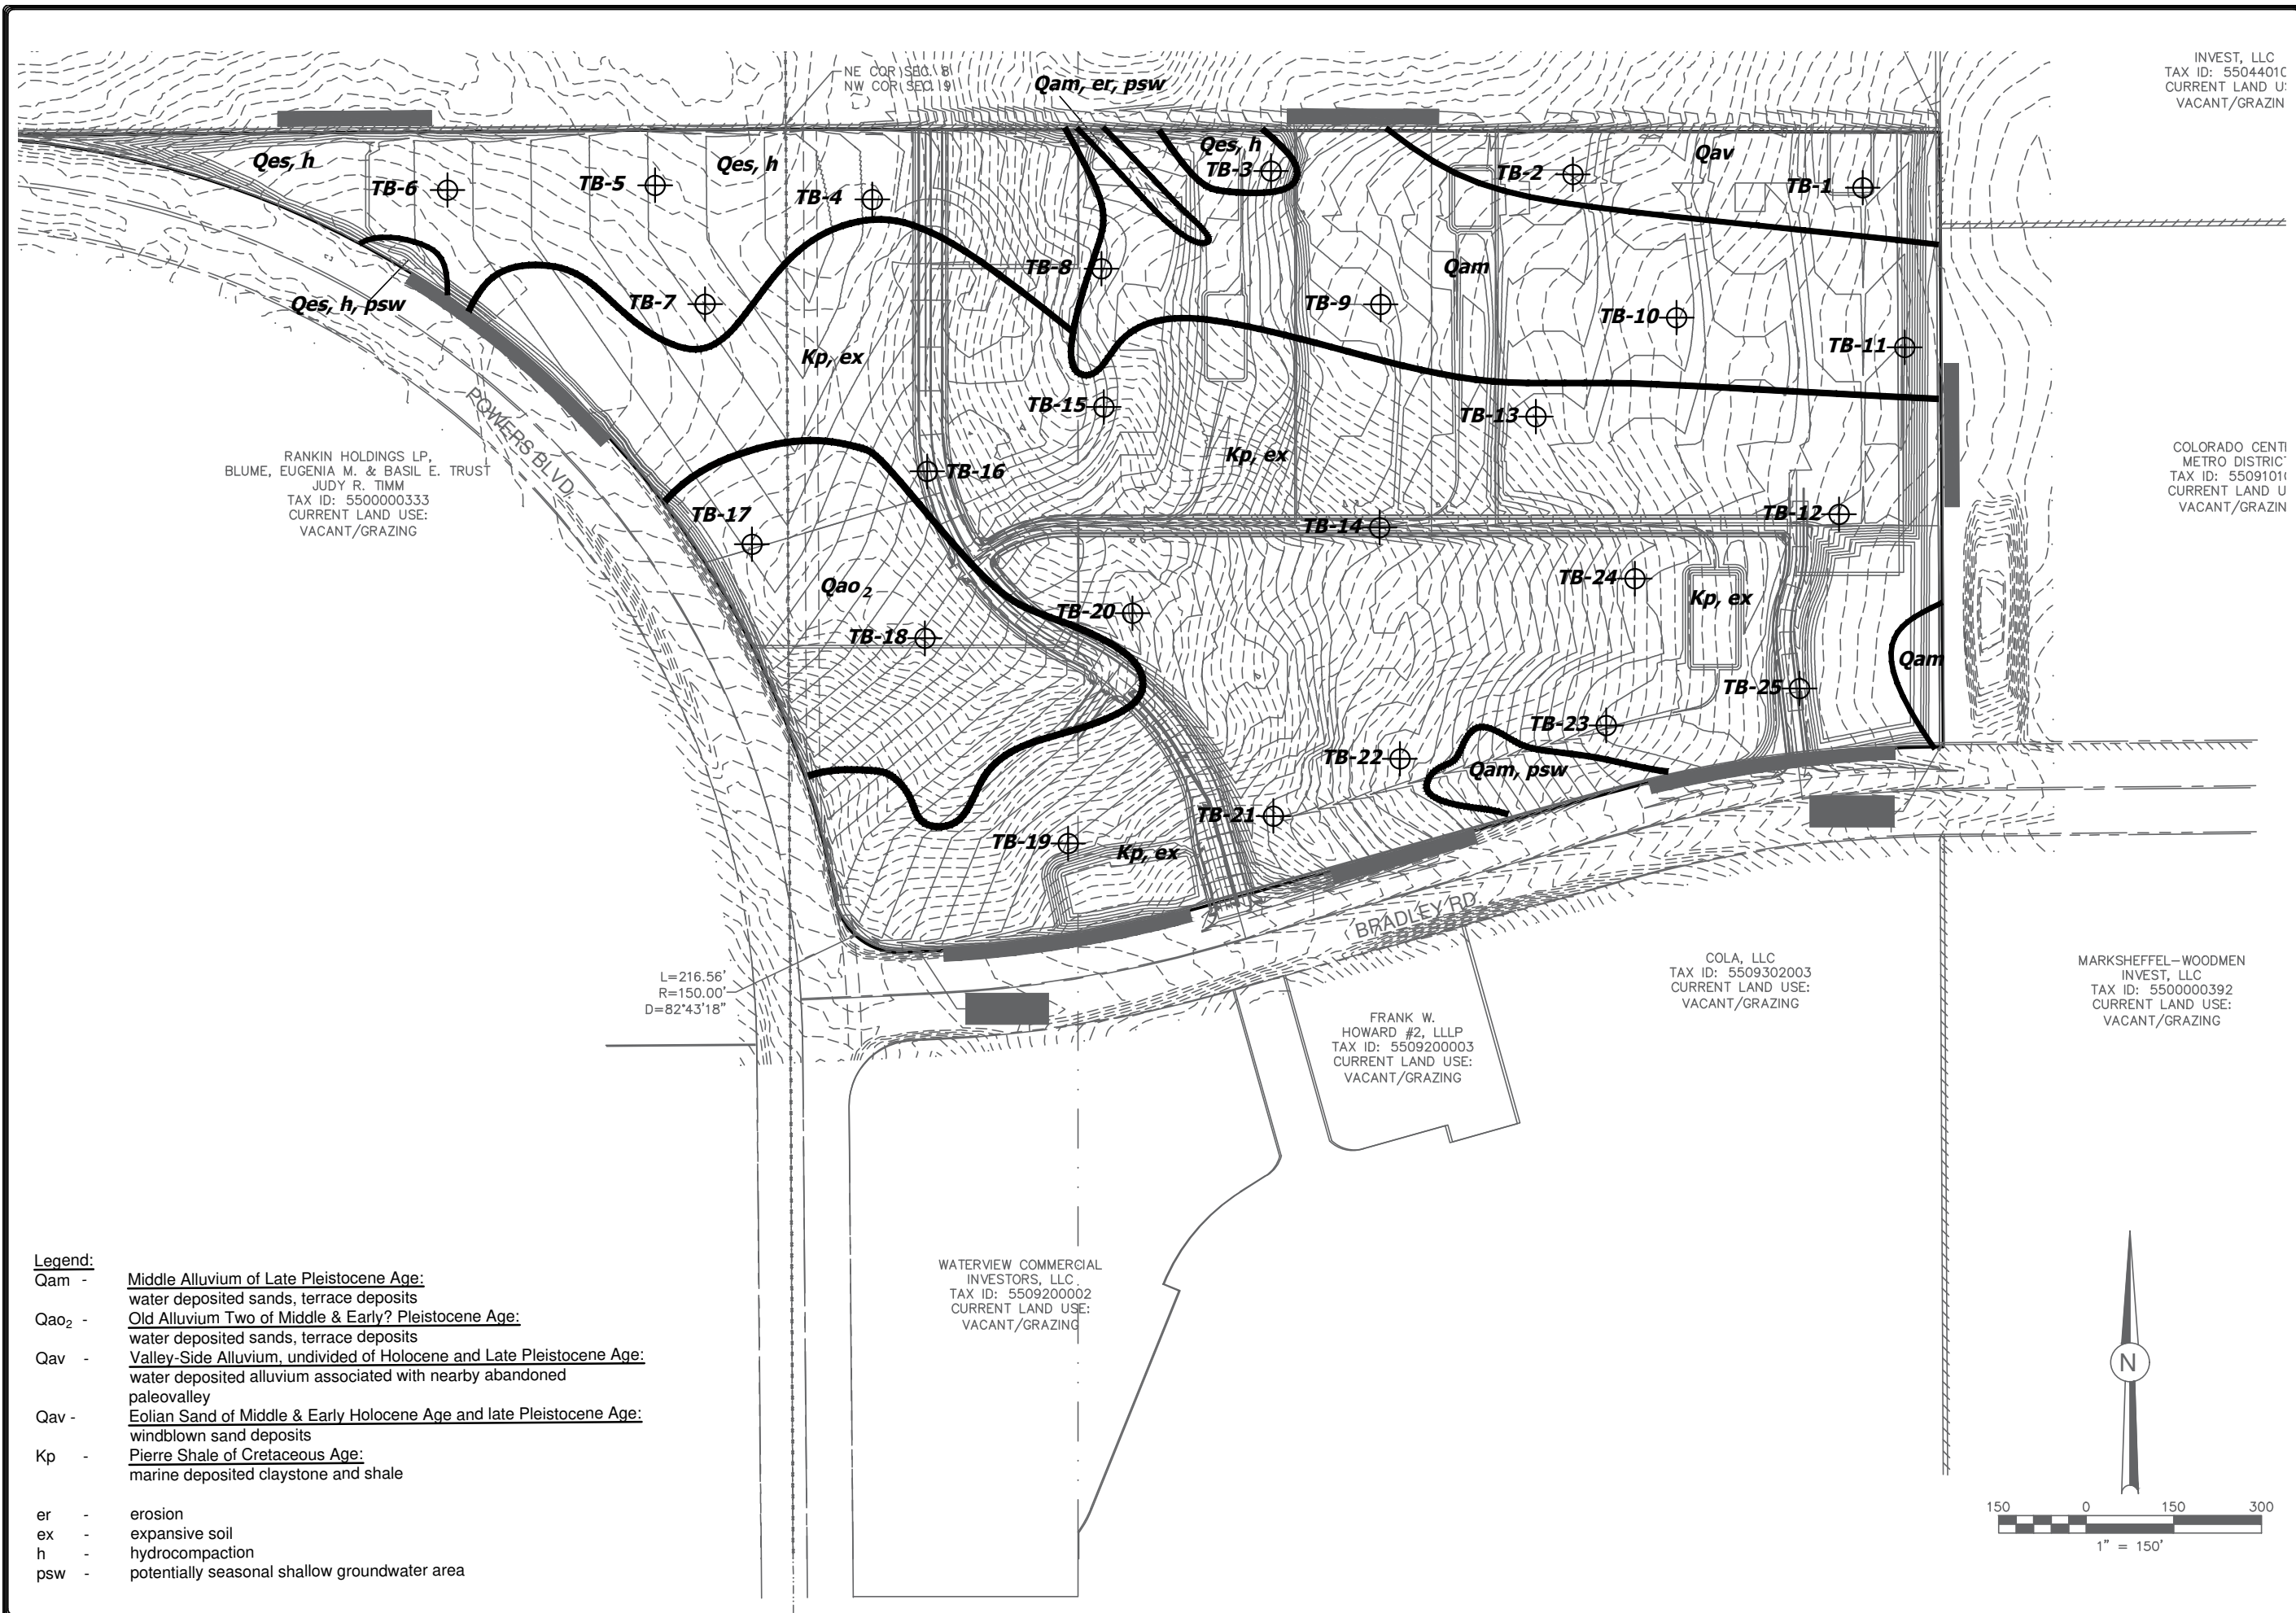
DRAWN
L.L.
CHECKED
DATE
7/11/22
SCALE
AS SHOWN
JOB NO.
200599
FIGURE No.
7

Detailed mapping has been performed on this site to produce an Engineering Geology Map Figure 7. This map shows the location of various geologic conditions of which the developers should be cognizant during the planning, design and construction stages of the project. Hazards include areas of collapsible soils/hydrocompaction, highly expansive soils, potential seasonal shallow groundwater, and shallow bedrock. Minor areas of erosion were also observed. These hazards and the recommended mitigation techniques are as follows:

Areas in which hydrocompaction have been identified are acceptable as building sites. In areas identified for this hazard classification, however, we anticipate a potential for settlement movements upon saturation of these surficial soils. The low density, uniform grain sized, windblown sand deposits are particularly susceptible to this type of phenomenon. Additionally, loose or collapsible soils may be encountered on this site. The majority of the soils encountered on-site do not exhibit collapsible characteristics; however, areas of soils with consolidation potential were encountered in the test borings drilled on site. Areas in the northwestern portion

Expansive soils are common in the area, and were encountered in the test borings drilled on site. Swells ranged from low to very high in the soils tested. The clay and claystone, if encountered beneath foundations, can cause differential movement in the structure foundation. These occurrences should be identified and dealt with on an individual basis or possibly mitigated during site grading.

The areas mapped with this hazard are located along the minor drainages in the northern and southern portion of the site, and in the low area in the northwestern portion of the site adjacent to the box culvert located under Powers Boulevard. In these areas, we would anticipate the potential for periodically high subsurface moisture conditions and possible frost heave potential, depending on the soil conditions.

Mitigation: The potential for settlement movement is directly related to saturation of the soils below the foundation areas. Therefore, good surface and subsurface drainage is extremely critical in these areas in order to minimize the potential for saturation of these soils. The ground surface around all permanent structures should be positively sloped away from the structure to all points, and water must not be allowed to stand or pond anywhere on the site. We recommend that the ground surface within 10 feet of the structures be sloped away with a minimum gradient of five percent. If this is not possible on the upslope side of the structures, then a well-defined swale should be created to intercept the surface water and carry it quickly and safely around and away from the structures. Roof drains should be made to discharge well away from the structures and into areas of positive drainage. Where several structures are involved, the overall drainage design should be such that water directed away from one structure is not directed against an adjacent building. Planting and watering in the immediate vicinity of the structures, as well as general lawn irrigation, should be minimized.

Should loose or collapsible soils be encountered beneath foundations, recompaction and moisture conditioning of the upper 2 to 3 feet of soil at 95 percent of its maximum Modified Proctor Dry Density ASTM D-1557 will be required. Exterior flatwork and parking areas may also experience movement. Proofrolling and recompaction of soft areas should be performed during site work.

Mitigation Should expansive soils be encountered beneath the foundation; mitigation will be necessary. Mitigation of expansive soils will require special foundation design. Overexcavation and replacement with non-expansive soils at a minimum of 95 percent of its maximum Modified Proctor Dry Density, ASTM D-1557 is a suitable mitigation, which is common in the area. Floor slabs on expansive soils should be expected to experience movement. Overexcavation and replacement has been successful in minimizing slab movements. Overexcavation depths of 4 to

6 feet are anticipated for the site. Mitigation may also include moisture conditioning and recompaction of the clay soils. The use of structural floors should be considered for basement construction on highly expansive clays.

Drilled piers are another option that is used in areas where highly expansive soils are encountered. Typical minimum pier depths are on the order of 25 feet or more and require penetration into the bedrock material a minimum of 4 to 6 feet, depending upon building loads. Final recommendations should be determined after additional investigation of the lots.

Mitigation: In these locations, foundations in areas subject to severe frost heave potential should penetrate sufficient depth so as to discourage the formation of ice lenses beneath foundations. At this location and elevation, a foundation depth for frost protection of 2.5 feet is recommended. In areas where high subsurface moisture conditions are anticipated periodically, a subsurface perimeter drain will be necessary to help prevent the intrusion of water into areas located below grade. A typical perimeter drain detail is presented in Figure 9. Additionally, swales should be created to intercept surface runoff and carry it safely around and away from structures. It is anticipated that the site grading will likely mitigate the dry drainages on the site, and a detention pond is proposed in the northwestern portion of the site. Lots adjacent to the detention pond may also require drains to help prevent the intrusion of water into areas below grade during periods of high moisture. Several detention ponds are proposed across the site.
