**Conditions Study for
Southwest Downtown Study Area
Colorado Springs, Colorado**

FINAL

June 2018

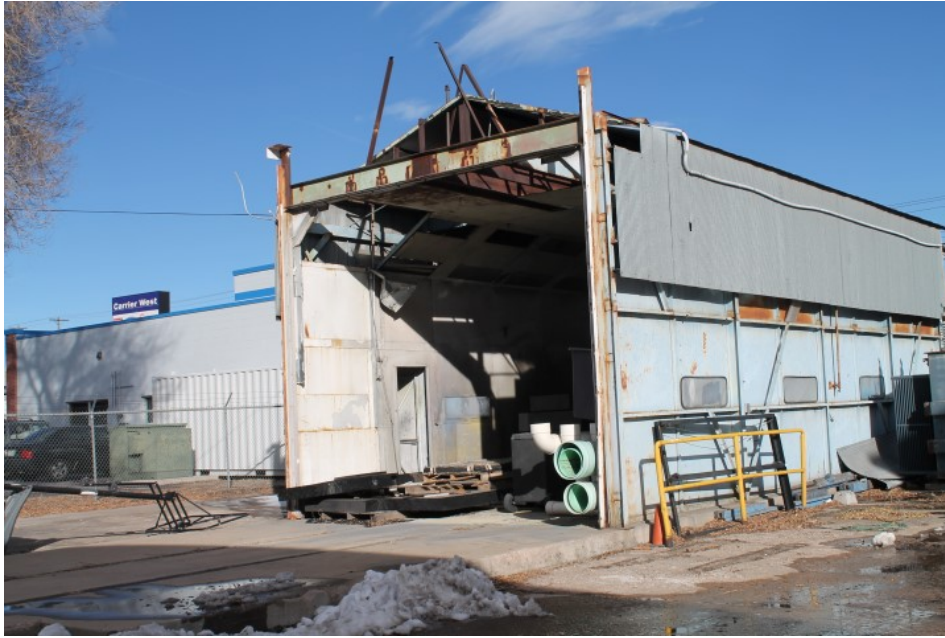
Figure 2-4 Multiple examples of deteriorated building exterior and structure, potentially hazardous conditions, unsafe level changes, building code violations, dilapidated building interior, unprotected electrical systems, inadequate fire suppression systems (Photo A-17)

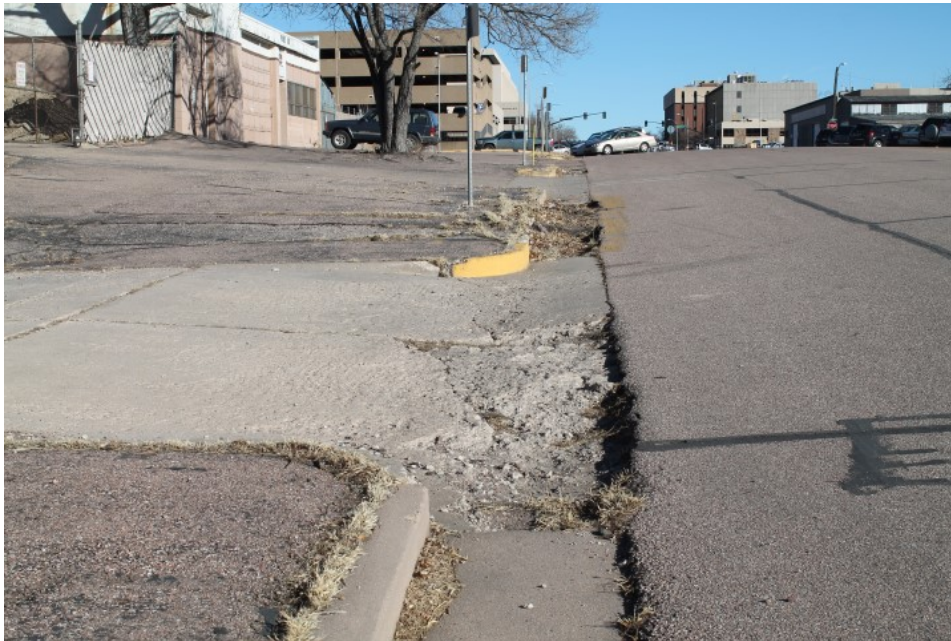
Figure 2-5 Presence of trash and debris, substandard driveway/curb cuts, cracked and uneven surfaces, unsafe level changes, deteriorated curb and gutter, inadequate and deteriorated sidewalk, inadequate site maintenance, non-conformance to development regulations (Photo B-11)

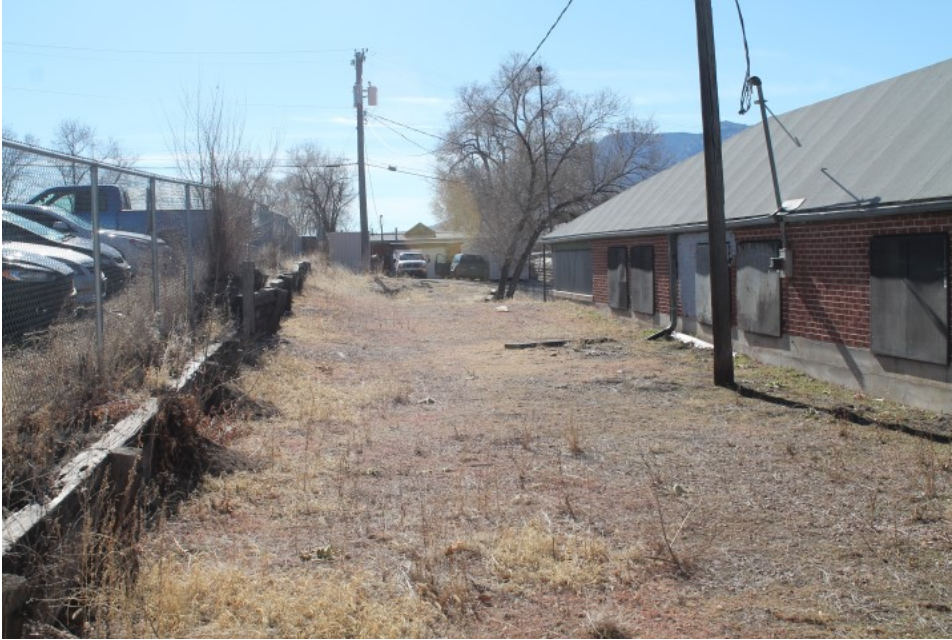
Figure 2-10 Presence of trash and debris, vagrants/graffiti/vandalism (Photo D-5)

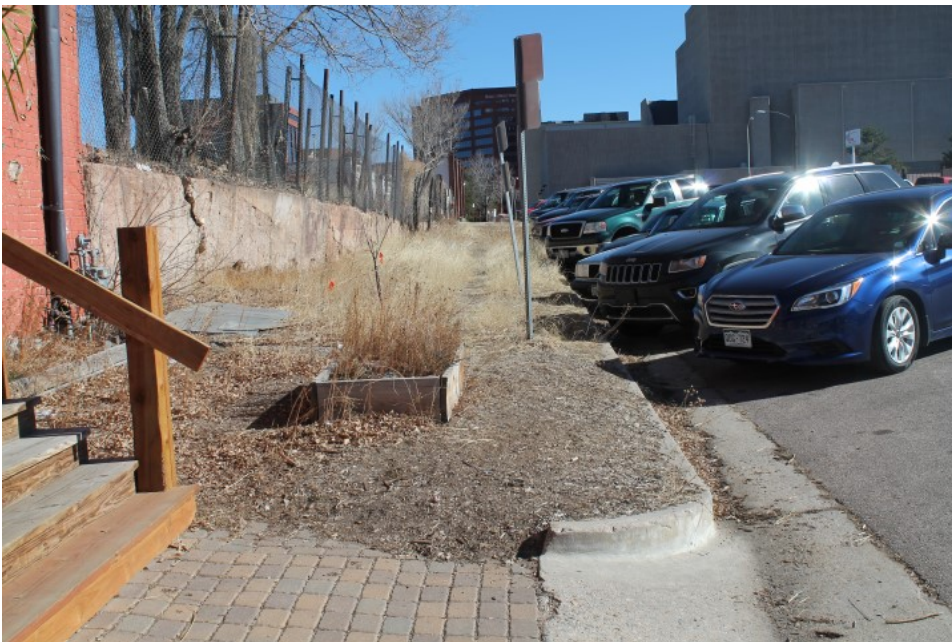
Figure 2-11 Poor vehicle access, substandard driveway/curb cuts, cracked or uneven pedestrian surfaces, unsafe level changes, inadequate and deteriorated sidewalk, presence of trash and debris, unsafe level changes, inadequate site maintenance, non-conformance to development regulations, deteriorated site walls (Photo D-10)
