MORENO AND CASCADE EXISTING CONDITIONS SURVEY

DRAFT REPORT ————————————————————————————————————	
Prepared for: Colorado Springs Urban Renewal Authority	Prepared by: Economic & Planning Systems, Inc.
	July 15, 2025

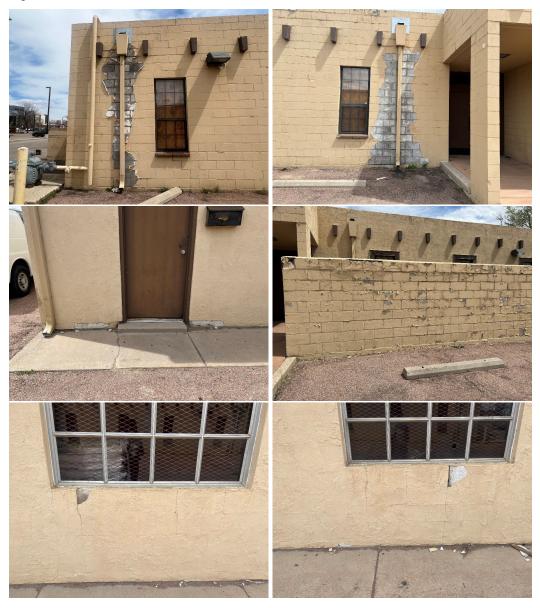
Figure 2. Deteriorated Exterior Finishes

Buildings in the Study area have deteriorated exterior finishes with peeling paint, exposed cinder block, and chipped and cracked exteriors around doors and windows, shown in Figure 2. One structure had the downspout removed and laying next to the building, shown in Figure 3.

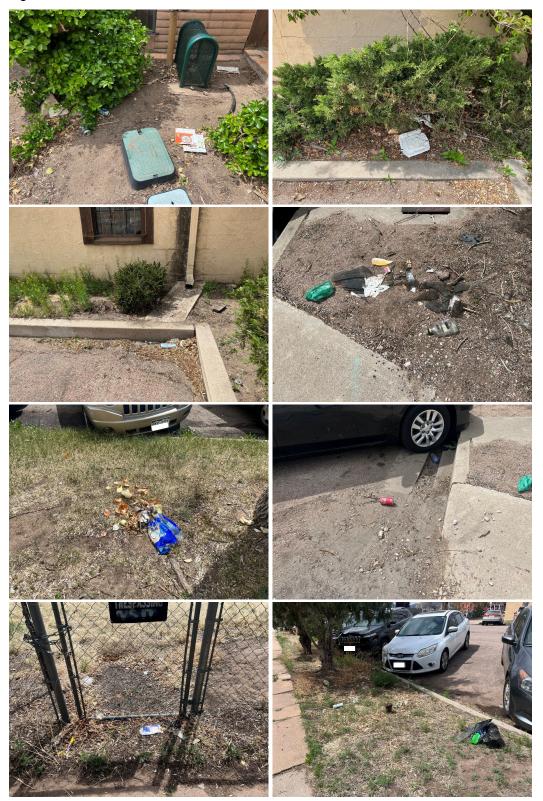
Figure 4. Excessive Litter

Throughout the Study Area unsafe and unsanitary conditions were documented, including excessive litter, vandalism, and vagrants. Additionally, cracked and uneven surfaces were observed along the sidewalk on the south side of Moreno Avenue. Excessive litter was observed and documented thoughout the property and along Moreno Avenue, shown in **Figure 4**. This included general trash, drink containers, cardboard, plastic bags, takeout containers, and old food. There was evidence of vandalism and a vagrant in the Study Area, shown in **Figure 5**. Cracked and uneven sidewalks along Moreno Avenue are shown below in **Figure 6**.

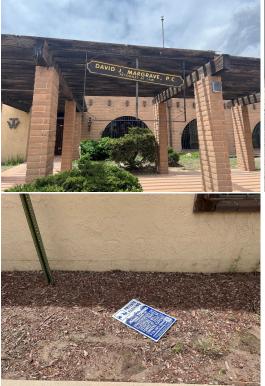
Figure 7. Deteriorated Signage

Deteriorated site improvements observed on Parcel 1, the old office building, include deteriorated signs (Figure 7), walls/pergola (Figure 8), and on-site parking surfaces (Figure 9). The sidewalk along Moreno Avenue adjacent to Parcels 2 to 6 was deteriorated as shown previously in Figure 6. In addition, overgrown vegetation was observed throughout the Study Area, shown in Figure 10.

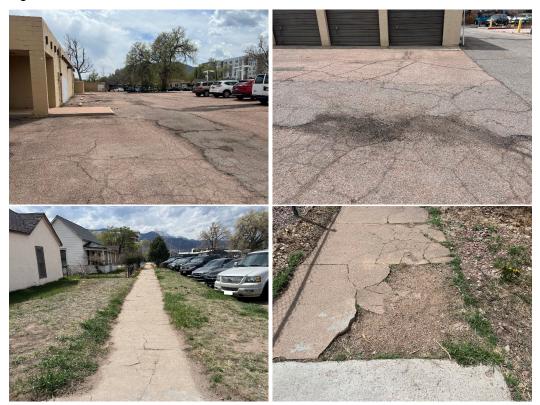
Figure 11. Deteriorated Pavement and Sidewalks

4. Infrastructure: unusual topography or inadequate public improvements or utilites Inadequate infrastructure was observed throughout the Study Area, predominately in the form of deteriorated pavement and sidewalks, lack of pavement, and overhead utilites. Deteriorated pavement was observed in the alley behind Parcel 1 and in the office building parking lot, shown in Figure 11. As previously mentioned, there is deteriorated sidewalk along Moreno Street (Figure 11). The alley behind the residential properties (Parcels 2 to 6) south of Moreno Street is unpaved, shown in Figure 12. Additionally, overhead utilites were present in the alley behind Parcel 1 and along Sahwatch Street, shown in Figure 13.

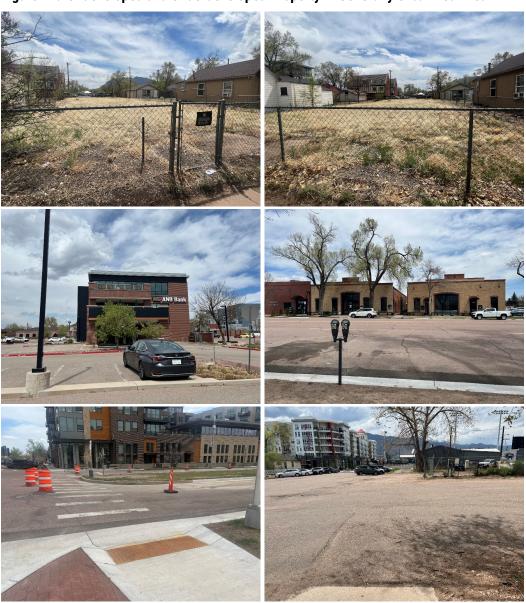
Figure 15. Vacant Structures

The Study Area is located in Downtown Colorado Springs and is surrounded by urban development, as shown in **Figure 14** a bank directly north, high-rise apartments to the west and east, additional office and retail in the Trolley Block to the east, and Weidner Field to the west. Parcel 6 is undeveloped and the remaining parcels in the Study Area are underdeveloped compared to the development opportunities available in the urban core of the community. Additionally, the office building on Parcel 1 is currently vacant, shown in **Figure 15**.
