Wetland Delineation and Habitat Assessment Report
252 Heavy Stone View - Creekside at Rockrimmon
USACE Action No. SPA-2021-00106

Prepared for: Premier Homes, Inc.

Prepared by: Auckland
Environmental Consulting

June 21, 2021

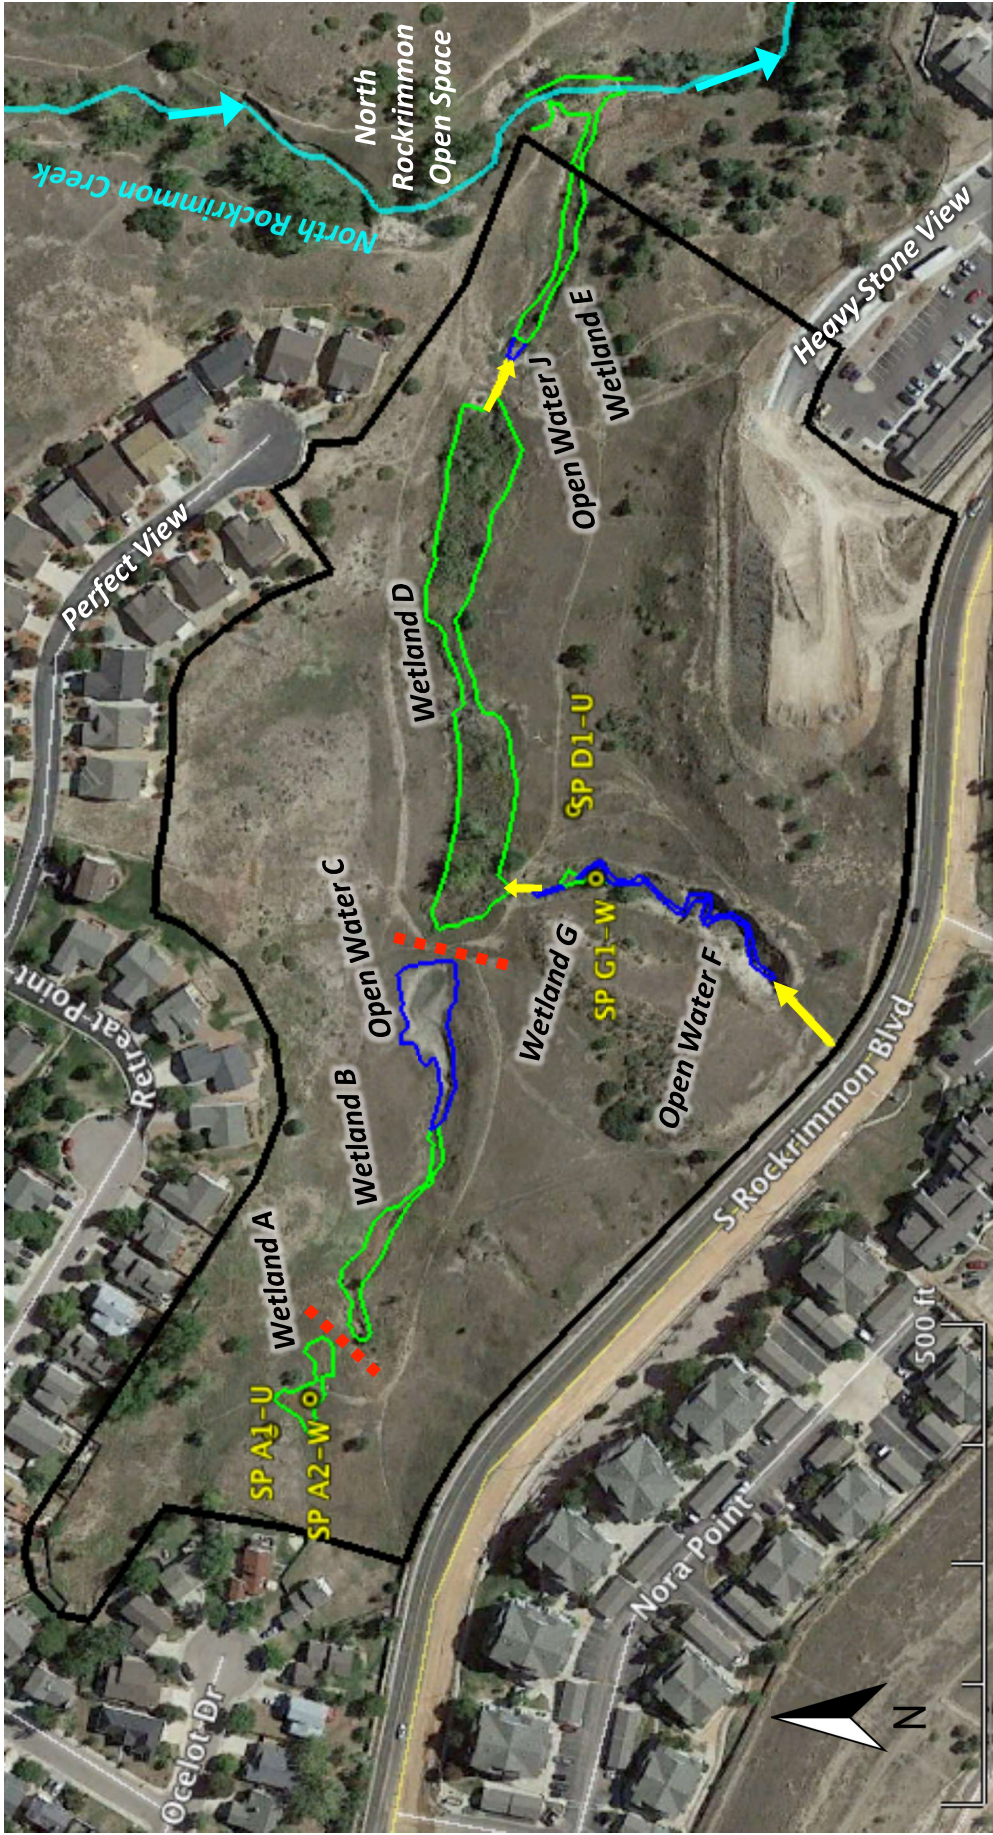
Most of the open water and wetland features (i.e. “wetlands”) on the Site are along the valley bottom. All are categorized as palustrine and there are no streams associated with them (Cowardin, 1979). The wetlands are of moderate quality. Vegetative diversity is low and hydrology has been modified by stormwater and the construction of dams and culverts. However, they provide valuable functions including wildlife habitat, aesthetics, and water quality improvement (by slowing and filtering stormwater runoff before it reaches North Rockrimmon Creek). These aquatic resources are described below, starting at the west/upper end of the valley. See Table 1 for a summary, Figure 2 for mapping, and Appendix C for photographs.

- Legend**
- Site Boundary
 - Open Water*
 - Wetland*
 - Sampling Point (SP)
 - Culvert and Flow Direction
 - Upland Break

*Delineated May 21, 2021

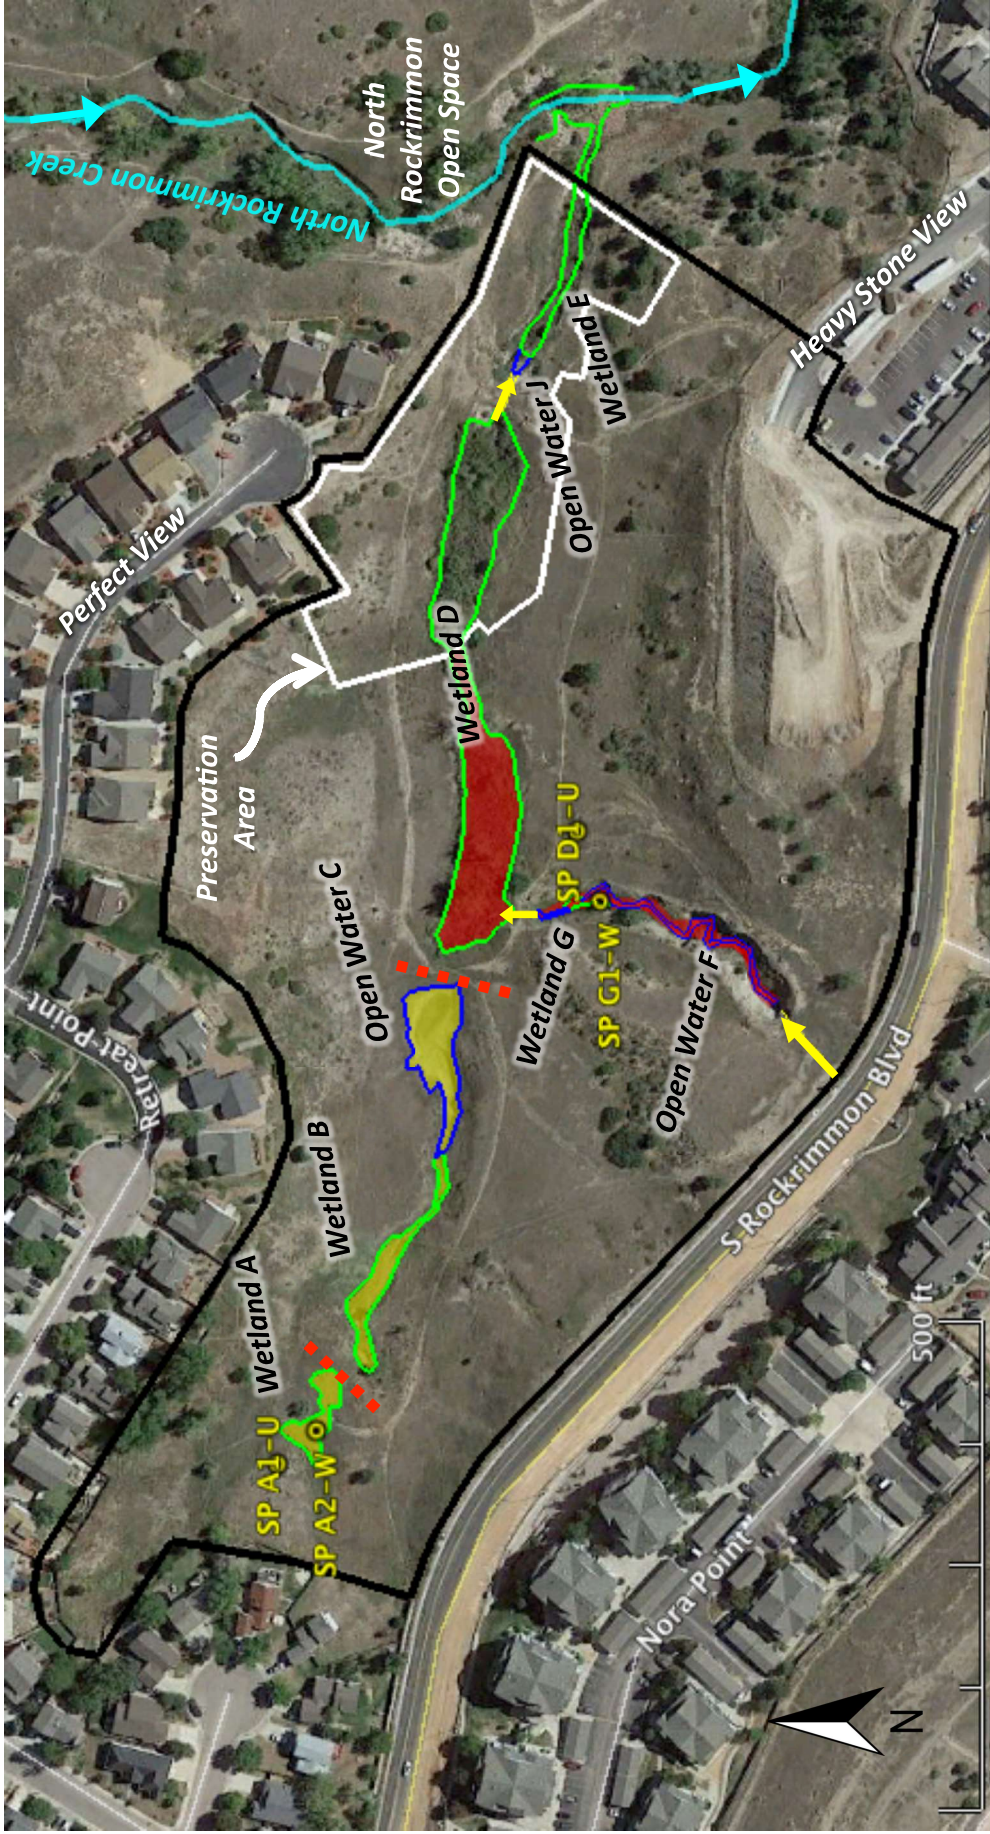
The project would result in permanent impacts to 0.36 acre of presumed WUS (Table 1) (Figure 3). Impacted WUS are comprised of 0.32 acre of palustrine scrub-shrub wetlands (Wetlands D and G) and 0.04 acre of open water in an eroded gully (Open Water F) (Appendix A). No temporary WUS impacts are expected. The majority of the direct impacts would be to Wetland D and caused by grading of slopes for lots and construction of a stormwater detention pond.

The project would also permanently impact 0.13 acre of wetlands (Wetlands A and B) and a 0.14 acre seasonally ponded area that are presumed to be non-jurisdictional because they lack a surficial hydrologic connection to downstream WUS (Table 1) (Figure 3). Grading of the Property to create lots and roads would fill these areas.

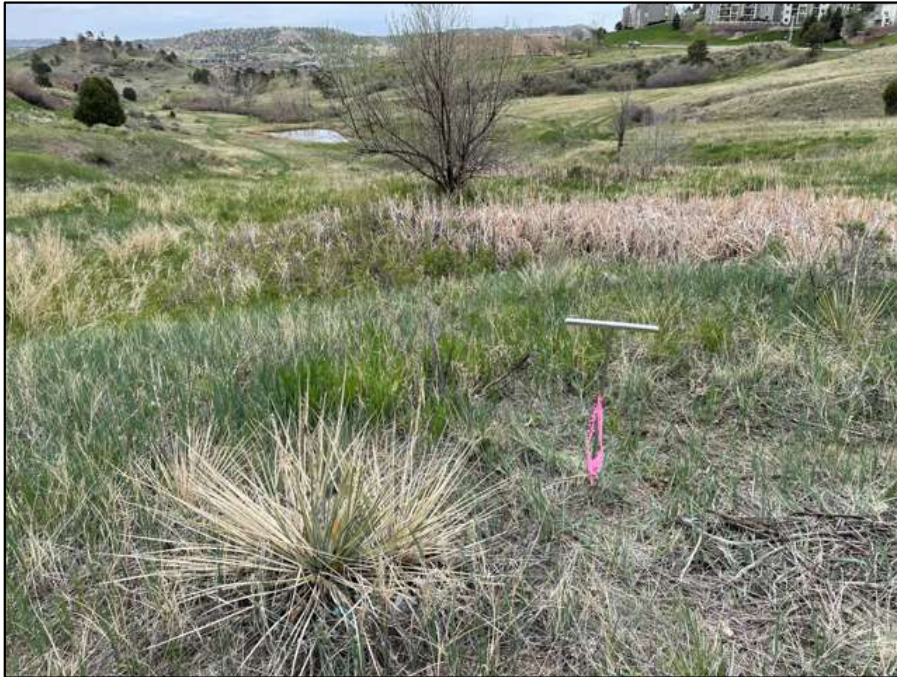
1. Upland Sampling Point (SP) A1-U, facing east from the top of the valley and across the Site. Cattails at Wetland A are visible beyond the sampling point. *May 21, 2021.*

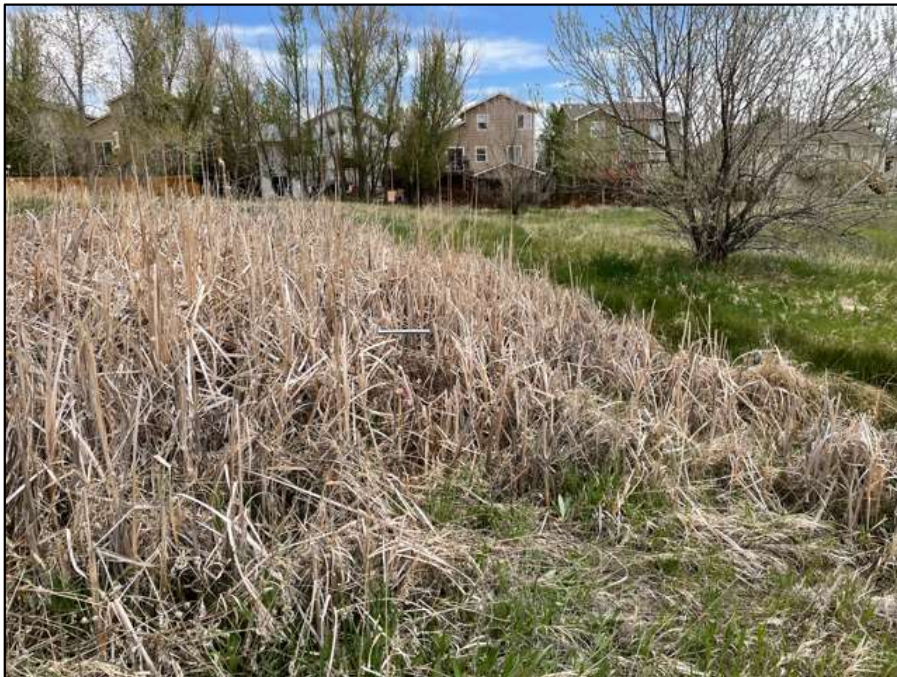
2. Facing north towards Wetland A and SP A1-W. *May 21, 2021.*

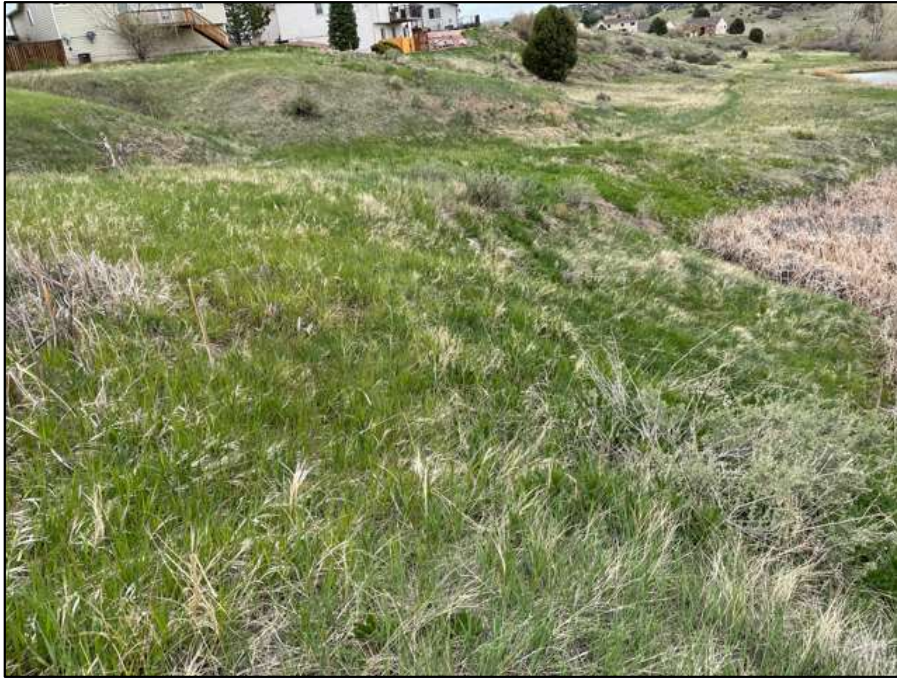
3. Facing northeast across the upland break on the slope between Wetland A (photo left) and Wetland B (photo right). *May 21, 2021.*

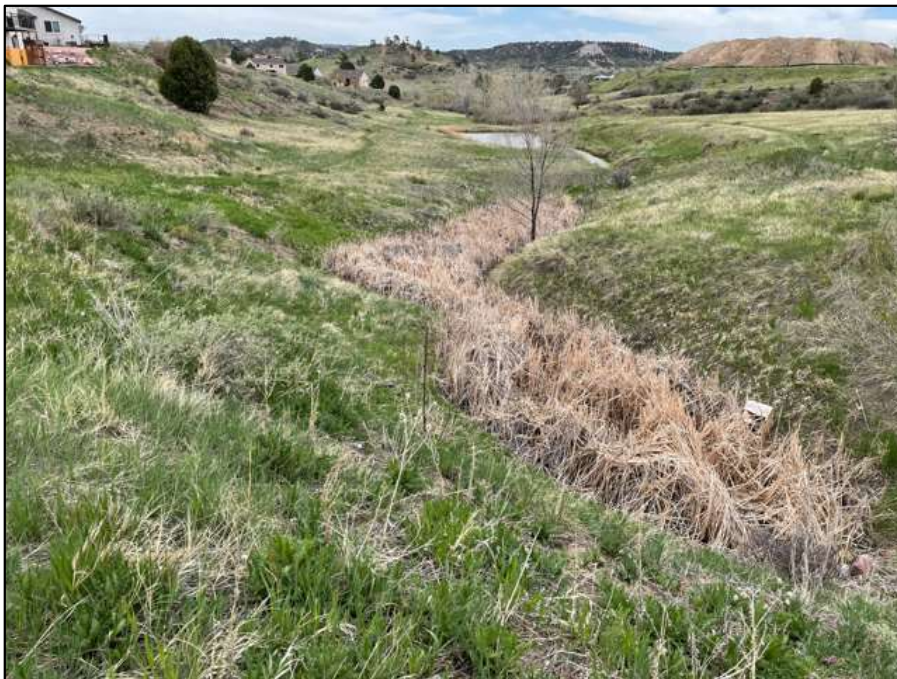
4. Facing east down the valley, towards Wetland B and Open Water C (pond). *May 21, 2021.*

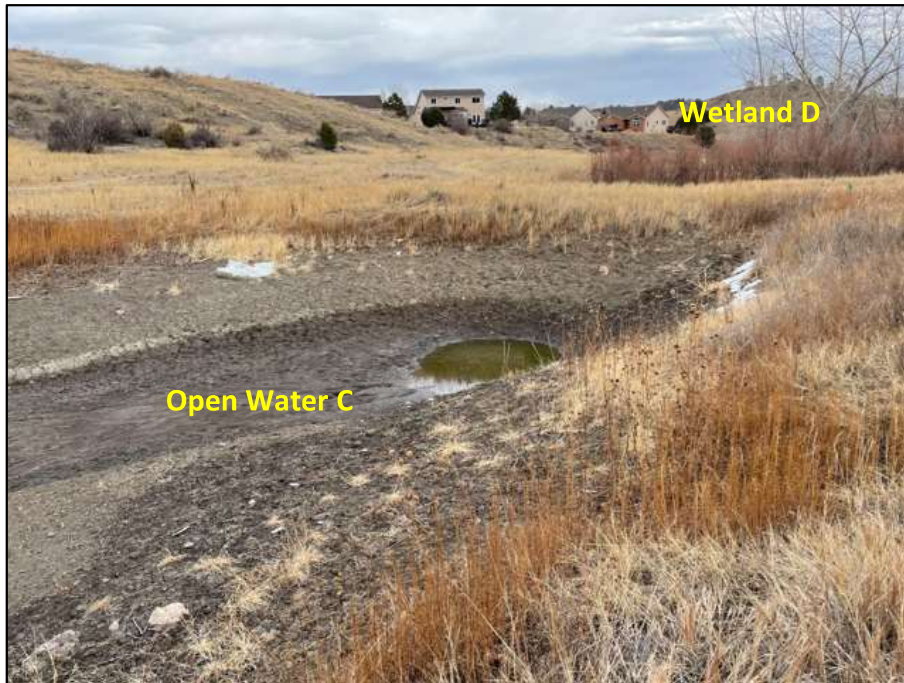
- Open Water C is a pond created by construction of an elevated access road that functions as a dam. The pond was almost dry in March, but full in May. No culvert or evidence of flow from a buried culvert were observed. The pond perimeter is vegetated with a narrow, patchy band of Canadian horseweed (*Erigeron canadensis*) (FACU) (30%), curly dock (FAC) (15%), annual sunflower (*Helianthus annuus*) (5%) (FACU) and Canada thistle (5%) (FAC). In March these plants were mostly dead and in May they were submerged in water. Therefore, the open water boundary was delineated based on the May water level, which corresponds with the ordinary high water marks seen in March and aerial photographs. The OHWM is approximately two feet below the top of the access road. The access road/dam creates a 35-foot wide upland break, with no surficial hydrologic connection, between Open Water C and Wetland D.

5. Photo facing northeast across Open Water C (pond) when it was almost dry. The pond is formed by an access road that functions as a dam. There is no culvert to convey surface flows downstream of the pond. March 8, 2021.

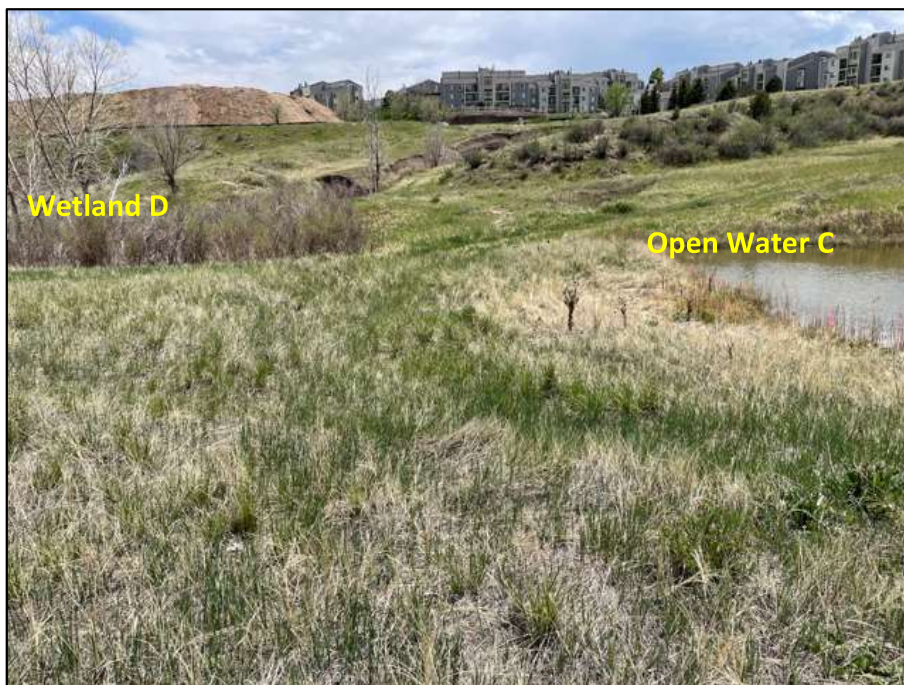
6. Photo facing south towards Rockrimmon Boulevard and across the access road between Open Water C and Wetland D. Open Water F and Wetland G are located in the gully on the far slope; they flow into the upper end of Wetland D. May 21, 2021.

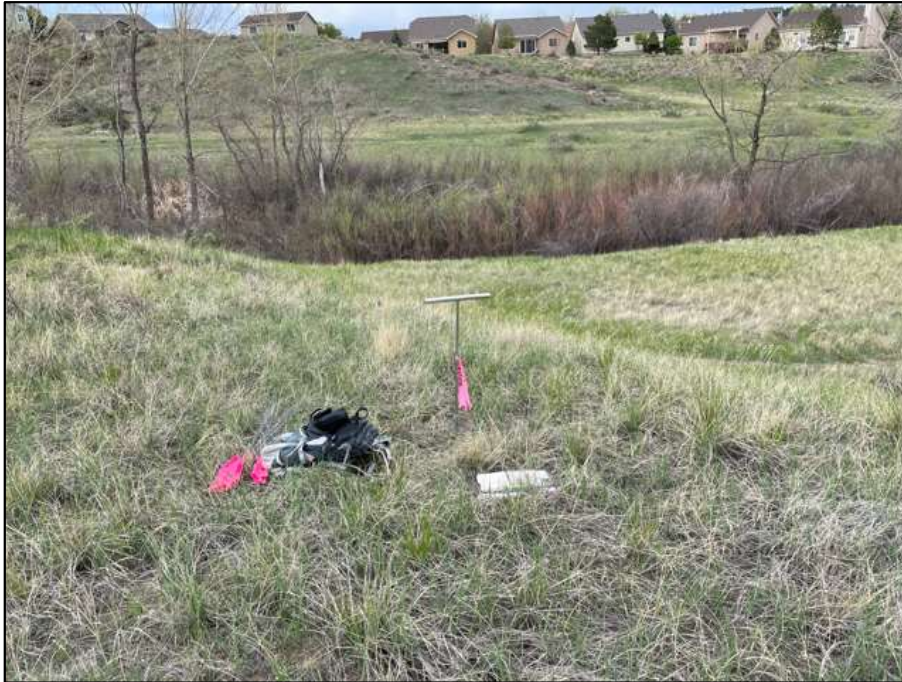
7. Facing north towards SP D1-U and Wetland D. *May 21, 2021.*

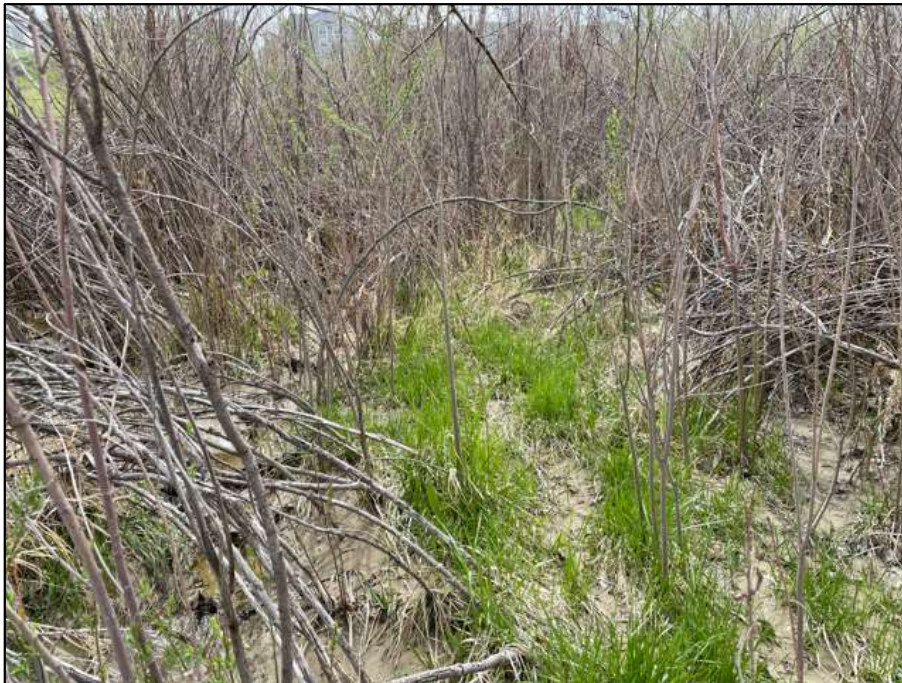
- Wetland D is the largest wetland. It extends for approximately 550 feet along the flattest portion of the valley. The hydrologic source appears to be a combination of groundwater and surface flows. Stormwater from Open Water F flows into the upper end of the wetland via a culvert. The wetland bottom is flat with no clearly defined channel, 30% to 60% bare ground in the herbaceous layer, and the diversity of herbaceous species is low. This appears to be due to a combination of the fairly flat topography and the large volume of eroded sediment that flows into the wetland from Open Water F. There is not a continuous defined channel through the dense vegetation and fine sediment. In May, flow was a trickle that occasionally concentrated in small channels that were approximately one-foot wide and one to two inches deep. Therefore, no portion of this area was mapped as open water or could be considered a stream. Narrowleaf willow (FACW) (60% cover) is the dominant species throughout the wetland. In the upper half of Wetland D, there is also approximately 20% cover of broadleaf cattails (OBL) and 30% cover of plains cottonwood (FAC) trees. In the lower half, cattails are replaced by grasses such as bluejoint (*Calamagrostis canadensis*) (FACW) and there is approximately 10% tree cover consisting of peach leaf willows (FACW) instead of cottonwoods. In some areas, common snowberry (FACU) is abundant along the upland edge of the wetland. The wetland ends at a 48-inch diameter culvert that flows to Open Water J.

8. Dense wetland vegetation in Wetland D. Soil was saturated at the surface, but flows were limited to small trickles in a few areas. Conditions were similar in Wetland E. Photo taken near upper/west end and facing west. *May 21, 2021.*

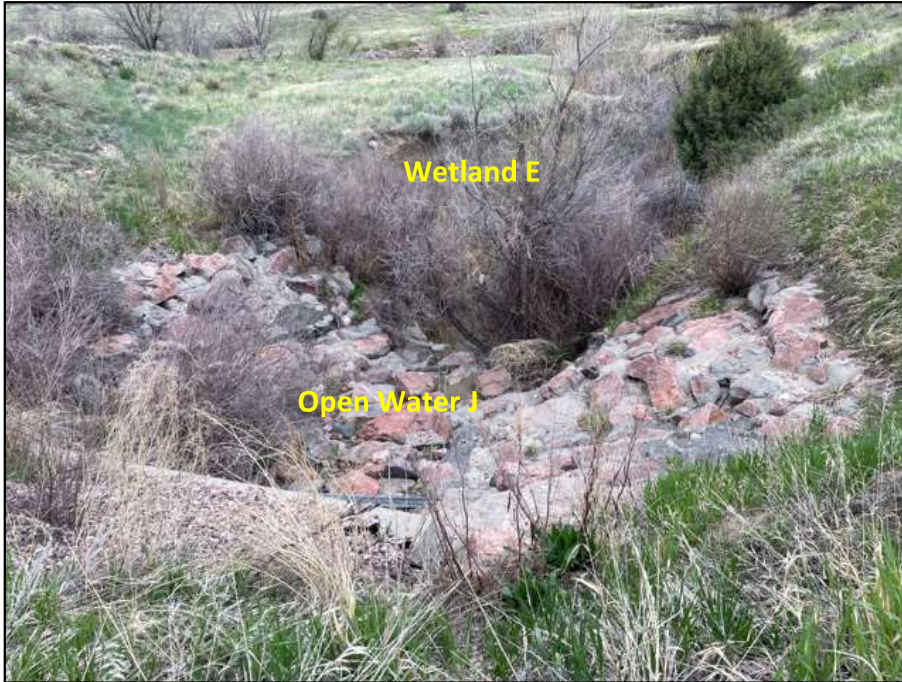
- Wetland E is along the bottom of a narrow, incised channel. The wetlands are six to 15 feet wide and the channel banks are eight to twelve feet high. Wetlands vegetation extends across the channel bottom and consists of dense sandbar willows (~60% cover)

with a few small trees (plains cottonwoods and peachleaf willows). The steep banks are vegetated with herbaceous species and mature shrubs. There are no signs of recent erosion, thus it appears that the channel eroded over twenty years ago and is now stable. It is likely buffered from flashy upstream stormwater flows by Wetland D. Observed hydrology was similar to Wetland D, surface saturation and a discontinuous trickling flow with no defined channel. Wetland E ends at the property boundary, but the wetland channel continues east for approximately 60 feet where it converges with North Rockrimmon Creek.

9. Photo taken from path on top of a 48-inch diameter culvert and facing east/downstream. The Wetland E channel is deeply incised, but vegetation is well-established. Open Water J consists of grouted riprap at the culvert outflow, flows were a trickle and below the ordinary high water mark. *May 21, 2021.*

Options considered, but rejected, for improving the existing wetlands included removing the culvert between Wetlands D and E or grading down the banks of the deeply incised channel at Wetland E. Removing the culvert could destabilize the upstream wetlands or increase downstream erosion. Grading above Wetland E would impact native habitats along the channel including pine-oak woodlands on the steep slope to the south. Also, even though the Wetland E channel is deeply incised, that appears to have happened over 20 years ago and there are now dense sandbar willows growing throughout the channel bottom and established shrub cover on the banks.

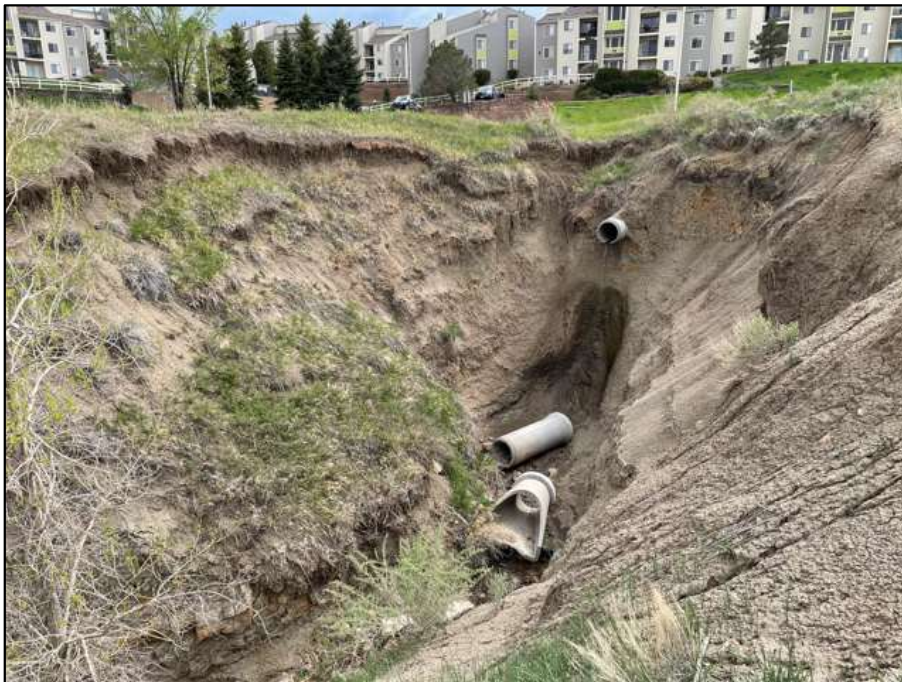
There is a large eroded gulch (Open Water F and Wetland G) that extends from South Rockrimmon Boulevard to the bottom of the valley via a steep side slope (Table 1) (Figure 2) (Appendix C: Site Photographs). The water source is a large culvert that appears to collect stormwater flow from the streets and a detention pond. Stormwater runoff has eroded a gulch that is approximately 20-feet deep at the upper end. Due to the flashy flows and high rate of erosion, the area is significantly disturbed, normal circumstances are not present, and most of the gulch is not vegetated or vegetation (sandbar willows) is dead. The open water sections were delineated based on the estimated “ordinary” high water mark. During the May site visit, there was a trickle of water coming from the culvert and flowing through the channel. However, since there had been recent precipitation, it could not be determined if flows were entirely from stormwater (i.e. ephemeral) or if groundwater also contributes to flow. There is a small wetland near the south end of the gulch (Appendix D Wetland Determination Data Forms, SP G1-W). Vegetation is growing on a low bench that is protected from high flows by a sharp bend and an established cottonwood tree. Understory vegetation includes wetland and upland species; narrowleaf willow (FACW), snowberry (FACU), curl dock (FAC), and smooth brome (UPL). Wetland species are dominant. Below the wetlands, the last section of the Open Water F channel cuts through a small upland area vegetated smooth brome (an upland species). The gulch ends at an approximately 24” diameter culvert that drains into the upper end of Wetland D. The overall quality and ecological value of this feature is negative because stormwater flows erode high volumes of sediment that then flow into downstream wetlands along the valley.

10. Stormwater outlet at the top of the eroded gully (Open Water F). Photo is facing south toward S. Rockrimmon Boulevard. Runoff appears to come from roads and a detention basin in the apartment complex. *May 21, 2021.*

3. The existing stormwater flow from the culvert at South Rockrimmon Boulevard is not required to be treated in a detention basin and would be diverted towards the preserved wetlands. In order to avoid indirect wetland impacts, an outfall structure would be designed for the area above the wetlands that would maintain a low flow channel and prevent erosion during high flows. If possible high flows would be directed across the low area south of Wetland D to support the growth of riparian vegetation. Outlet protection measures would be installed in uplands and may include an energy dissipator/forebay system, a porous landscape detention basin to slow flows and support riparian vegetation, upland grade control structures to prevent erosion, and/or a flow spreader.

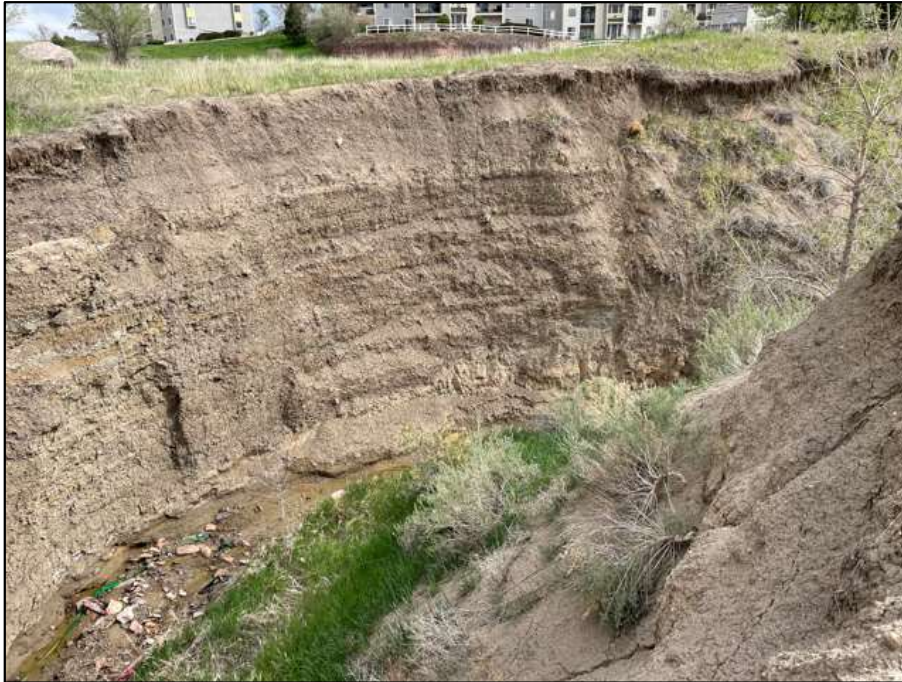
11. Facing southeast across a typical section of the eroded gully/Open Water F. Dark clay soils with orange oxidization were observed along the walls of the gully from top to bottom. *May 21, 2021.*

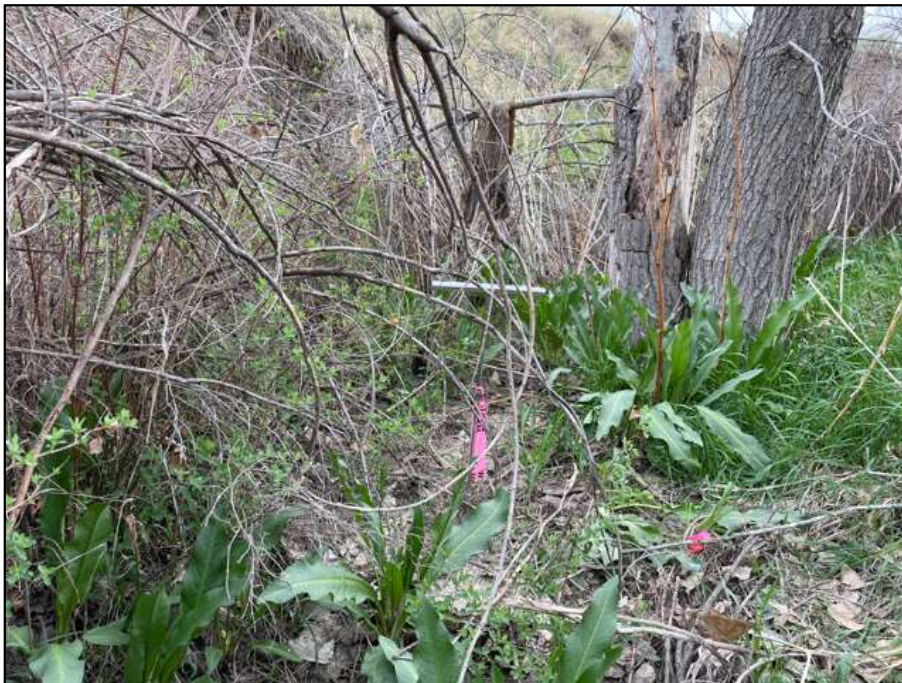
12. Wetland G and SP G1-W, facing south/upstream within the eroded gully. Wetland vegetation was limited to this one small area that was protected by a bend in the gully and the cottonwood tree. *May 21, 2021.*
