Final Report

Zebulon Flats Existing Conditions Survey

City of Colorado Springs Urban Renewal Authority

November 12, 2020

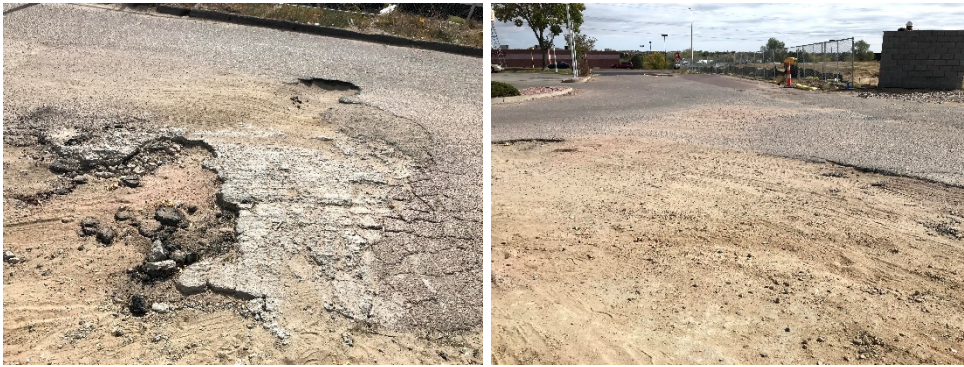
Figure 2. Poor Provision of Street Improvements

In the southeast corner of the Study Area, poor provisions of the streets for vehicular traffic were observed in the form of large potholes and deteriorating pavement, shown in **Figure 2**. Throughout the Study Area, provisions of walkways for pedestrians were observed in the form of lack of sidewalks. In particular in the northeast corner and northwest corner there are curb cuts and the beginning of a sidewalk that abruptly ends, shown in **Figure 3**. Additionally, there were no sidewalk or pedestrian improvements along any of the other perimeters of the property, which is evident in other photos included in this study.

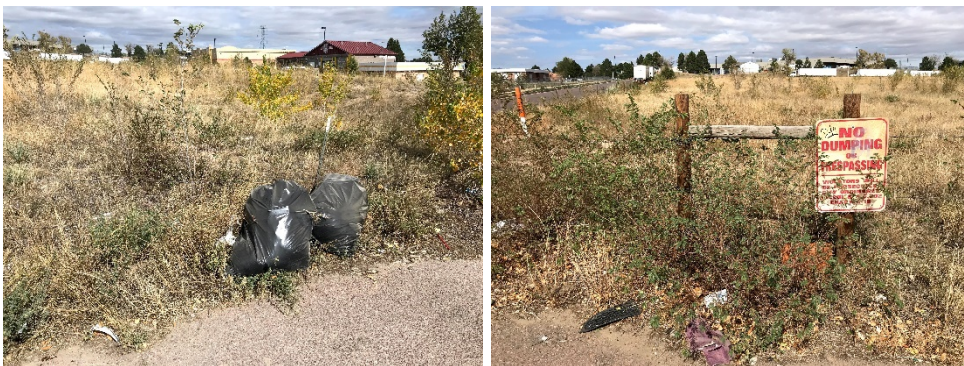
Figure 4. Illegal Dumping

Throughout the Study Area unsafe and unsanitary conditions were documented, including illegal dumping and litter. Illegal dumping was observed at the southern edge of the property, shown in **Figure 4**. Excessive litter was observed and documented throughout the property and along each edge of the property, shown in **Figure 5**. Additionally, there was evidence of crime along Verde Drive adjacent to the property. Broken glass was on the ground, which appears to be from a previous break-in to a parked vehicle, shown in **Figure 6**.

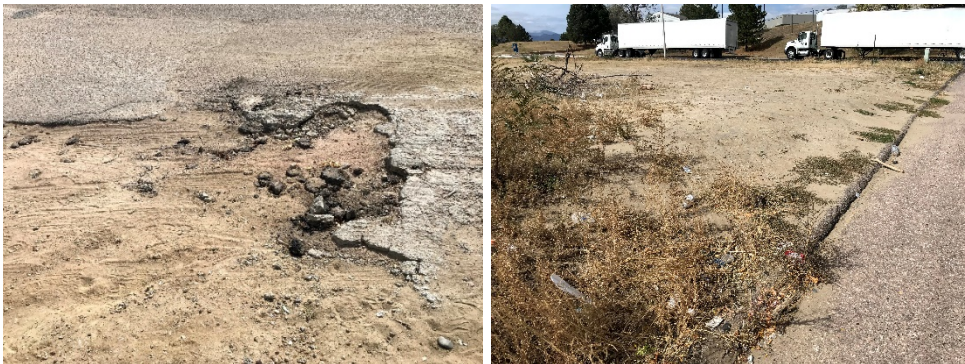
Figure 10. Deteriorated Pavement and Curbs and Missing Sidewalks

Inadequate infrastructure was observed throughout the Study Area, predominately in the form of deteriorated pavement, deteriorated or missing curbs, and missing sidewalks, shown in **Figure 10**. Additionally, unusual topography was observed on the southeast side of the property in the form of steep slopes, shown in **Figure 11**.

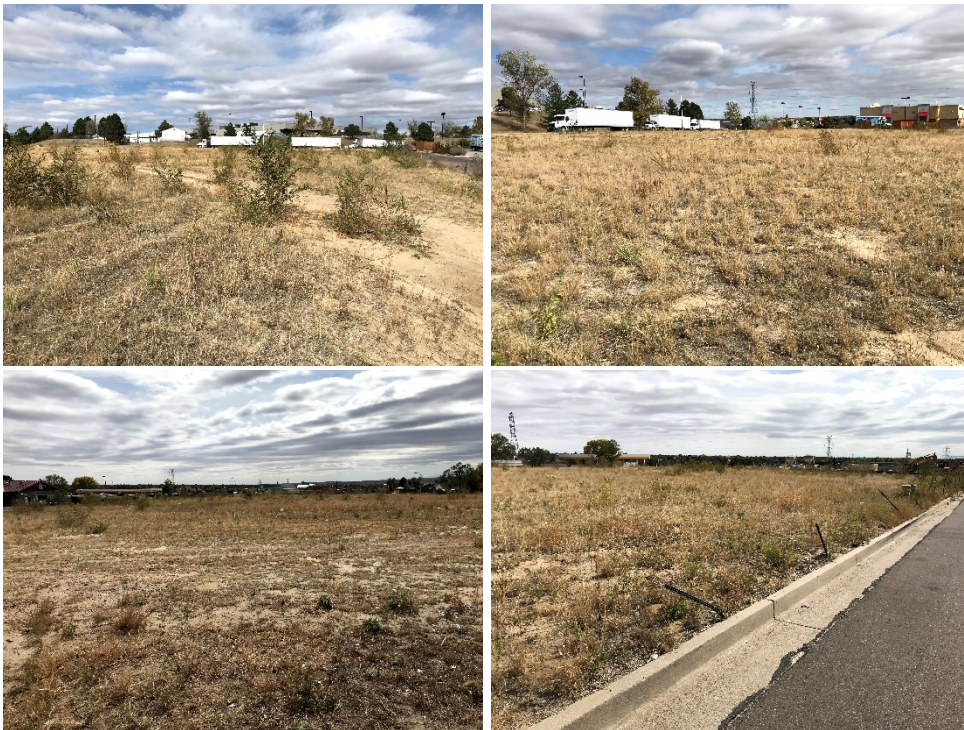
Figure 12. Vacant Property

The entire 3.28 acre property is vacant with no building improvements. The property is surrounded by development with three commercial properties to the east, development to the north, a project under construction to the south, plans for a church to the west, and a housing development to the southwest, shown in **Figure 12**.
