APPLICATION FOR VOLUNTARY CLEAN-UP

Remediation of Existing Abandoned Landfill Mesa Valley Springs Property Colorado Springs, Colorado

VERSION 2
December 10, 2018

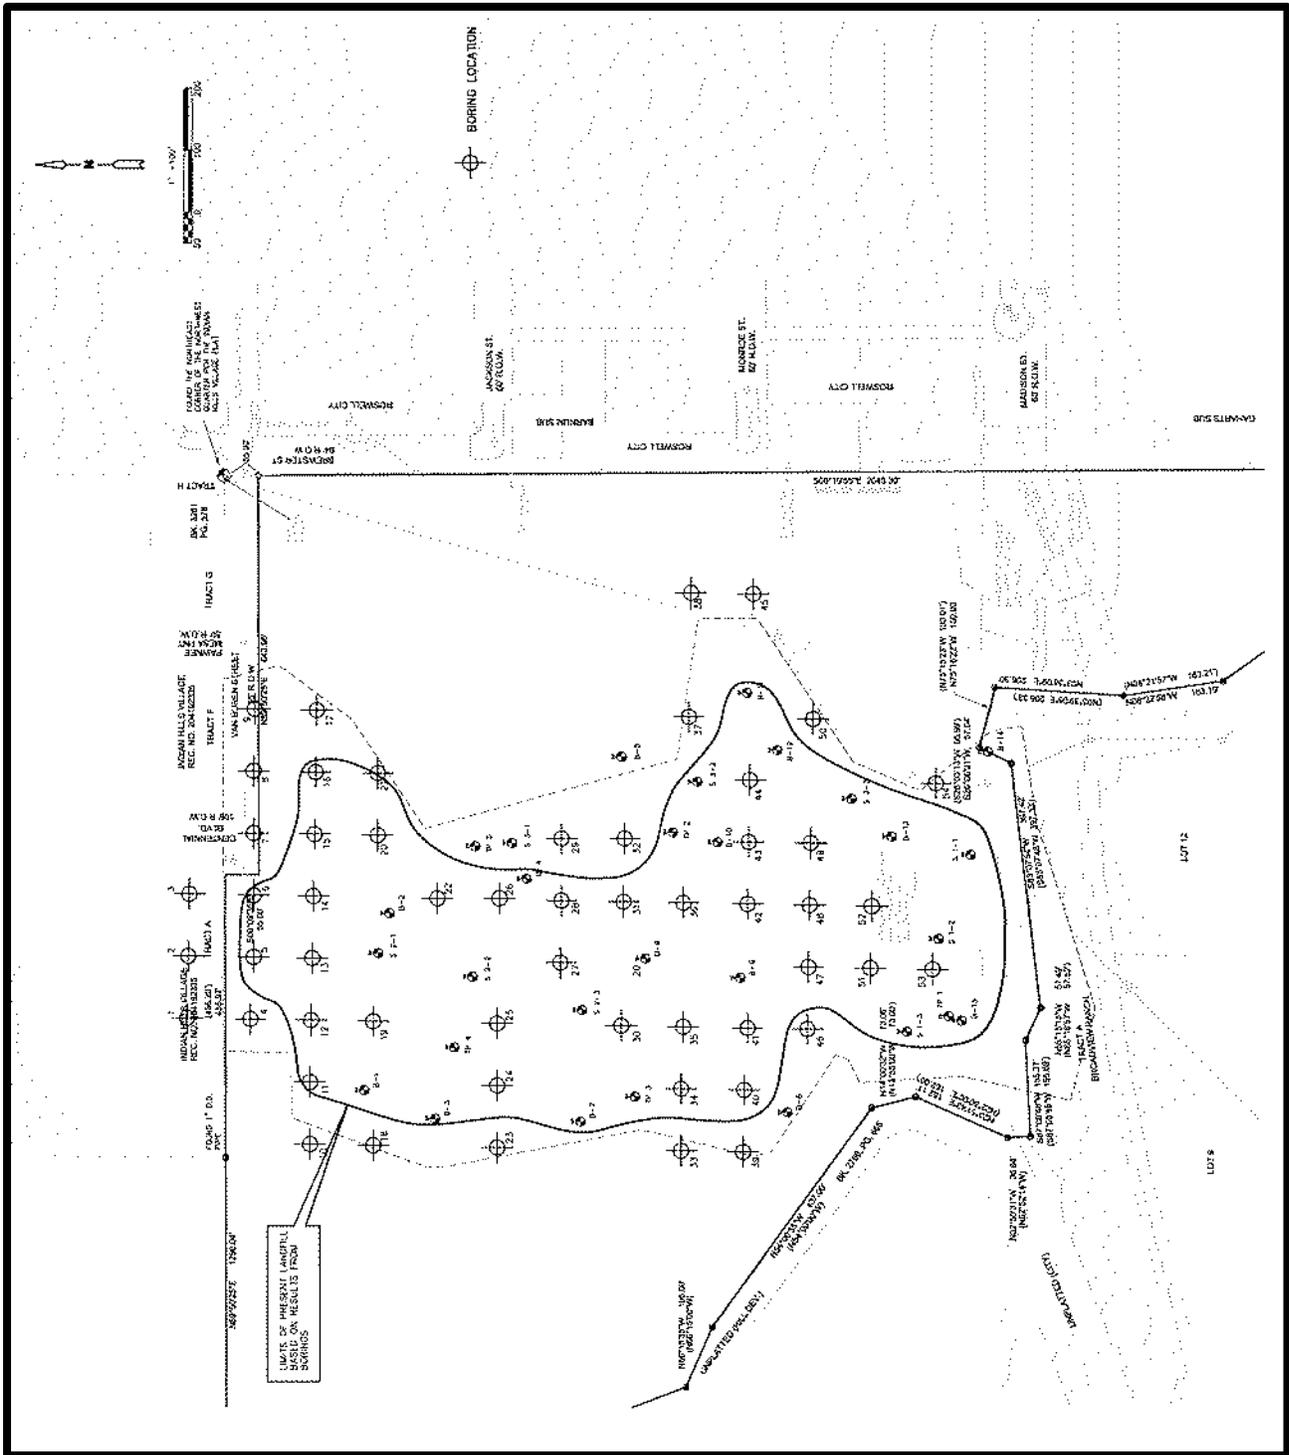
FIGURE 3.1
PROJECT SITE AND ABANDONED LANDFILL LIMITS

Readings taken in 2005 and 2006 found that landfill gas was detected in 11 of the 19 temporary wells installed at the project site. According to lab analyses, concentrations of methane gas ranging from 43% to slightly more than 58% existed in three of these wells. Seven methane gas wells were installed at the project site in 2018. Analytical results indicate methane concentrations of 82.4% by volume in one well and 0.399% by volume in another well. There was no detection of methane in the other wells.

Landfill gas is occurring due to the lack of a proper final cover, infiltration of surface and groundwater into the solid waste, and poor consolidation of the solid waste. Because the soils utilized to cover the landfill and the variance in the depth of the soil cover over the waste, the generation of landfill gas may be sustained for several years if the site remains in its present condition.

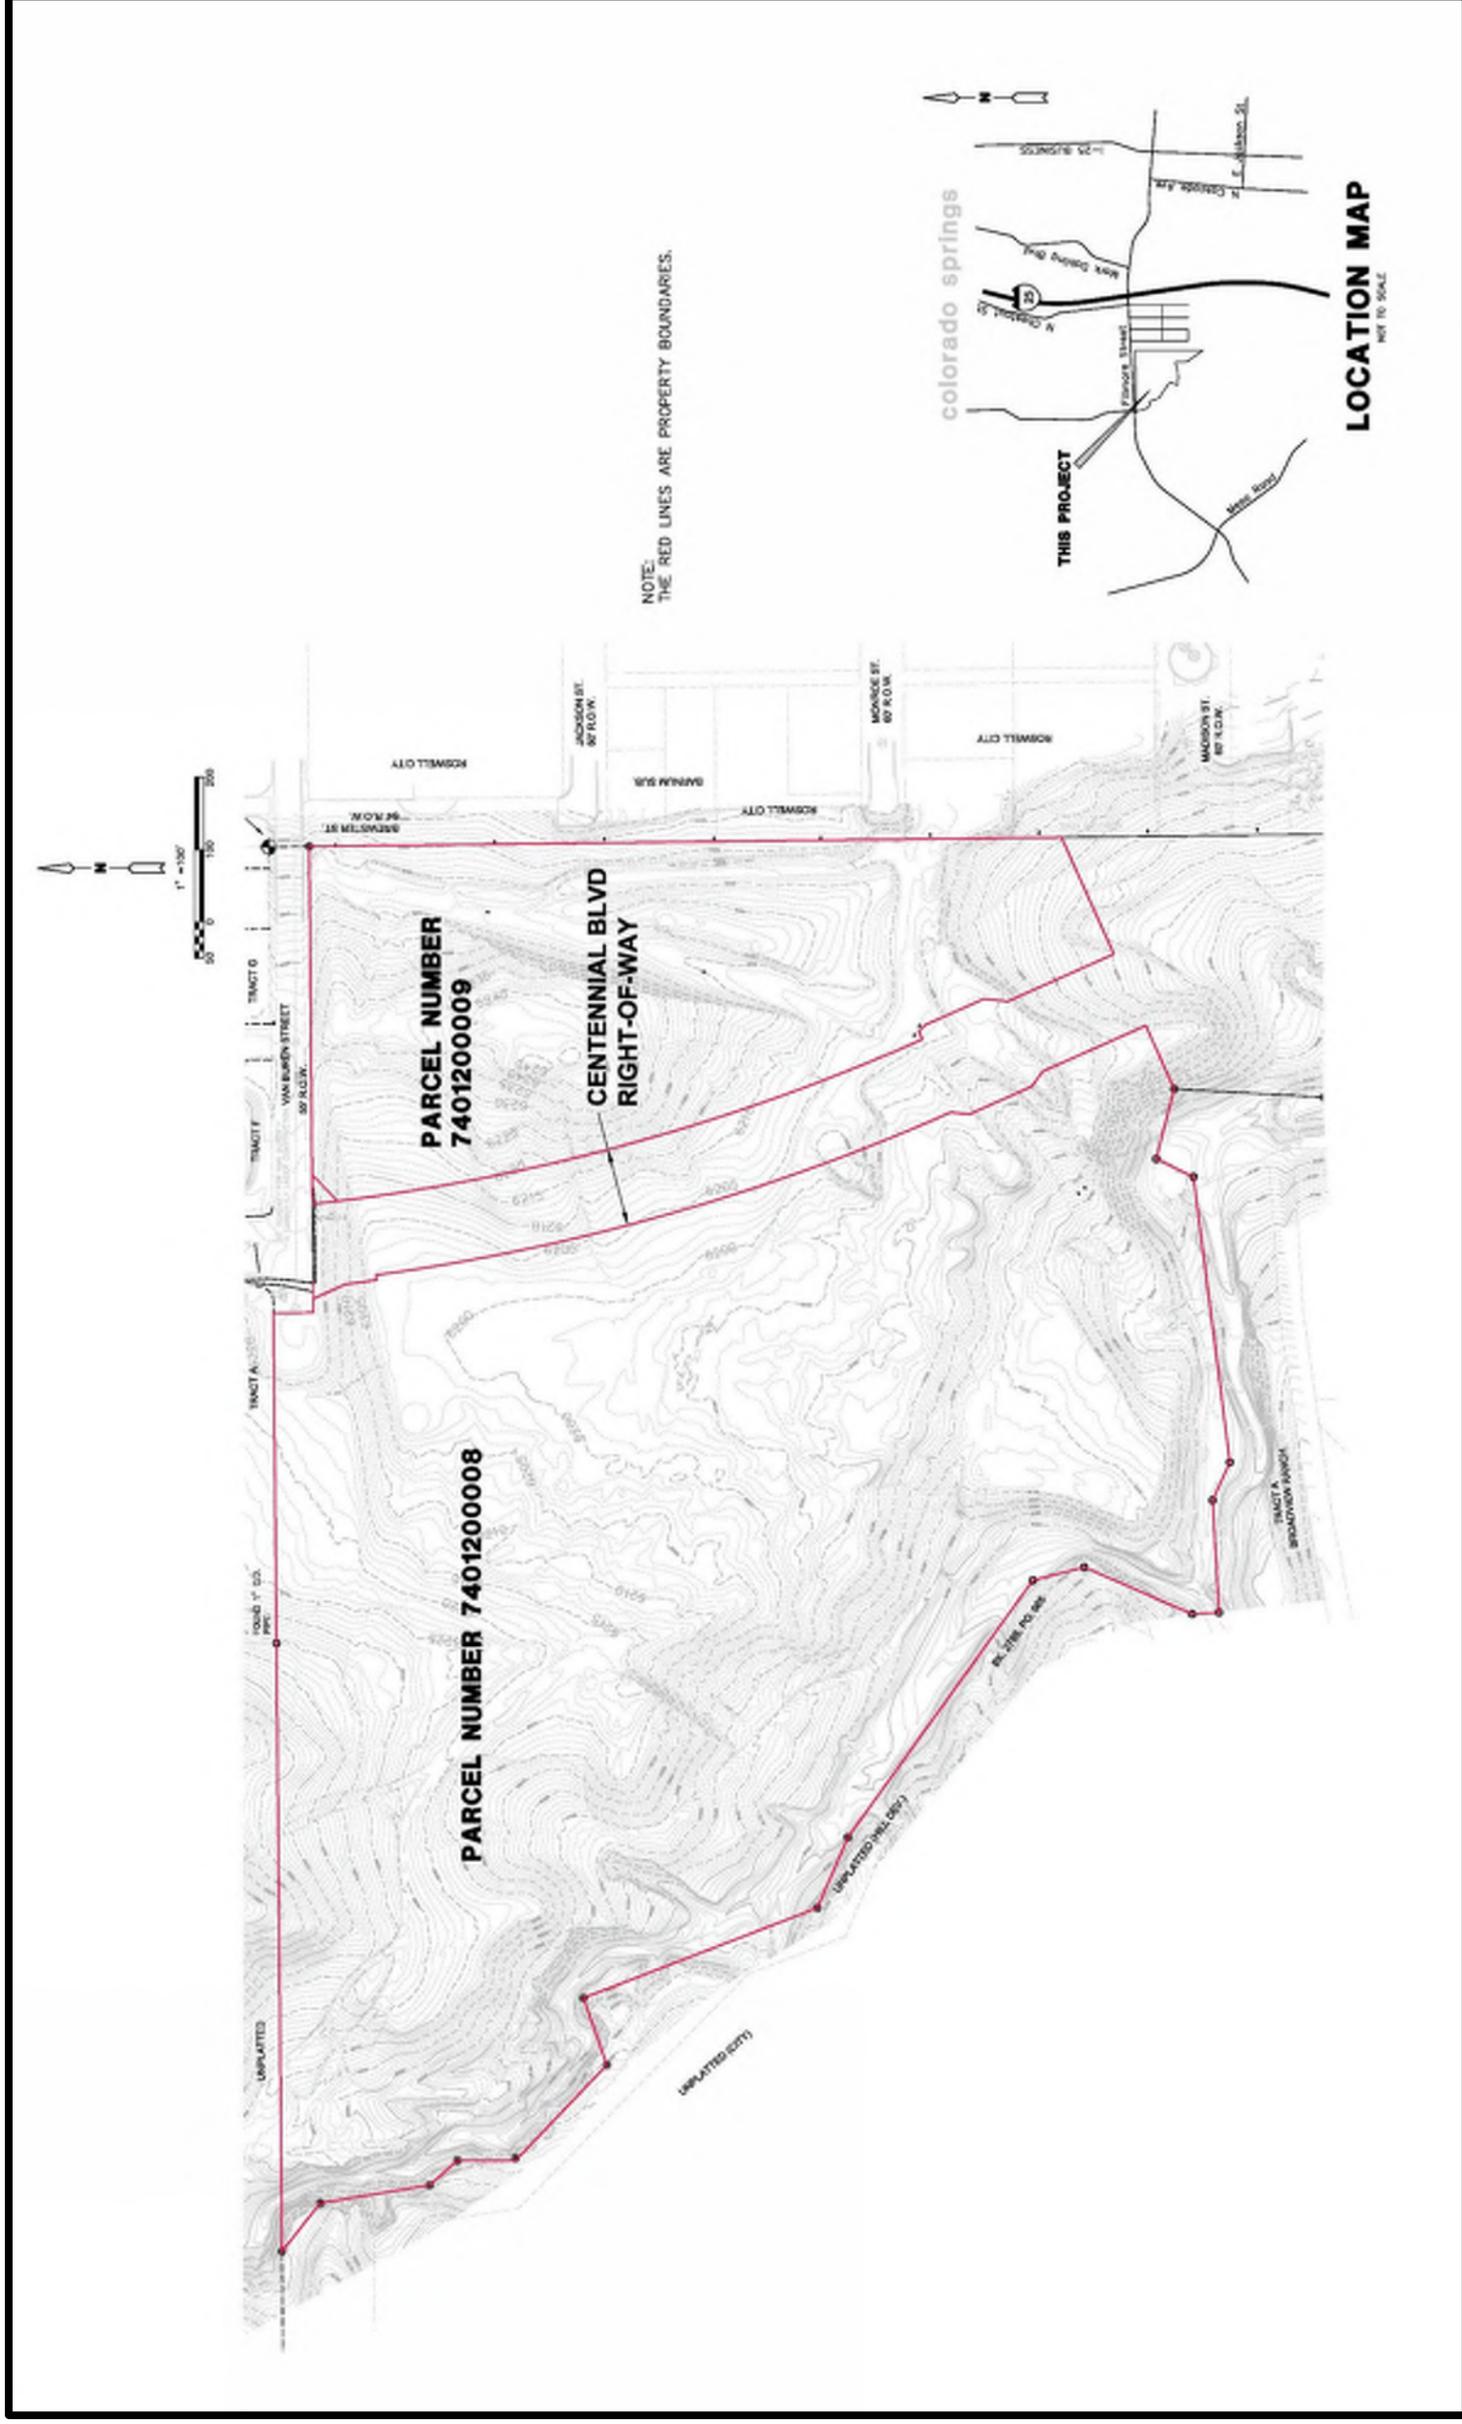
FIGURE 3.2
TOPOGRAPHIC MAP OF PROJECT SITE

Soil borings and test pits were excavated in 1986, 2005, and 2018. These soil borings and test pits indicate the landfill follows the general course of a gully that bisects the larger property from north to south. The depth of solid waste appears to vary from less than five feet to more than 40 feet. Cover over the solid waste also varies, with soil cover on portions of the landfill being less than one foot to more than 25 feet. The greatest depth of cover appears to be in the southern portion of the landfill.

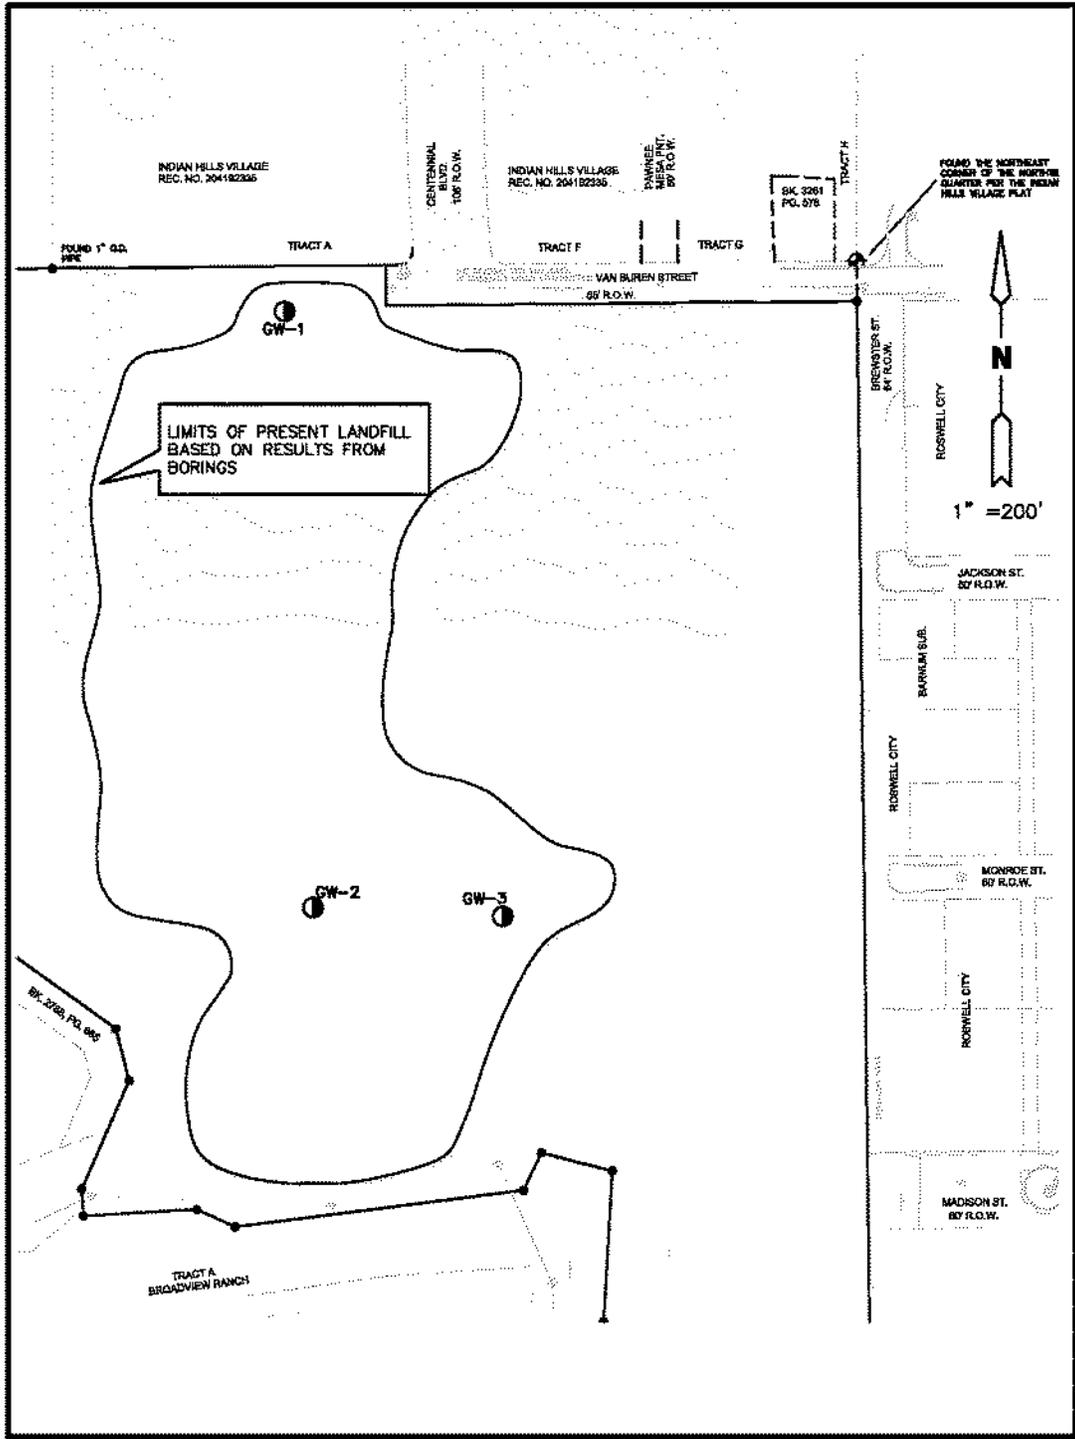
FIGURE 3.3
GROUNDWATER MONITORING WELL LOCATIONS

Well Number	Northing	Easting
GW-1	377857.67	188152.81
GW-5	376978.31	188111.21
GW-6	376955.23	188386.43

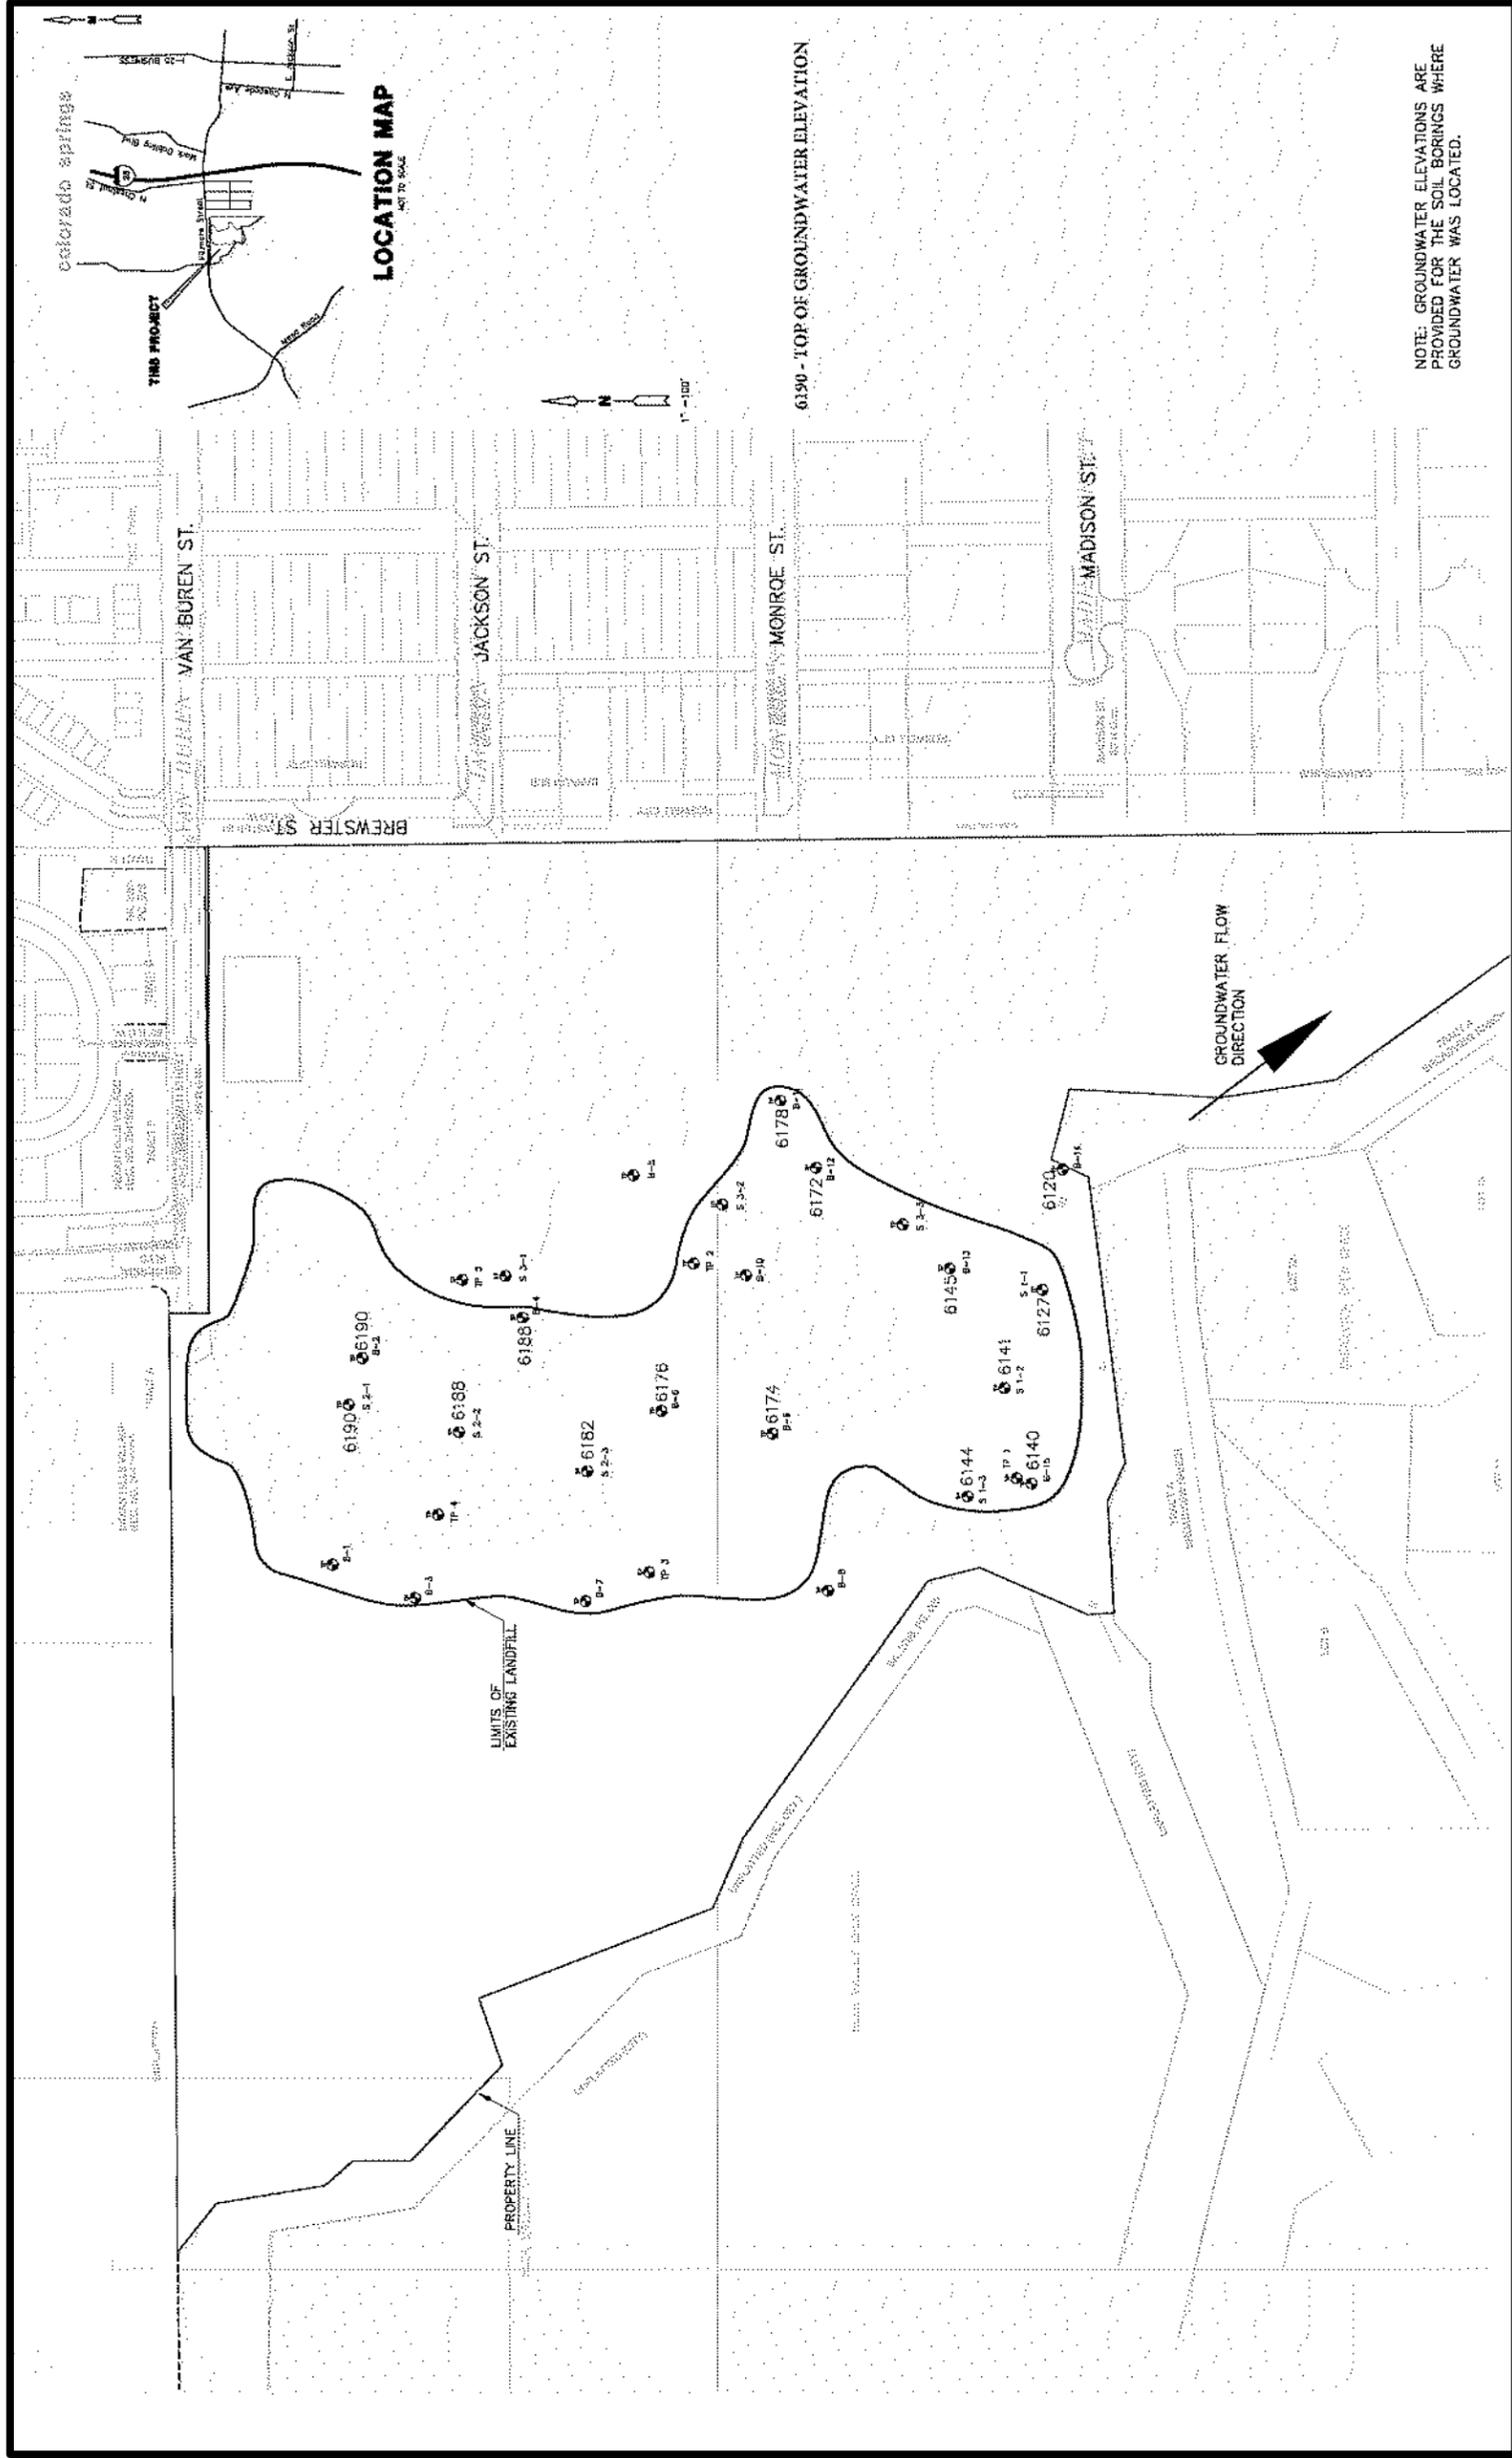
FIGURE 3.4
GROUNDWATER DEPTHS AND FLOW DIRECTION

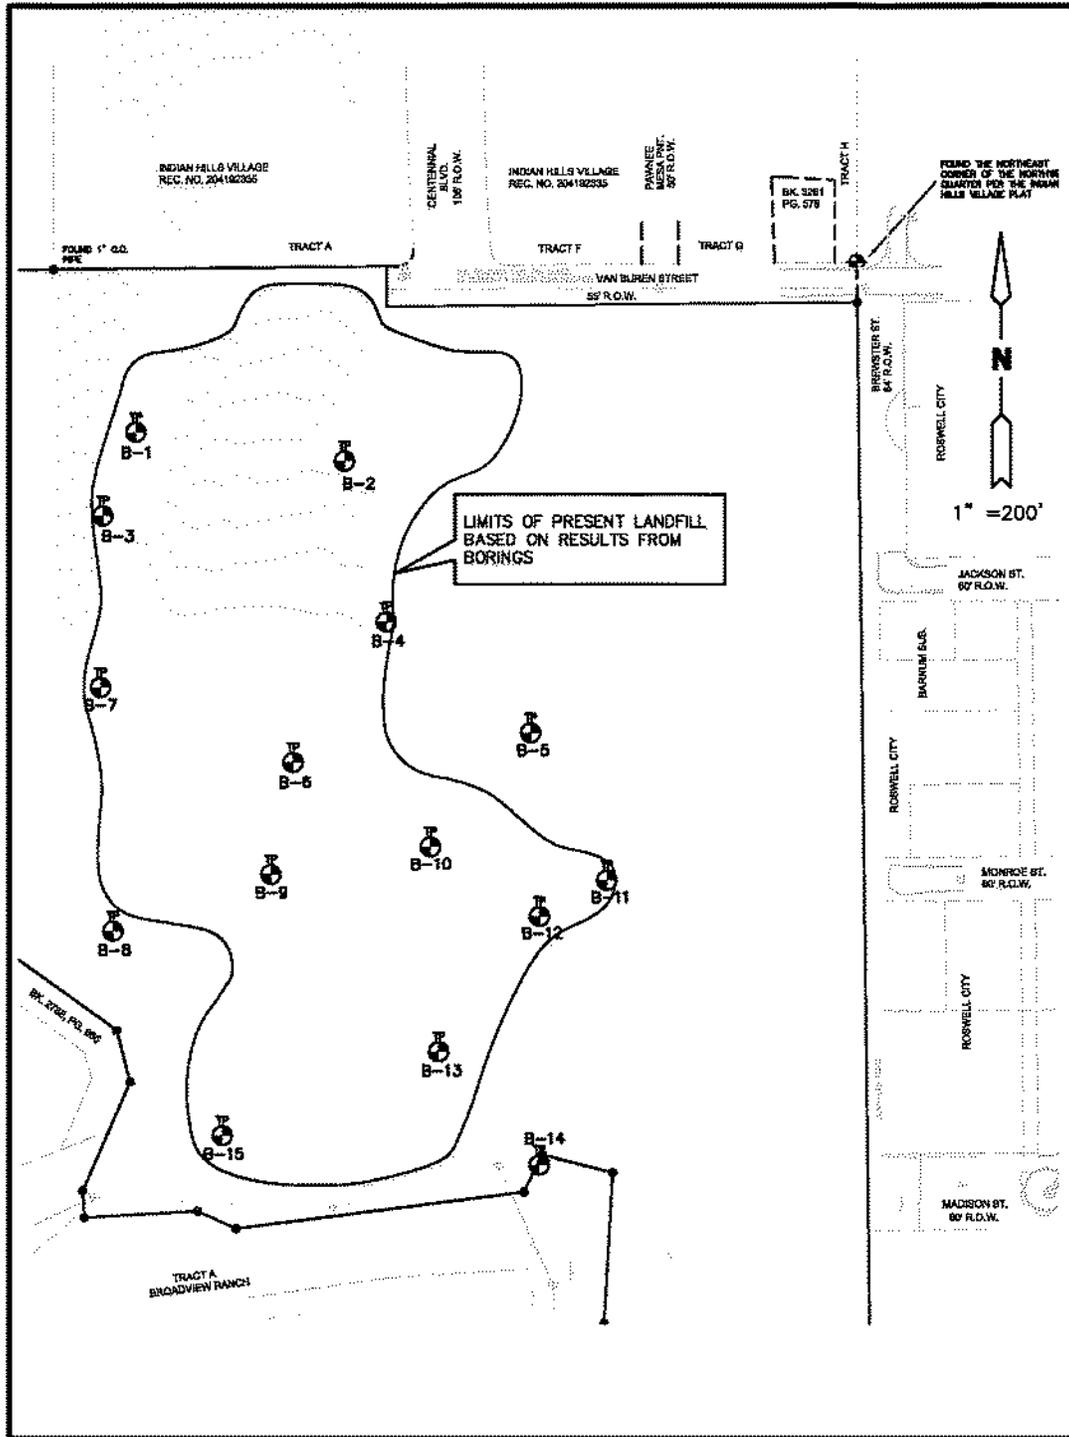
**FIGURE 3.5
LOCATION OF BORINGS DRILLED IN JULY 2005**

On July 14 and July 15, 2005, Kleinfelder mobilized to the project site with a track-mounted drilling rig equipped with 4-inch continuous flight augers to drill 15 subsurface borings to delineate the approximate boundary and size of the landfill and to evaluate what type of wastes were placed in the landfill. All borings were drilled through the landfill material to bedrock. Samples were collected at regular intervals and observed in the field to determine if the soil material was native, soil fill, or landfill. Kleinfelder returned to the site within 24 hours of drilling to measure the static water level in each boring. Figure 3.5 shows the location of the borings drilled in July 2005. Table 3.6 summarizes the static water levels for each boring and lists the constituents found in these borings.

Waste encountered in the subsurface investigation indicated that the drainage and valley, in the central portion of the larger parcel of land comprising the project site, was filled with waste. The maximum thickness of this waste, based on our subsurface investigation, is estimated to be about 40 feet. The borings indicate that the surface soil cover ranges from about ground surface to 20 feet in thickness. Soil was also found layered and mixed within the solid waste landfill layer.

**TABLE 3.6
STATIC WATER LEVEL AND CONSTITUENTS FOUND
IN BORINGS DRILLED IN JULY 2005**

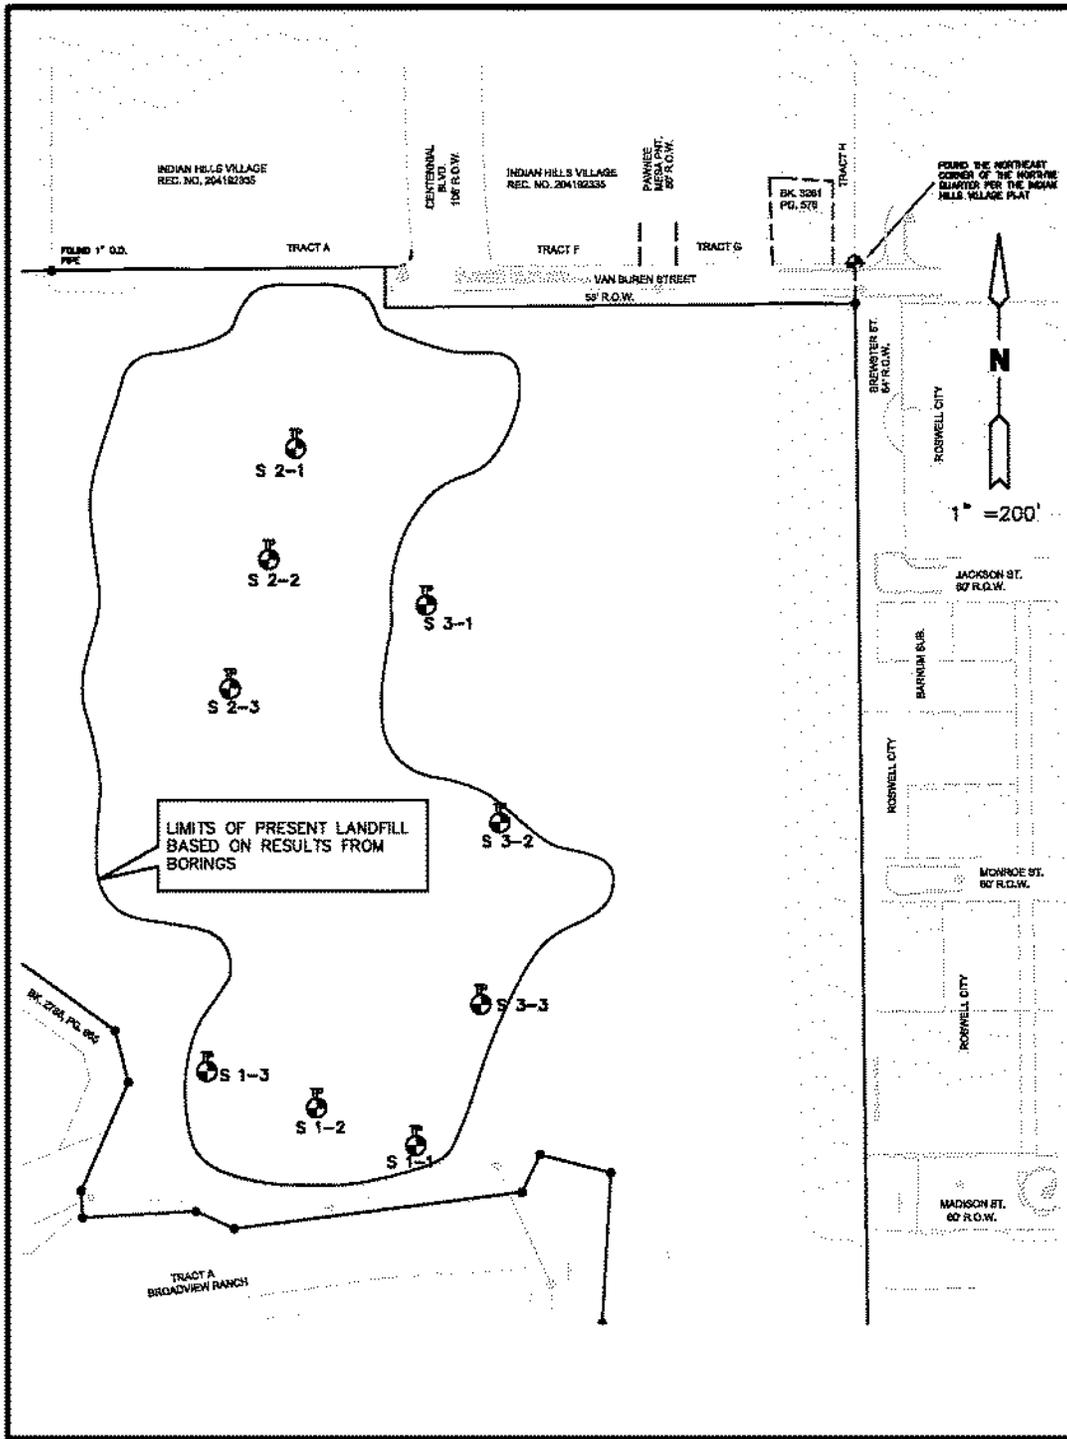
**FIGURE 3.6
LOCATION OF BORINGS DRILLED IN NOVEMBER 2005**

Nine subsurface borings were drilled to delineate the depth of solid wastes and to evaluate what type of wastes were present within the landfill. Borings 1 through 3 of Set 1 were located along the southern boundary of the larger parcel of property on the project site. Borings 1 through 3 of Set 2 were in the northern portion of this parcel; and, Borings 1 through 3 of Set 3 were located in the central portion. A map that shows the locations of these nine borings is presented in Figure 3.6; while Table 3.7 summarizes the static water levels for each boring and lists the constituents found in these borings.

**TABLE 3.7
STATIC WATER LEVEL AND CONSTITUENTS FOUND
IN BORINGS DRILLED IN NOVEMBER 2005**

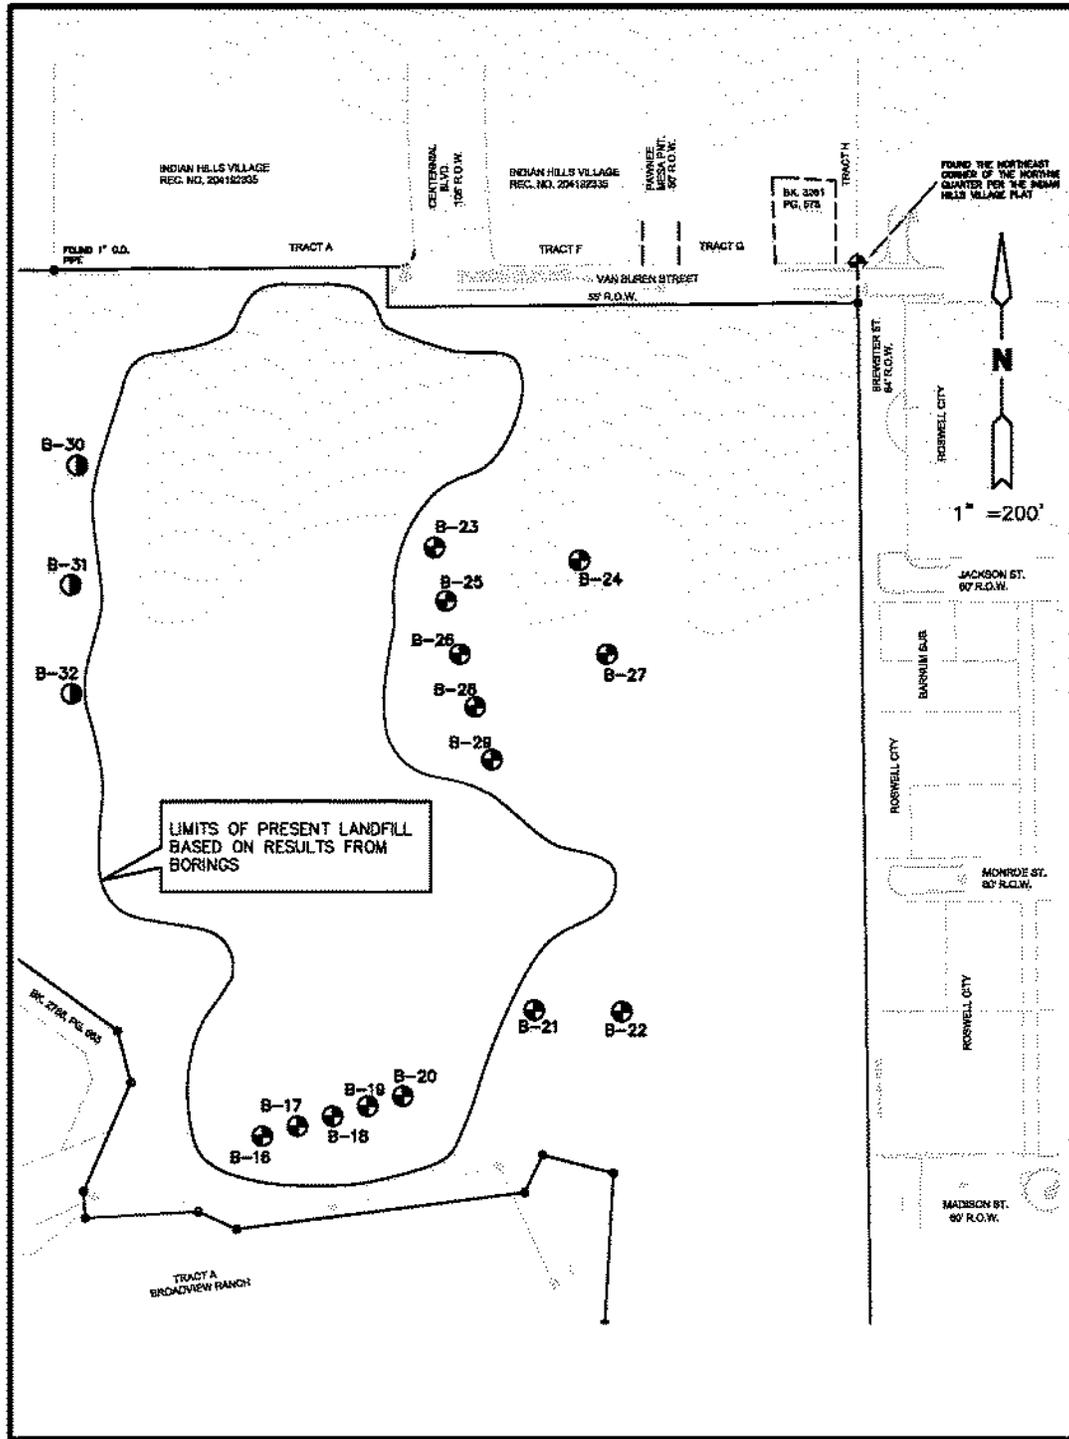
**FIGURE 3.7
LOCATION OF BORINGS DRILLED IN AUGUST 2018**

**TABLE 3.9
DATA FOR AND CONSTITUENTS FOUND IN
BORINGS DRILLED IN AUGUST 2018**

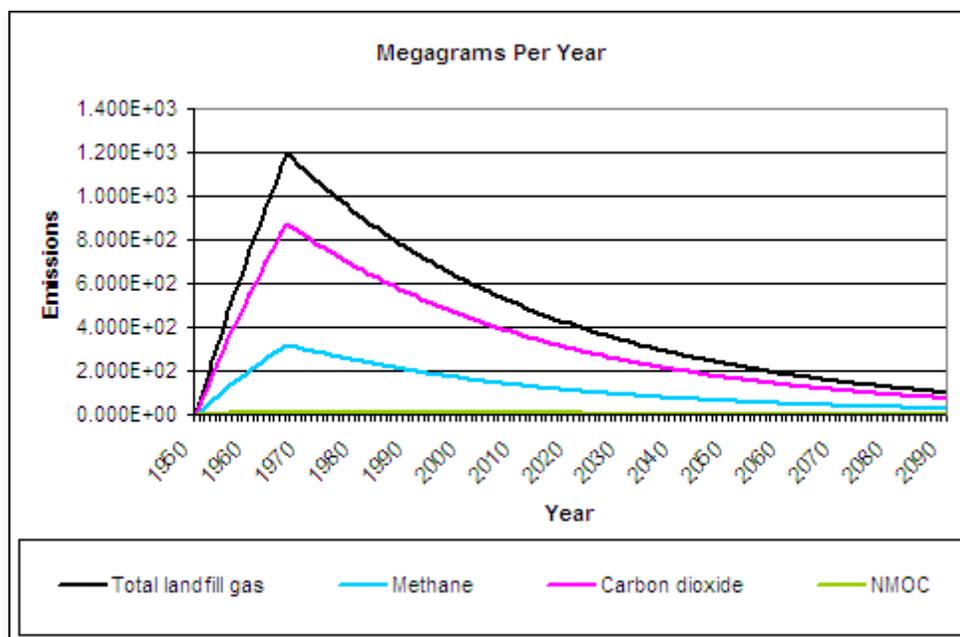
The chart in Figure 3.8 provides the results of the first computer model run. As can be seen, the landfill gas generation peaked in 1970 and has decreased significantly. Based on the model results the landfill is estimated to be generating 198,500 cubic meters of methane a year and 1,588 cubic meters of Non-Methane Organic Compounds (NMOC).

**FIGURE 3.8
RESULTS OF FIRST LANDGEM COMPUTER MODEL RUN**

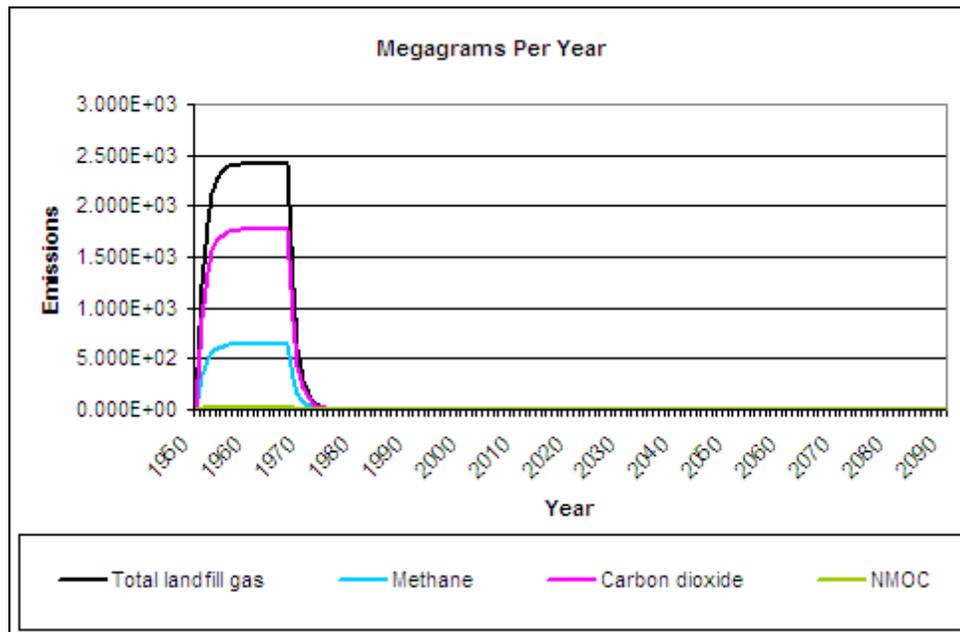
For methane, the peak period ended in 1967 with an annual estimated generation rate of 970,000 cubic meters of landfill gas. By 2011 it is estimated the landfill is generating 0.00000004079 cubic meters of gas annually. The amount of NMOC generated in 2011 is estimated to be 0.000000003263 cubic meters per year. This model run indicates that a minimal amount of gas is being generated and likely little gas is being discharged from the landfill.

**FIGURE 3.9
RESULTS OF SECOND LANDGEM COMPUTER MODEL RUN**

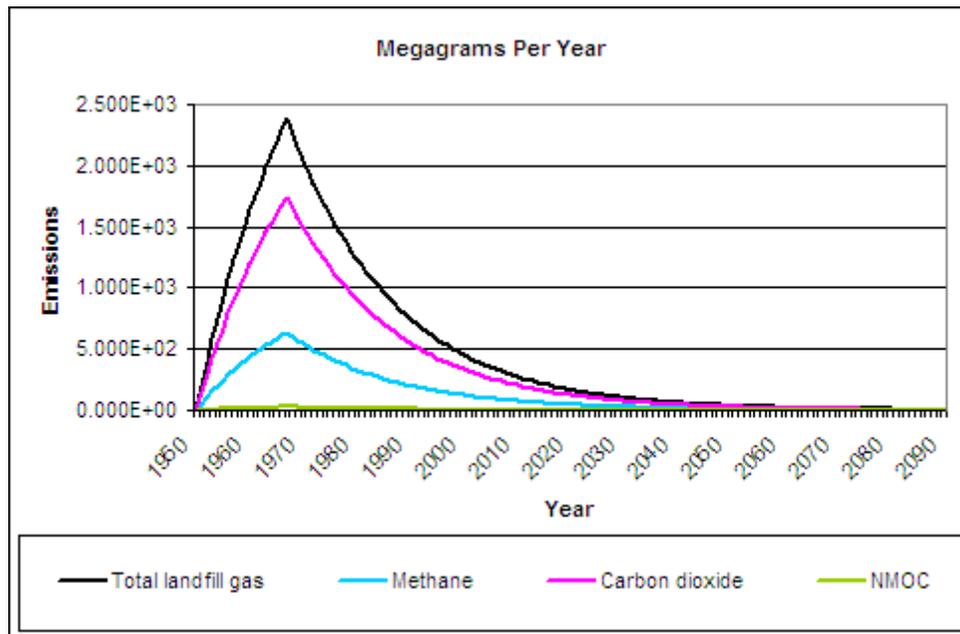
For methane, the peak period ended in 1968 with an annual generation of 952,300 cubic meters of landfill gas. By 2018 the landfill is estimated to be generating 75,500 cubic meters of gas annually.

**FIGURE 3.10
RESULTS OF THIRD COMPUTER MODEL RUN**

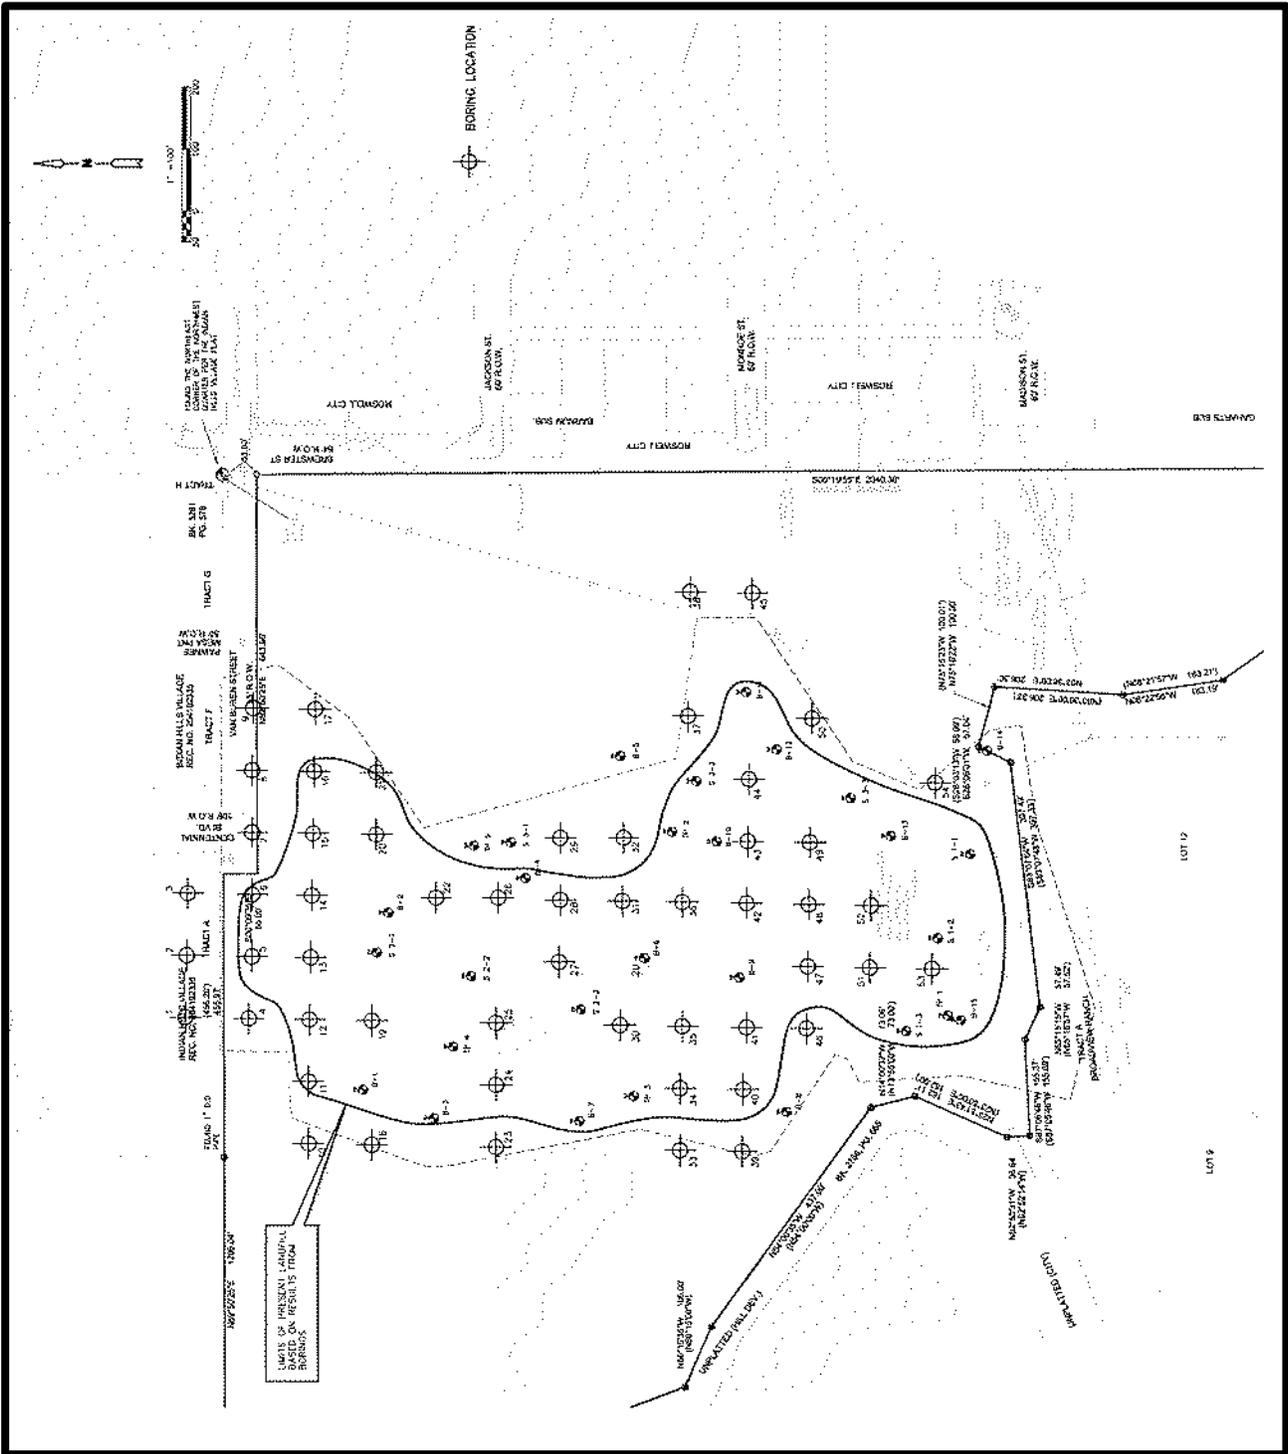
FIGURE 4.1
EXTENT OF ABANDONED LANDFILL ON PROJECT SITE

The centerpiece of the remediation plan is the consolidation of the landfill to provide a more environmentally-secure site that also allows for reclamation of a portion of the landfill. Based on site investigations, solid waste deposited in the landfill consists of a large amount of wood, paper, plastics, metals, and some construction and demolition debris. Because no CDPHE records exist regarding this landfill, it is suspected that the site was utilized as an open-dump site with limited or no supervision. Further, it is also likely that little, if any, effort was made to compact the waste. Given these circumstances, it is probable a number of voids exist within the landfill. In addition, because the site was not properly operated, it is expected that a large amount of the fill at the site was soil from other construction sites. Because of the amount of soil found in the various borings taken at the site, it is anticipated that a significant portion of the landfill is comprised of soil.

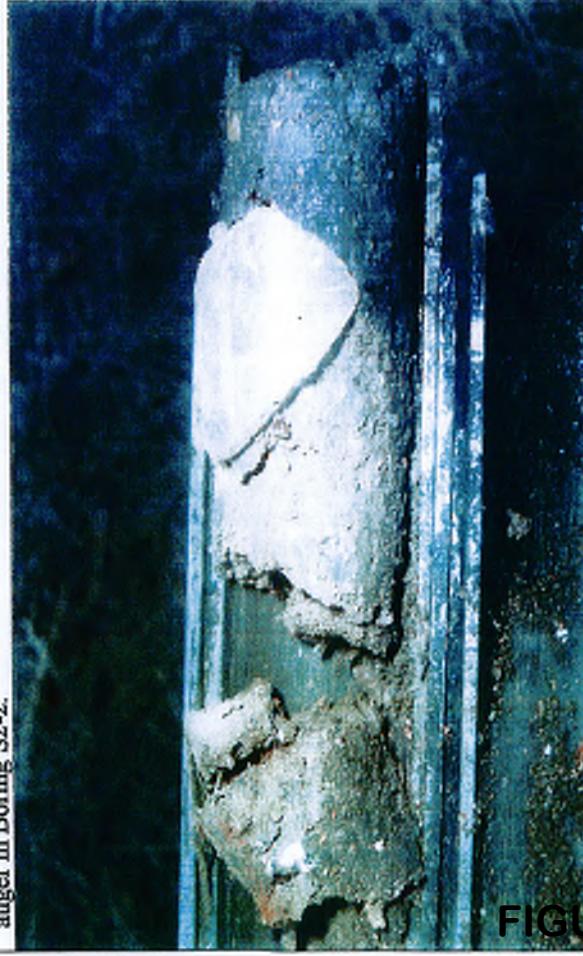
Photograph 15 – Looking at soil that was collected in Boring S2-2. Note the black discoloration of the soil. The black soil was found within the landfill material.

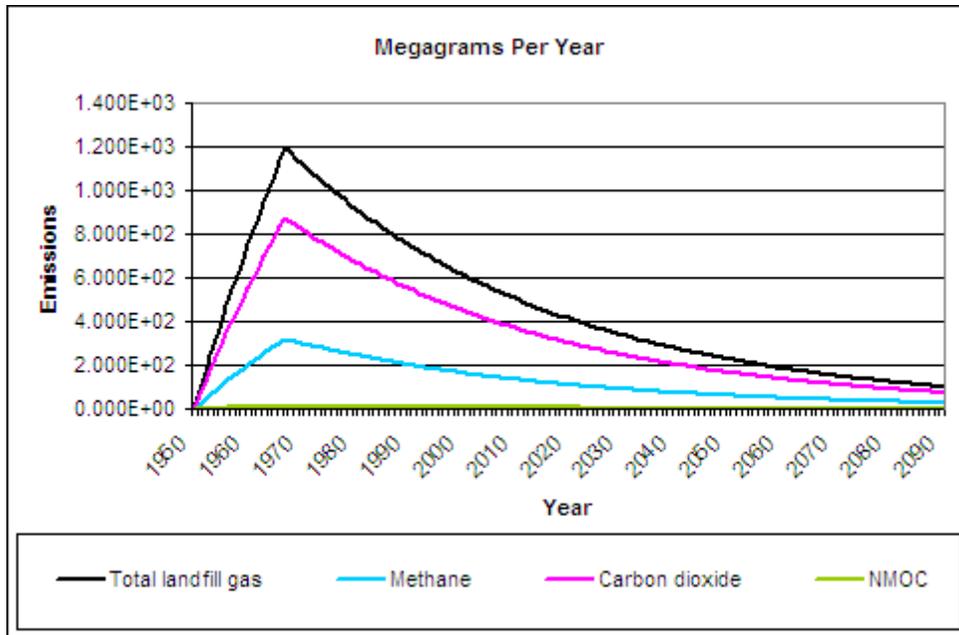
The following chart provides the results of the first computer model run. As can be seen, the landfill gas generation peaked in 1970 and has decreased significantly. Based on the model results the landfill is estimated to be generating 198,500 cubic meters of methane a year and 1,588 cubic meters of Non-Methane Organic Compounds (NMOC).

RESULTS OF FIRST COMPUTER MODEL RUN

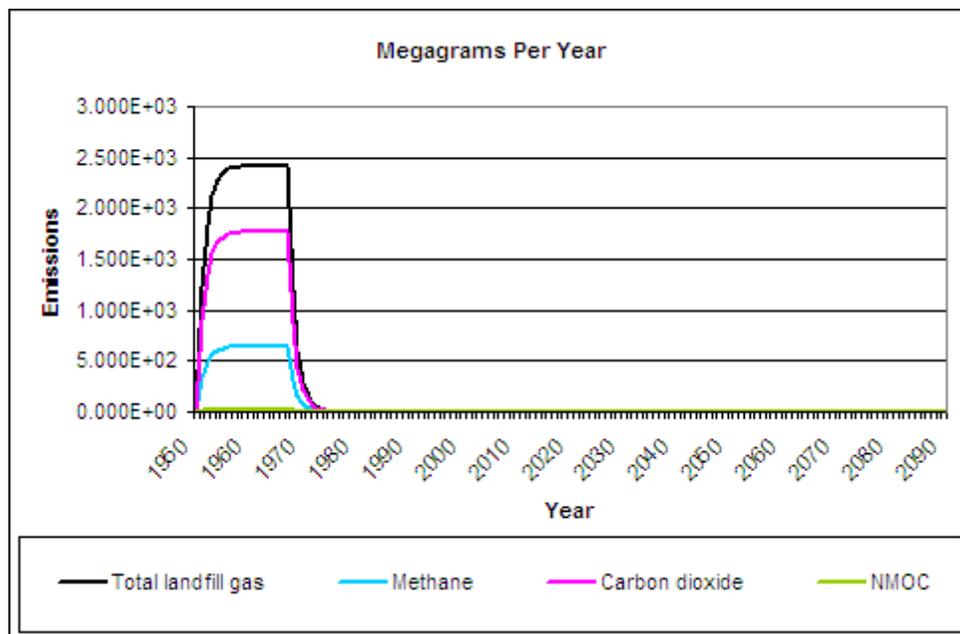
For methane, the peak period ended in 1967 with an annual estimated generation rate of 970,000 cubic meters of landfill gas. By 2011 it is estimated the landfill is generating 0.00000004079 cubic meters of gas annually. The amount of NMOC generated in 2011 is estimated to be 0.000000003263 cubic meters per year. This model run indicates that a minimal amount of gas is being generated and likely little gas is being discharged from the landfill.

RESULTS OF SECOND COMPUTER MODEL RUN
