APPLICATION FOR VOLUNTARY CLEAN-UP

Remediation of Existing Abandoned Landfill Mesa Valley Springs Property Colorado Springs, Colorado

VERSION 2
December 10, 2018

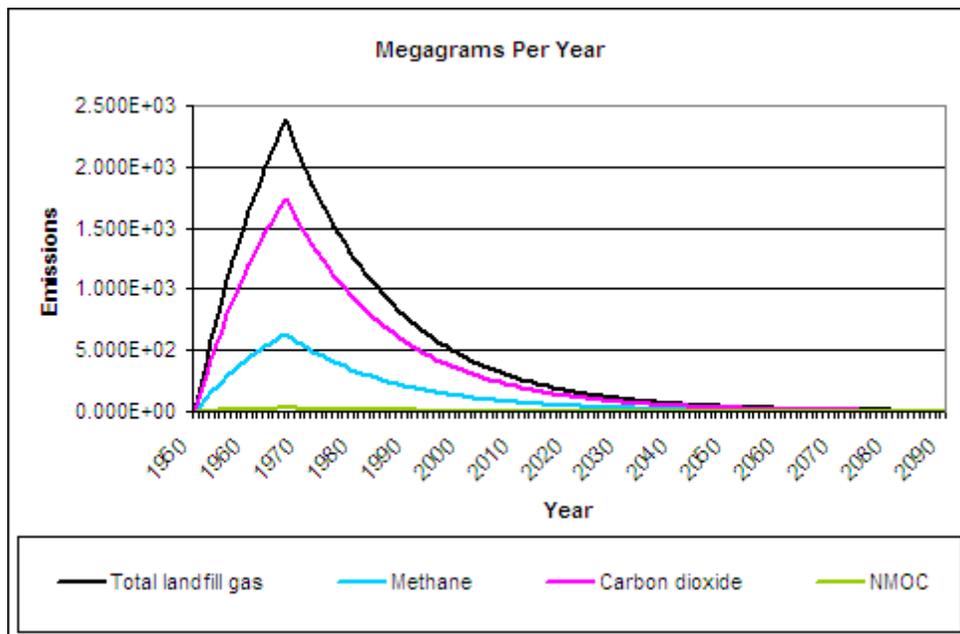
For methane, the peak period ended in 1968 with an annual generation of 952,300 cubic meters of landfill gas. By 2018 the landfill is estimated to be generating 75,500 cubic meters of gas annually.

RESULTS OF THIRD COMPUTER MODEL RUN

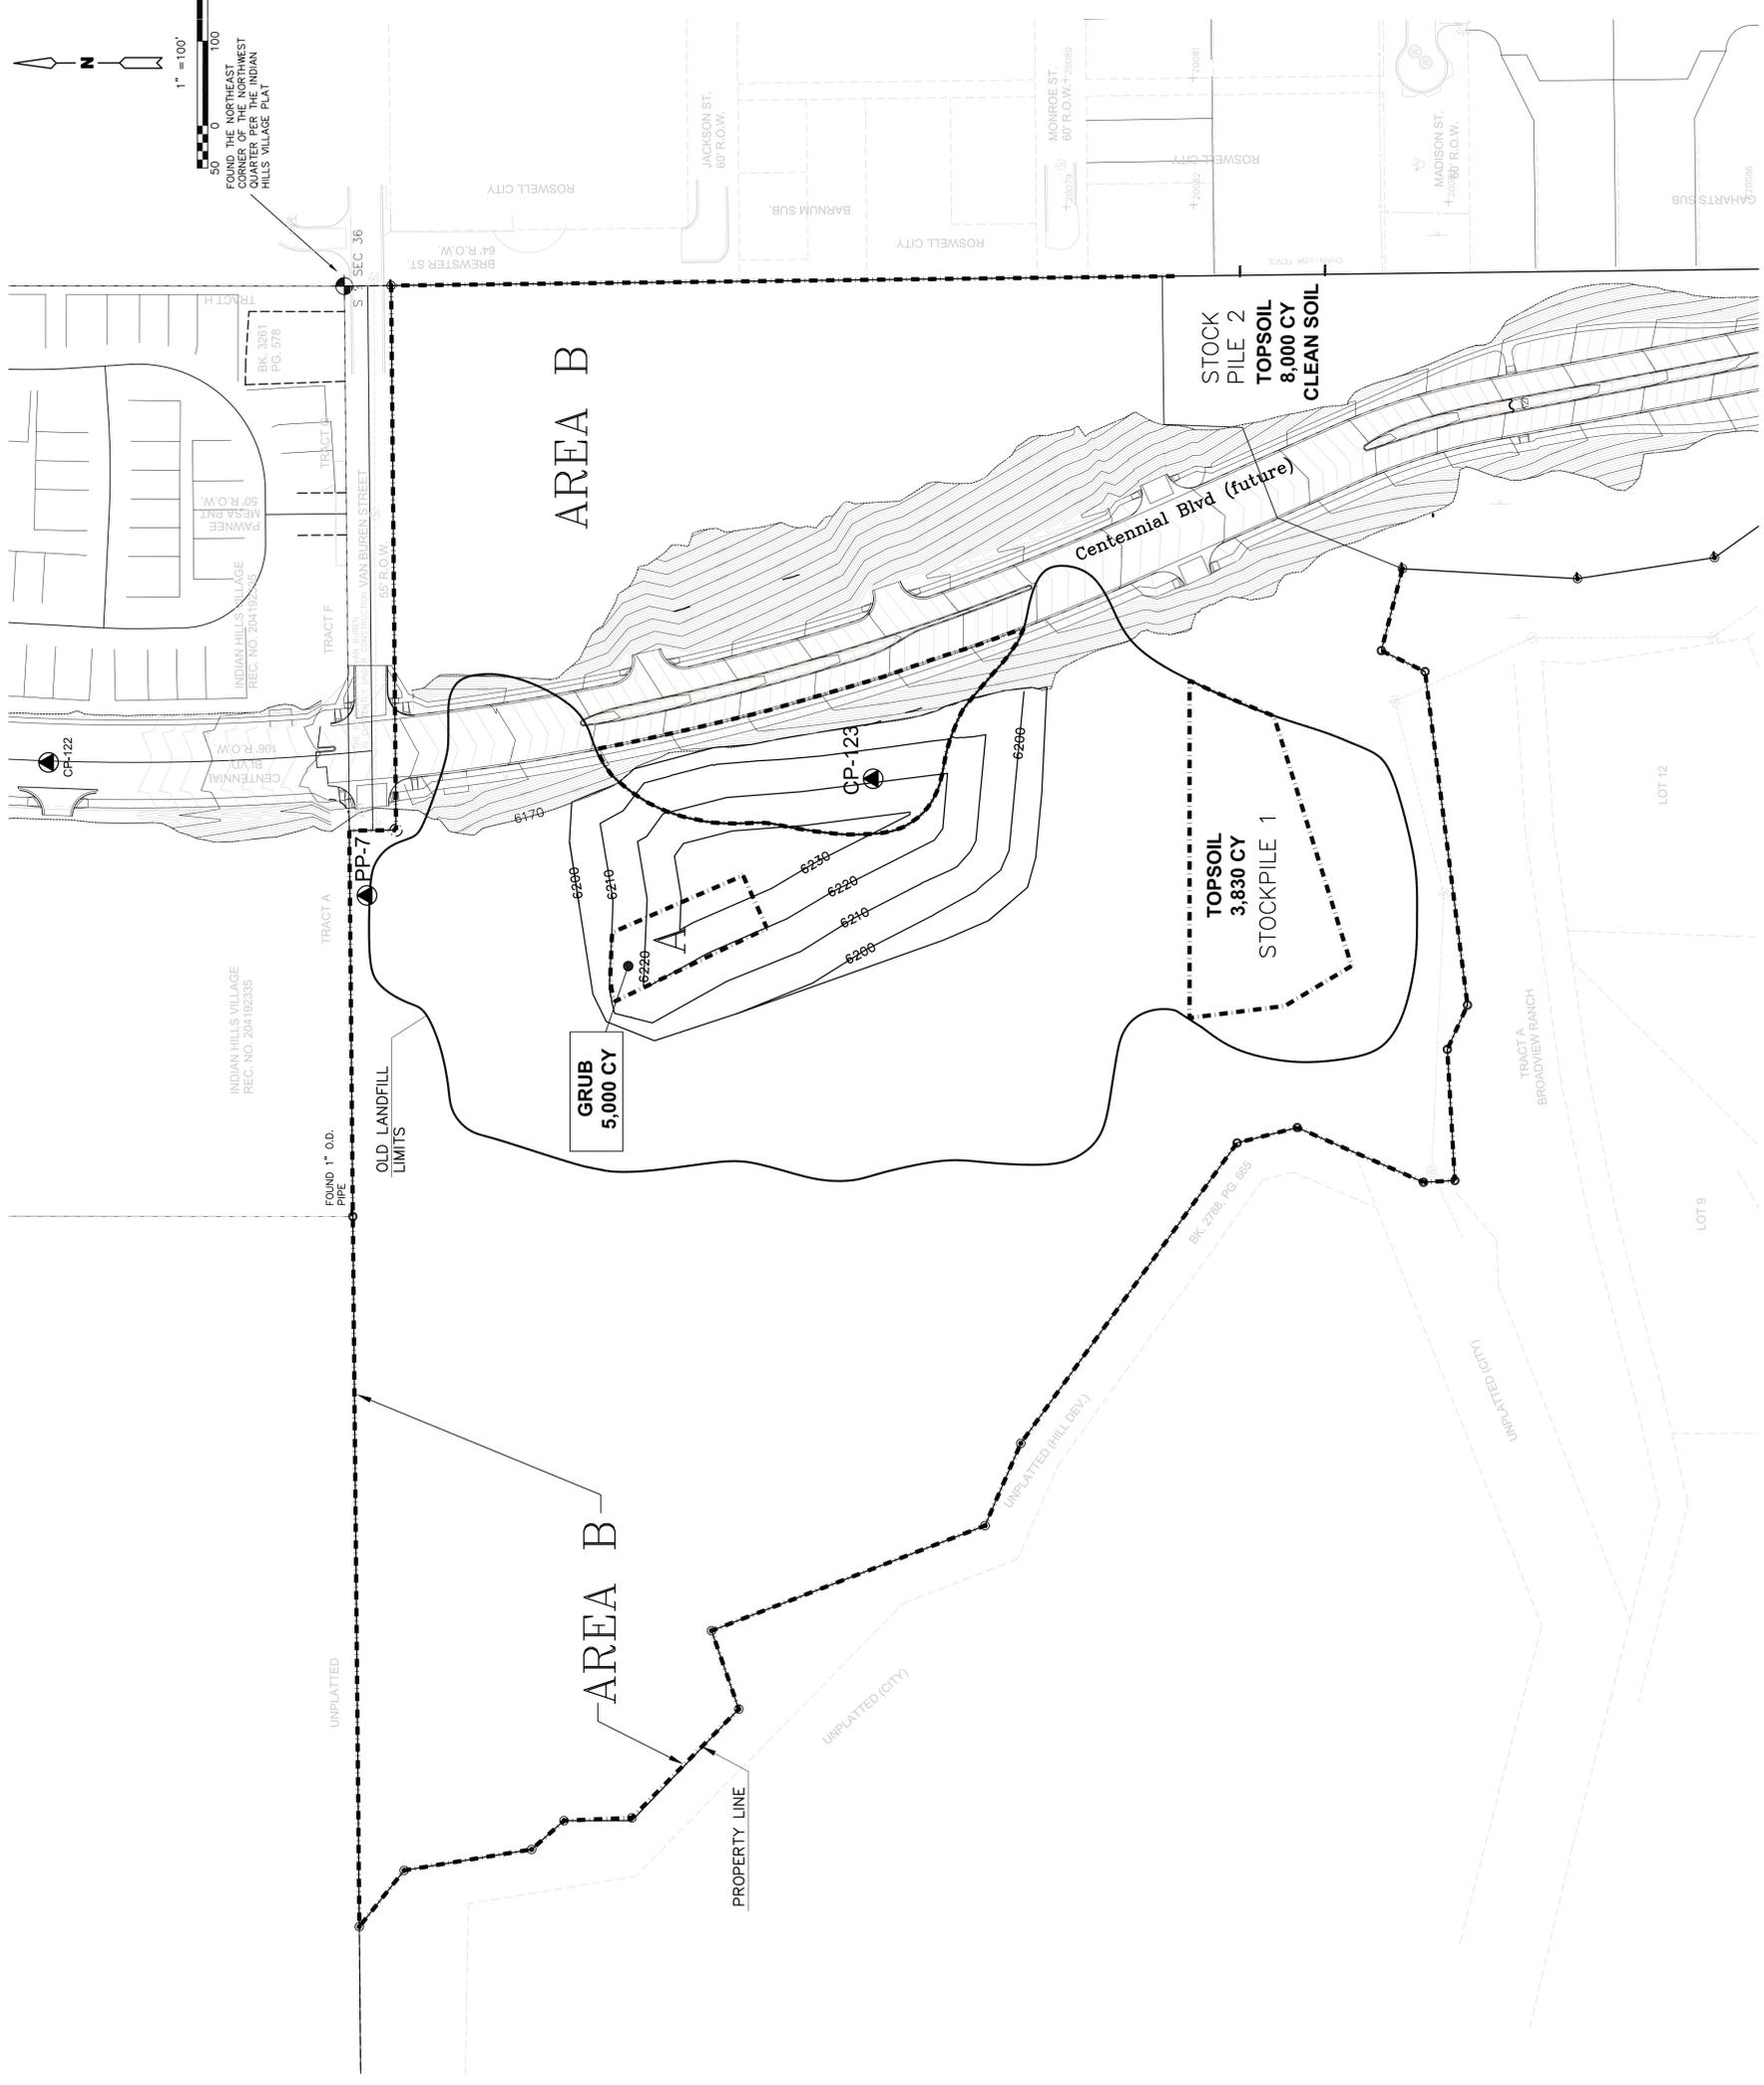
- STEPS:**
- STEP 1: CLEAR/CHIP TREES FROM ENTIRE SITE AND STOCKPILE IN AREA SOUTH OF STOCKPILE 2. COVER THE CHIPPED WOOD WITH WIRE MESH TO MINIMIZE BLOWING. ROOTS, SOIL, OR MATERIAL THAT CANNOT BE CHIPPED WILL BE PLACED IN AREA A.
 - STEP 2: CLEAR AND GRUB THE VEGETATION FROM ENTIRE SITE AND STOCKPILE VEGETATION IN AREA A
 - STEP 3: ALL TOP SOIL FROM THE ENTIRE AREA OF THE WORK THAT IS OUTSIDE OF THE BOUNDARY OF THE EXISTING TRASH AREA.
 - STEP 4: PLACE TOPSOIL REMOVED IN STEP 3 IN STOCKPILE 1.

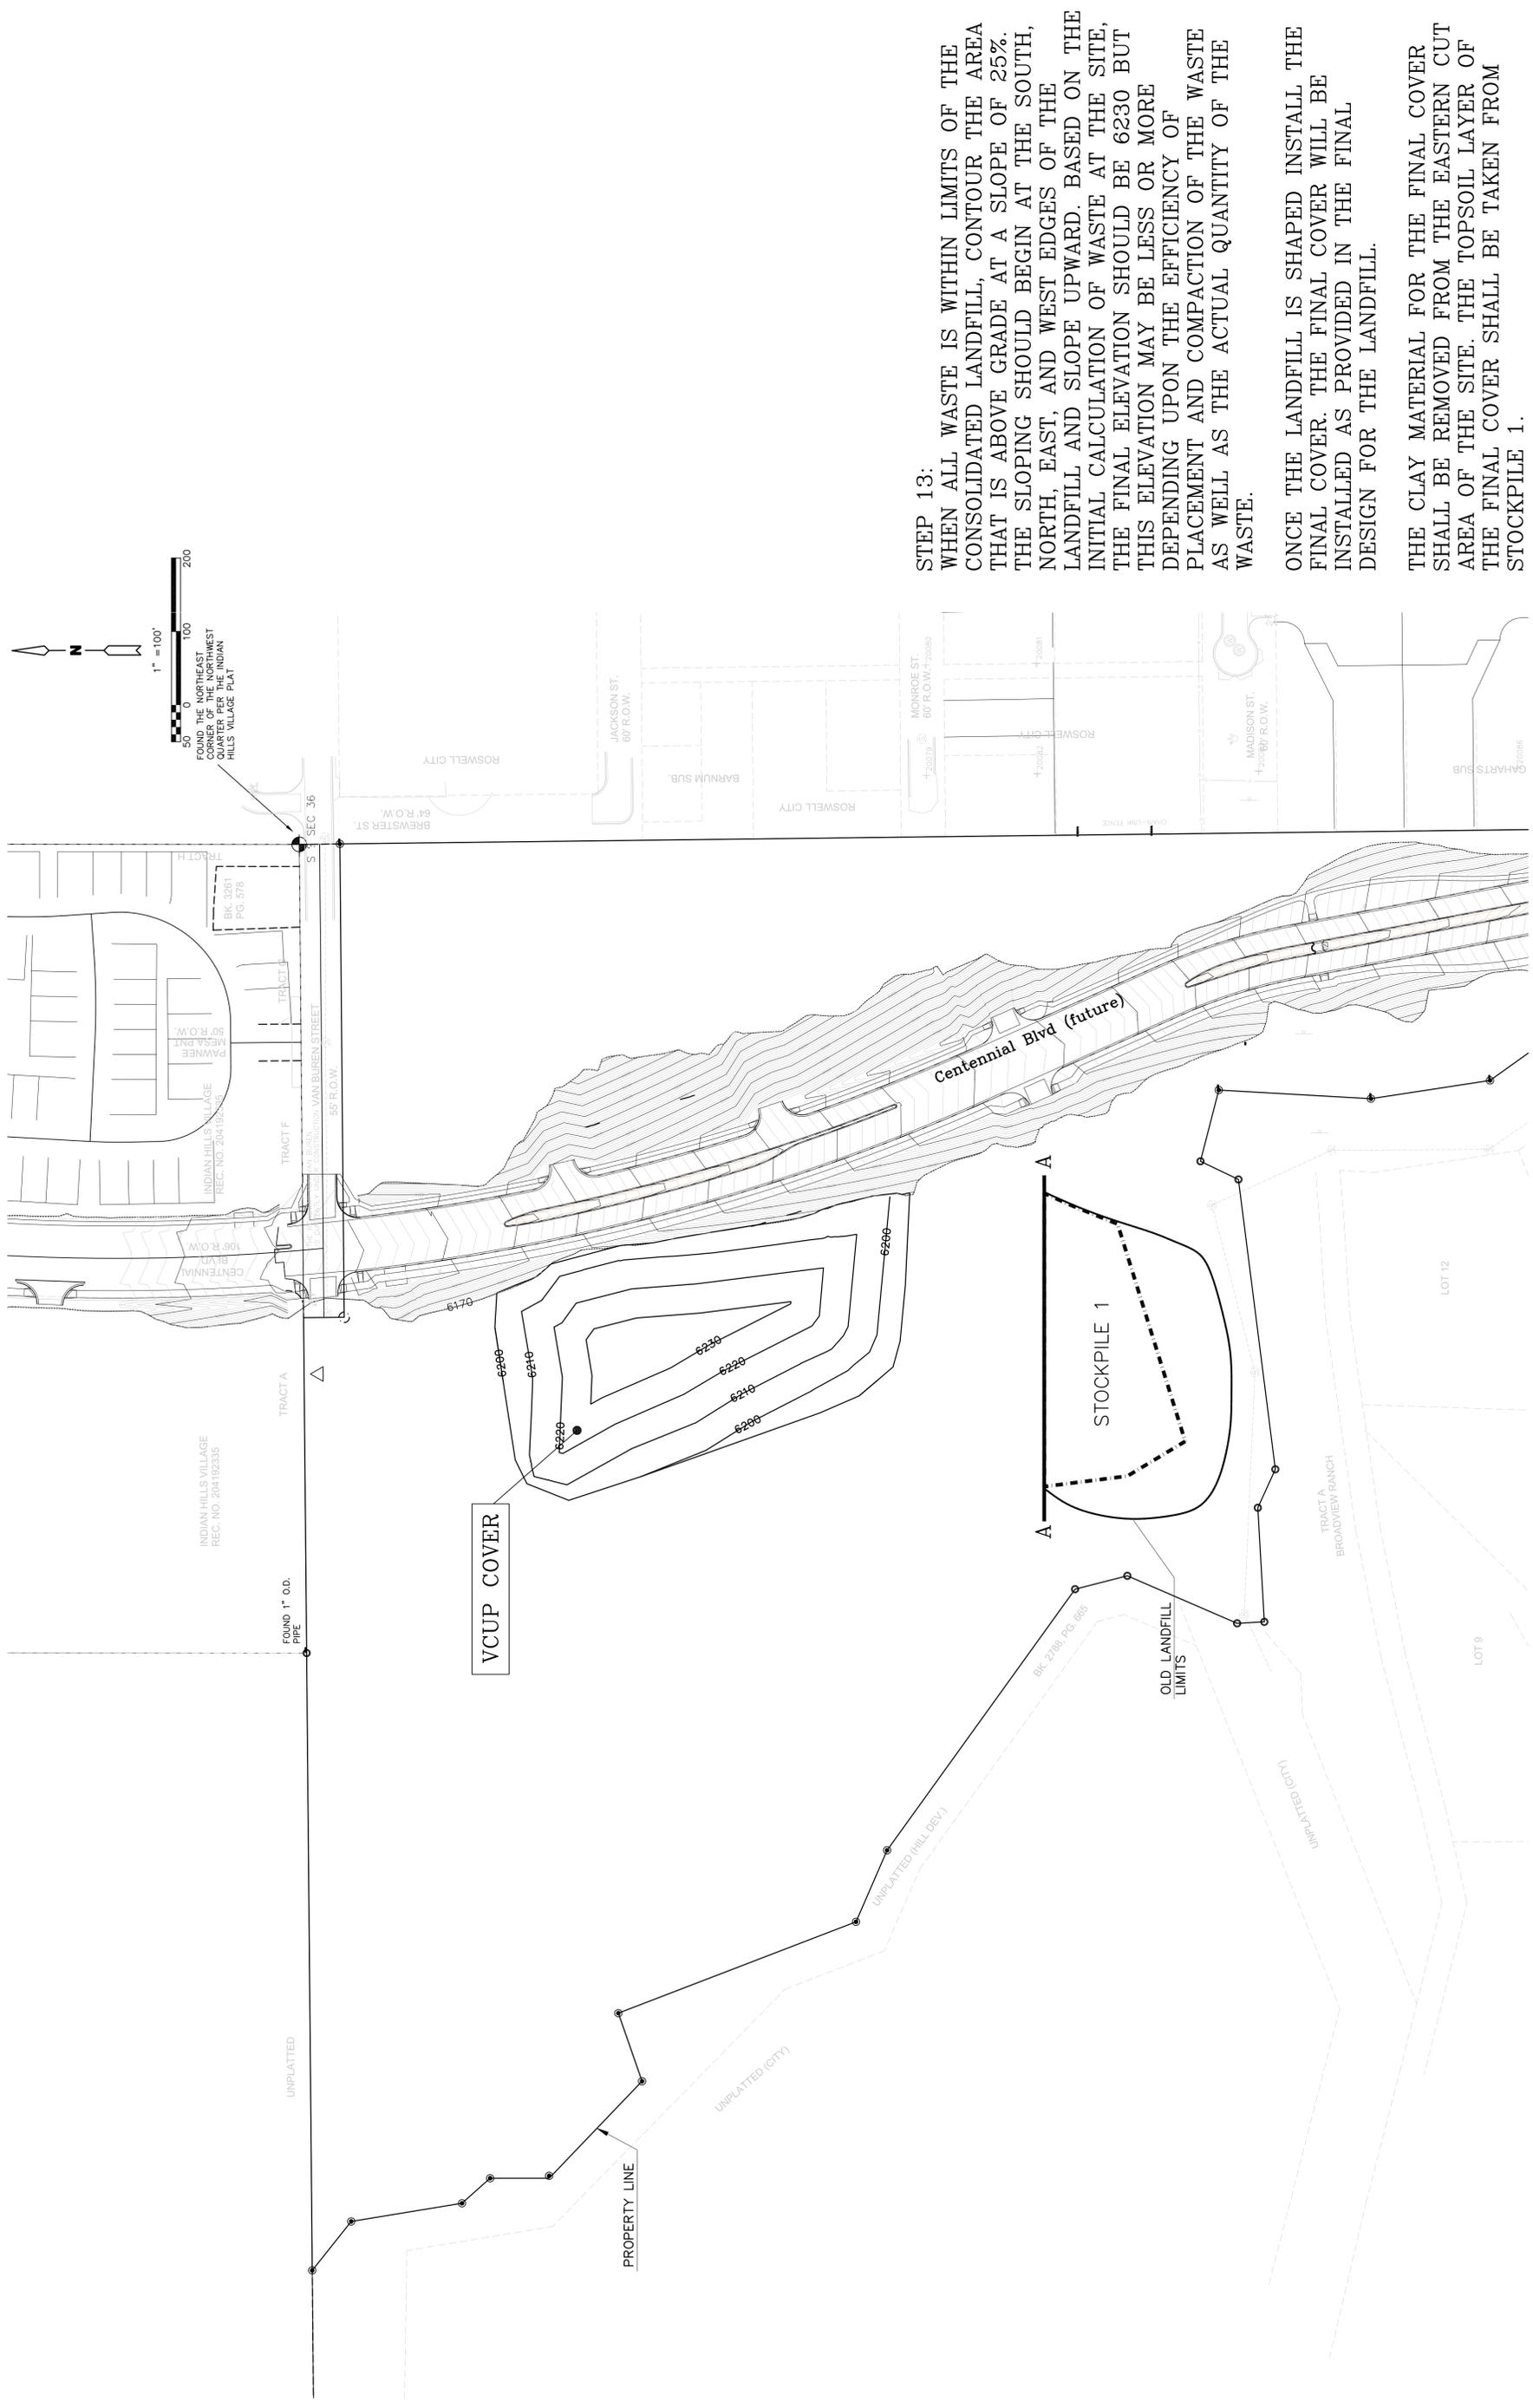
STEP 13:
 WHEN ALL WASTE IS WITHIN LIMITS OF THE CONSOLIDATED LANDFILL, CONTOUR THE AREA THAT IS ABOVE GRADE AT A SLOPE OF 25%. THE SLOPING SHOULD BEGIN AT THE SOUTH, NORTH, EAST, AND WEST EDGES OF THE LANDFILL AND SLOPE UPWARD. BASED ON THE INITIAL CALCULATION OF WASTE AT THE SITE, THE FINAL ELEVATION SHOULD BE 6230 BUT THIS ELEVATION MAY BE LESS OR MORE DEPENDING UPON THE EFFICIENCY OF PLACEMENT AND COMPACTION OF THE WASTE AS WELL AS THE ACTUAL QUANTITY OF THE WASTE.
