Final Report

Hancock Commons Existing Conditions Survey

City of Colorado Springs Urban Renewal Authority

Economic & Planning Systems, Inc.

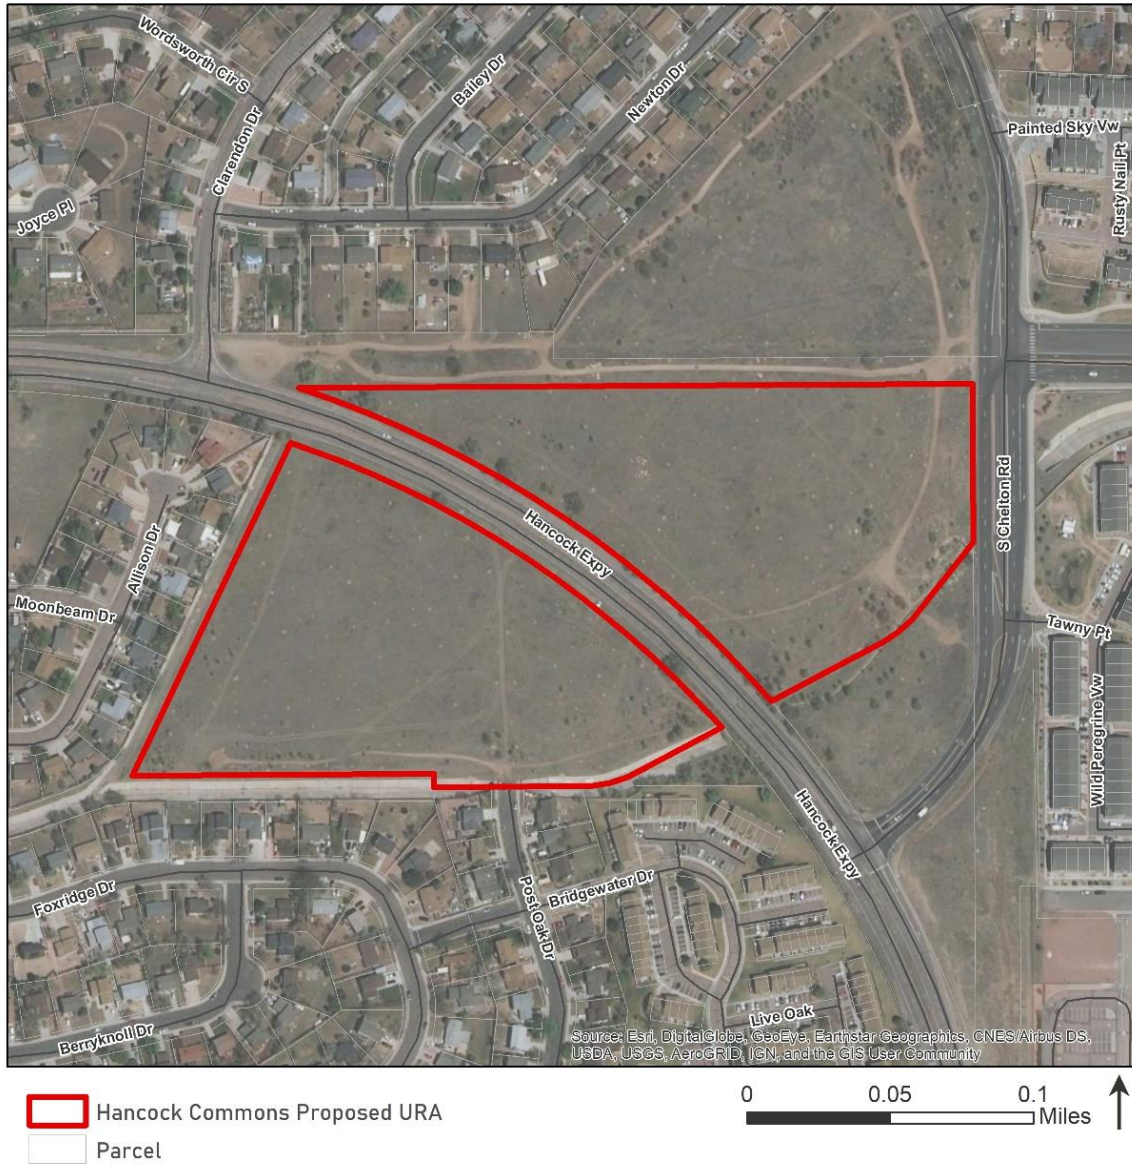
Figure 1. Hancock Commons Proposed URA Boundary and Parcels

The proposed Hancock Commons Urban Renewal Plan Area is comprised of one parcel on approximately 18.59 acres of land, as shown in **Table 1** and **Figure 1**. The parcel is owned by FKF Group. The parcel is divided by Hancock Expressway with Chelton Road to the east and Clarendon Drive to the west. The parcel is vacant with no building improvements.

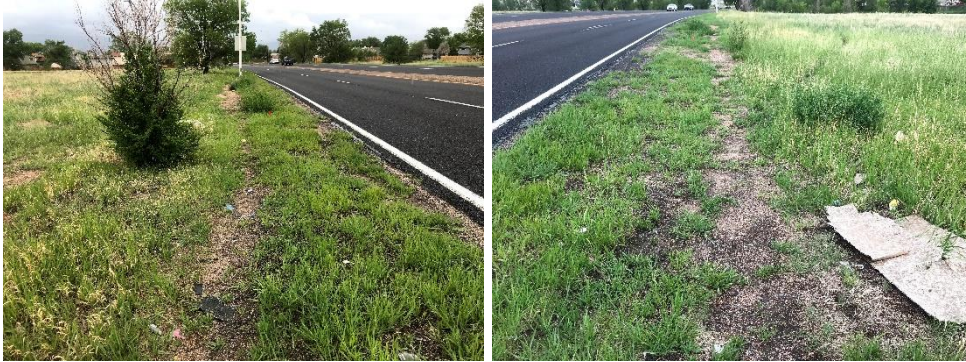
Figure 2. Lack of Sidewalks

Along Hancock Expressway, provisions of walkways for pedestrians were observed in the form of lack of sidewalks. It was observed sidewalks are needed for pedestrian safety as there is an informal pathway along the south side of Hancock Expressway through the Study Area, shown in **Figure 2**.

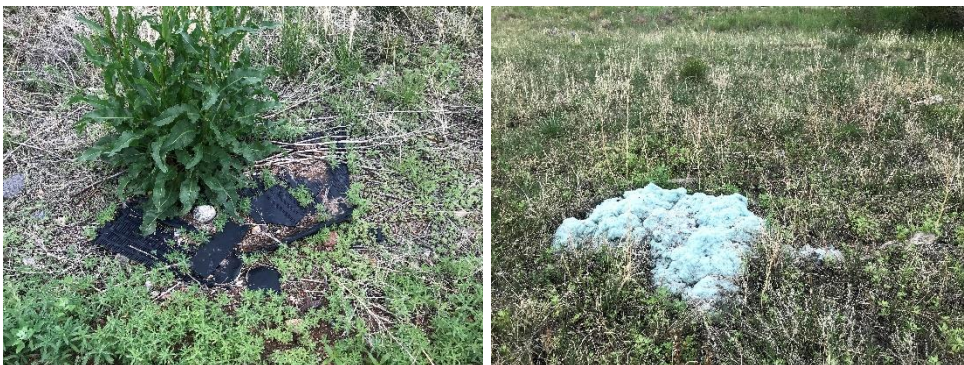
Figure 3. Excessive Litter

Throughout the Study Area unsafe and unsanitary conditions were documented. Excessive litter was observed and documented throughout the property and was especially apparent along Hancock Expressway, shown in **Figure 3**. The litter observed was more than just typical highway litter (food wrappers and drink containers) and included rubber car mats, foam insulation, blankets, cardboard boxes, and plywood. The Study Area is also in a floodplain and is prone to flooding due to the inadequate drainage system under Hancock Expressway, shown below in **Figure 5**.

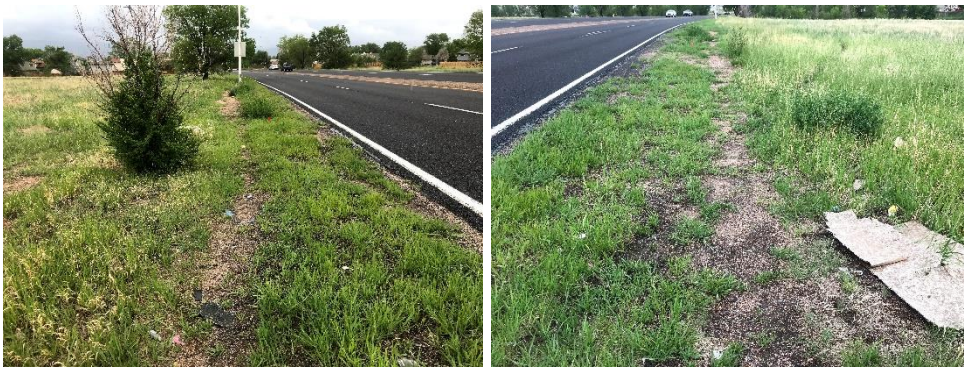
Figure 4. Missing Sidewalks

Inadequate infrastructure was observed throughout the Study Area, in the form of missing sidewalks, shown in **Figure 4**, and inadequate drainage. The drainage under Hancock Expressway is undersized and backs up causing the property to flood. Majority of the Study Area is within the 100-year and 500-year floodplain, shown below in **Figure 5**.

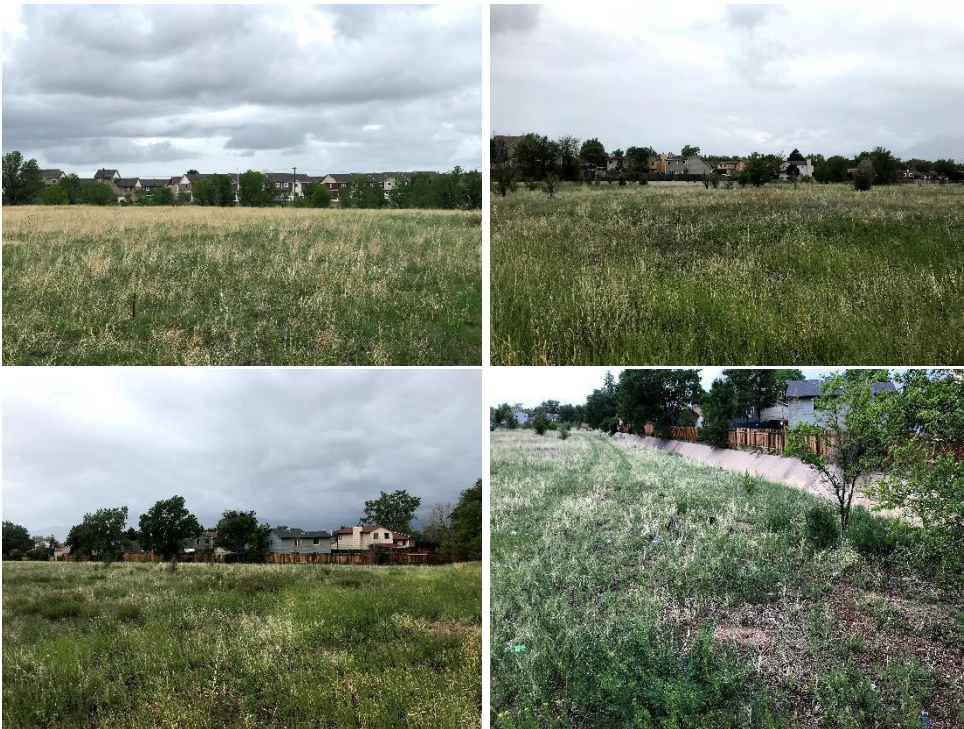
Figure 6. Vacant Property in Generally Urbanized Area

The entire 18.59-acre Study Area is vacant with no building improvements. The Study Area is surrounded by residential development, shown in **Figure 6**, with single family detached homes to the north, west, and south of the property. Additionally, to the east of Chelton Road are townhome units. This area in southeast Colorado Springs and near the airport is largely developed and predominantly residential.
