## Draft Report

# Project Garnett Existing Conditions Survey

City of Colorado Springs Urban Renewal Authority

December 23, 2022

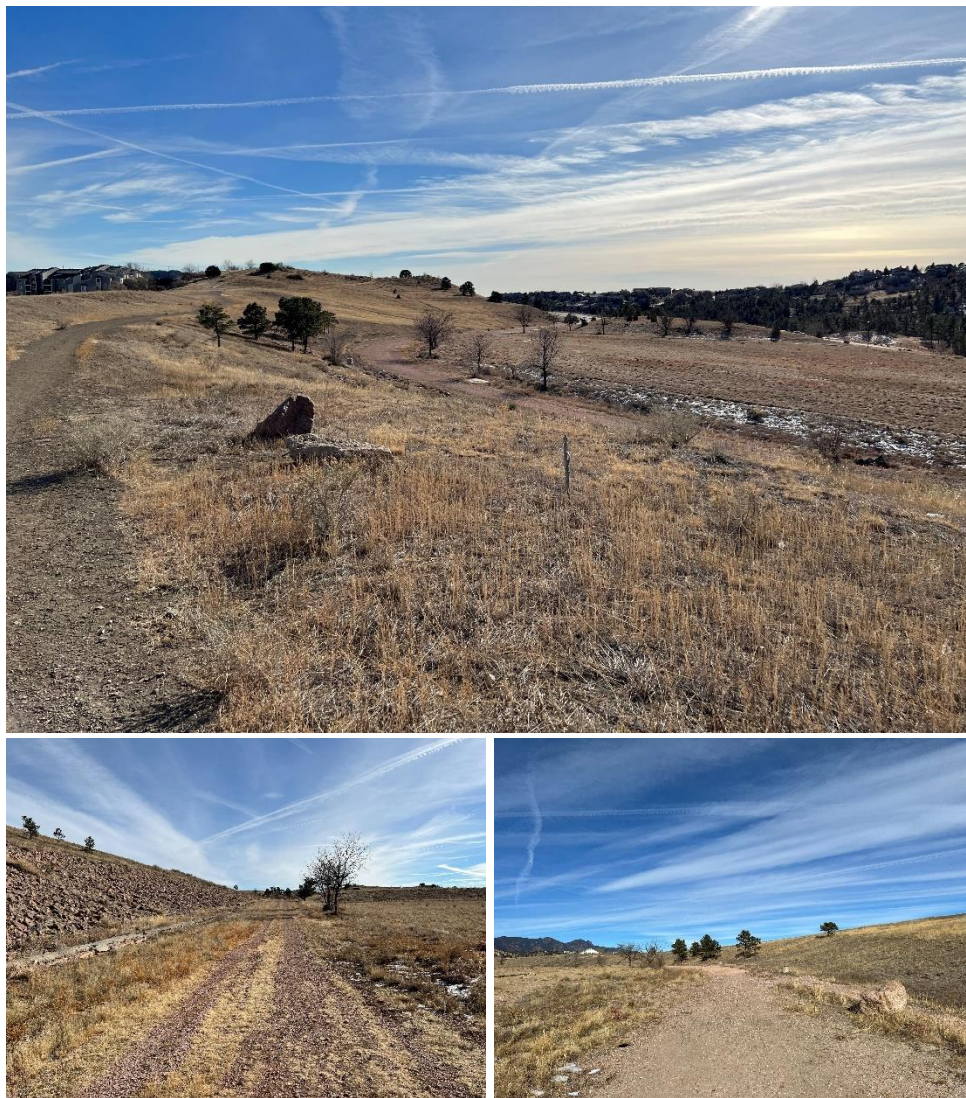
**Figure 2. Poor Internal Vehicular or Pedestrian Circulation**

The Study Area includes a large area, nearly 90 acres, and there is a lack of internal connectivity through the site. There is only a dirt road that connects the east and west sides of the site, shown in **Figure 2**. There are multiple driveways along the south side of the property, but these are all gated off and either end abruptly or lead to a dirt path. This lack of street layout in the Study Area creates poor provision for vehicular traffic, shown in **Figure 3**. Poor provisions of street improvements for pedestrians were observed in lack of sidewalks, shown in **Figure 4**.

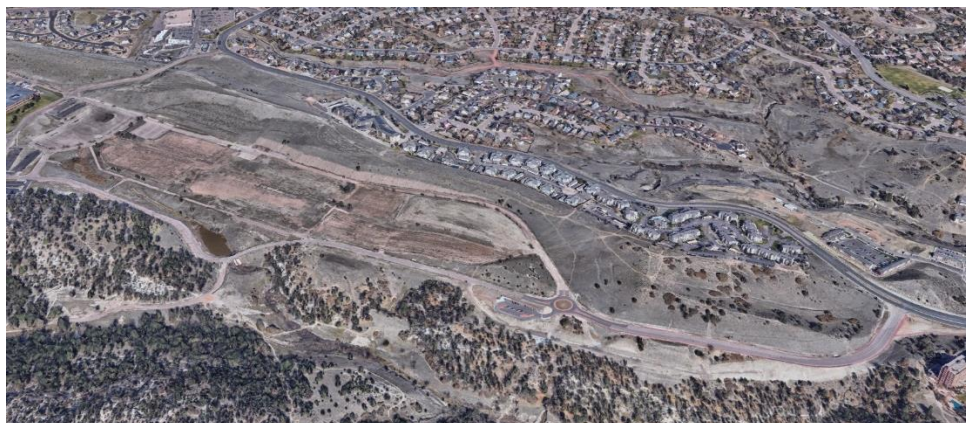
**Figure 5. Poor Vehicular Access**

The Study Area is a large site with minimal internal vehicular access, shown in **Figure 5**. The road along the southside of the property has multiple driveways for vehicles that either abruptly end or turn into a dirt road. There is only one dirt road that extends through the center of the property connecting the east side to the west side of the site.

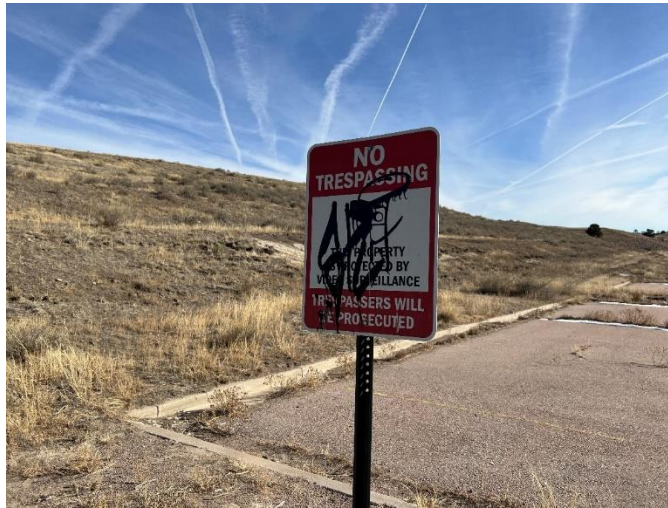
**Figure 6. Vandalism/Graffiti**

Throughout the Study Area unsafe and unsanitary conditions were documented, including vandalism/graffiti, evidence of vagrants, and litter. Vandalism/graffiti was observed on a no trespassing sign on the west side of the property, shown in **Figure 6**. There was evidence of vagrants on the property with a fire pit and some litter, shown in **Figure 7**.

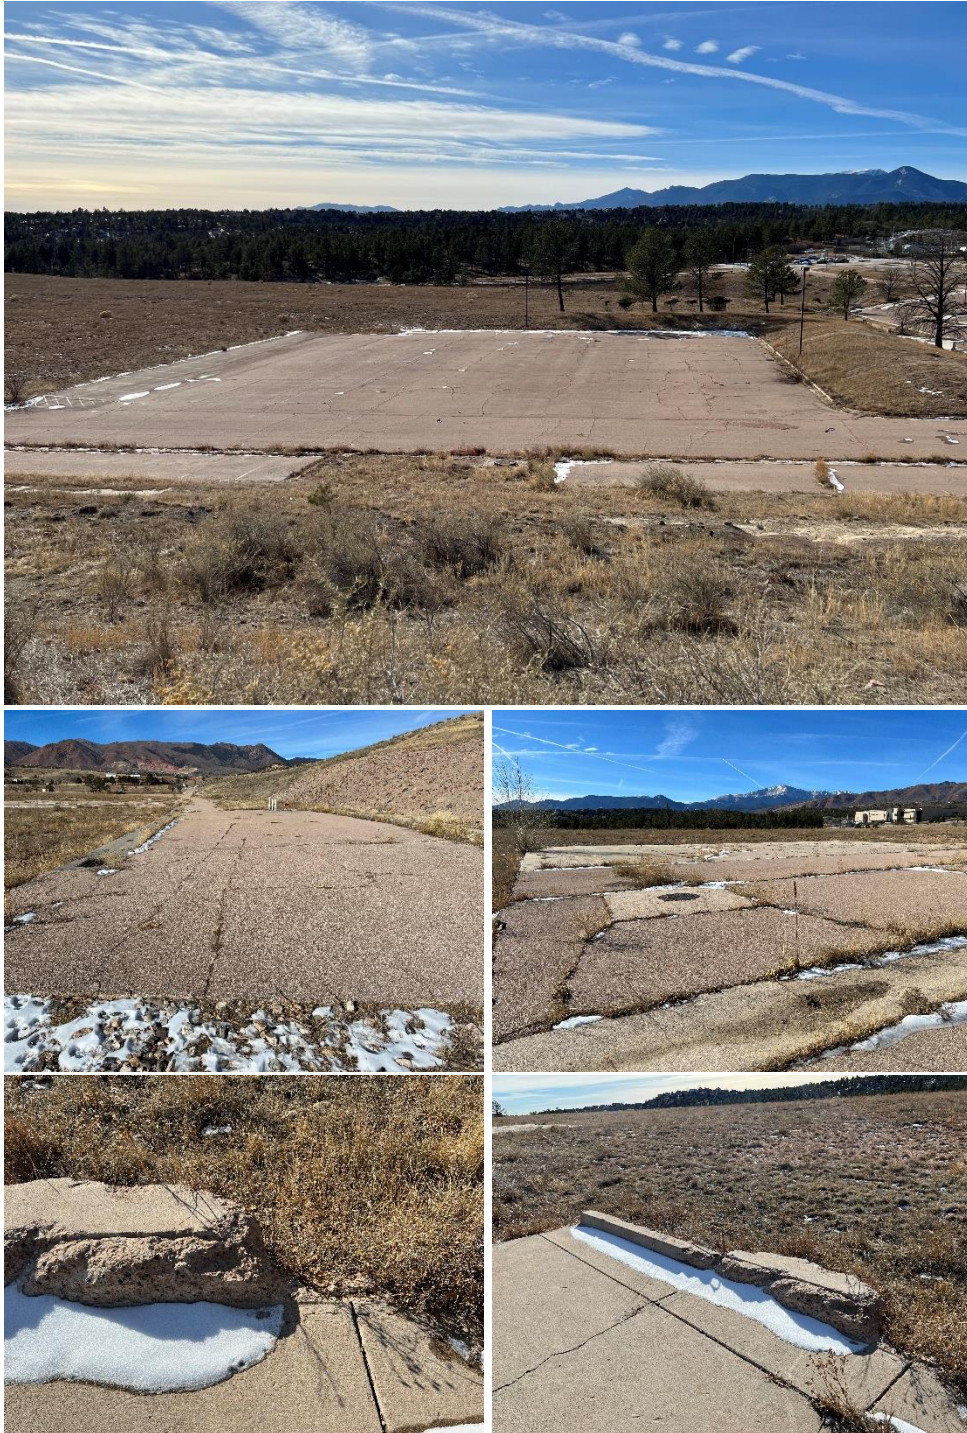
**Figure 8. Deteriorated On-site Parking Surfaces and Curbs**

Deterioration of the site was observed under the conditions of deteriorated on-site parking surfaces and curbs, as shown in **Figure 8**. The parking lot located on the north side of the property is deteriorated with cracked pavement, overgrown vegetation, faded or missing line painting, and deteriorated curb.

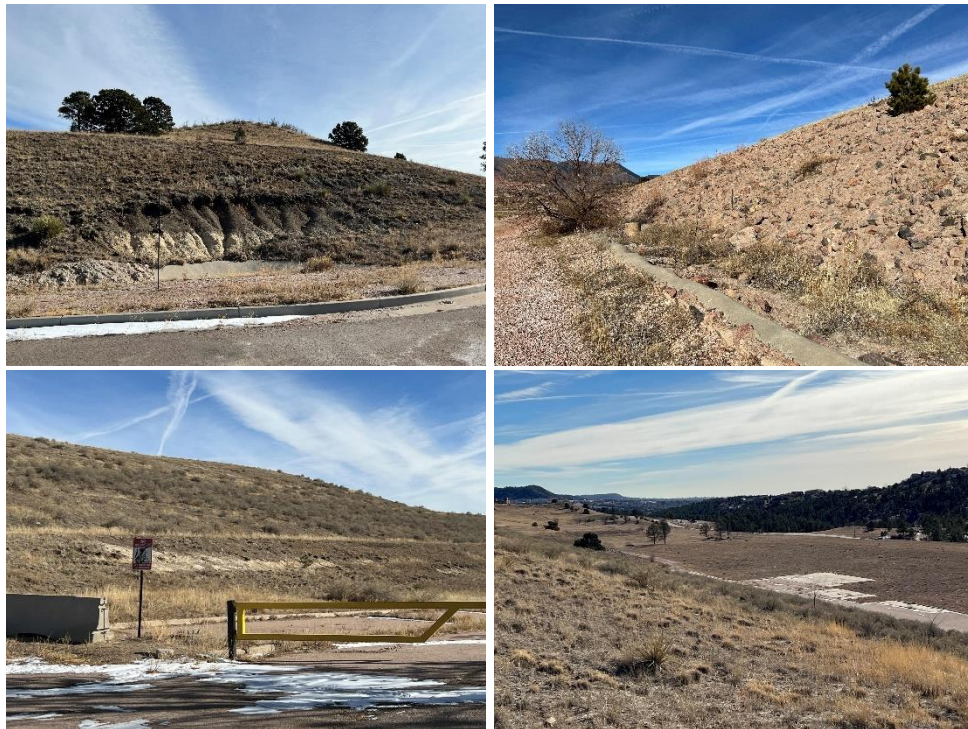
**Figure 9. Unusual Topography**

Unusual topography was observed on the east side of the property and continues along the north side to the west with very steep slopes, shown in **Figure 9**. These sections of the property would require significant grading to enable development. As previously mentioned, there are deteriorated pavement and curbs at both the east and west vehicle entrances to the site, shown in **Figure 10**. Throughout the site there is a lack of site infrastructure including pavement, curb, sidewalks, and lighting. Connections internally are all dirt paths or roads without curb and sidewalks shown in **Figure 11**. There is infrastructure for lighting with multiple bases along a dirt road without light posts.

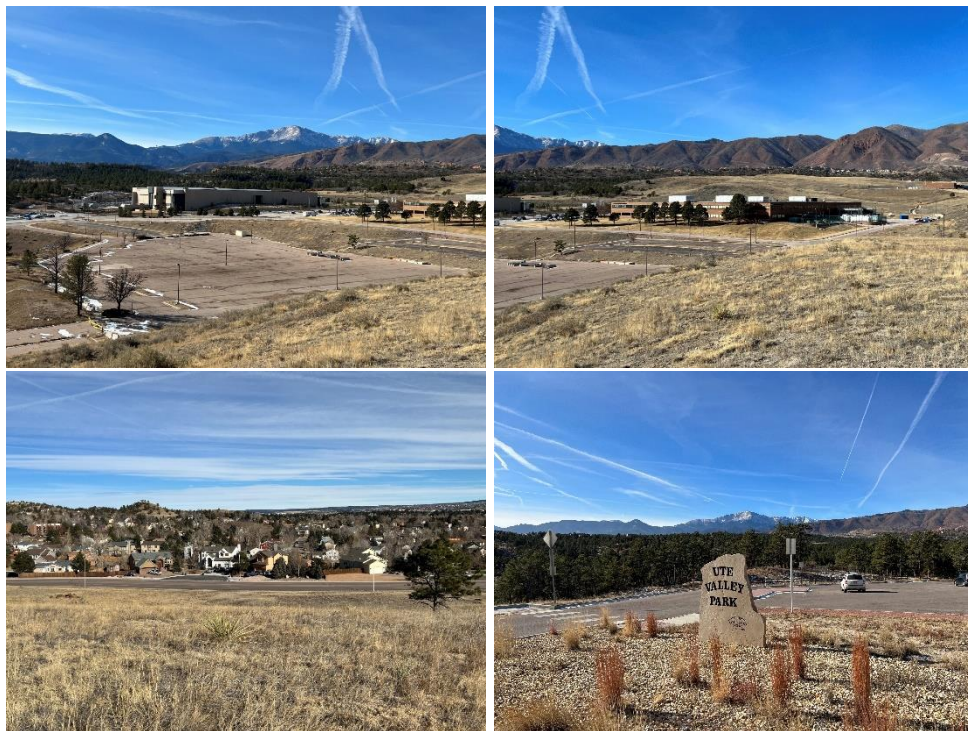
**Figure 12. Undeveloped/Underdeveloped Parcels in a Generally Urbanized Area**

The Study Area is comprised of parcels that are undeveloped/vacant and it is a brownfield site with former industrial activity from Hewlett Packard Enterprise Company (HPE). The surrounding area is largely developed and urbanized with commercial office buildings to the west, residential development to the north, a tech center to the east, and Ute Valley Open Space to the south, shown in **Figure 12**.
