Condition Study Report

City Gate Existing Conditions Survey

City of Colorado Springs Urban Renewal Authority

Economic & Planning Systems, Inc.

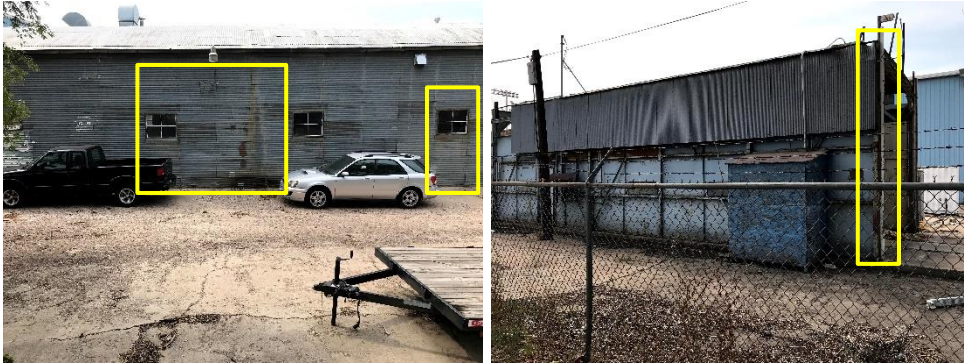
Figure 2. Deteriorated Exterior Finishes and Ancillary Structures

Structures located on parcel 3 in the Study Area have deteriorated exterior finishes with rusted and worn-out metal siding, shown in **Figure 2**. These structures are for industrial manufacturing and were constructed in 1980 or earlier.

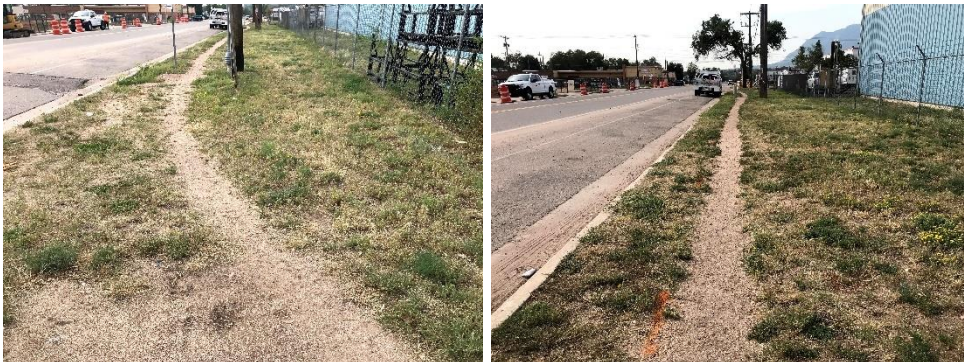
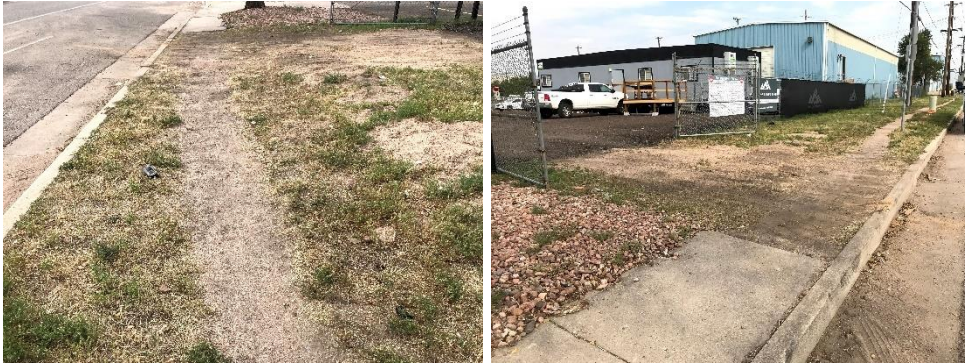
Figure 3. Poor Provision of Street Improvements for Pedestrians

Along South Sierra Madre Street on parcel 6 in the Study Area, poor provisions of street improvements for pedestrians were observed in the form of lack of sidewalks, shown in **Figure 3**. Throughout this portion of the Study Area, provisions of walkways for pedestrians were missing and an informal dirt path shows evidence of pedestrian use. There is a curb, but not a paved sidewalk to connect to the sidewalks along parcels 3 and 8. This is a disconnect in the existing pedestrian network on adjacent properties. Additionally, poor provisions of street improvements for vehicles were observed in the form of potholes and cracked pavement throughout the study area, shown below in **Figure 4**.

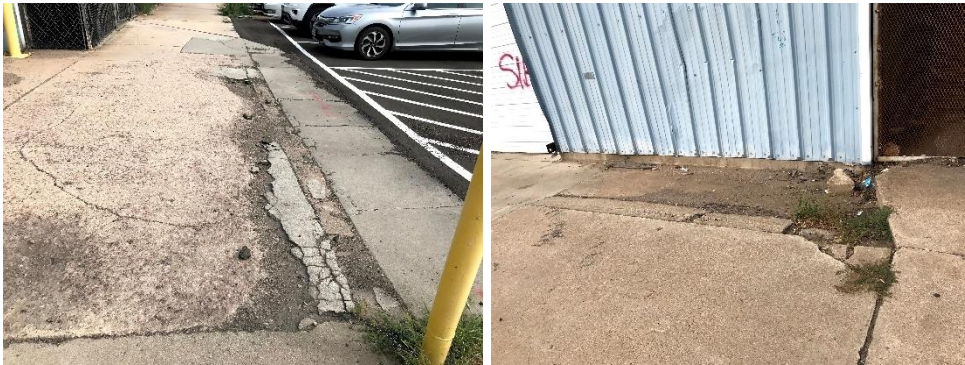
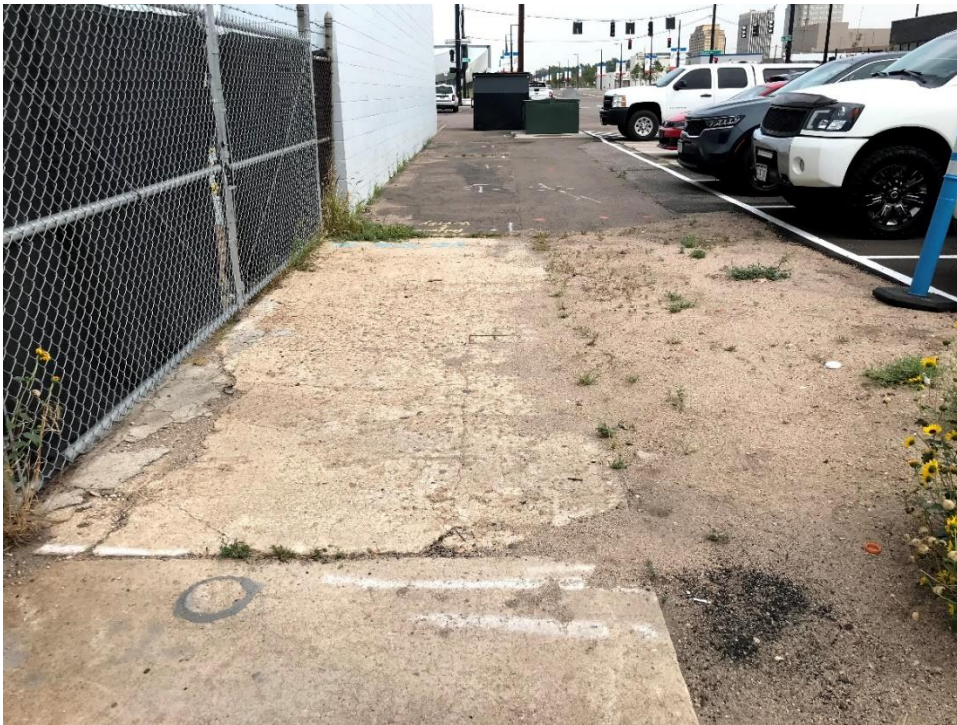
Figure 5. Cracked or Uneven Surfaces for Pedestrians

Throughout the Study Area unsafe and unsanitary conditions were documented, including cracked or uneven surfaces for pedestrians, litter, and vandalism/graffitti. Cracked and uneven surfaces for pedestrians were observed along South Sierra Madre Street, shown in **Figure 5**. Excessive litter was observed and documented throughout the Study Area and was especially apparent along South Sierra Madre Street and parcel 8, shown in **Figure 6**. Vandalism/graffitti was observed on a building on parcel 3, shown in **Figure 7**.

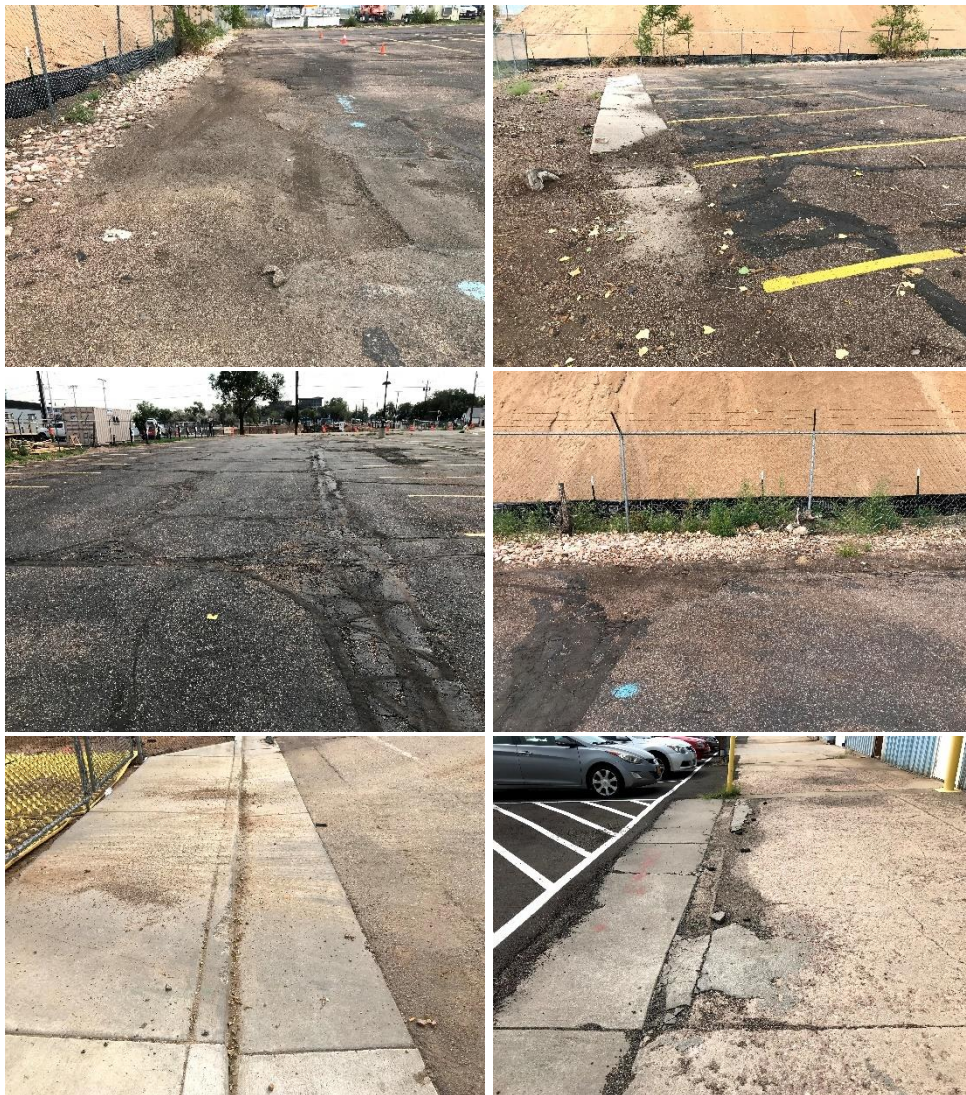
Figure 8. Deteriorated On-Site Parking Surfaces, Curb, & Sidewalks

Deteriorated site improvements observed include deteriorated on-site parking surfaces, curb, and sidewalks, shown in **Figure 8**. The parking lot on parcel 8 has cracked pavement and potholes. Additionally, cracked sidewalks were observed along South Sierra Madre Street adjacent to parcel 3 and deteriorated curb was observed along West Rio Grande Street. Overgrown vegetation was observed throughout the Study Area, shown in **Figure 9**.

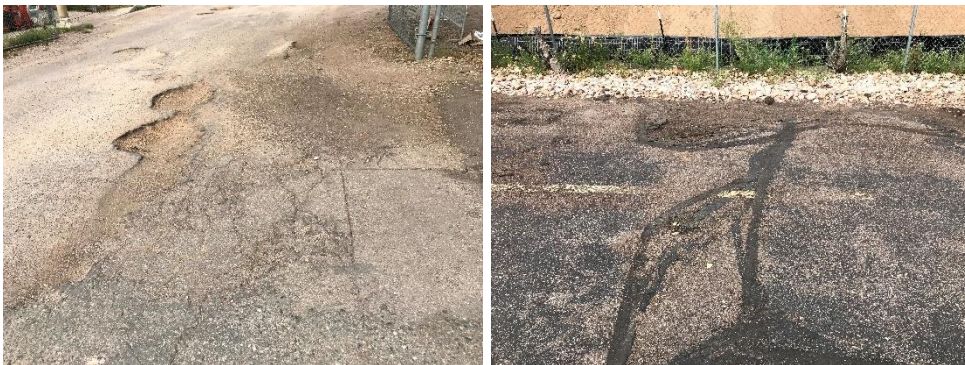
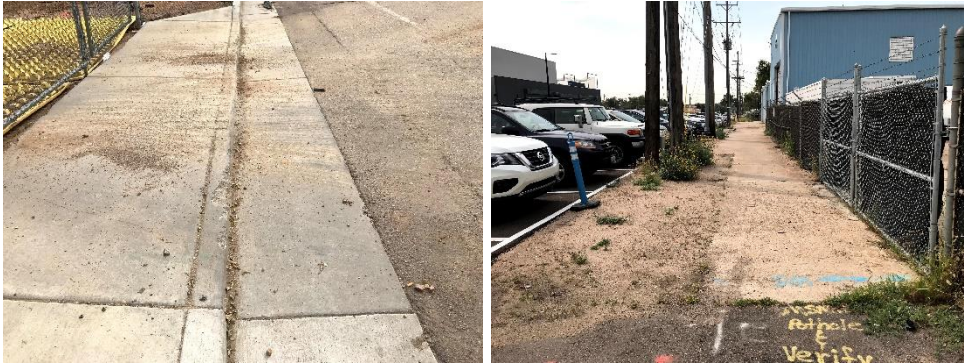
Figure 10. Deteriorated Pavement, Curb, and Sidewalks

Inadequate infrastructure was observed throughout the Study Area, predominately in the form of deteriorated pavement, curbs, and sidewalks, shown in **Figure 10**. Additionally, a portion of the Study Area along South Sierra Madre Street is missing a sidewalk, shown in **Figure 11**.

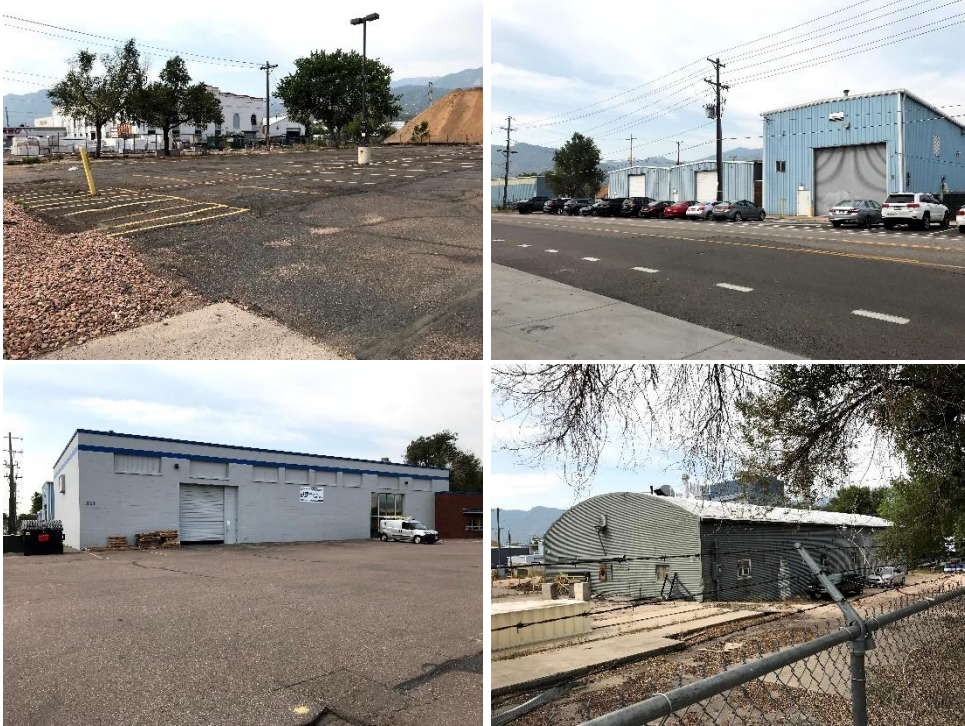
Figure 12. Undeveloped/Underdeveloped Parcels in a Generally Urbanized Area

The Study Area is comprised of parcels that are undeveloped/vacant and underdeveloped, shown in **Figure 12**. Parcel 8 is undeveloped and was previously used as a surface parking lot and parcels 2, 4, 9, and 11 are vacant with no building improvements. All other parcels in the Study Area are older industrial properties with buildings constructed as early as the 1950s. The Study Area is within the Colorado Springs Downtown and is adjacent to the Weidner Soccer Stadium. Additionally, the area is urbanized with development to the north, south, and east of the Study Area and a railroad to the west.
