Final Report

Hancock Commons Existing Conditions Survey

City of Colorado Springs Urban Renewal Authority

July 23, 2021

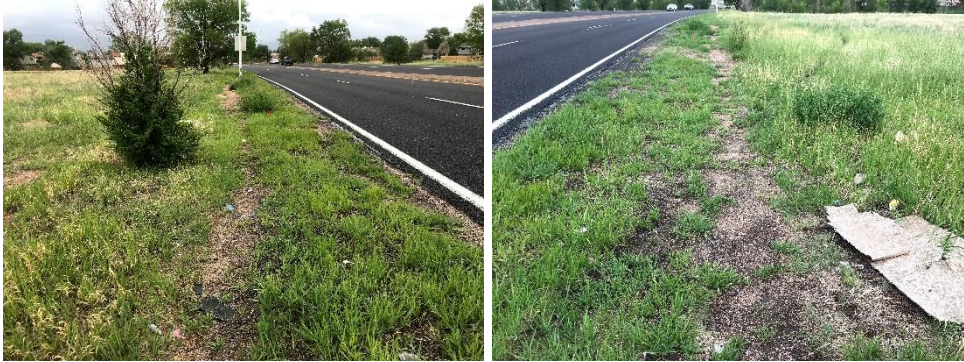
Figure 2. Lack of Sidewalks

Along Hancock Expressway, provisions of walkways for pedestrians were observed in the form of lack of sidewalks. It was observed sidewalks are needed for pedestrian safety as there is an informal pathway along the south side of Hancock Expressway through the Study Area, shown in **Figure 2**.
