Subject: The Sands Project - Channel Improvements for Approximately 110 acres within Section 33, Township 13 South, Range 65 West, Colorado Springs, Colorado. Western Environment and Ecology, Inc. Project Number 757-001-01

Figure 1 - Project Location Map
Sands Project - Channel Improvements
East Fork Sand Creek Subtributary
Colorado Springs, Colorado

Project: The Sands Project - Channel Improvements Date: 8-17-17
 Location: Section 33, T13S, R65W Investigator(s): Austin Curry, Brendan Calonge
Colorado Springs, CO.

Subject: The Sands - Sand Creek East Fork Sub-Tributary CLOMR - ESA Complinance/Threatened and Endangered Species Survey - Sand Creek East Fork, El Paso County, Colorado. Western Environment and Ecology, Inc. Project Number 757-001-01

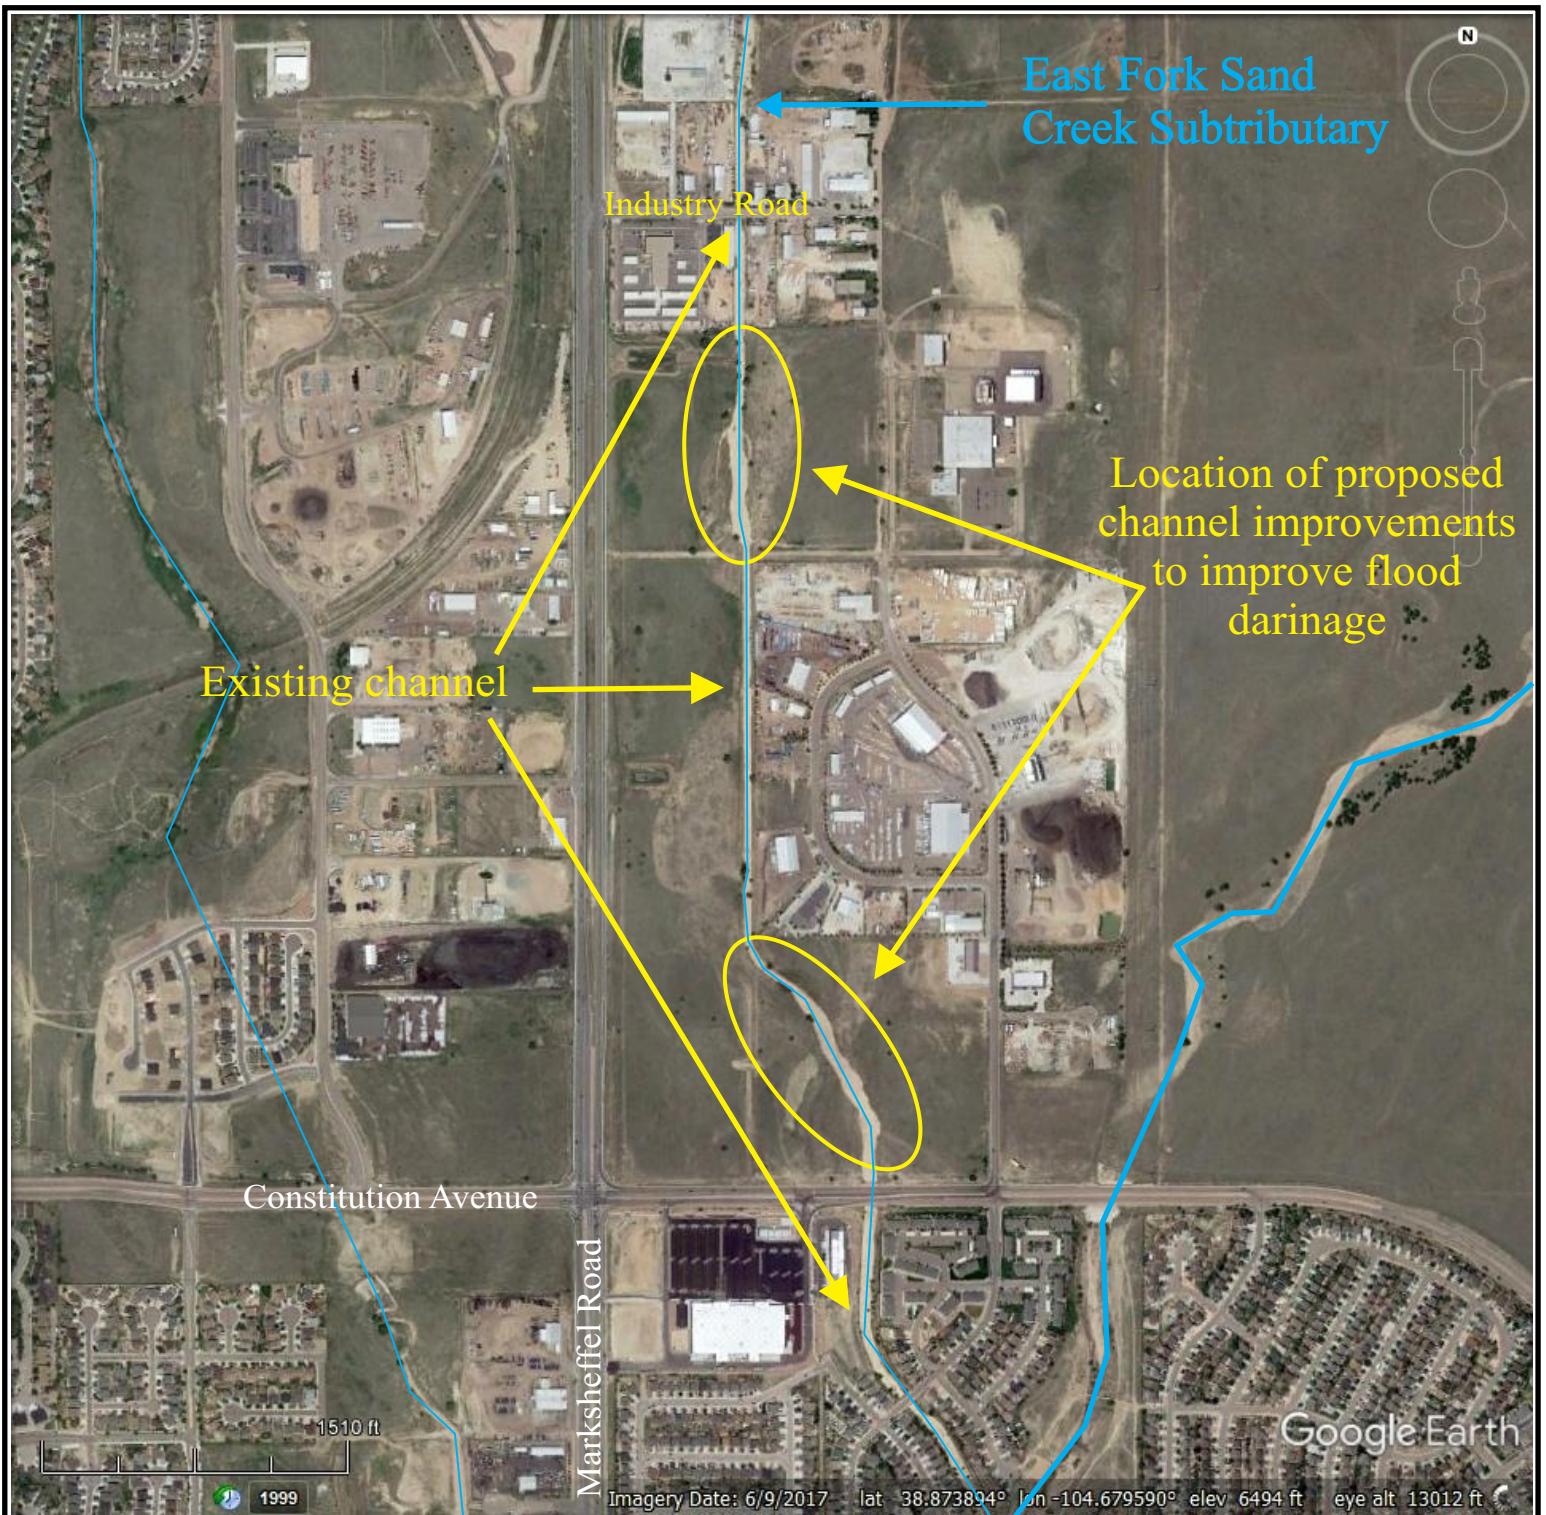
Figure 2 - Site Map
Sands Project - Channel Improvements
East Fork Sand Creek Subtributary
Colorado Springs, Colorado
FIGURE 16

The property is currently vacant and bordered to the south by Constitution Avenue and to the west by Marksheffel Road (Figure 2). Adjacent lots to the north and east are occupied by Industrial Business Parks. A residential development and a King Soopers supermarket are located to the south across Constitution Avenue. A tributary of the East Fork of Sand Creek bisects the northern and southern portions of the property (see attached photos).

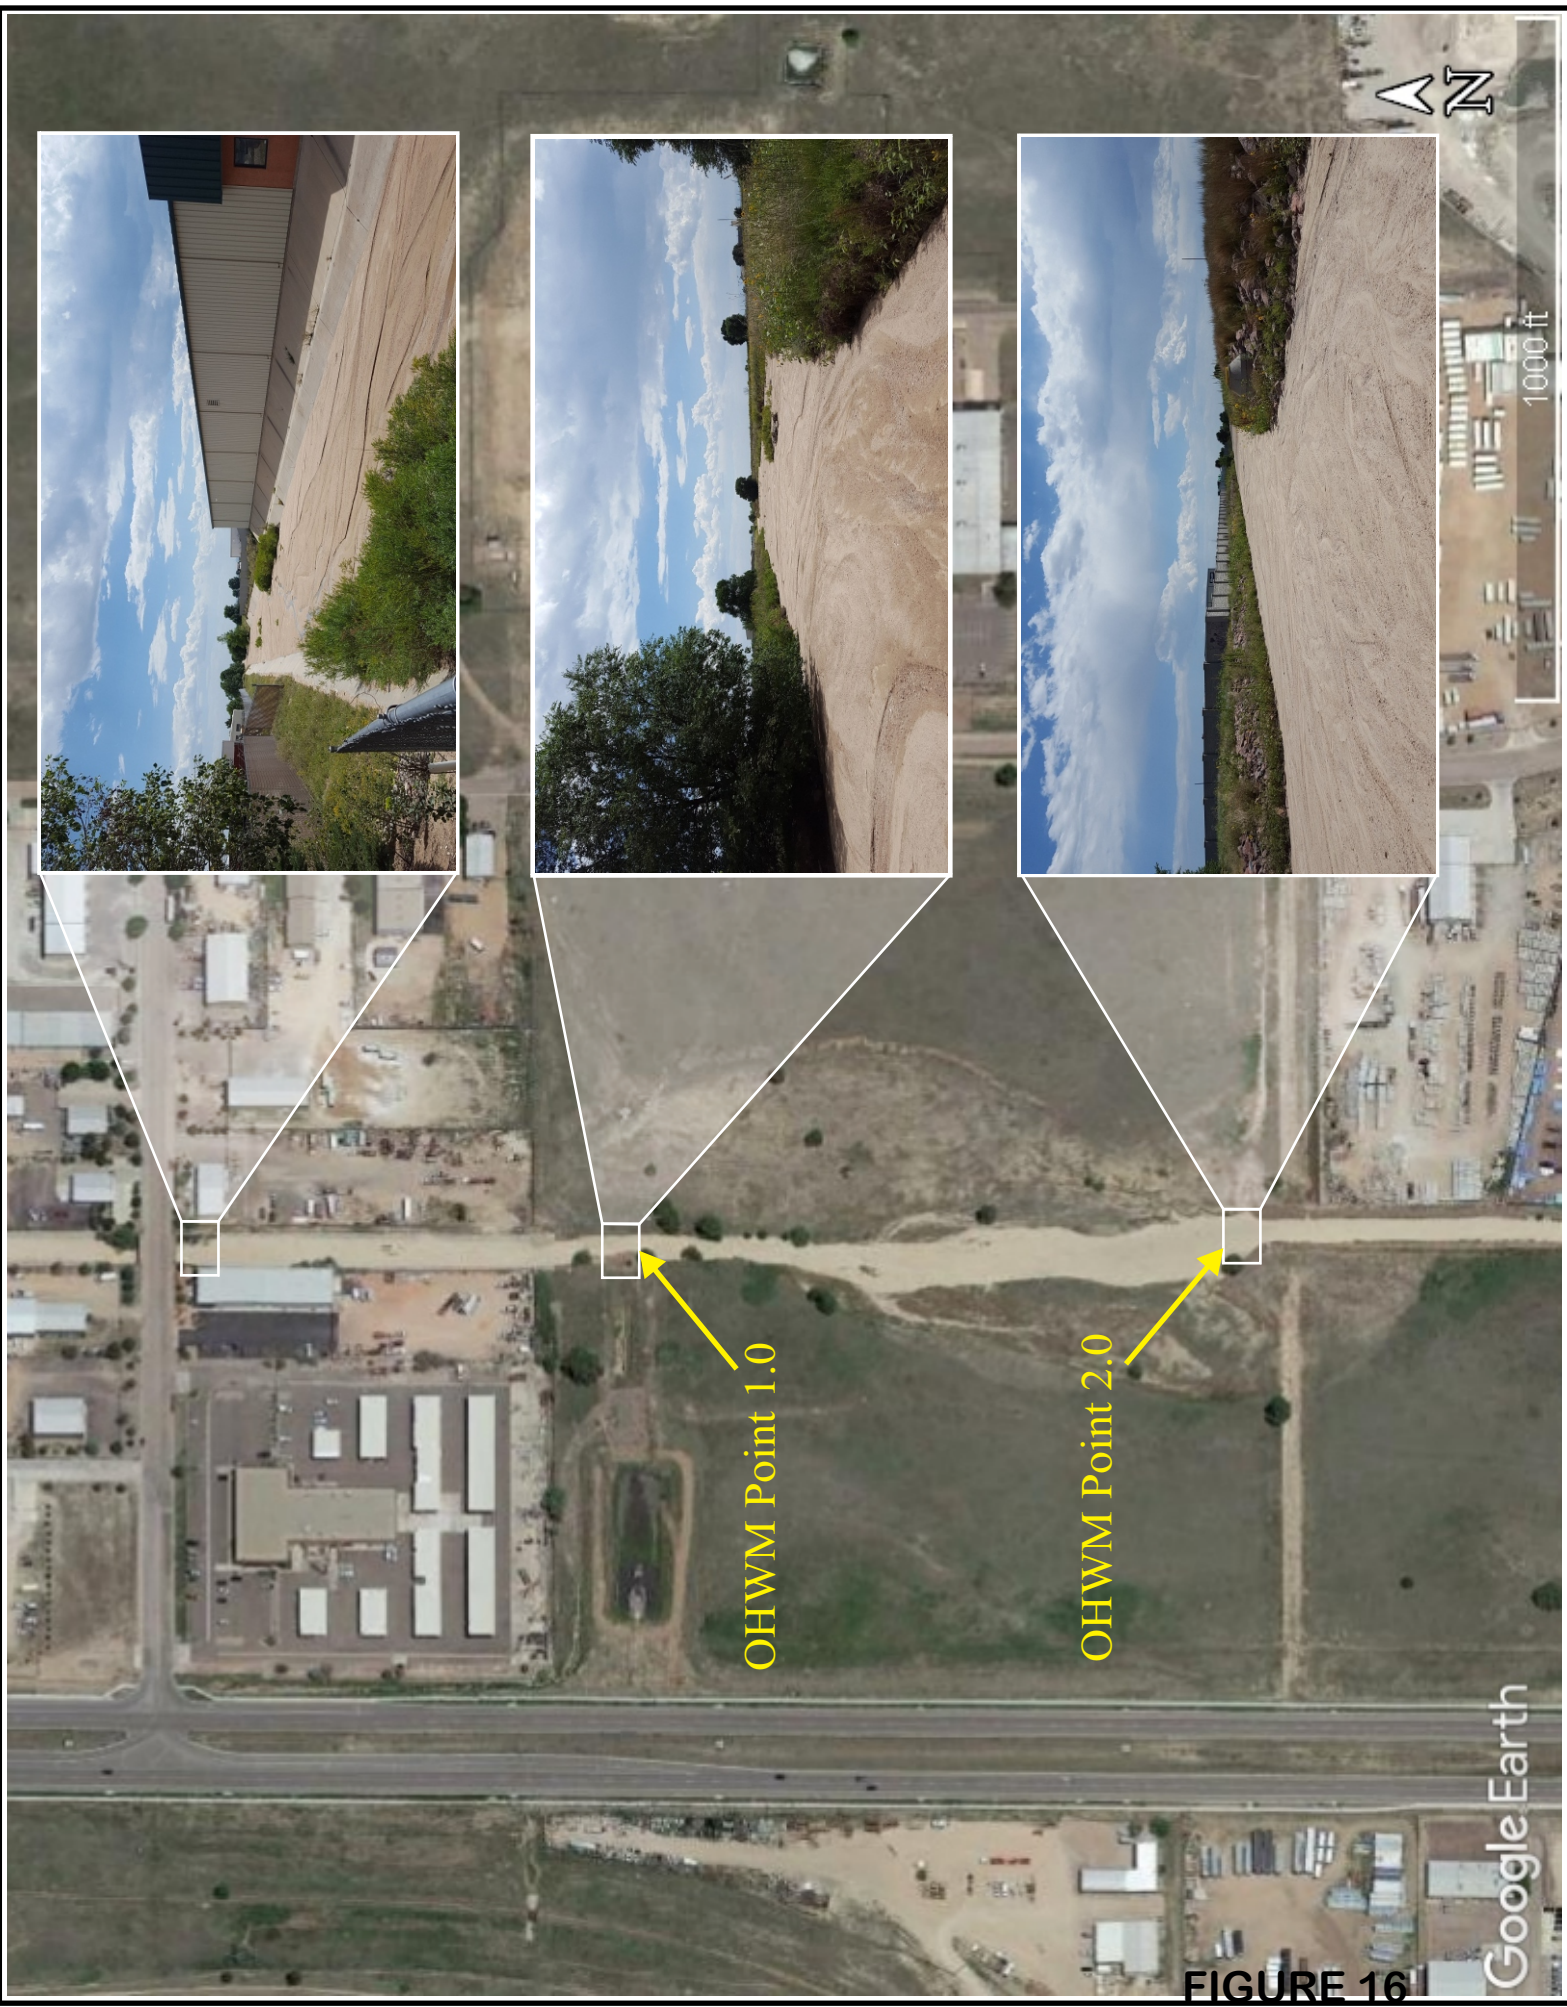
OHWM Point 1.0

OHWM Point 2.0

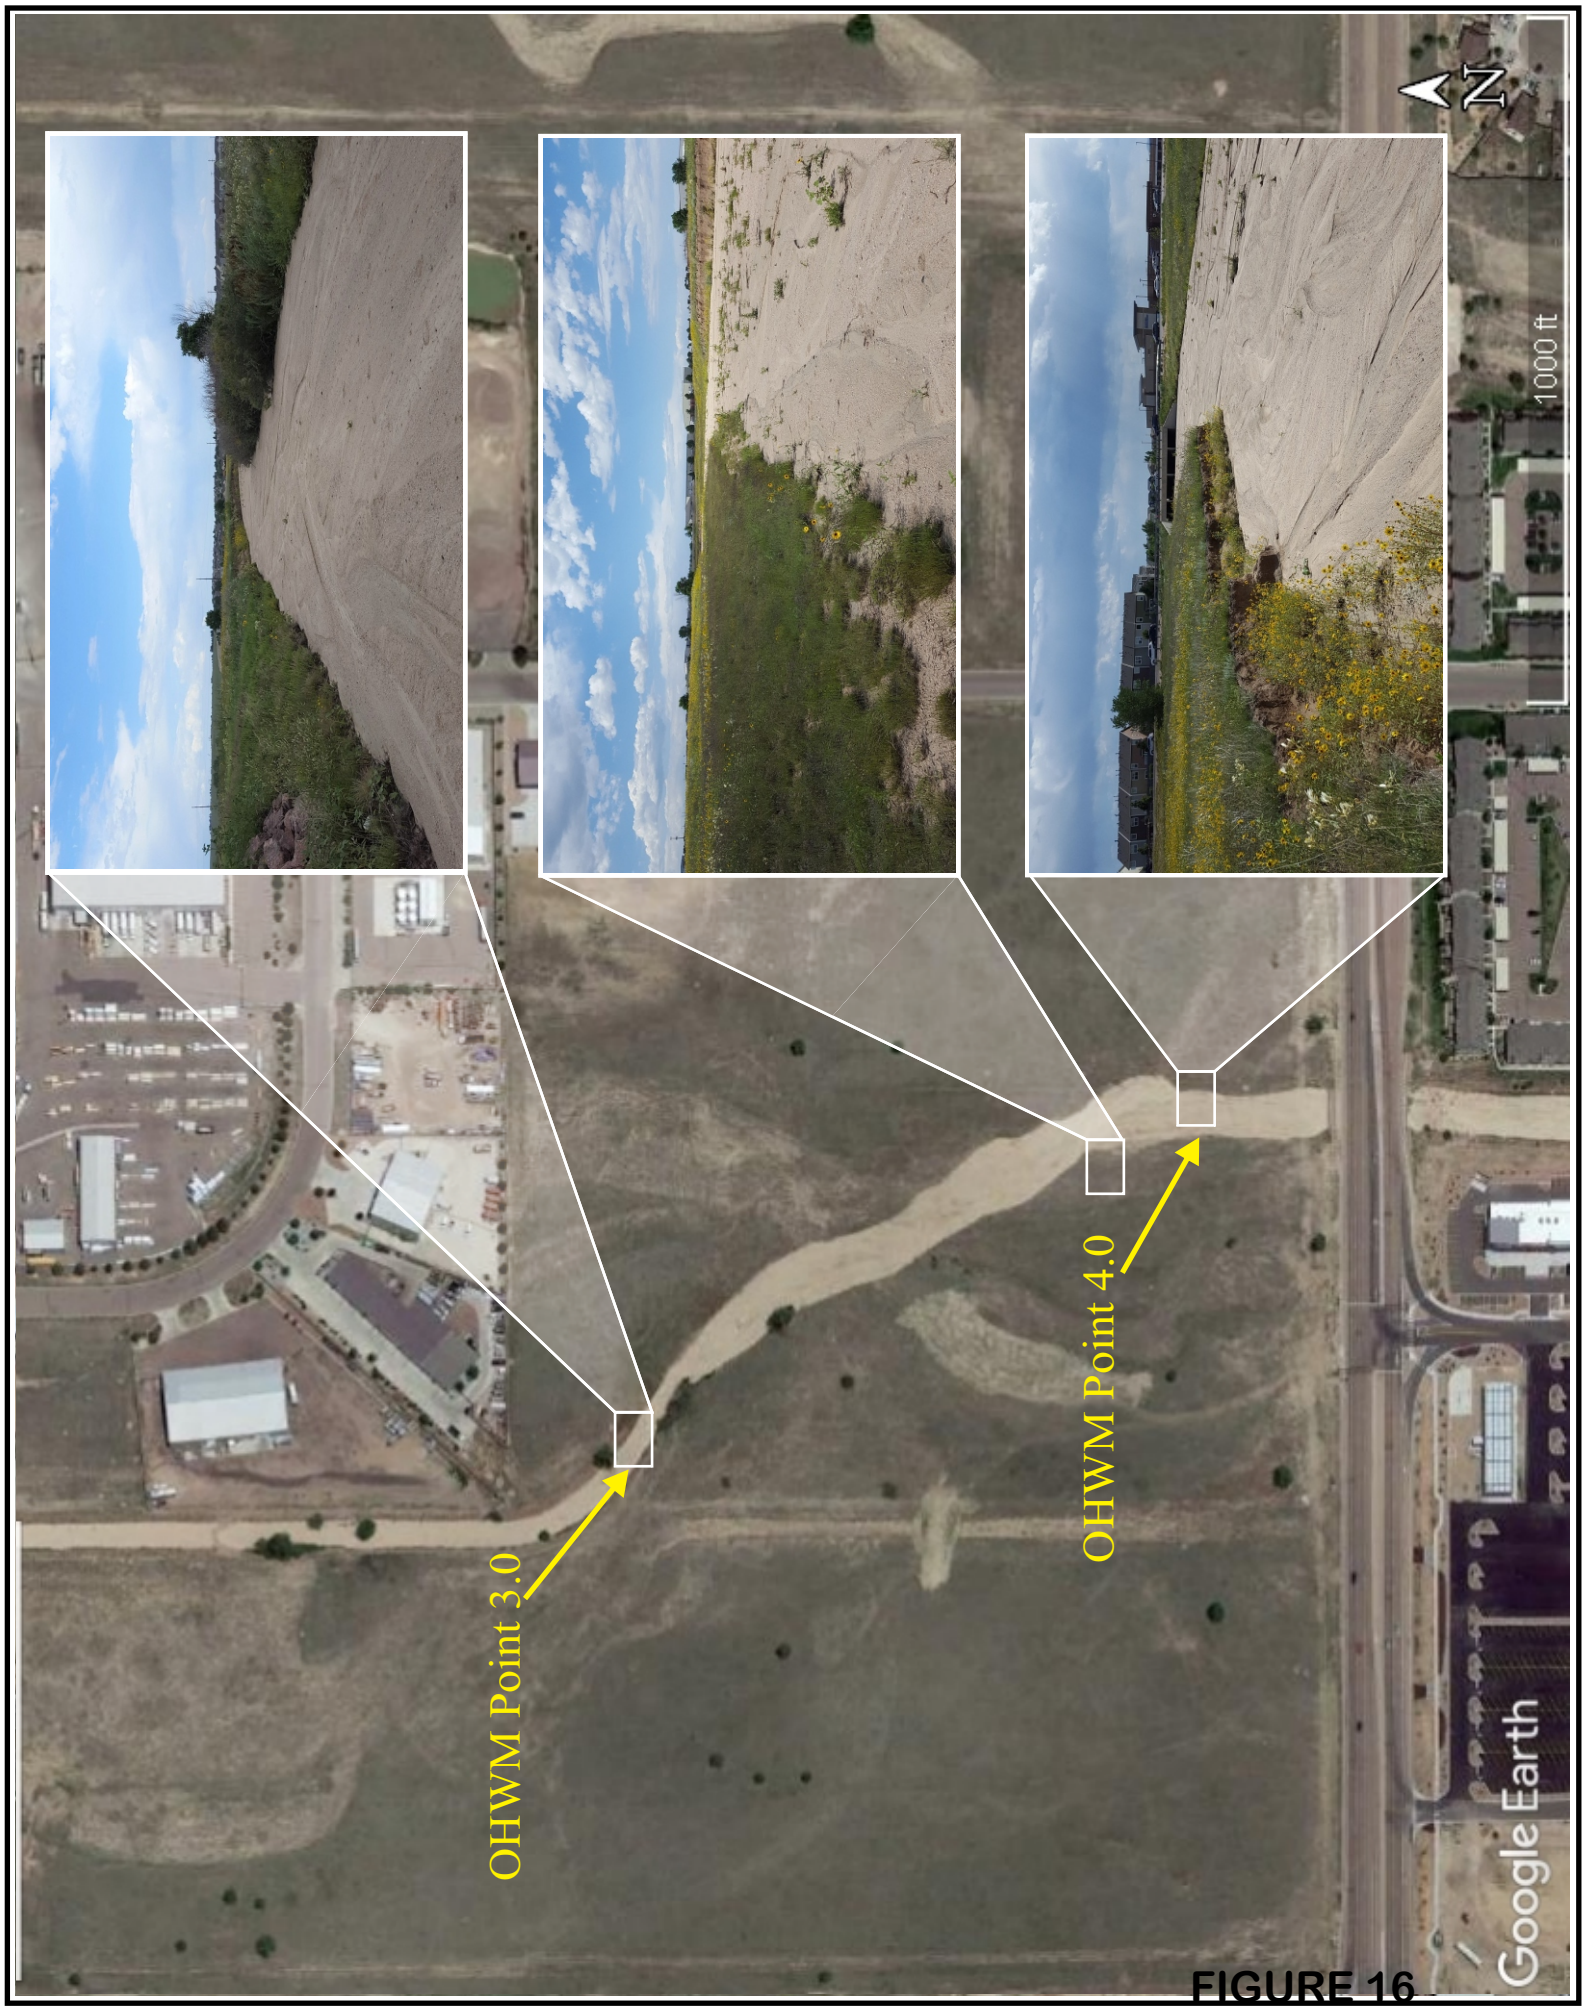
OHWM Point 3.0

OHWM Point 4.0

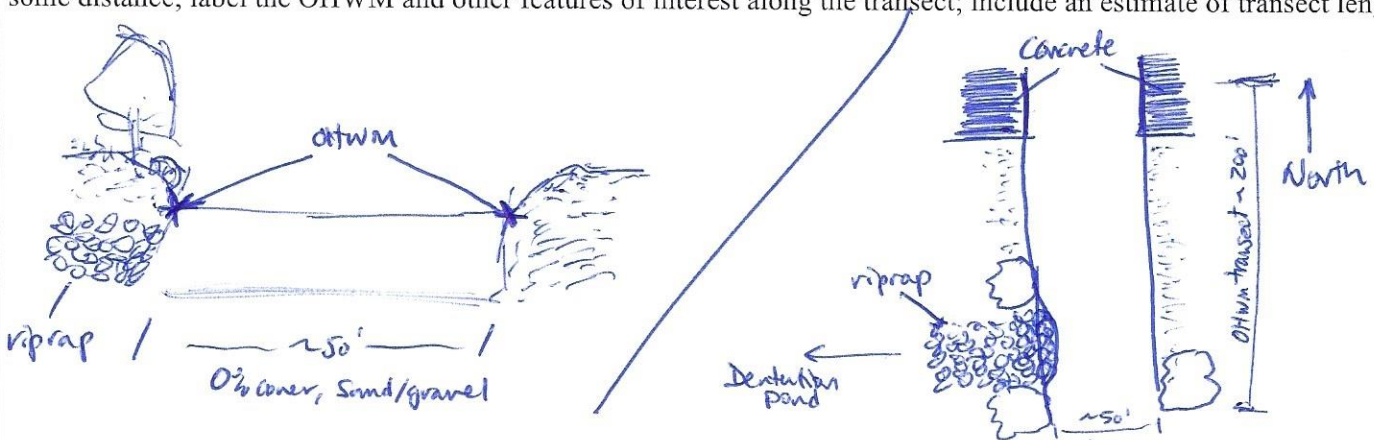
Transect (cross-section) drawing: (choose a location that is representative of the dominant stream characteristics over some distance; label the OHWM and other features of interest along the transect; include an estimate of transect length)

Clay/Silt <0.05mm	Sand 0.05 – 2mm	Gravel 2mm – 1cm	Cobbles 1 – 10cm	Boulders >10cm	Developed Soil Horizons (Y/N)
Above OHWM	50	30	20			
Below OHWM		50	50

Tree (%)	Shrub (%)	Herb (%)	Bare (%)
Above OHWM	5	25	95	25
Below OHWM	0	0	0	100

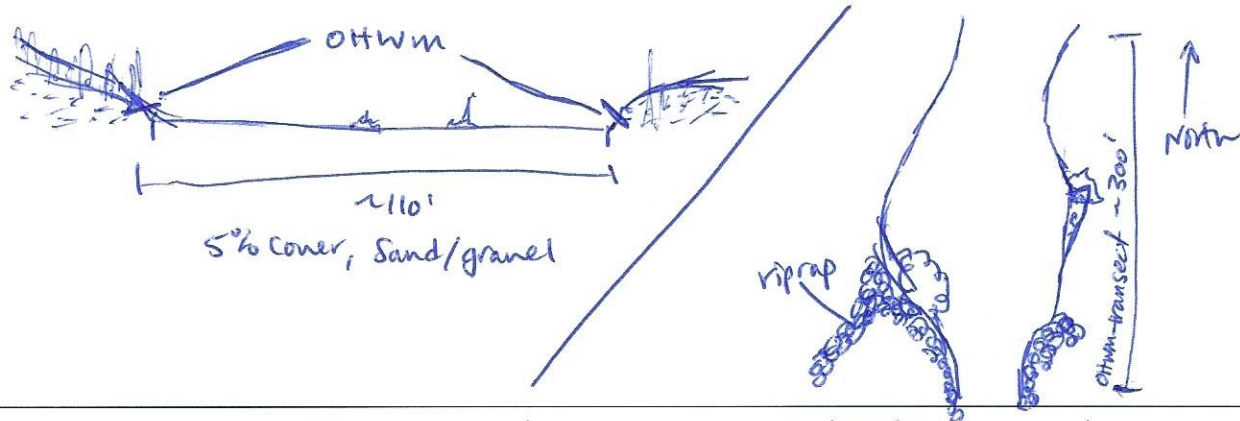
Transect (cross-section) drawing: (choose a location that is representative of the dominant stream characteristics over some distance; label the OHWM and other features of interest along the transect; include an estimate of transect length)

Clay/Silt <0.05mm	Sand 0.05 - 2mm	Gravel 2mm - 1cm	Cobbles 1 - 10cm	Boulders >10cm	Developed Soil Horizons (Y/N)
Above OHWM	40	60				
Below OHWM		50	50	<5

Above OHWM - Saturated at 24"
Below OHWM - water at 20"

Tree (%)	Shrub (%)	Herb (%)	Bare (%)
Above OHWM	10	0	80	5
Below OHWM	0	0	5	95

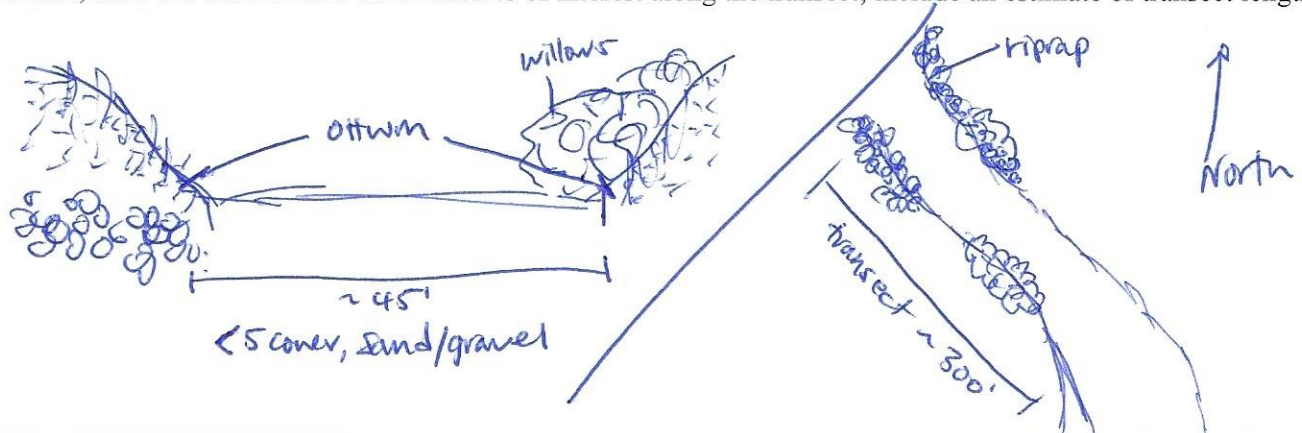
Transect (cross-section) drawing: (choose a location that is representative of the dominant stream characteristics over some distance; label the OHWM and other features of interest along the transect; include an estimate of transect length)

Clay/Silt <0.05mm	Sand 0.05 – 2mm	Gravel 2mm – 1cm	Cobbles 1 – 10cm	Boulders >10cm	Developed Soil Horizons (Y/N)
Above OHWM	60	40				YES
Below OHWM		100

Below OHWM - Water at 18"

Tree (%)	Shrub (%)	Herb (%)	Bare (%)
Above OHWM	20	20	55	5
Below OHWM		15		85

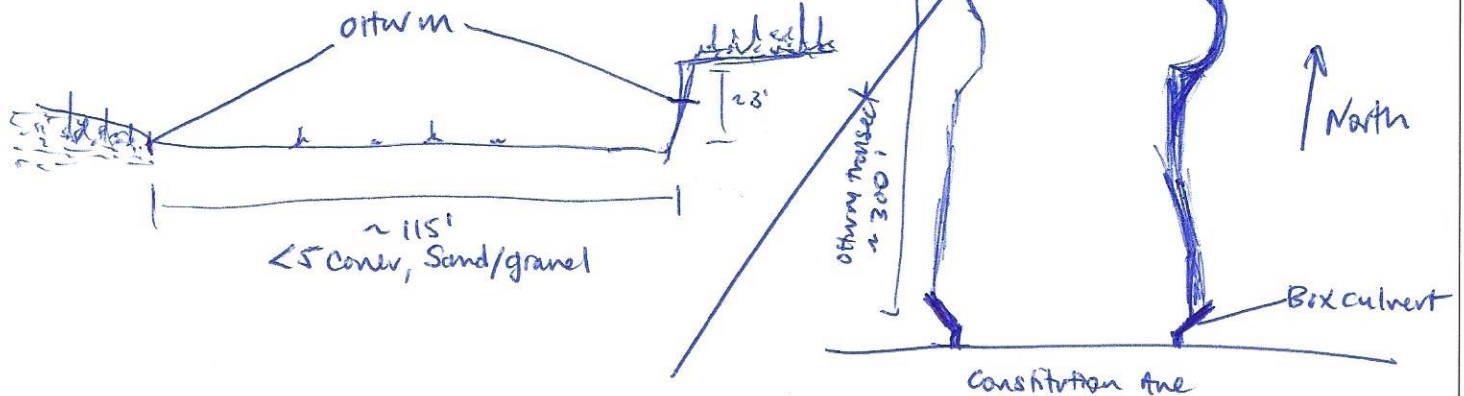
Transect (cross-section) drawing: (choose a location that is representative of the dominant stream characteristics over some distance; label the OHWM and other features of interest along the transect; include an estimate of transect length)

Clay/Silt <0.05mm	Sand 0.05 – 2mm	Gravel 2mm – 1cm	Cobbles 1 – 10cm	Boulders >10cm	Developed Soil Horizons (Y/N)
Above OHWM	50	50				
Below OHWM	25	90	5-10

Above OHWM - No sat at 24"
Below OHWM - Sat at 20"

Tree (%)	Shrub (%)	Herb (%)	Bare (%)
Above OHWM			95	25
Below OHWM			25	95

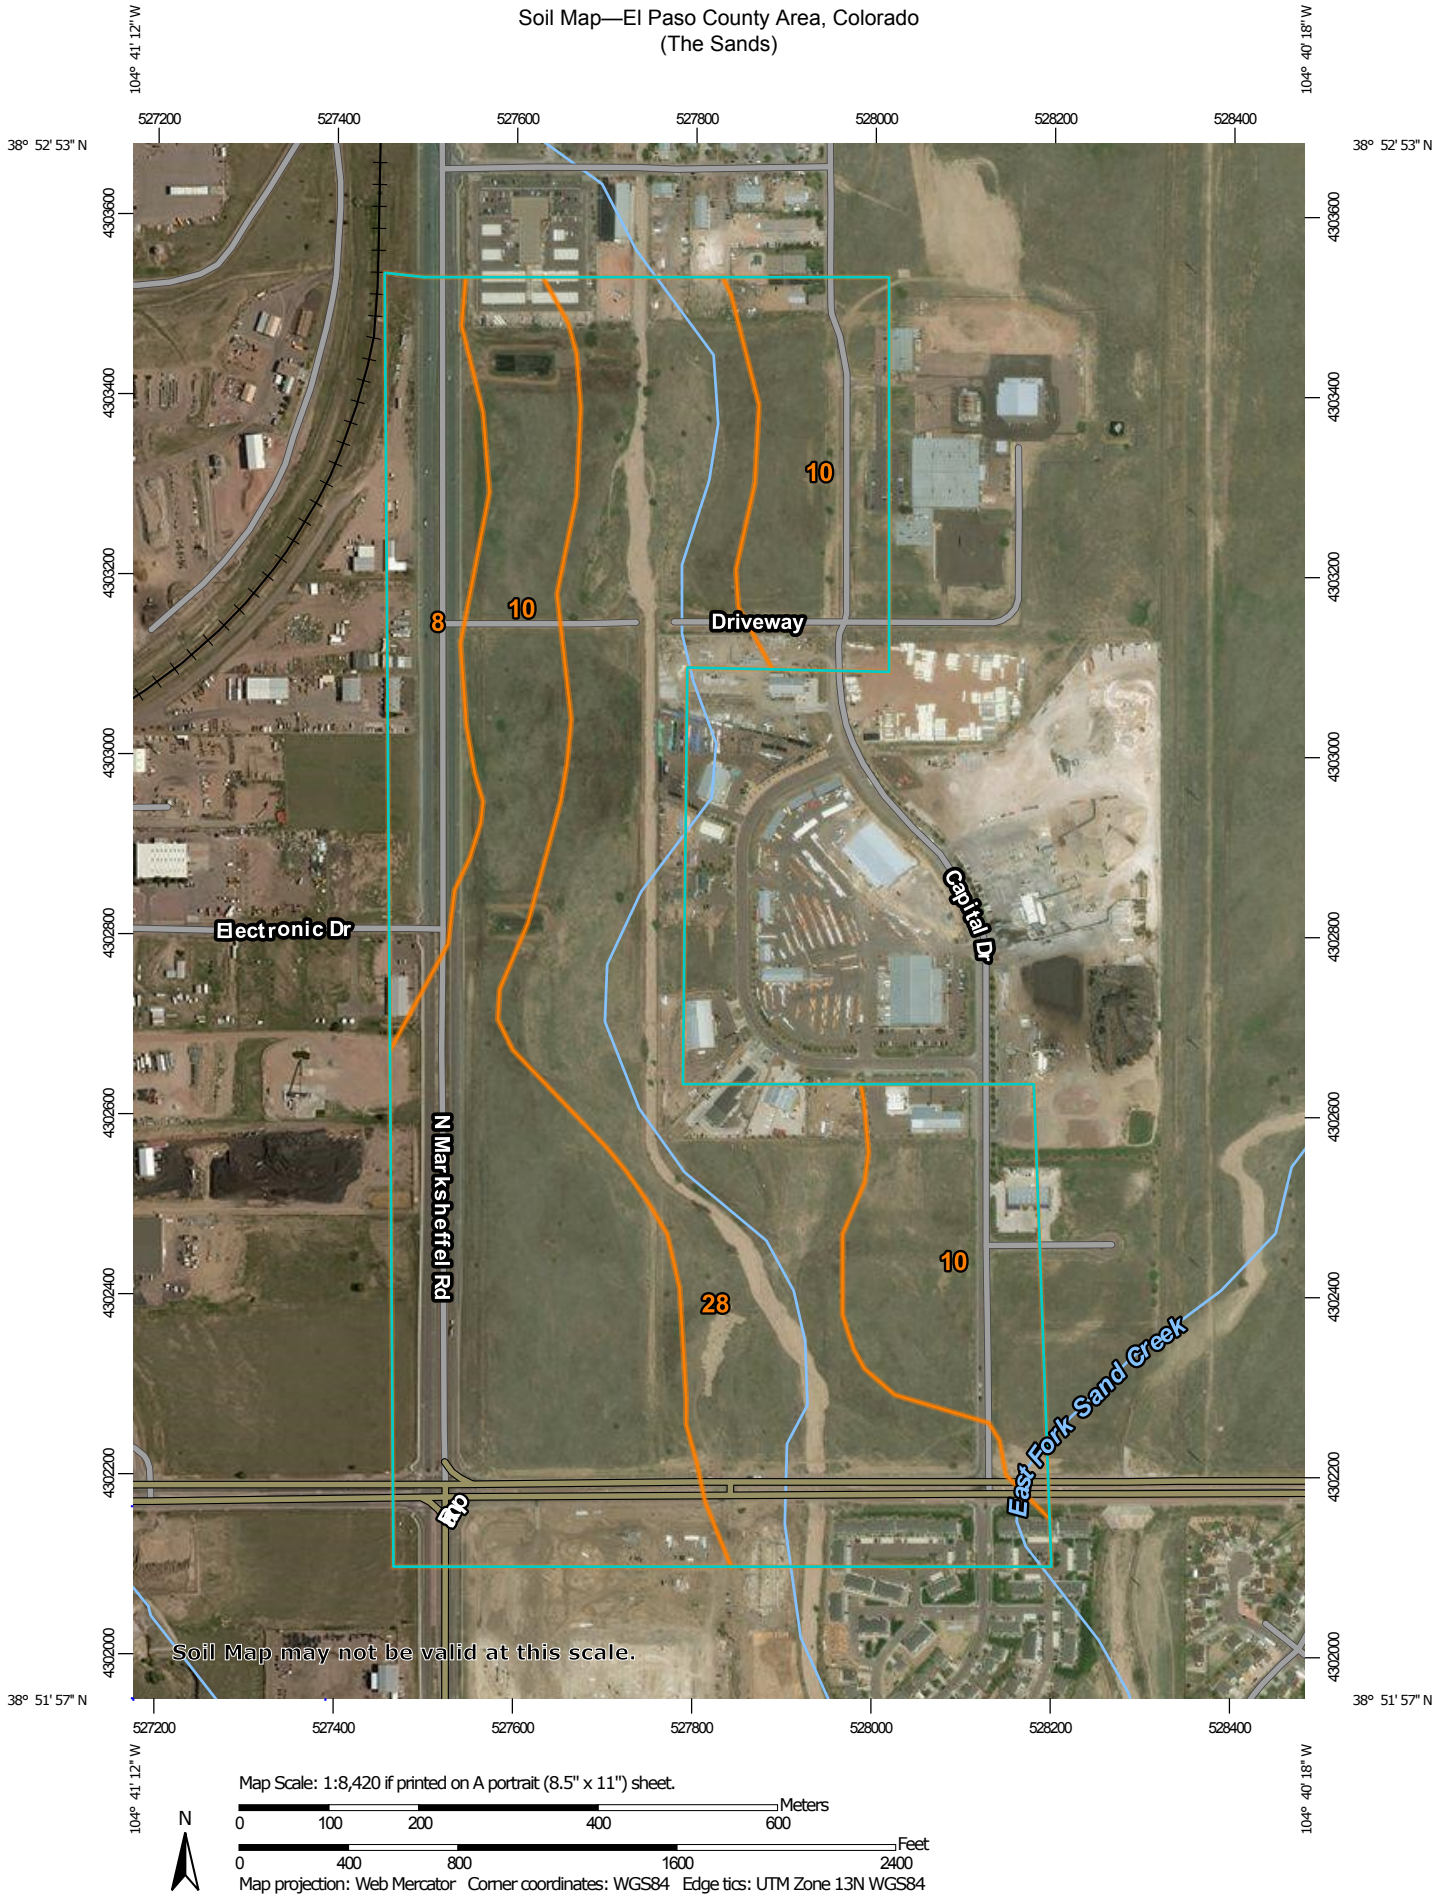
Soil Map—El Paso County Area, Colorado
(The Sands)

El Paso County Area, Colorado (CO625)			
Map Unit Symbol	Map Unit Name	Acres in AOI	Percent of AOI
8	Blakeland loamy sand, 1 to 9 percent slopes	18.3	9.4%
10	Blendon sandy loam, 0 to 3 percent slopes	100.4	51.5%
28	Ellicott loamy coarse sand, 0 to 5 percent slopes	76.4	39.2%
Totals for Area of Interest		195.1	100.0%
