# Final Report

## Lowell-Draper Existing Conditions Survey

City of Colorado Springs Urban Renewal Authority

August 30, 2021

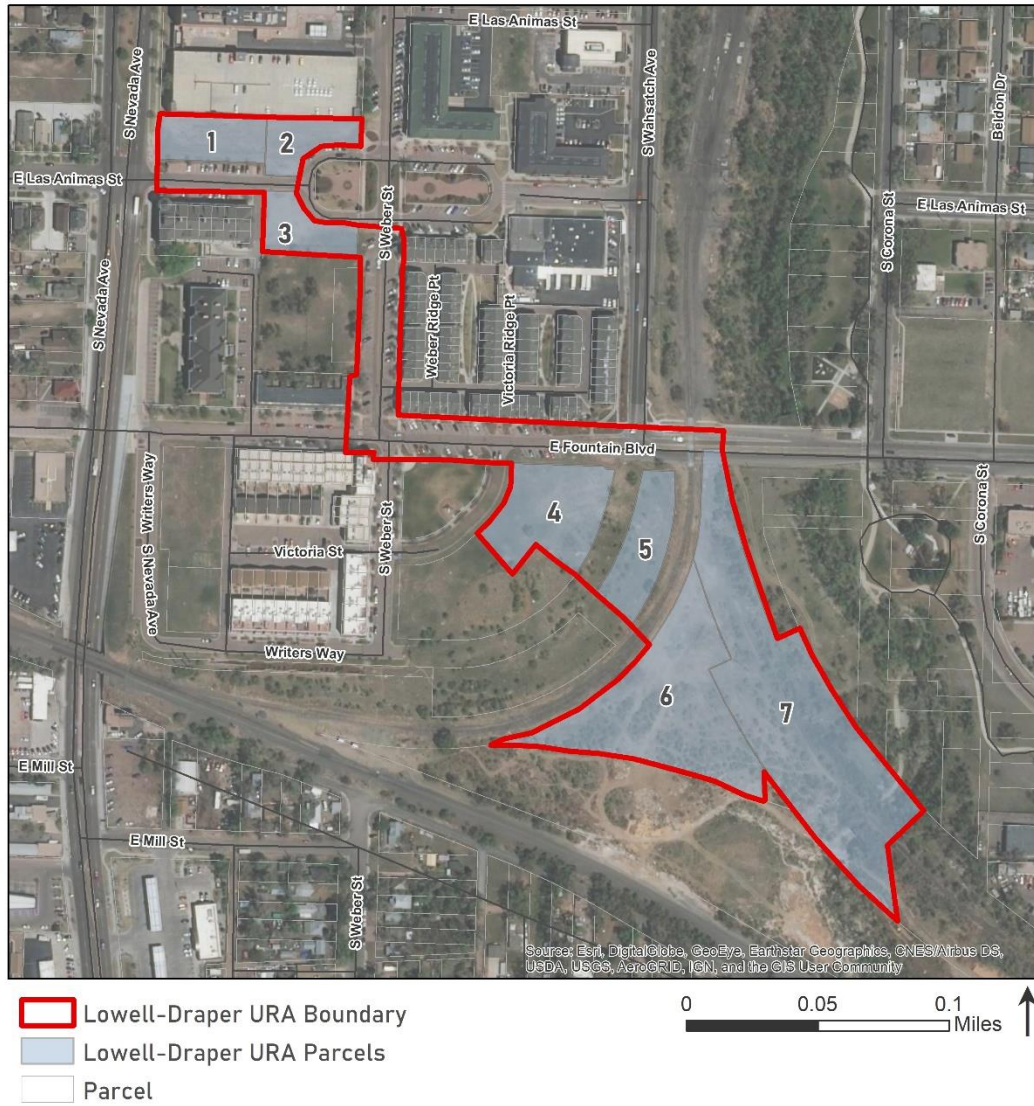
**Figure 1. Lowell-Draper Proposed URA Boundary and Parcels**

The proposed Lowell-Draper Urban Renewal Plan Area is comprised of seven parcels on approximately 7.26 acres of land and adjacent right of way (ROW), as shown in **Table 1** and **Figure 1**. All parcels are owned by Qof Lowell Commons LLC. Parcels 1 to 3 are located along East Las Animas Street with South Weber Street to the east and South Nevada Avenue to the west. Parcels 4 to 7 are located south of East Fountain Boulevard with South Corona Street to the east and South Weber Street to the west. All seven parcels are vacant and have no building improvements.

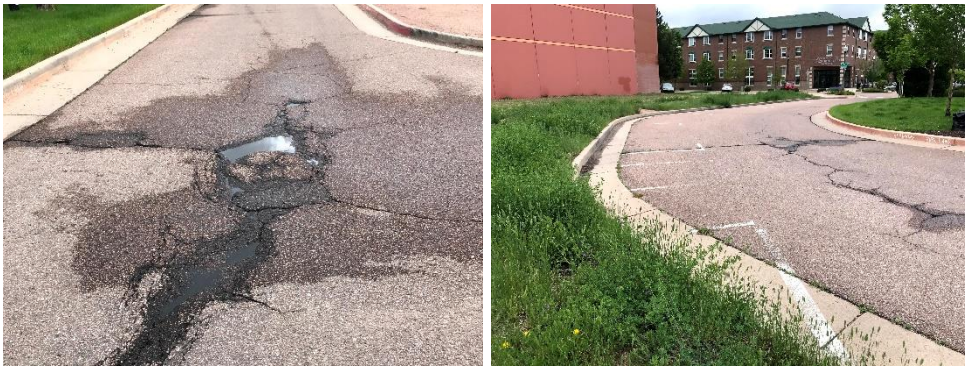
**Figure 2. Poor Provision of Street Improvements**

Along East Las Animas Street near parcels 1, 2, and 3 of the Study Area, poor provisions of the streets for vehicular traffic were observed in the form of large potholes and deteriorating pavement, shown in **Figure 2**. Throughout this portion of the Study Area, provisions of walkways for pedestrians were observed in the form of lack of sidewalks. In particular, parcel 3 has curb cuts but no paved sidewalk, shown in **Figure 3**. Additionally, there are no sidewalk or pedestrian improvements along parcels 4, 5, or 6 to connect to the existing pedestrian network on adjacent properties.

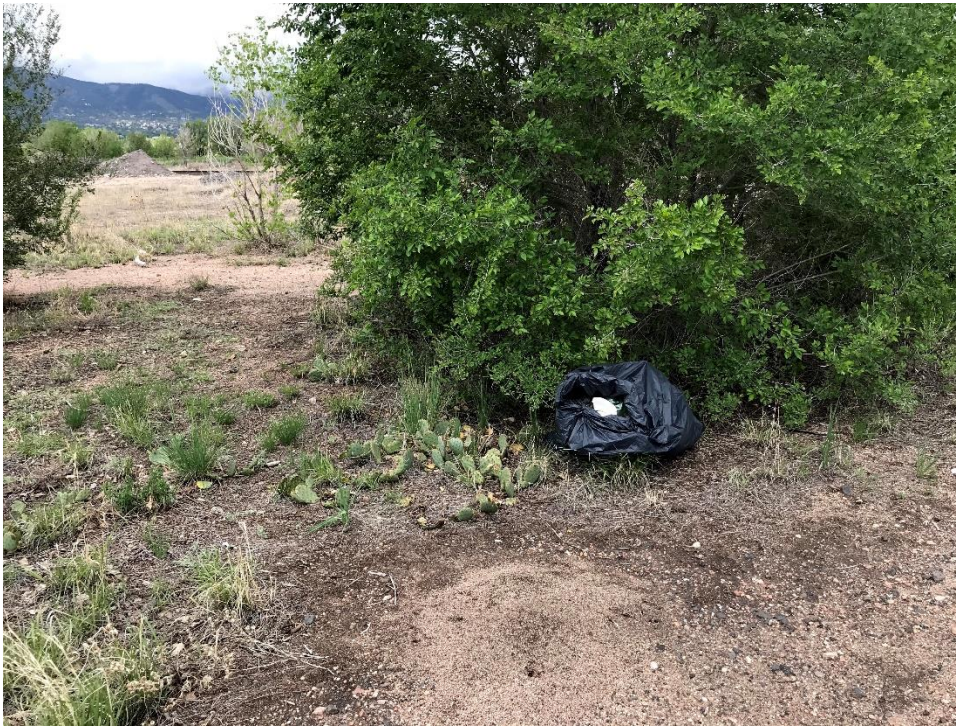
**Figure 4. Illegal Dumping**

Throughout the Study Area unsafe and unsanitary conditions were documented, including illegal dumping, litter, and evidence of vagrants. Illegal dumping was observed southeast of the railroad tracks, shown in **Figure 4**. Excessive litter was observed and documented throughout the properties and was especially apparent along East Fountain Boulevard, shown in **Figure 5**. There was evidence of vagrants on the property with a makeshift sleeping area shown in **Figure 6**. Additionally, using Google Earth imagery there were excessive homeless encampments throughout parcels 6 and 7, shown in **Figure 7**.

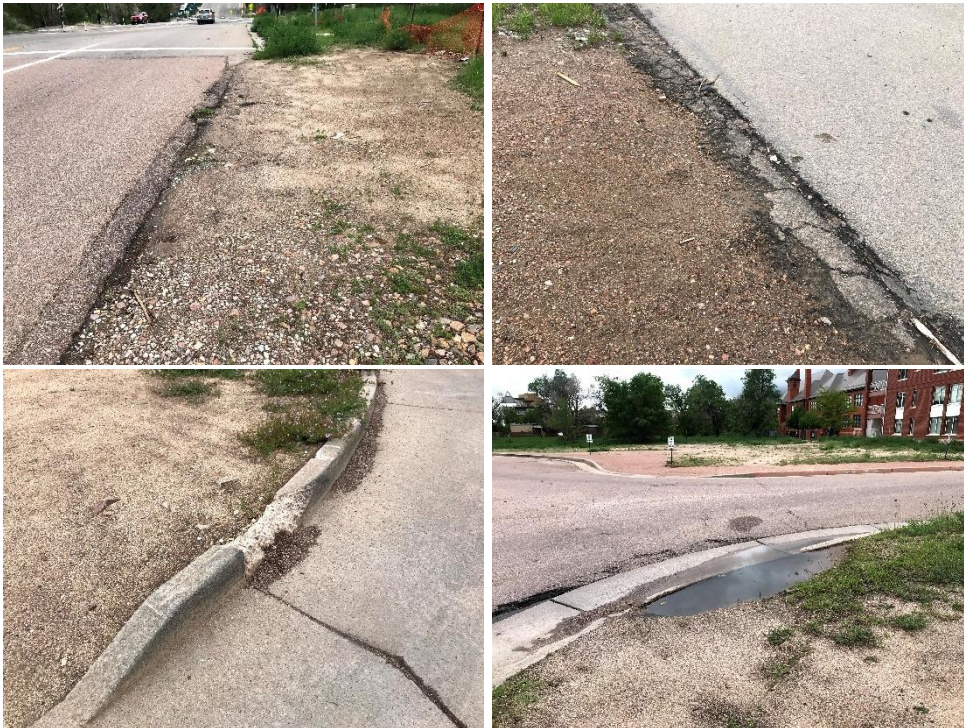
**Figure 8. Deteriorated Curbs**

There are very minimal site improvements on the properties. Of the improvements in place, deterioration of curbs was most apparent. This was observed for the parcels along East Fountain Boulevard as well as parcels along East Las Animas Street in the Study Area, shown in **Figure 8**. Overall, there was evidence that the properties have been neglected with little maintenance.

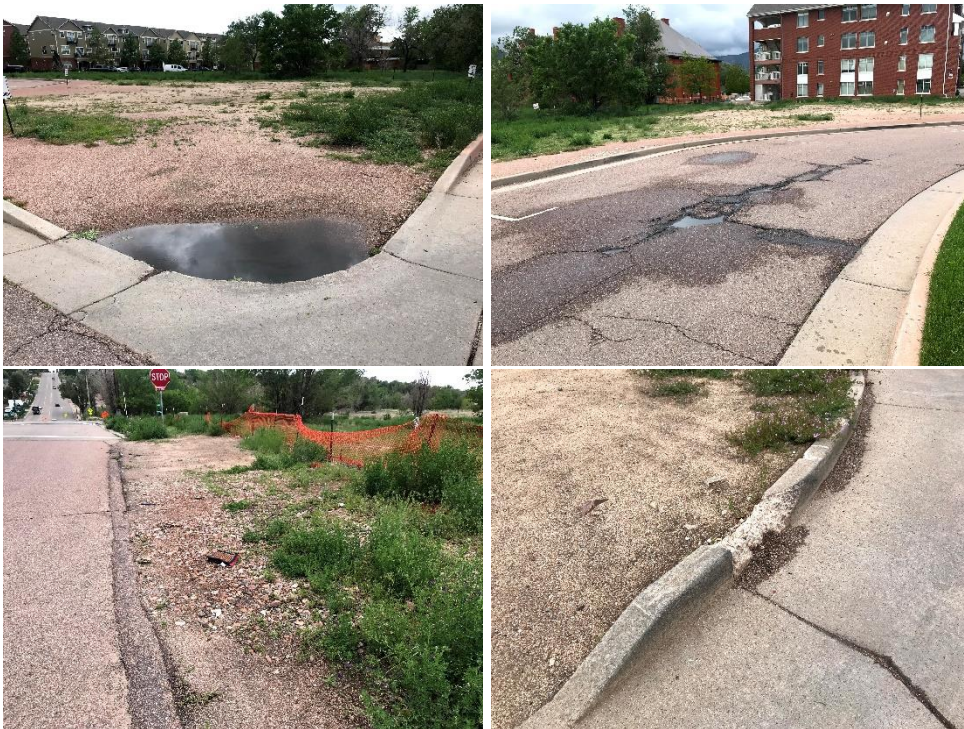
**Figure 9. Deteriorated Pavement and Curbs and Missing Sidewalks**

Inadequate infrastructure was observed throughout the Study Area, predominately in the form of deteriorated pavement, deteriorated or missing curbs, and missing sidewalks, shown in **Figure 9**. Additionally, unusual topography was observed in parcels 6 and 7 in the form of steep slopes, shown in **Figure 10**.

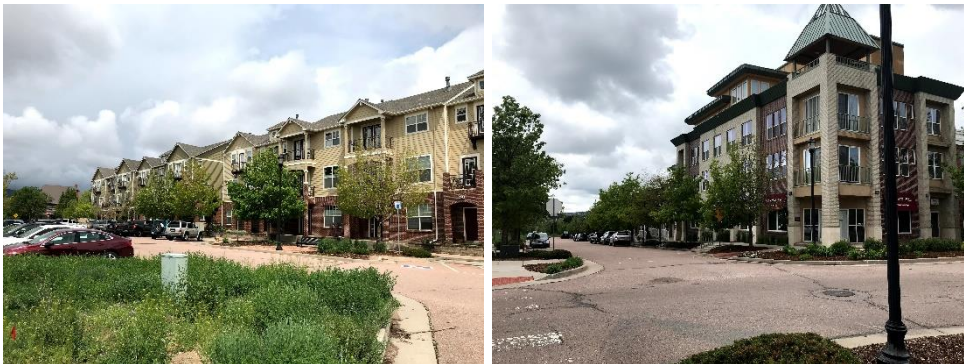
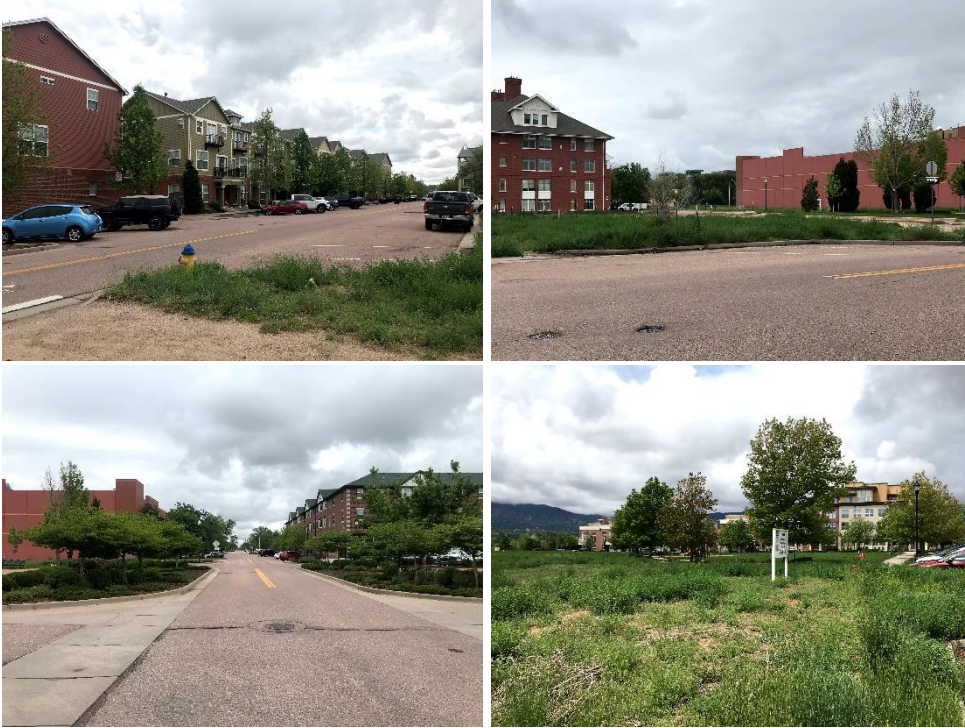
**Figure 11. Vacant Property in Generally Urbanized Area**

The entire 7.26-acre Study Area is vacant with no building improvements. The properties are surrounded by development, shown in **Figure 11**, with townhomes and a park along East Fountain Road and South Weber Street, Colorado Springs Police Department north of parcels 1 and 2, and various commercial properties and Shooks Run Trail east of parcel 7. Additionally, railroad tracks run through the Study Area between parcels 5, 6, and 7. There are multiple planned and proposed infill developments on parcels near the Study Area that will be market rate housing. This area southeast of downtown is very urban and the Study Area are one of the few remaining properties undeveloped.
