ODYSSEY AT NORTH WEBER EXISTING CONDITIONS SURVEY

FINAL REPORT

Prepared for:
Colorado Springs Urban Renewal Authority

May 30, 2025

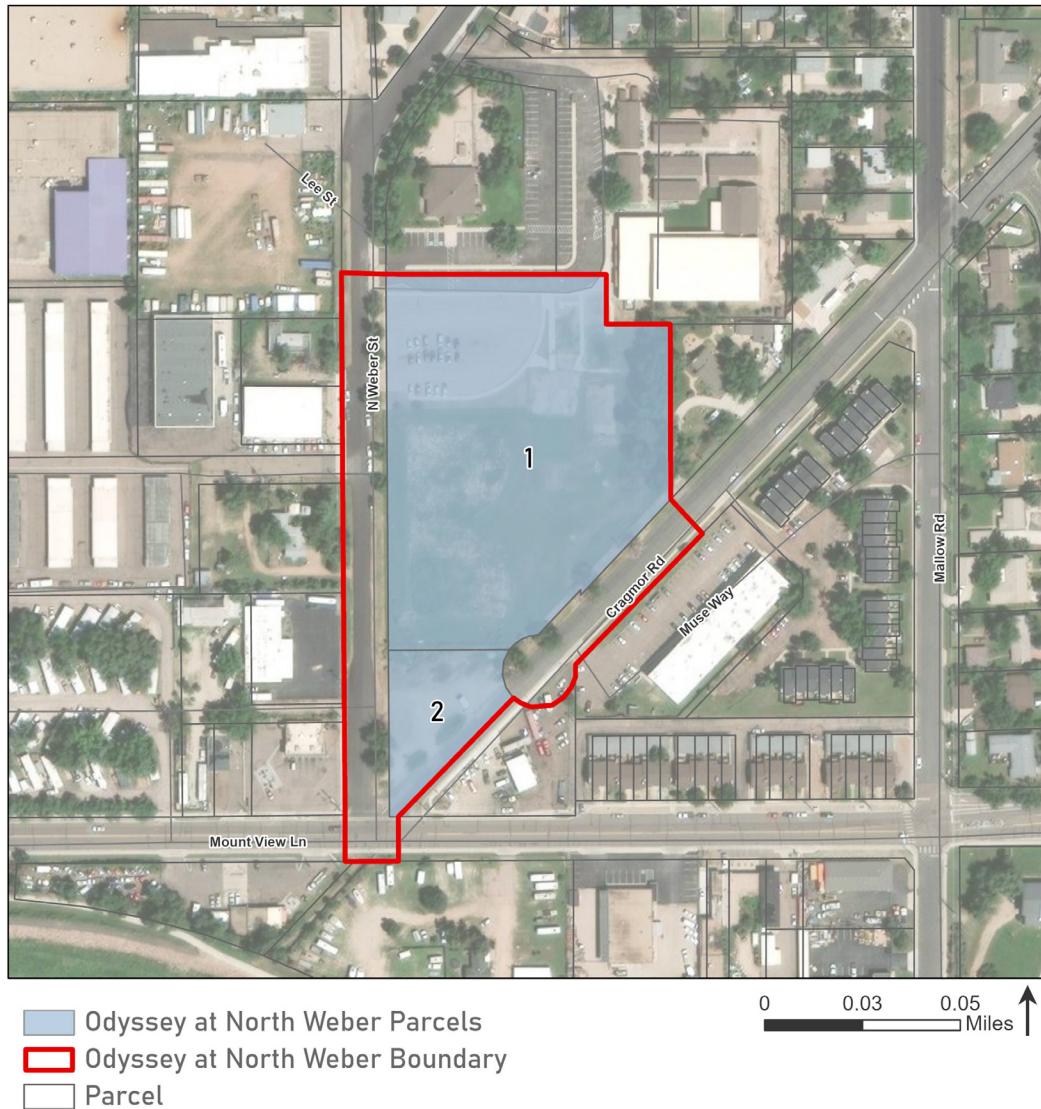
Figure 1. Odyssey at North Weber Proposed URA Boundary and Parcels

The proposed Odyssey at North Weber Urban Renewal Plan Area is comprised of two parcels on approximately 4.4 acres of land and adjacent right of way (ROW), as shown in **Table 1** and **Figure 1**. Both parcels are owned by Weber Investors LLC and are currently vacant. The office buildings with 3,628 square feet on parcel 1 were demolished. The demolition occurred after the El Paso County Assessor determined property assessments for the year and is therefore captured in the table below.

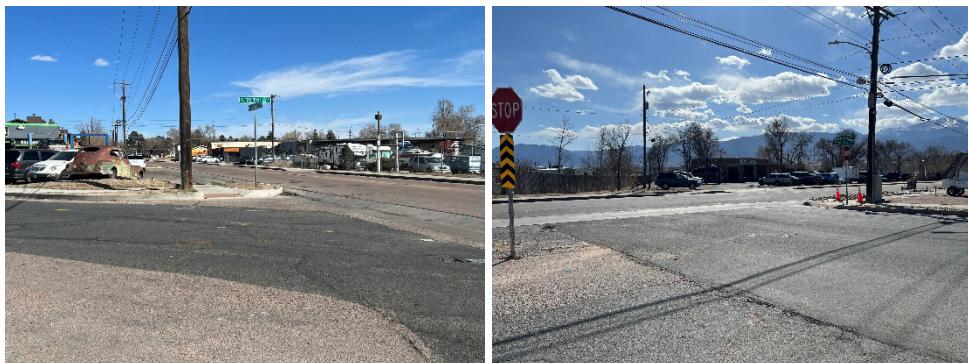
Figure 2. Poor Provision of Street Improvements

At the intersection of Mount View Lane, poor provisions of the streets for vehicular traffic and poor internal vehicular circulation were observed with the diagonal intersection of Cragmor Road that causes vehicular safety issues, shown in **Figure 2**. The angle of Cragmor Road that intersects Mount View Lane and North Weber Street creates an odd 4-way intersection with only stop signs at Cragmor Road and North Weber Street. This causes poor visibility that impacts traffic safety.

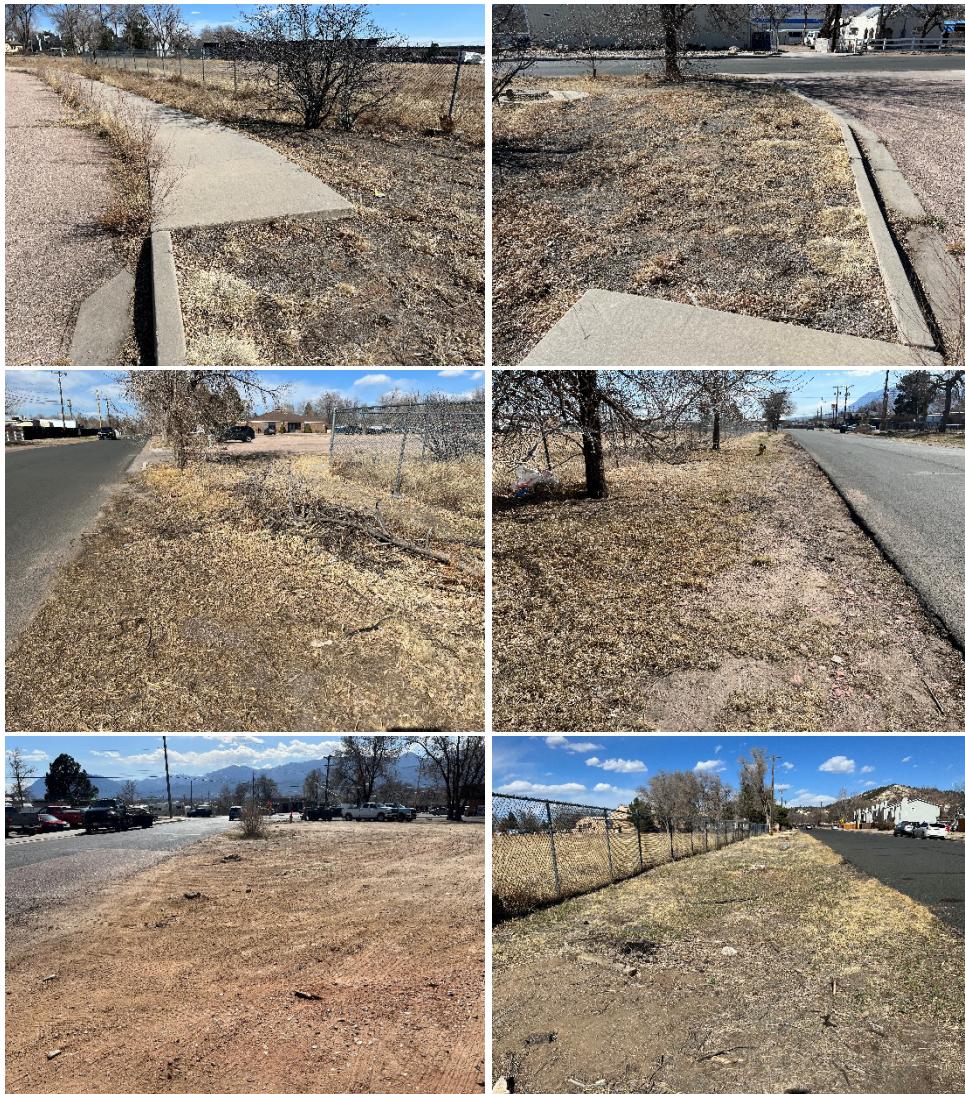
Figure 3. Lack of Sidewalks

Throughout most of the Study Area, provisions of walkways for pedestrians were observed in the form of a lack of sidewalks. In particular, the sidewalk at the north side of the Study Area along North Weber Street abruptly stops at the parking lot and creates a gap in the pedestrian network, shown in **Figure 3**. During the site visit pedestrians were observed walking along the side of North Weber Road due to the lack of sidewalks. Additionally, there are no sidewalks or pedestrian improvements along parcel 2 and on the east side of parcel 1.

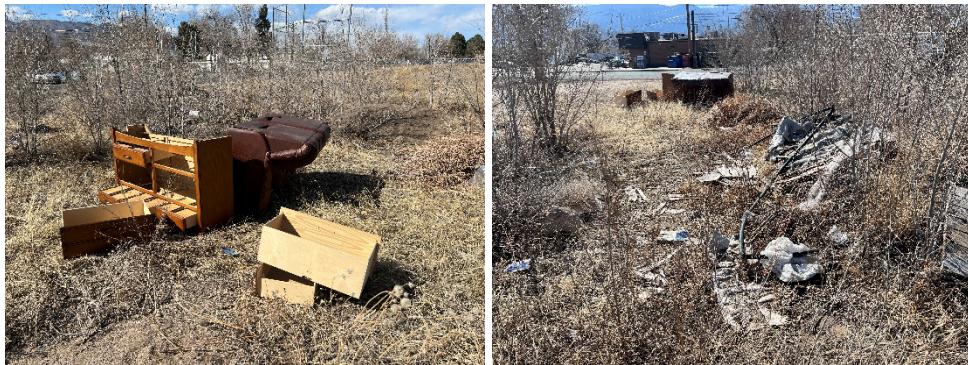
Figure 4. Illegal Dumping

Throughout the Study Area unsafe and unsanitary conditions were documented, including illegal dumping, excessive litter, and vandalism. Illegal dumping was observed on parcel 2 at the southern portion of the Study Area with old furniture in disrepair, shown in **Figure 4**. Excessive litter was observed and documented throughout the properties and was especially apparent on parcel 2, shown in **Figure 5**. This included general trash, drink containers, cardboard, plastic bags, a tire, and former building materials. There was evidence of vandalism in the Study Area, shown in **Figure 6**.

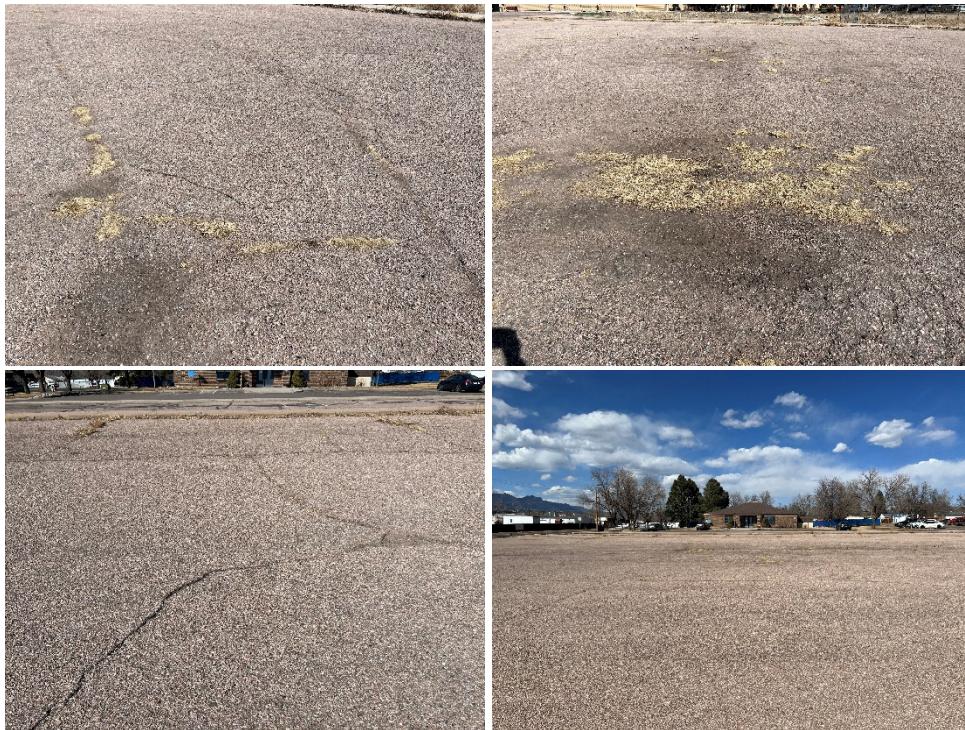
Figure 7. Deteriorated On-site Parking Surfaces

There are very minimal site improvements on the properties. Of the improvements in place, deterioration of parking surfaces and overgrown vegetation were observed. The parking lot on parcel 1 on the north side of the Study Area shows sign of deteration with cracked pavement and no lines/markings for designated spaces, shown in **Figure 7**. There was also edvidence of overgrown vegetation directly south of the existing parking lot, shown in **Figure 8**. Overall, there was evidence that the properties have been neglected with little maintenance.

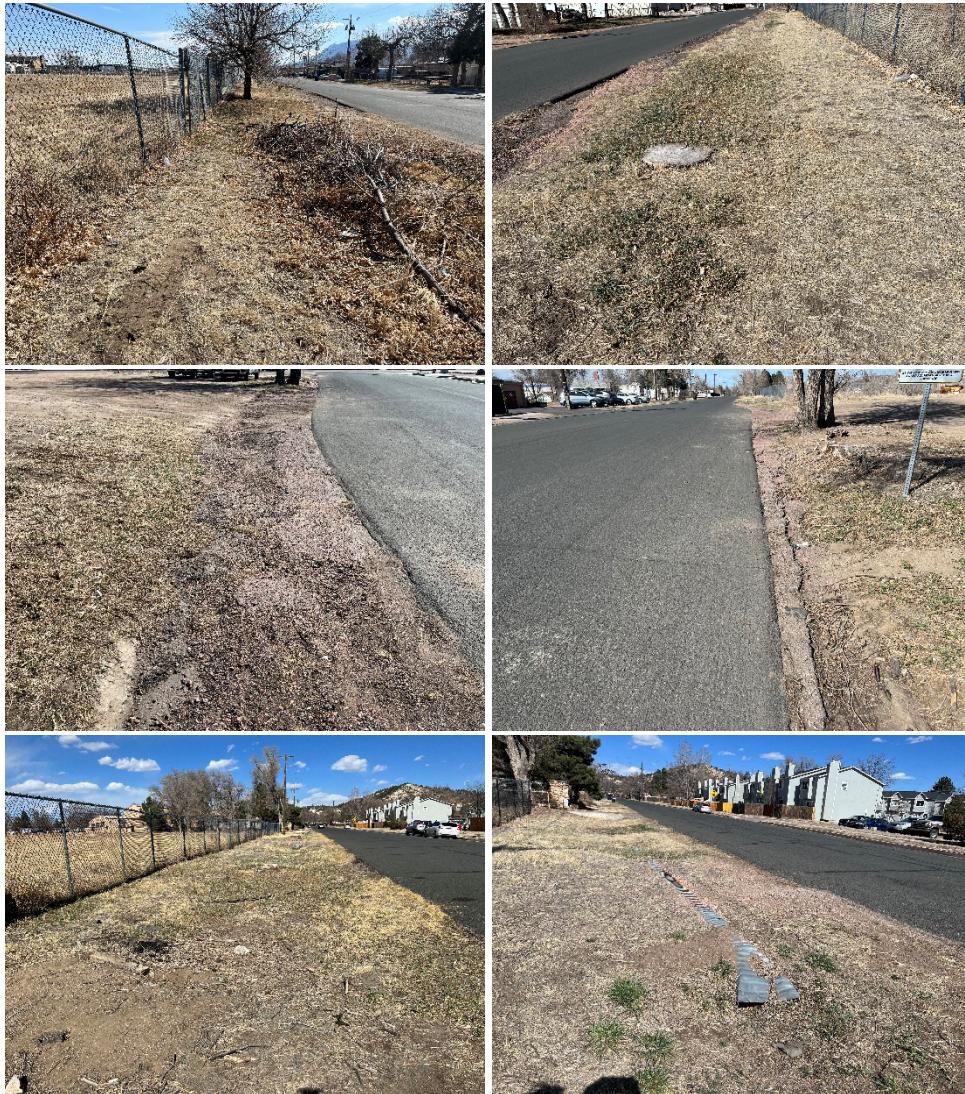
Figure 9. Lack of Curb, Gutter/Drainage, and Sidewalks

Inadequate infrastructure was observed throughout the Study Area, predominately in the form of missing curb, gutter/drainage, and sidewalks, shown in **Figure 9**. Additionally, overhead utilites were present along Cragmor Road, shown in **Figure 10**.

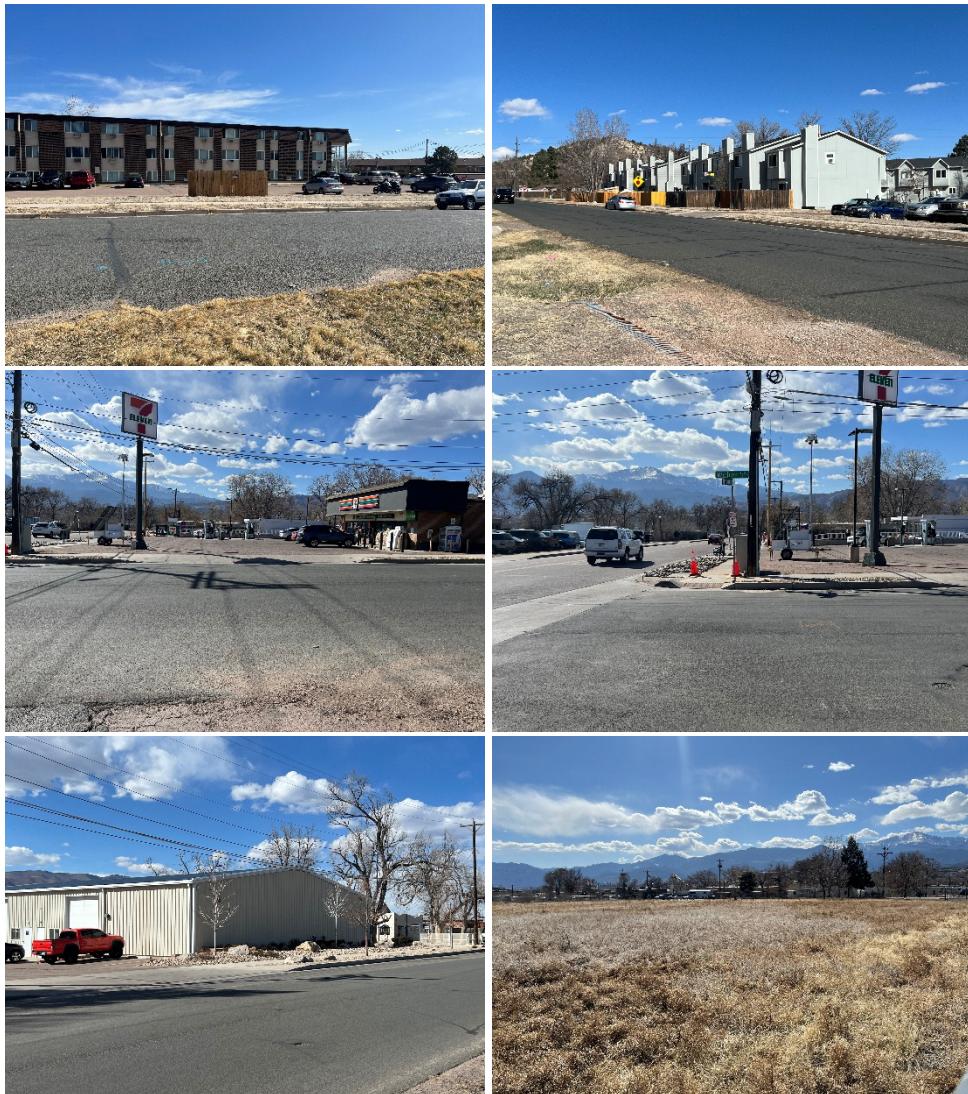
Figure 11. Vacant Property in Generally Urbanized Area

The entire 4.4-acre Study Area is vacant with no building improvements. The properties are surrounded by development, shown in **Figure 11**, with an education center directly north, Bruin Manor Apartments and an auto shop east, and 7-Eleven and other commercial properties west and south. This area in northern Colorado Springs near University of Colorado Colorado Springs is largely builtout and the Study Area is one of the few remaining sites undeveloped.
