MORENO AND CASCADE EXISTING CONDITIONS SURVEY

FINAL REPORT

Prepared for:
Colorado Springs Urban Renewal Authority

July 15, 2025

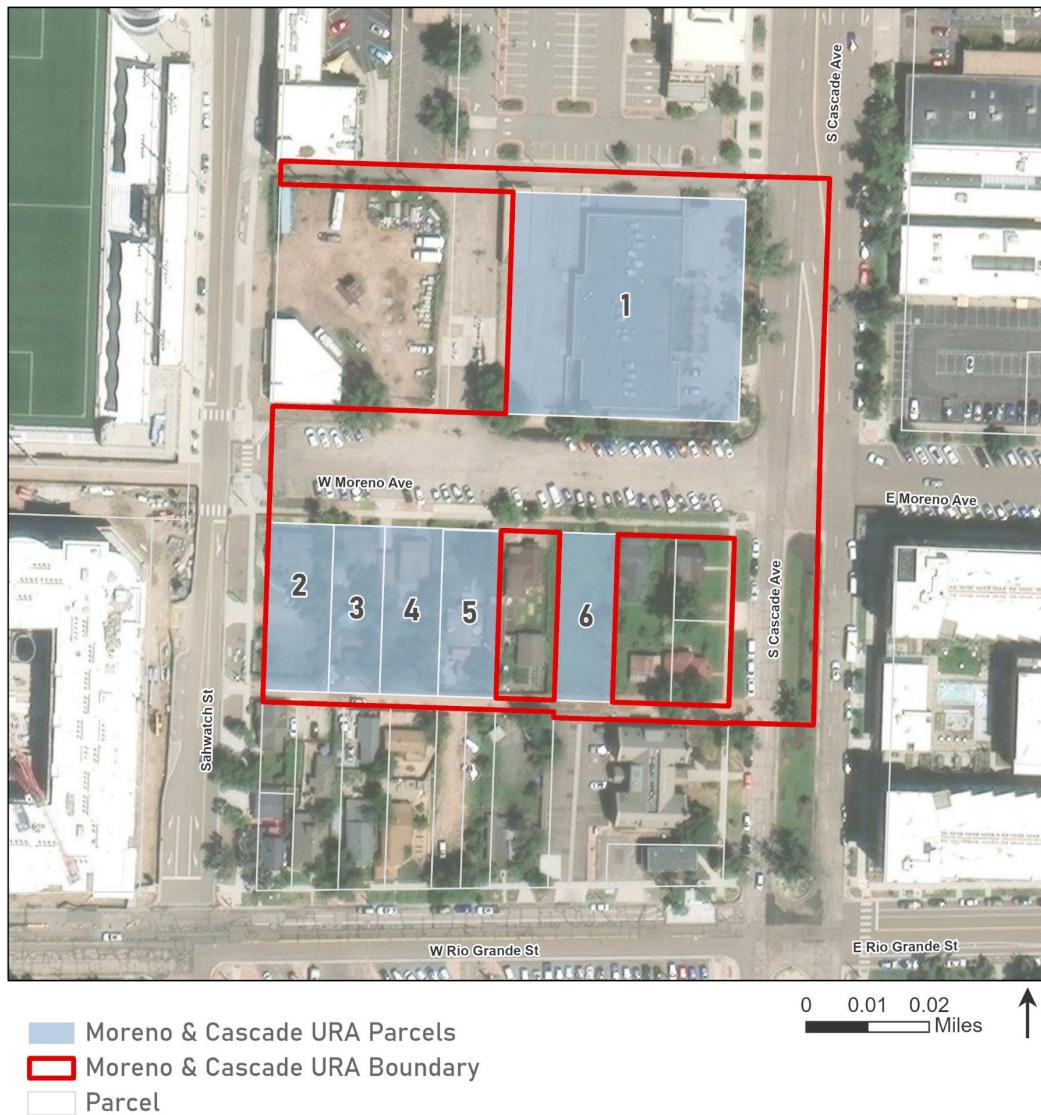
Figure 1. Moreno and Cascade Proposed URA Boundary and Parcels

The proposed Moreno and Cascade Urban Renewal Plan Area is comprised of six parcels on approximately 1.69 acres of land and adjacent right of way (ROW), as shown in **Table 1** and **Figure 1**. The ROW encompasses Moreno Avenue, Cascade Avenue, and alleys. The parcels are owned by DDJ No. 3 LLC and DDJ No. 1 LLC, which are the same ownership group. Parcel 1 includes a 13,300 square foot office building and 1,600 square foot storage garage, which are currently vacant. Parcels 2 to 5 are residential properties located south of Moreno Avenue, which include older, small single family homes, and Parcel 6 is a vacant residential lot.

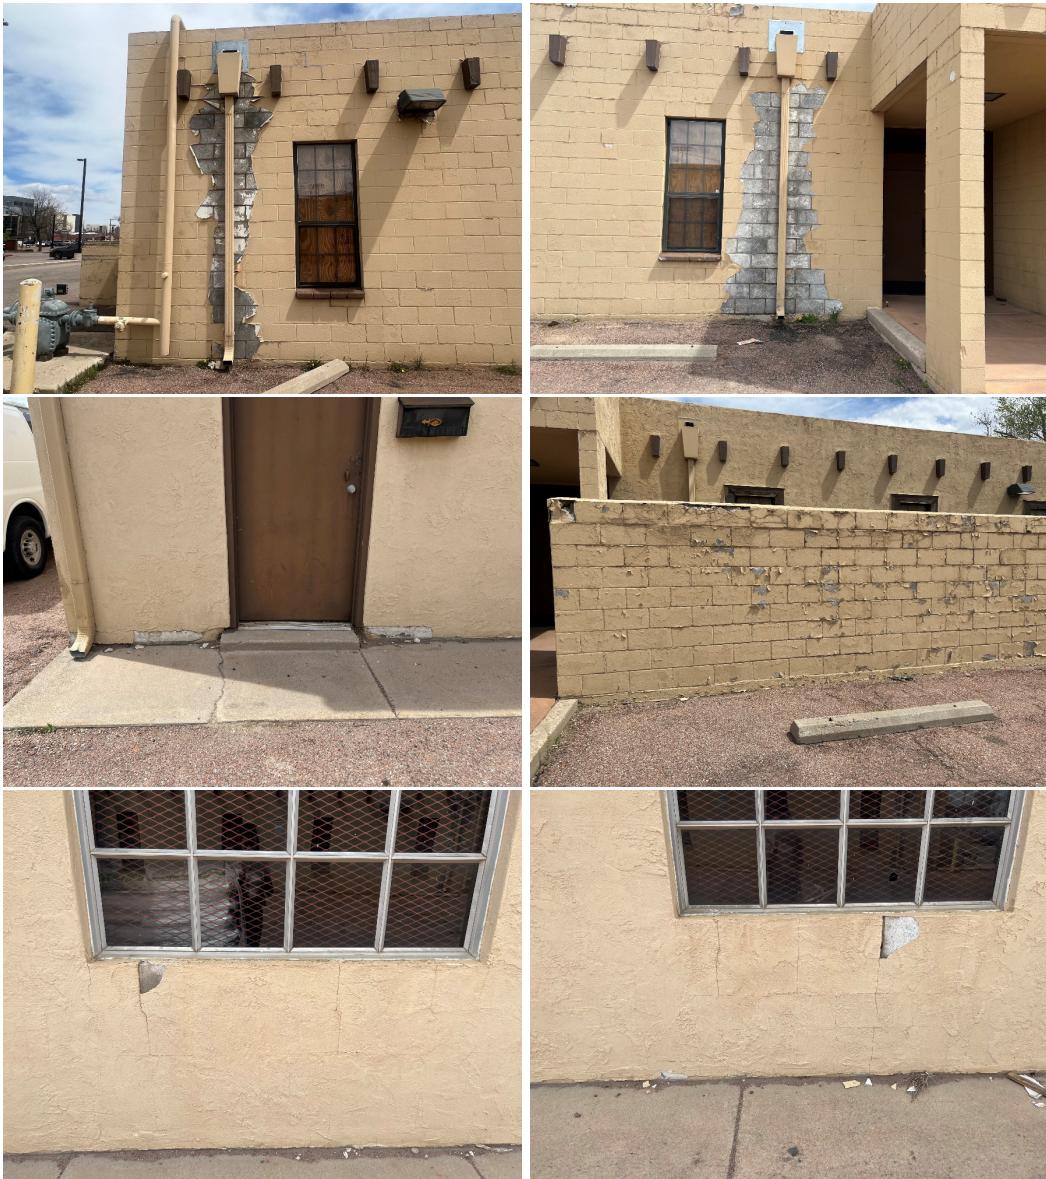
Figure 2. Deteriorated Exterior Finishes

Buildings in the Study area have deteriorated exterior finishes with peeling paint, exposed cinder block, and chipped and cracked exteriors around doors and windows, shown in **Figure 2**. One structure had the downspout removed and laying next to the building, shown in **Figure 3**.

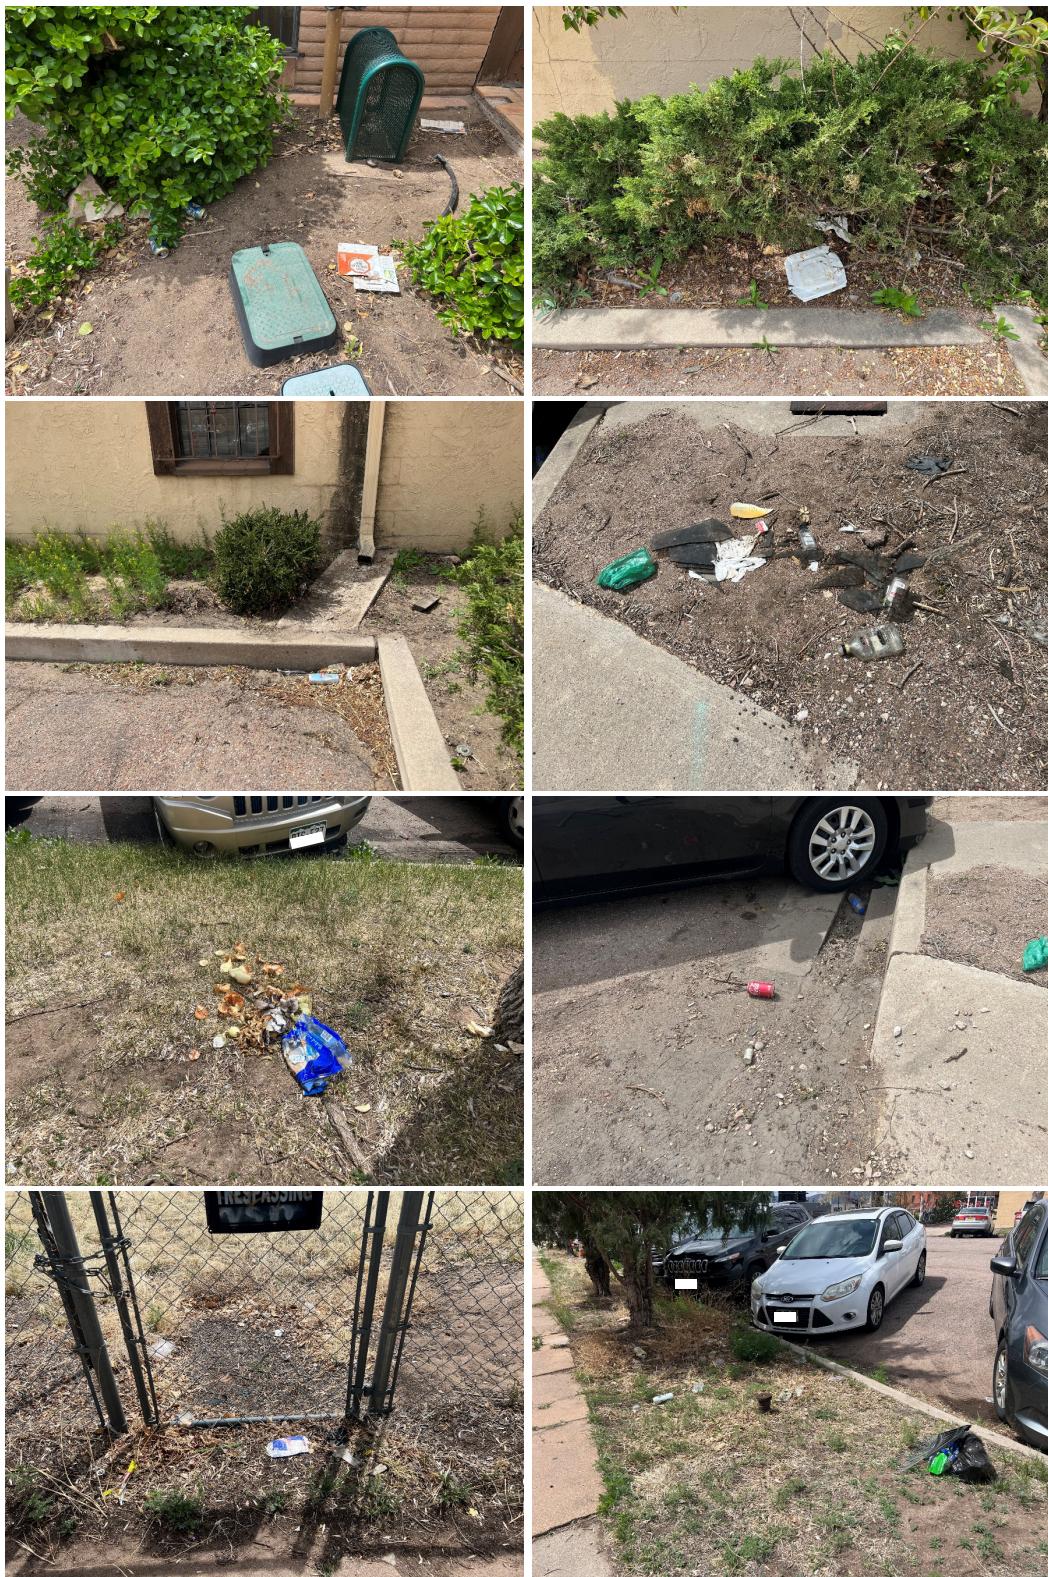
Figure 4. Excessive Litter

Throughout the Study Area unsafe and unsanitary conditions were documented, including excessive litter, vandalism, and vagrants. Additionally, cracked and uneven surfaces were observed along the sidewalk on the south side of Moreno Avenue. Excessive litter was observed and documented throughout the property and along Moreno Avenue, shown in **Figure 4**. This included general trash, drink containers, cardboard, plastic bags, takeout containers, and old food. There was evidence of vandalism and a vagrant in the Study Area, shown in **Figure 5**. Cracked and uneven sidewalks along Moreno Avenue are shown below in **Figure 6**.

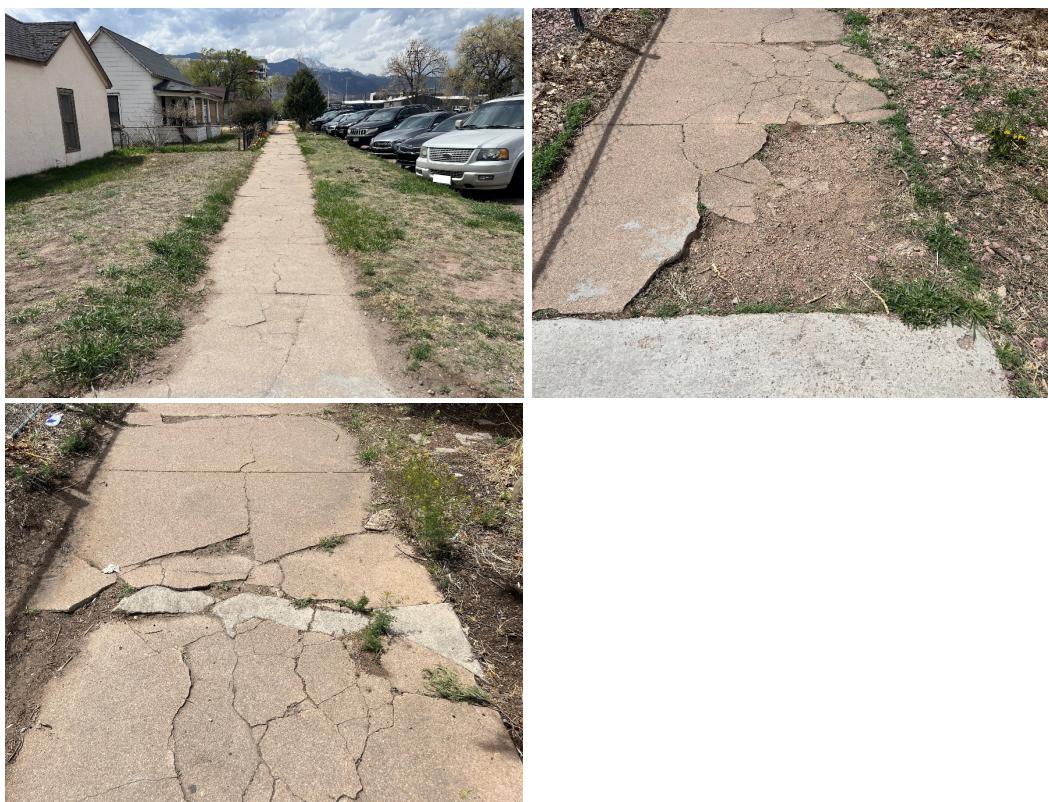
Figure 6. Cracked and Uneven Surfaces for Pedestrians

Deteriorated site improvements observed on Parcel 1, the old office building, include deteriorated signs (Figure 7), walls/pergola (Figure 8), and on-site parking surfaces (Figure 9). The sidewalk along Moreno Avenue adjacent to Parcels 2 to 6 was deteriorated as shown previously in Figure 6. In addition, overgrown vegetation was observed throughout the Study Area, shown in Figure 10.

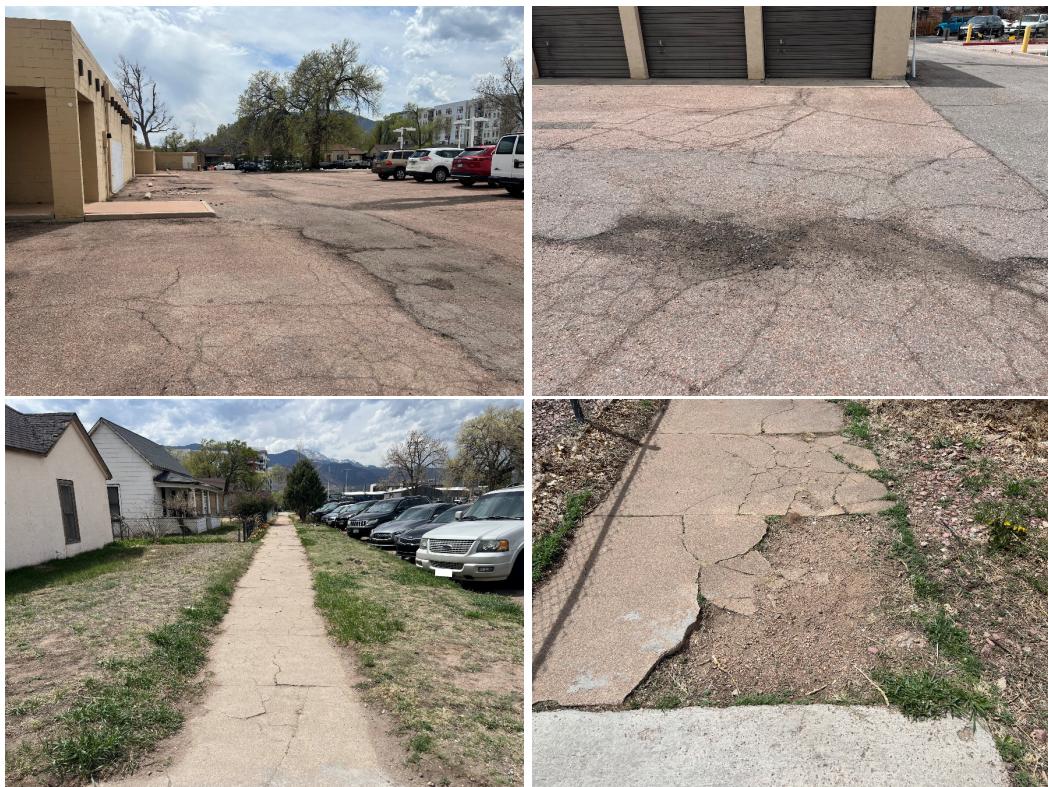
Figure 11. Deteriorated Pavement and Sidewalks

Inadequate infrastructure was observed throughout the Study Area, predominately in the form of deteriorated pavement and sidewalks, lack of pavement, and overhead utilites. Deteriorated pavement was observed in the alley behind Parcel 1 and in the office building parking lot, shown in **Figure 11**. As previously mentioned, there is deteriorated sidewalk along Moreno Street (**Figure 11**). The alley behind the residential properties (Parcels 2 to 6) south of Moreno Street is unpaved, shown in **Figure 12**. Additionally, overhead utilites were present in the alley behind Parcel 1 and along Sahwatch Street, shown in **Figure 13**.

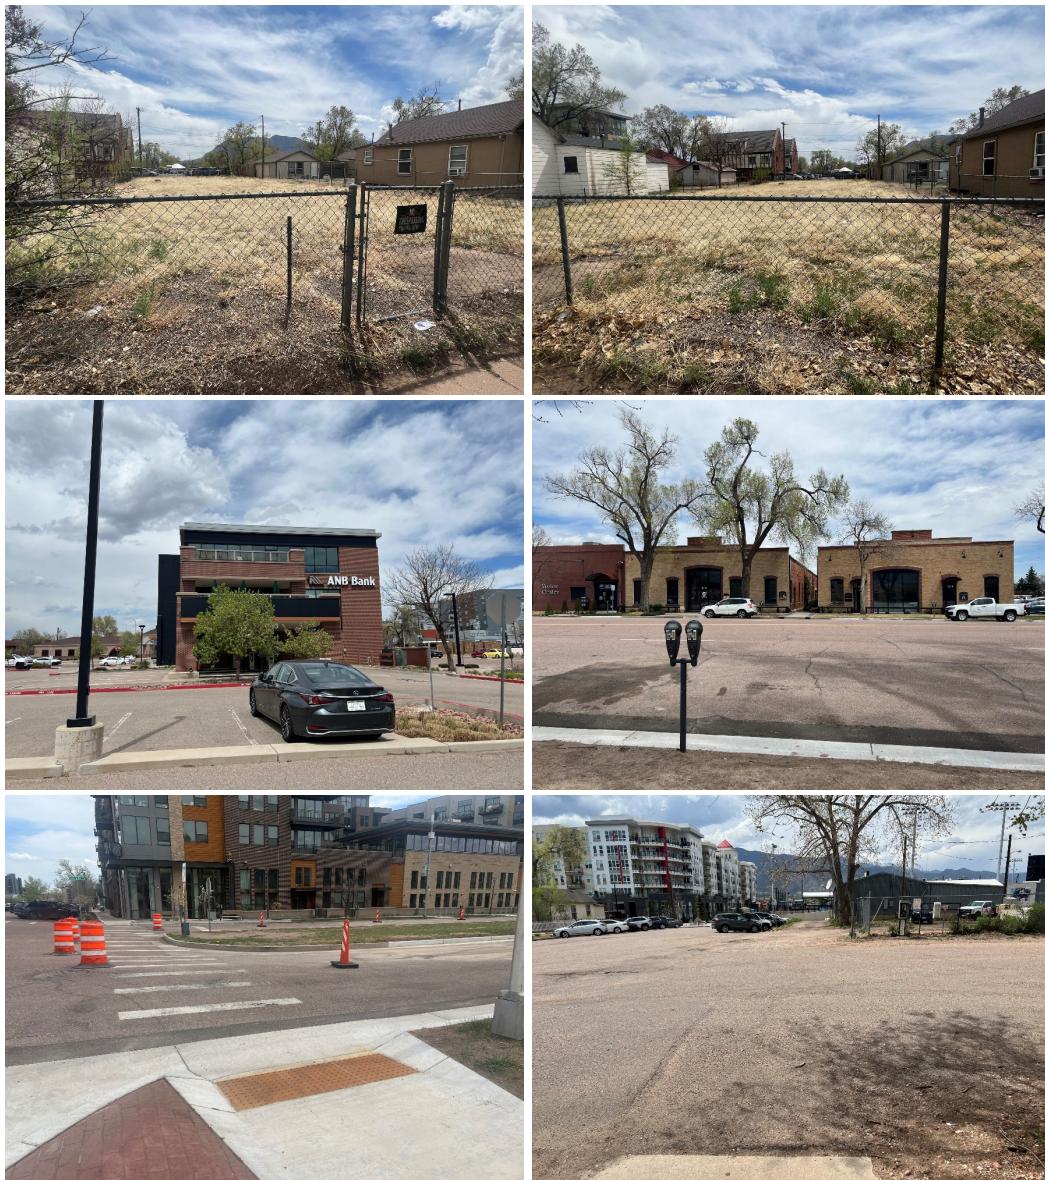
Figure 14. Undeveloped and Underdeveloped Property in Generally Urbanized Area

The Study Area is located in Downtown Colorado Springs and is surrounded by urban development, as shown in **Figure 14** a bank directly north, high-rise apartments to the west and east, additional office and retail in the Trolley Block to the east, and Weidner Field to the west. Parcel 6 is undeveloped and the remaining parcels in the Study Area are underdeveloped compared to the development opportunities available in the urban core of the community. Additionally, the office building on Parcel 1 is currently vacant, shown in **Figure 15**.
