Final Report

Bristow-Lowell Existing Conditions Survey

City of Colorado Springs Urban Renewal Authority

Economic & Planning Systems, Inc.

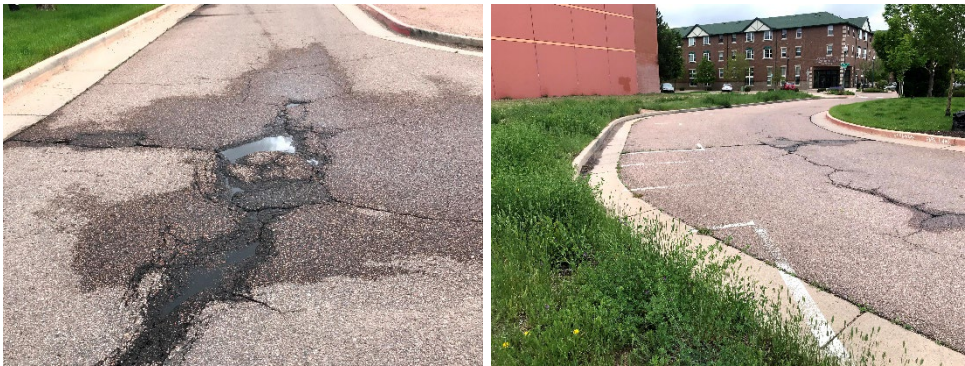
Figure 2. Poor Provision of Street Improvements

Along East Las Animas Street near parcels 1, 2, and 3 of the Study Area, poor provisions of the streets for vehicular traffic were observed in the form of large potholes and deteriorating pavement, shown in **Figure 2**. Throughout this portion of the Study Area, provisions of walkways for pedestrians were observed in the form of lack of sidewalks. In particular, parcel 3 has curb cuts but no paved sidewalk, shown in **Figure 3**. Additionally, there are no sidewalk or pedestrian improvements along parcels 4, 5, or 6 to connect to the existing pedestrian network on adjacent properties.

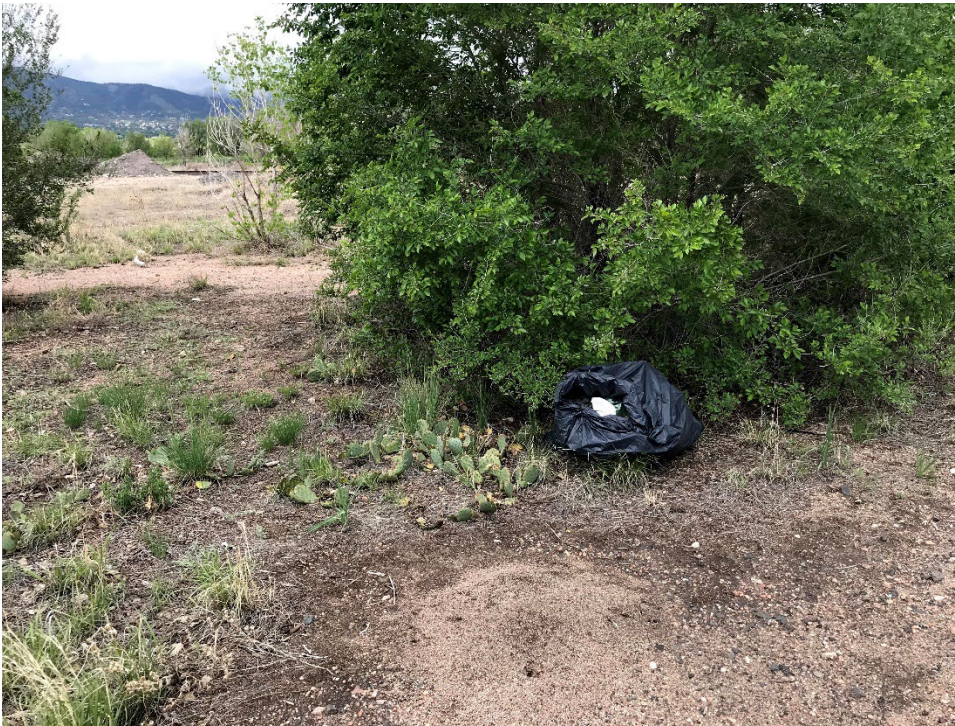
Figure 4. Illegal Dumping

Throughout the Study Area unsafe and unsanitary conditions were documented, including illegal dumping, litter, and evidence of vagrants. Illegal dumping was observed southeast of the railroad tracks, shown in **Figure 4**. Excessive litter was observed and documented throughout the properties and was especially apparent along East Fountain Boulevard, shown in **Figure 5**. There was evidence of vagrants on the property with a makeshift sleeping area shown in **Figure 6**. Additionally, using Google Earth imagery there were excessive homeless encampments throughout parcels 6 and 7, shown in **Figure 7**.

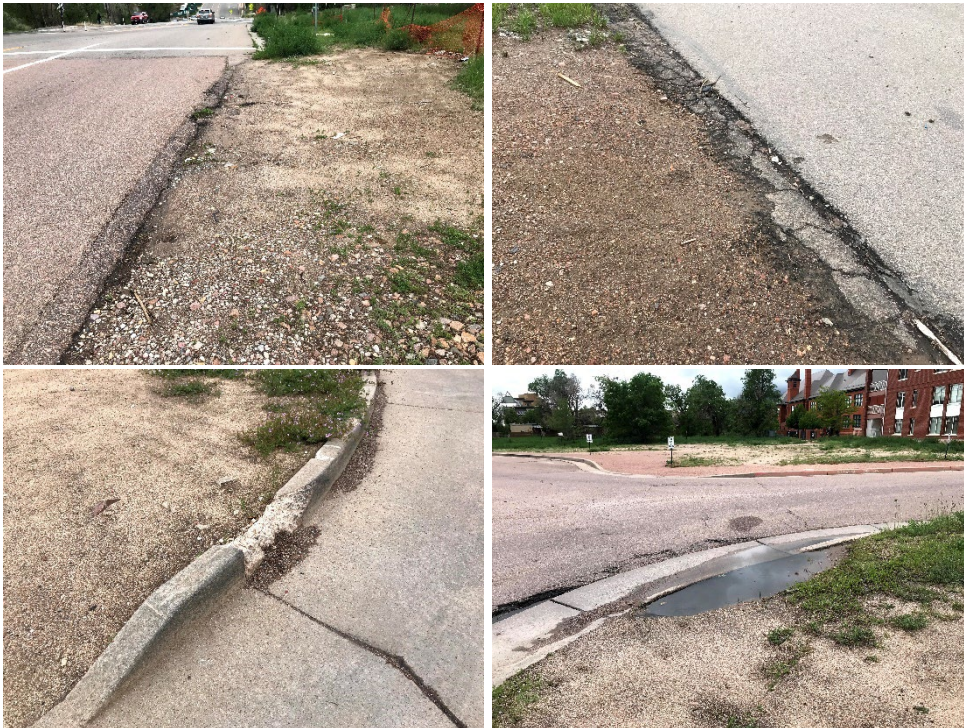
Figure 8. Deteriorated Curbs

There are very minimal site improvements on the properties. Of the improvements in place, deterioration of curbs was most apparent. This was observed for the parcels along East Fountain Boulevard as well as parcels along East Las Animas Street in the Study Area, shown in **Figure 8**. Overall, there was evidence that the properties have been neglected with little maintenance.

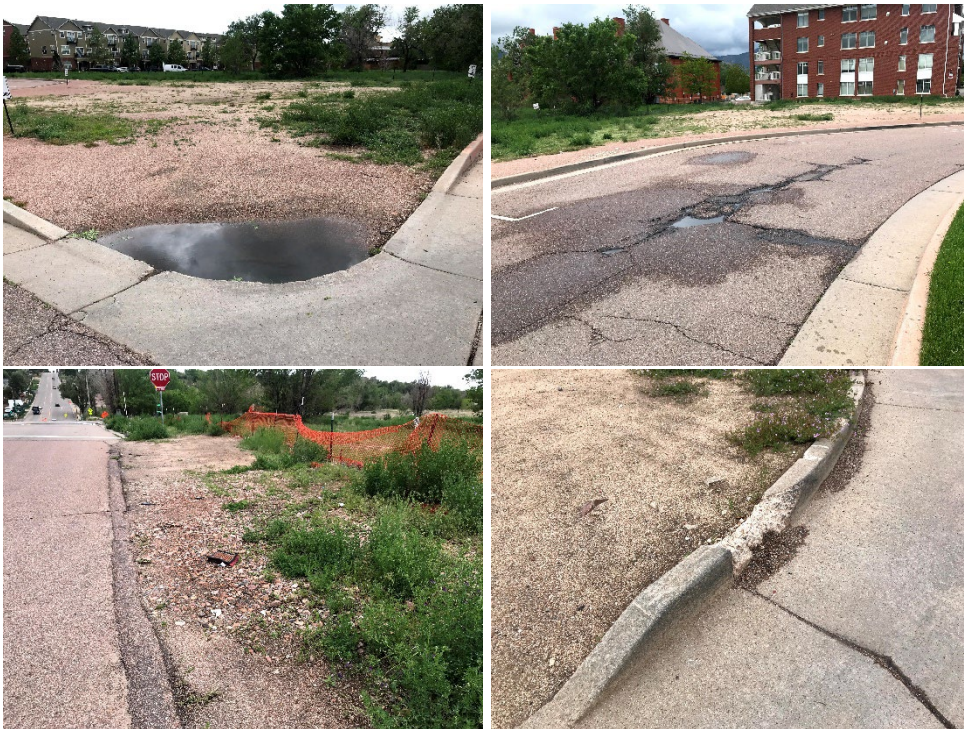
Figure 9. Deteriorated Pavement and Curbs and Missing Sidewalks

Inadequate infrastructure was observed throughout the Study Area, predominately in the form of deteriorated pavement, deteriorated or missing curbs, and missing sidewalks, shown in **Figure 9**. Additionally, unusual topography was observed in parcels 6 and 7 in the form of steep slopes, shown in **Figure 10**.

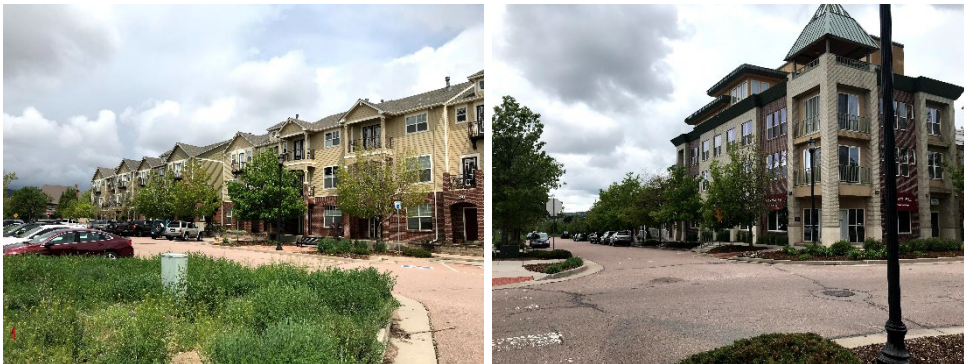
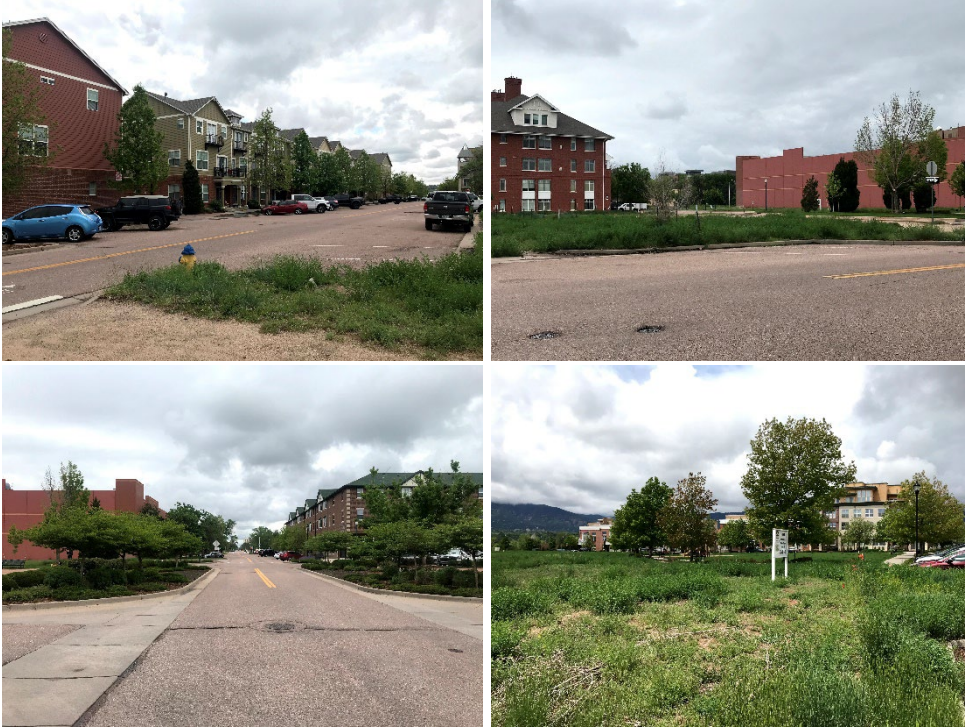
Figure 11. Vacant Property in Generally Urbanized Area

The entire 7.26-acre Study Area is vacant with no building improvements. The properties are surrounded by development, shown in **Figure 11**, with townhomes and a park along East Fountain Road and South Weber Street, Colorado Springs Police Department north of parcels 1 and 2, and various commercial properties and Shooks Run Trail east of parcel 7. Additionally, railroad tracks run through the Study Area between parcels 5, 6, and 7. There are multiple planned and proposed infill developments on parcels near the Study Area that will be market rate housing. This area southeast of downtown is very urban and the Study Area are one of the few remaining properties undeveloped.

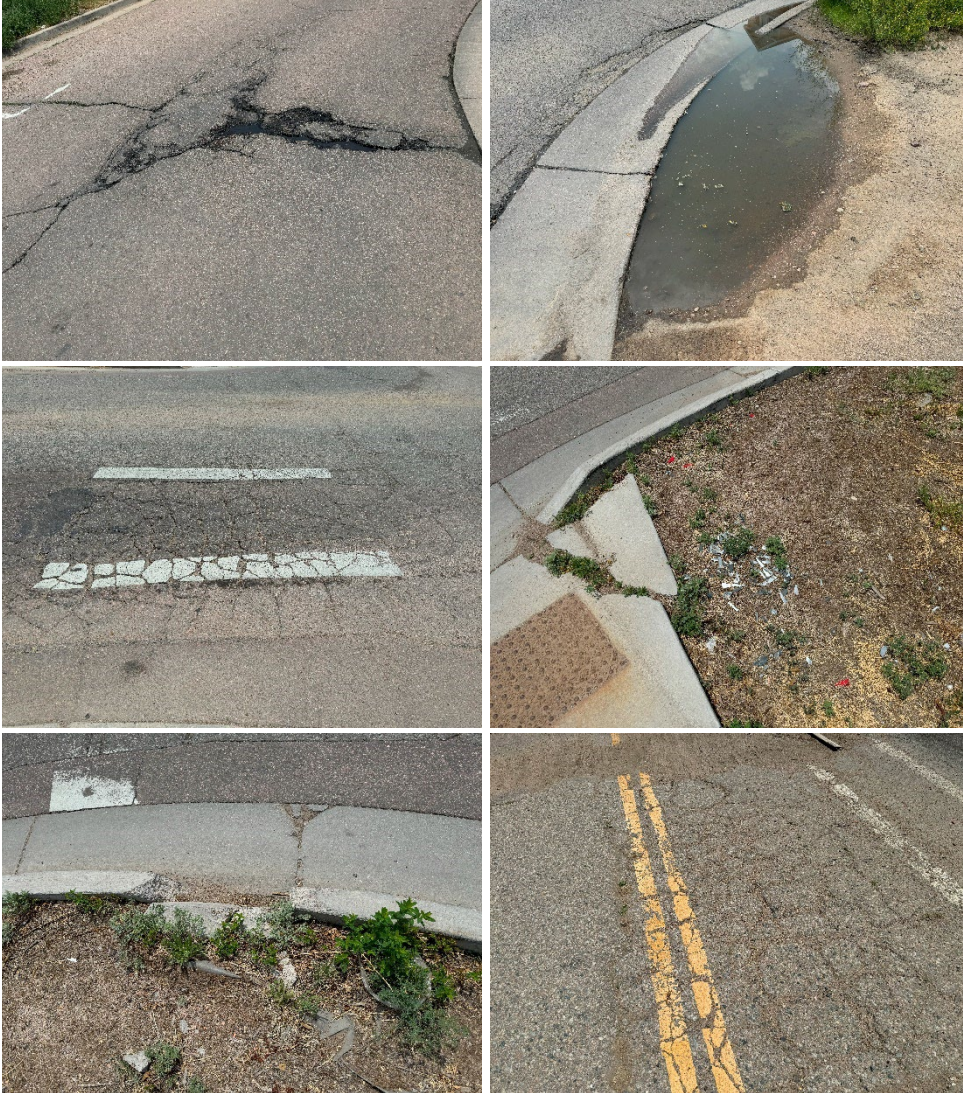
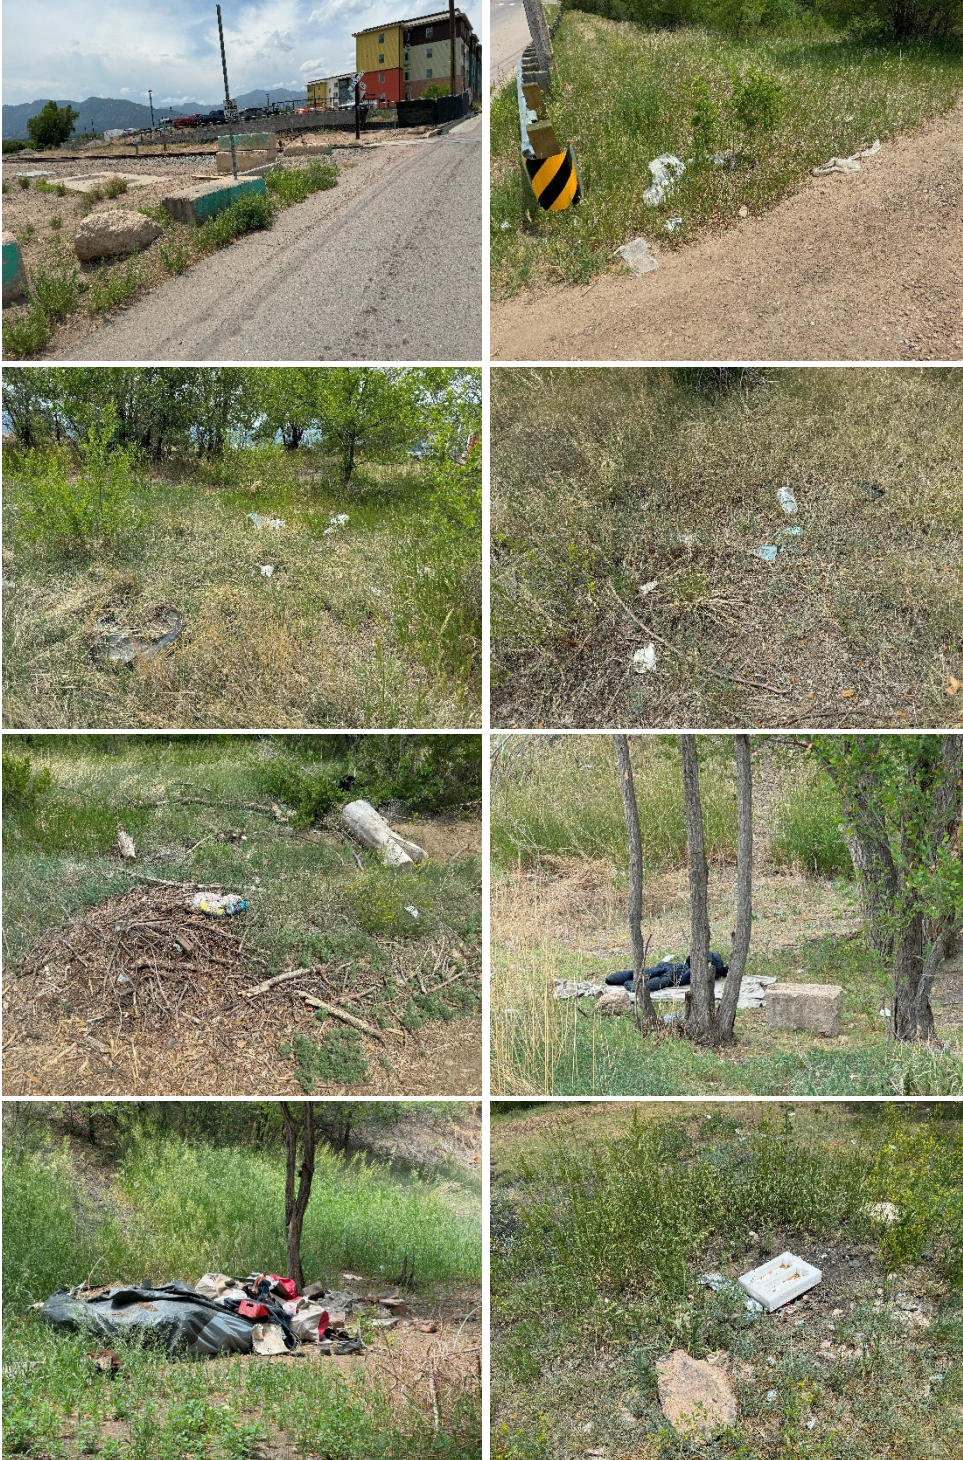
The following photos are from a site visit in June 2024 to confirm the findings of blight observed in May 2021 are still present.
