# ODYSSEY AT NORTH WEBER EXISTING CONDITIONS SURVEY

DRAFT REPORT	
Prepared for: Colorado Springs Urban Renewal Authority	Prepared by: Economic & Planning Systems, Inc.
	———— May 30, 2025

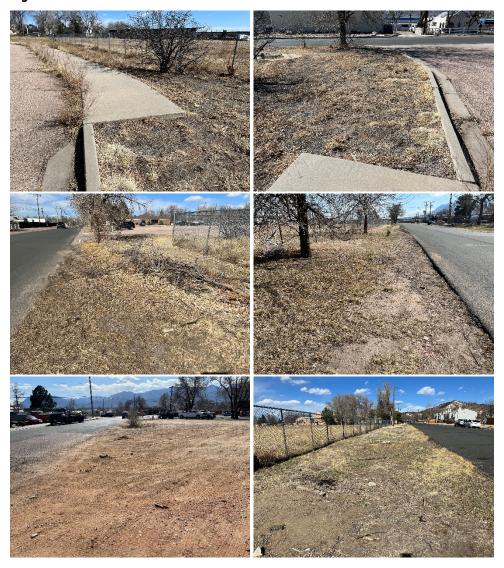
Figure 3. Lack of Sidewalks

Throughout most of the Study Area, provisions of walkways for pedestrians were observed in the form of a lack of sidewalks. In particular, the sidewalk at the north side of the Study Area along North Weber Street abruptly stops at the parking lot and creates a gap in the pedestrian network, shown in **Figure 3**. During the site visit pedestrians were observed walking along the side of North Weber Road due to the lack of sidewalks. Additionally, there are no sidewalks or pedestrian improvements along parcel 2 and on the east side of parcel 1.

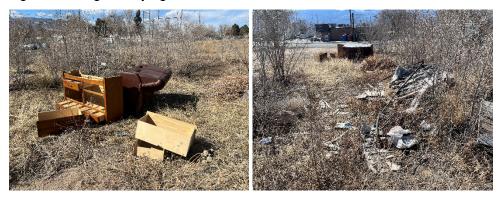
Figure 5. Excessive Litter

Throughout the Study Area unsafe and unsanitary conditions were documented, including illegal dumping, excessive litter, and vandalism. Illegal dumping was observed on parcel 2 at the southern portion of the Study Area with old furniture in disrepair, shown in **Figure 4**. Excessive litter was observed and documented thoughout the properties and was especially apparent on parcel 2, shown in **Figure 5**. This included general trash, drink containers, cardboard, plastic bags, a tire, and former building materials. There was evidence of vandalism in the Study Area, shown in **Figure 6**.

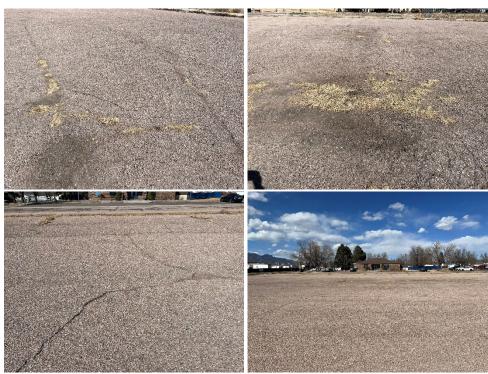
Figure 7. Deteriorated On-site Parking Surfaces

There are very minimal site improvements on the properties. Of the improvements in place, deterioration of parking surfaces and overgrown vegetation were observed. The parking lot on parcel 1 on the north side of the Study Area shows sign of deteration with cracked pavement and no lines/markings for designated spaces, shown in **Figure 7**. There was also edvidence of overgrown vegetation directly south of the existing parking lot, shown in **Figure 8**. Overall, there was evidence that the properties have been neglected with little maintenance.

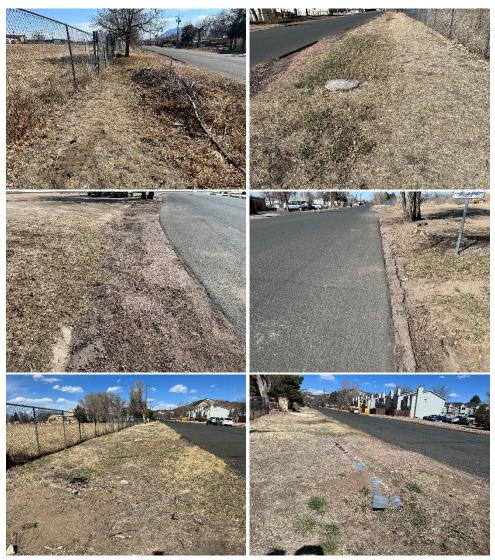
Figure 10. Presence of Overhead Utilities

Inadequate infrastructure was observed throughout the Study Area, predominately in the form of missing curb, gutter/drainage, and sidewalks, shown in **Figure 9**. Additionally, overhead utilites were present along Cragmor Road, shown in **Figure 10**.

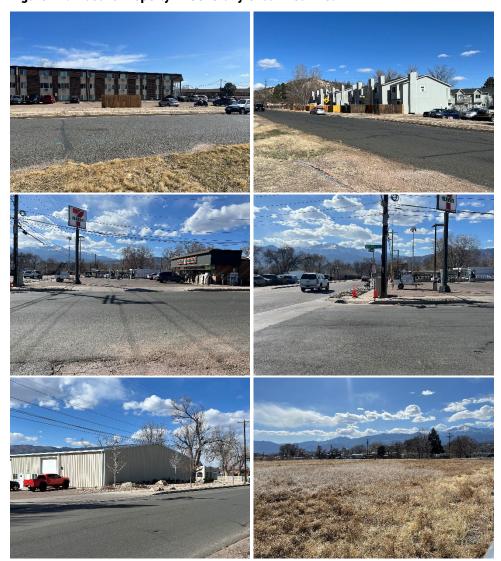
Figure 11. Vacant Property in Generally Urbanized Area

The entire 4.4-acre Study Area is vacant with no builing improvements. The properties are surrounded by development, shown in **Figure 11**, with an education center directly north, Bruin Manor Apartments and an auto shop east, and 7-Eleven and other commercial properties west and south. This area in northern Colorado Springs near University of Colorado Colorado Springs is largely builtout and the Study Area is one of the few remaining sites undeveloped.
