# Hofstead Slide, 1999

# Geologic Risks

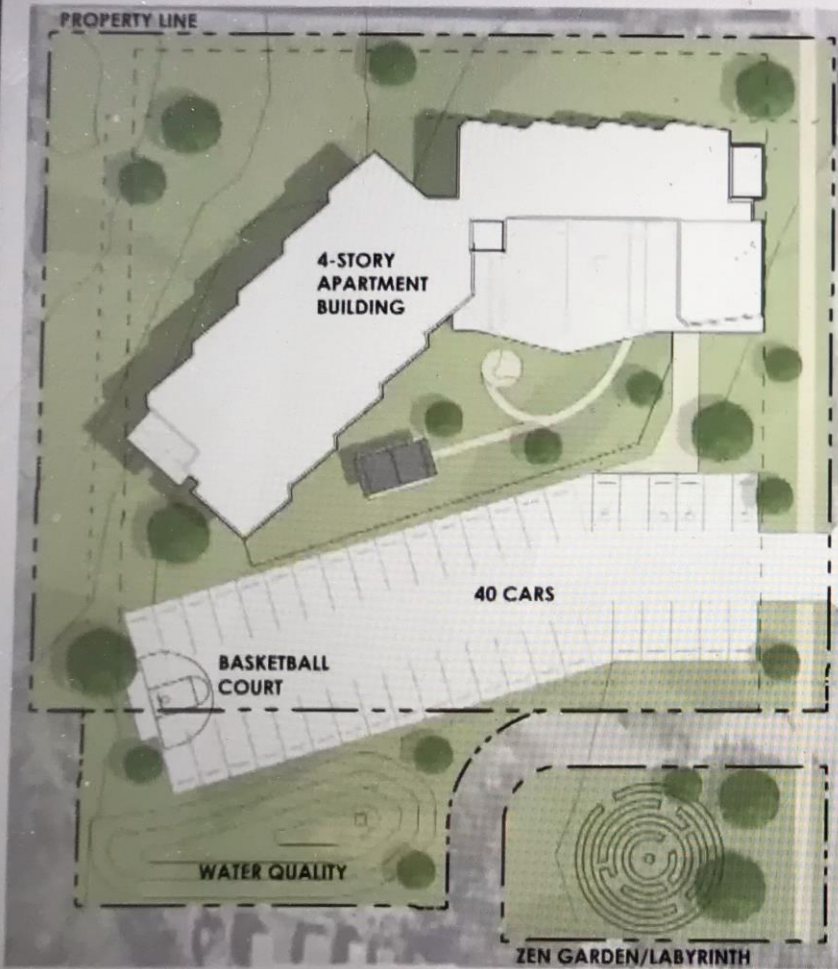
Initial Site Plan included in submittal to CHFA

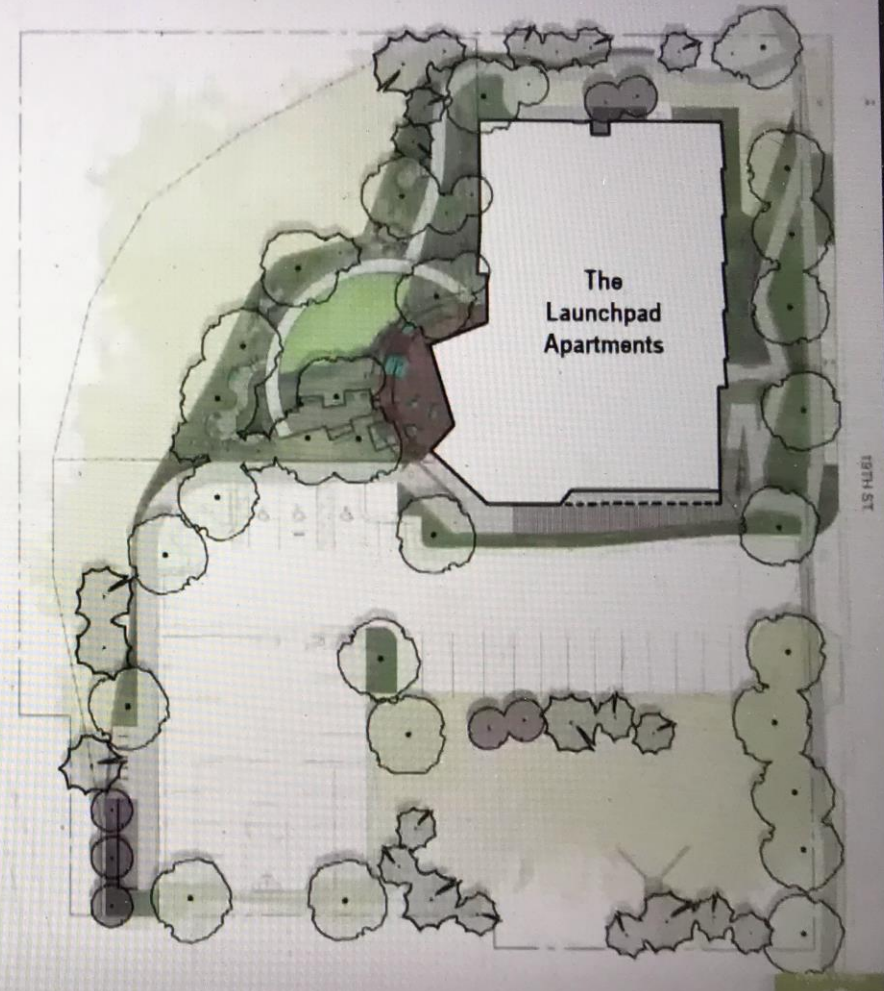
Revised Plan as submitted to the City, which addresses recommendations of Geohazard Report
