APPLICATION FOR VOLUNTARY CLEAN-UP

Remediation of
Existing Abandoned Landfill
Mesa Valley Springs Property
Colorado Springs, Colorado

Prepared by
Engineering Solutions & Design, Inc.
9393 W. 110th Street, Ste 500
Overland Park, KS 66210
(800) 298-1851

VERSION 2
December 10, 2018

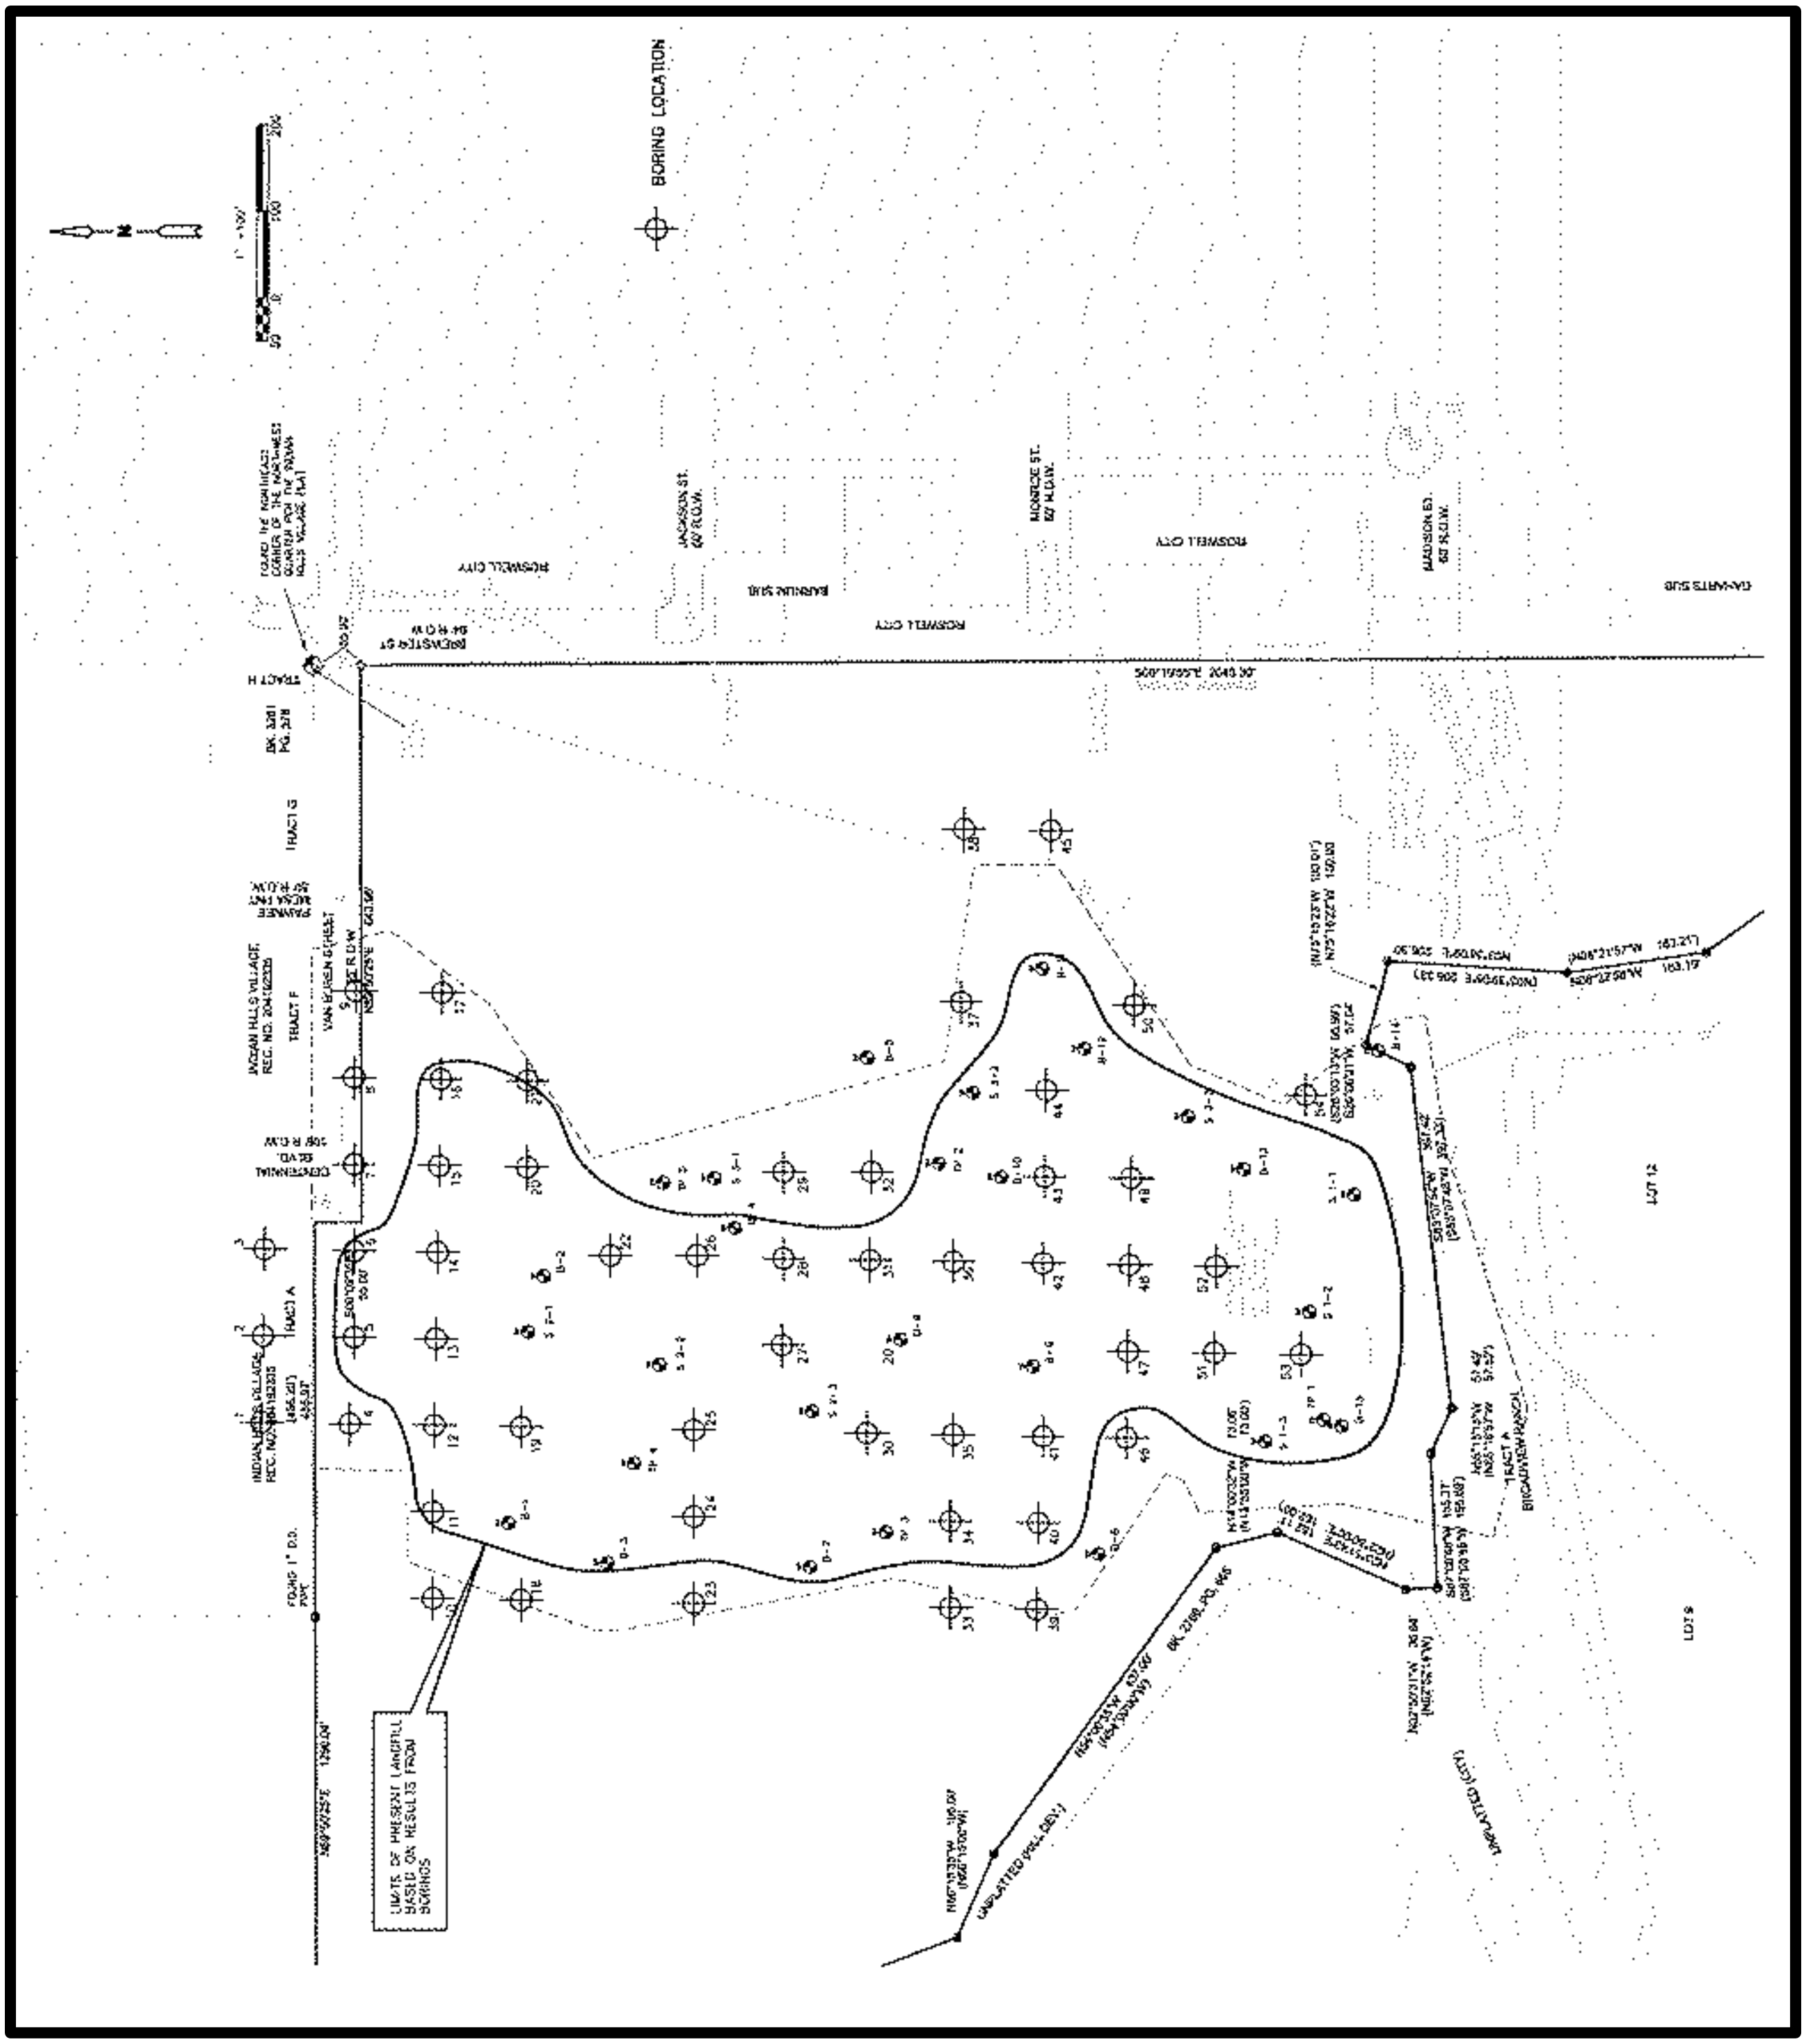
FIGURE 3.1
PROJECT SITE AND ABANDONED LANDFILL LIMITS

According to the Colorado Department of Public Health and Environment, the landfill was not registered or permitted by the state or county. Based on the types of materials found in the test pits and soil borings taken at the site, the landfill contains both municipal waste and construction debris. In addition, the test pits, soil borings, and surface conditions indicate that the waste was not compacted or uniformly placed.

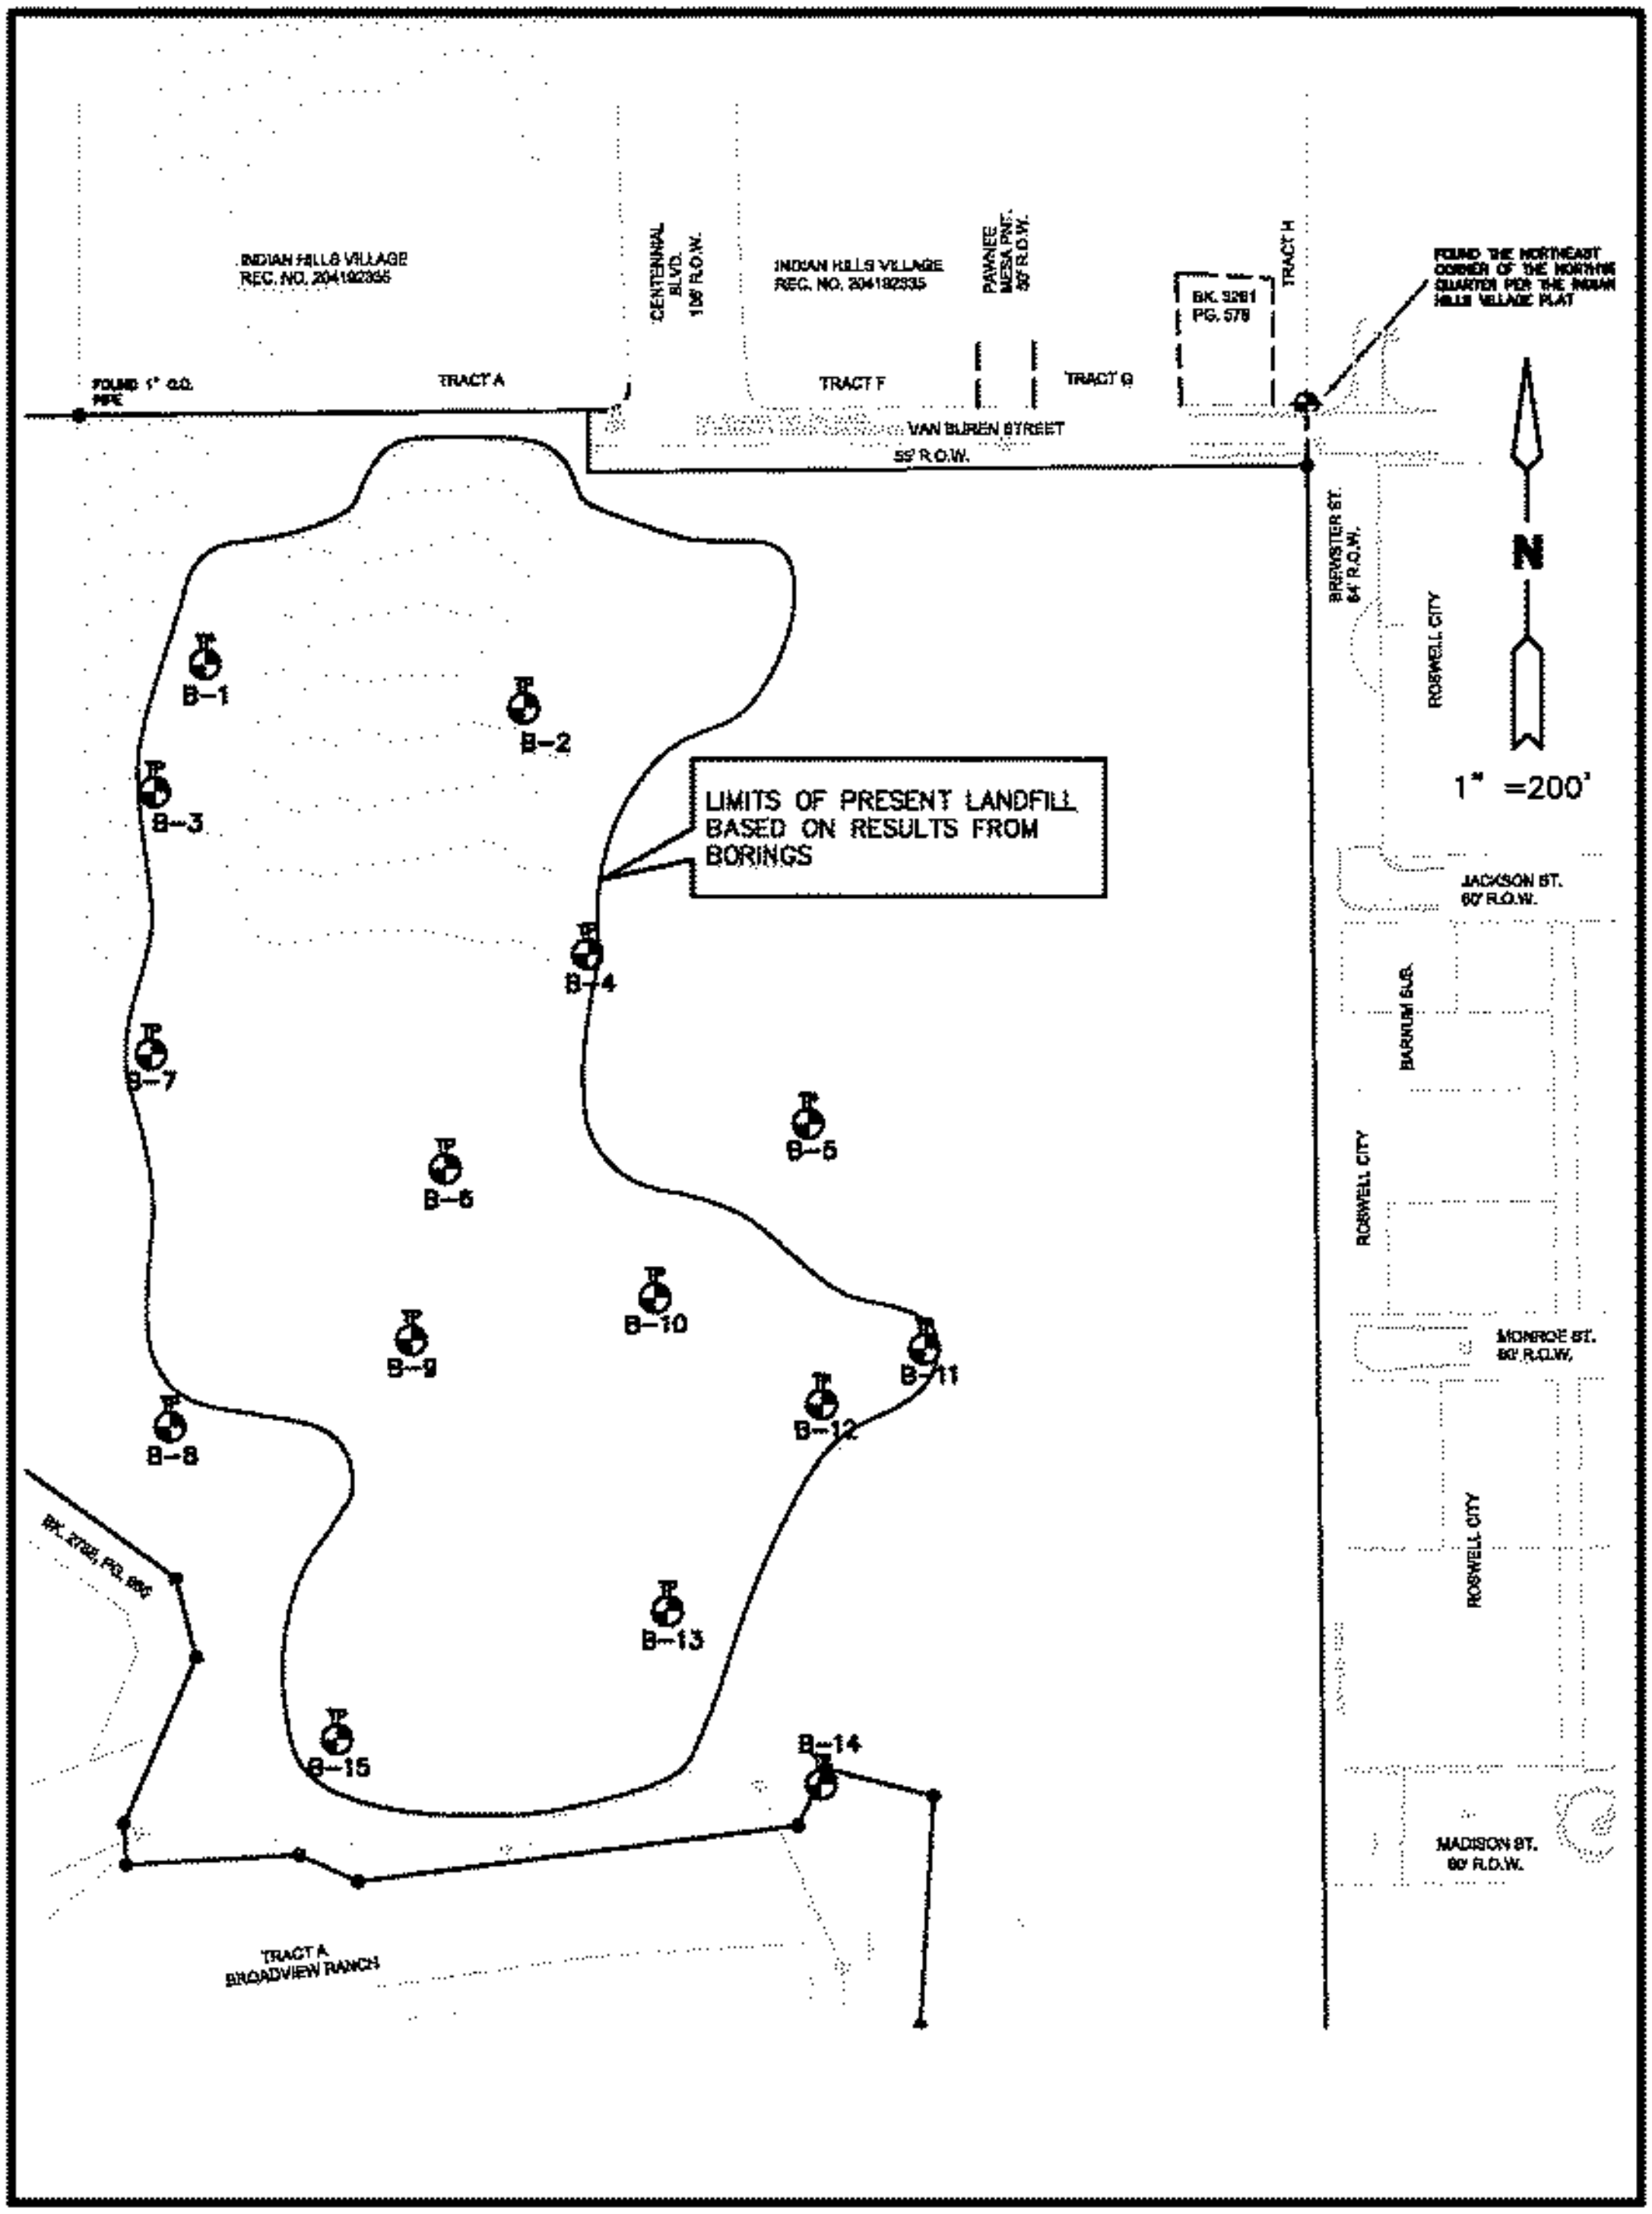
FIGURE 3.5
LOCATION OF BORINGS DRILLED IN JULY 2005

Waste encountered in the subsurface investigation indicated that the drainage and valley, in the central portion of the larger parcel of land comprising the project site, was filled with waste. The maximum thickness of this waste, based on our subsurface investigation, is estimated to be about 40 feet. The borings indicate that the surface soil cover ranges from about ground surface to 20 feet in thickness. Soil was also found layered and mixed within the solid waste landfill layer.

Waste materials observed in the landfill included solid wastes ranging mainly from wood, to organics, plastic, glass, rubber, metal, aluminum, galvanized wire, cloth, newspaper, and cardboard. The types of wastes encountered in the soil are also documented in more detail in the boring logs (see Appendix C).

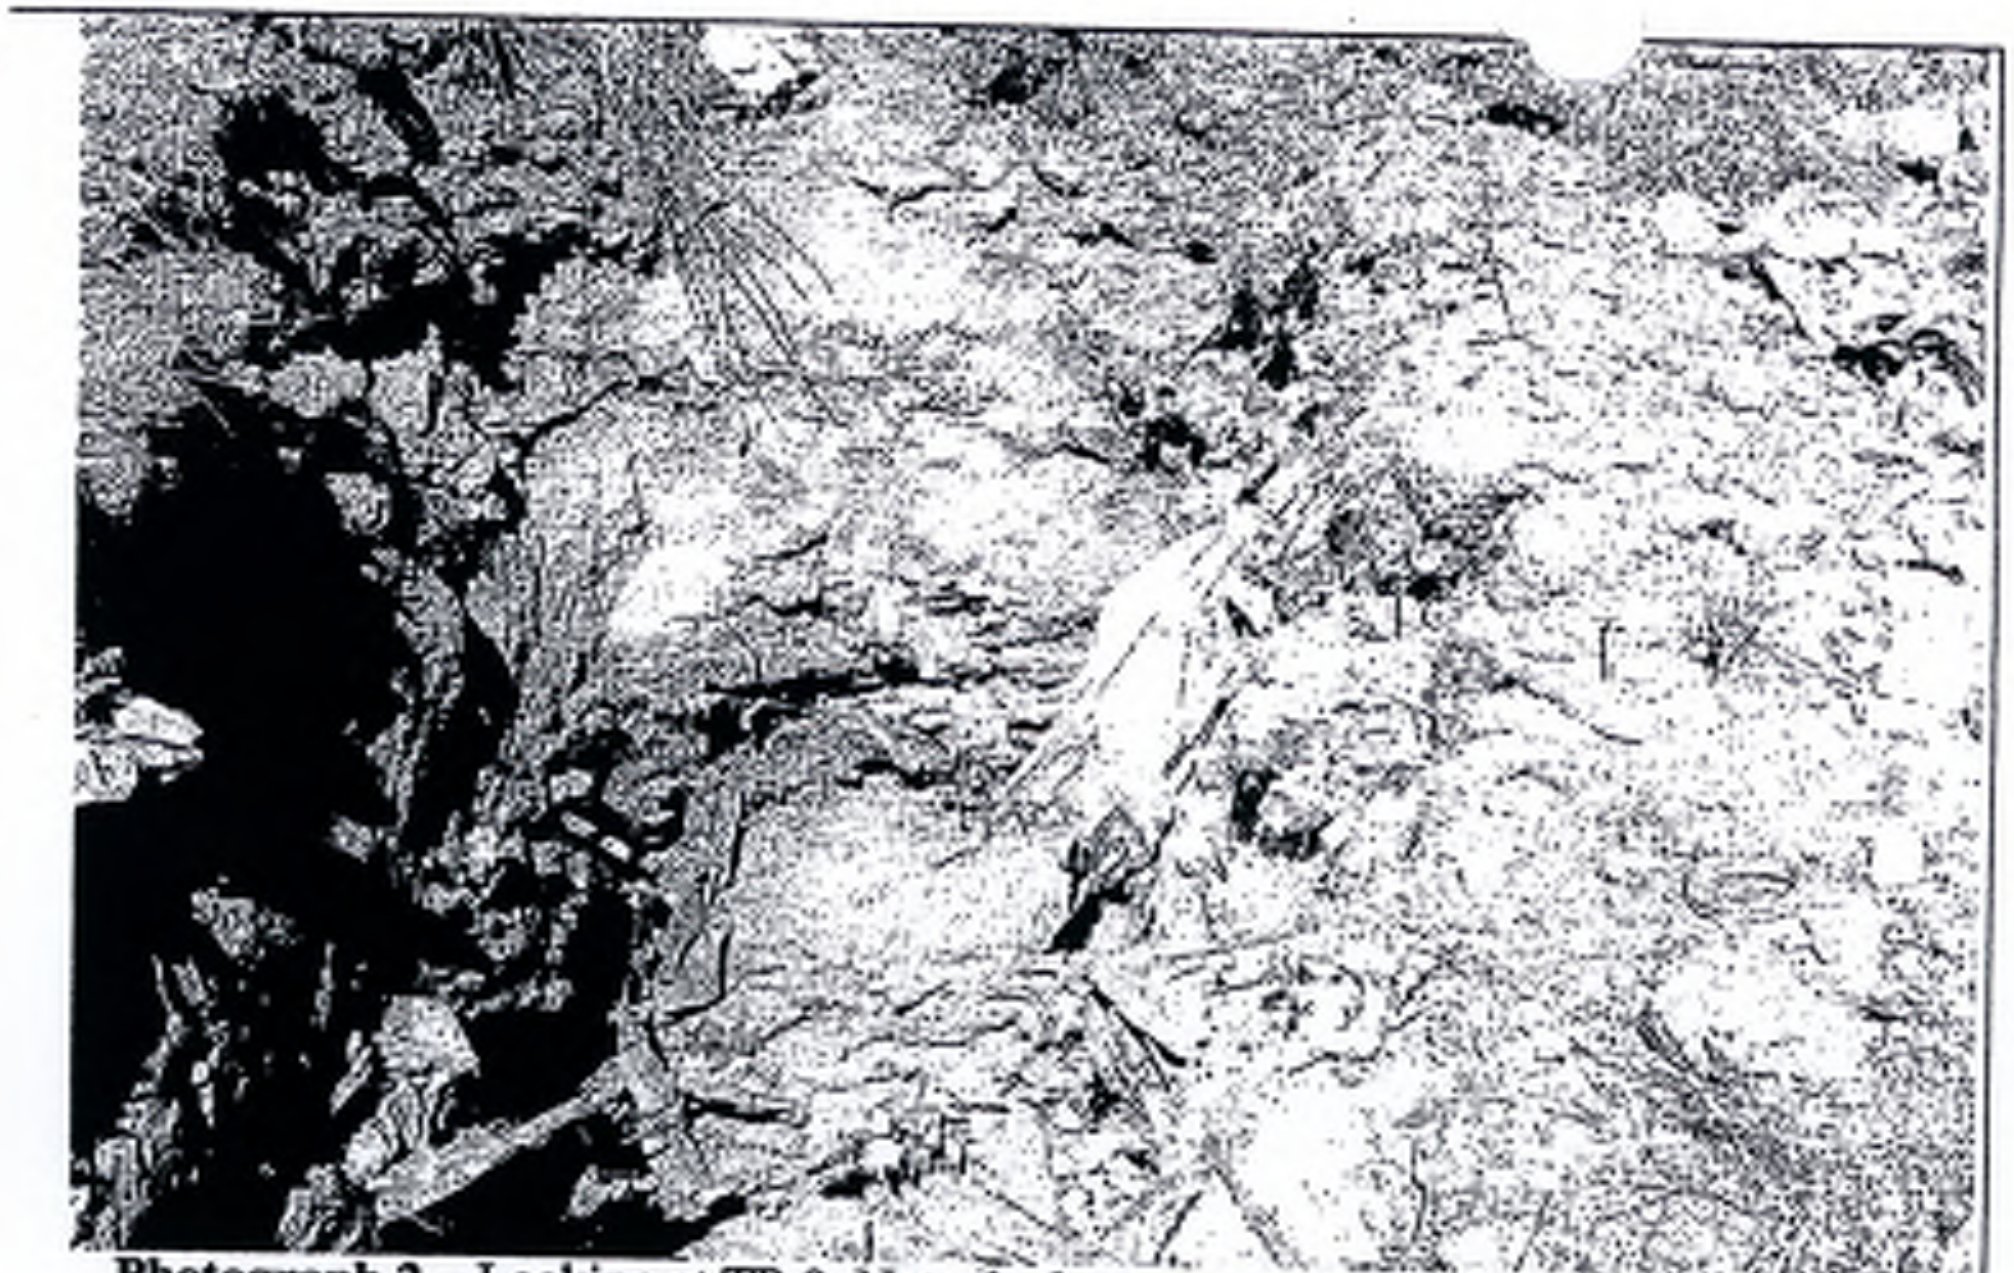
Photograph 2 – Looking at TP-2. Note the large amounts of debris within the soil.

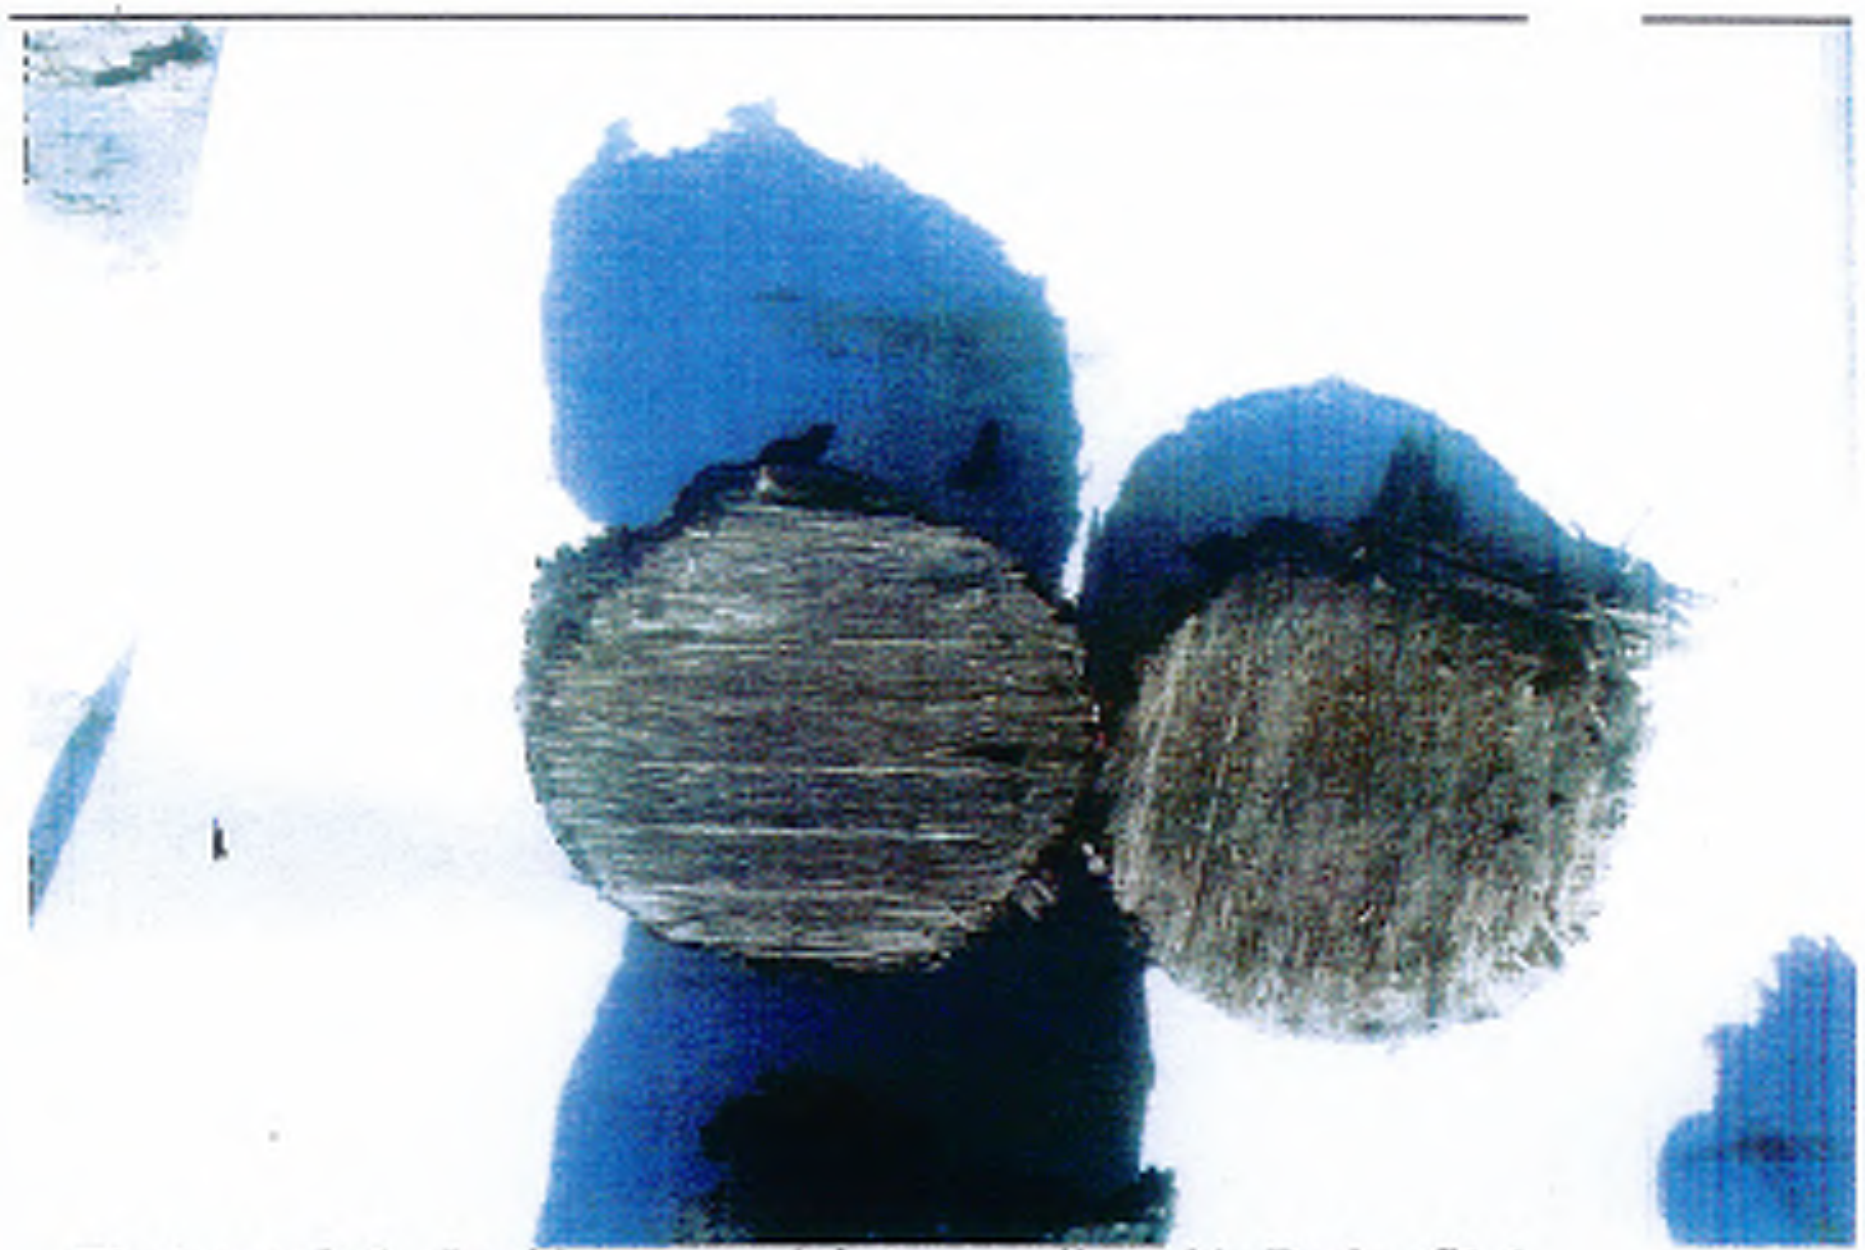
Photograph 6 – Looking at wood that was collected in Boring S1-1.

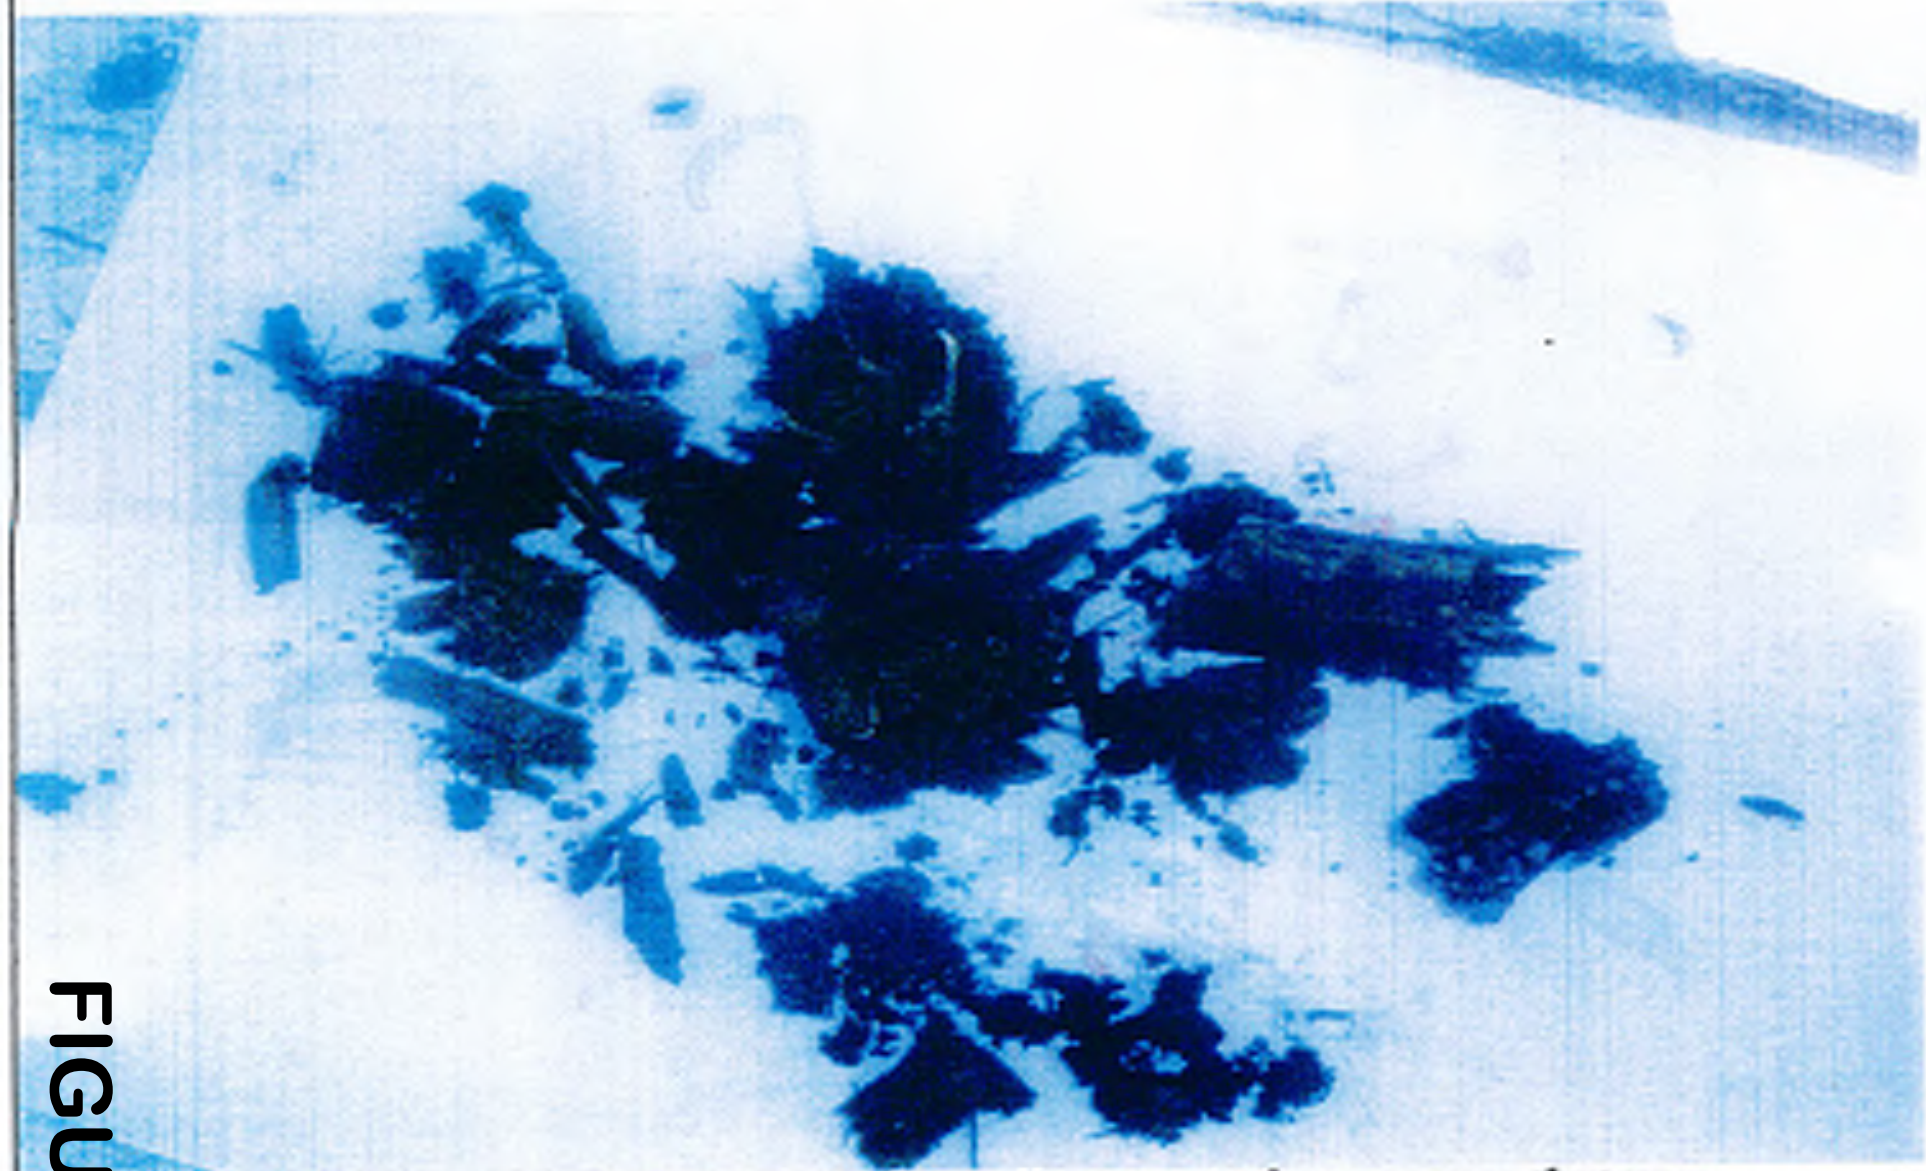
otograph 7 – Looking at wood and a small amount of newspaper that was llected from Boring S1-2.

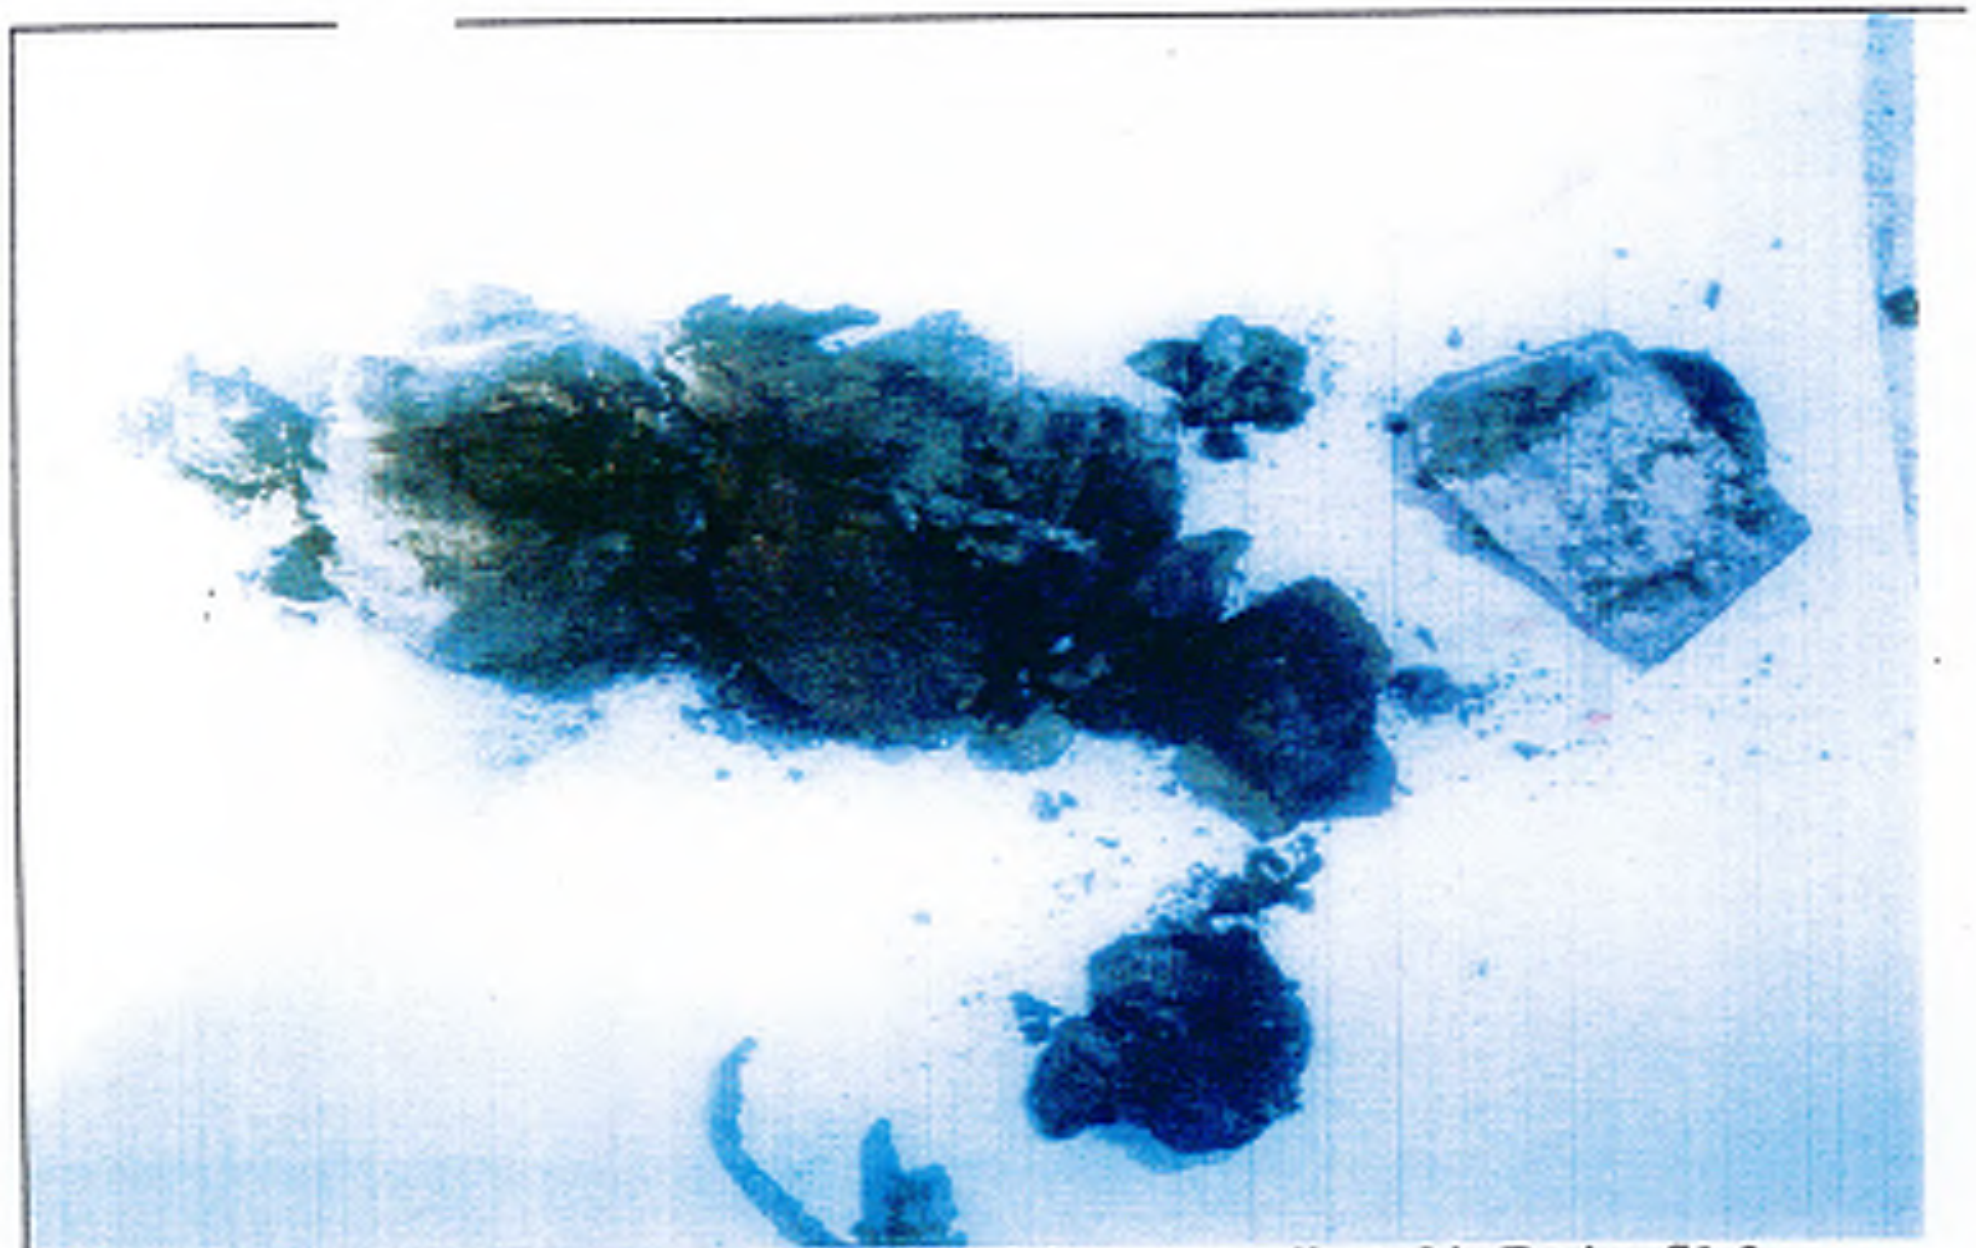
Photograph 9 – Looking at wood and metal that were collected in Boring S1-3.

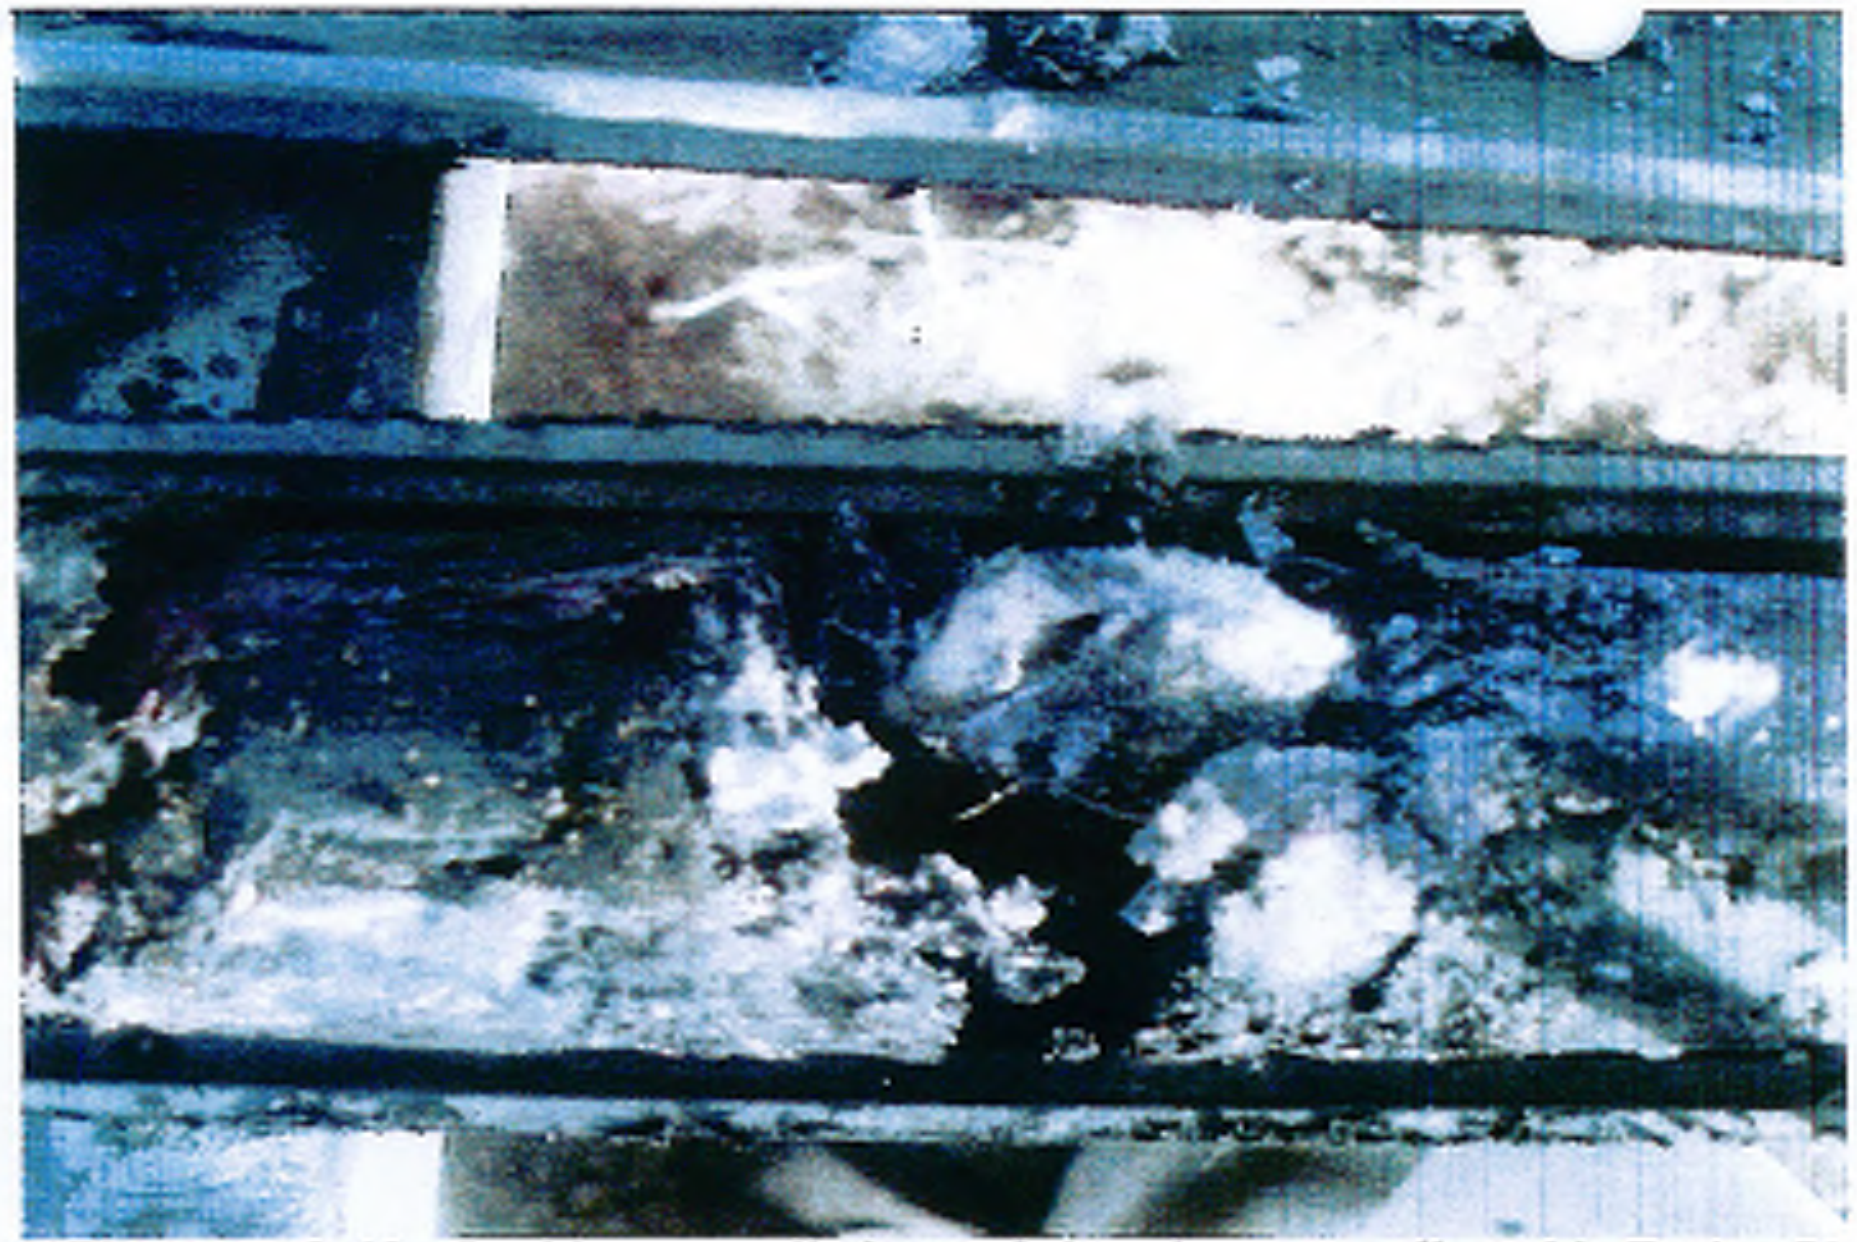
Photograph 10 – Looking at small pieces of glass that were collected in Boring S1

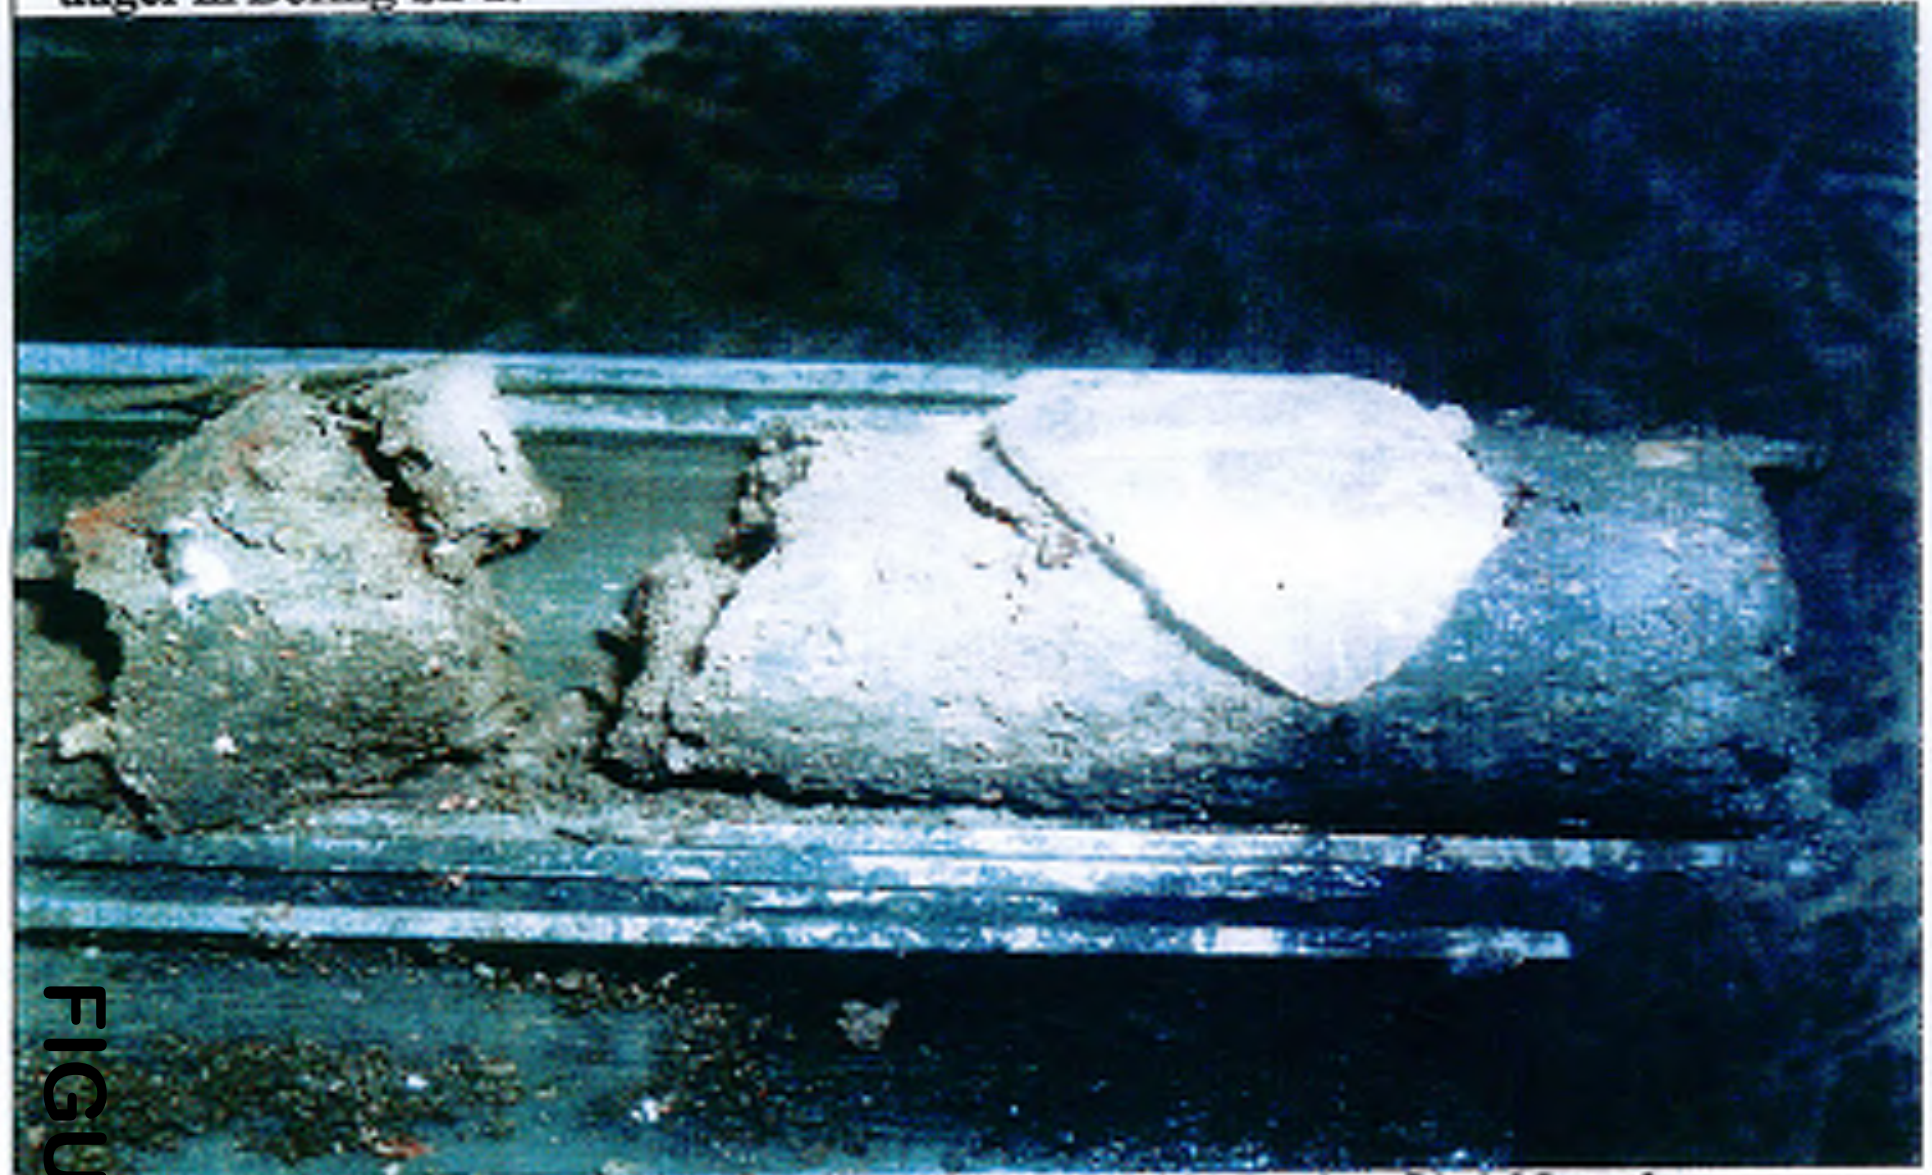
otograph 15 – Looking at soil that was collected in Boring S2-2.Note the ack discoloration of the soil. The black soil was found within the landfill material.
