APPLICATION FOR VOLUNTARY CLEAN-UP

Remediation of
Existing Abandoned Landfill
Mesa Valley Springs Property
Colorado Springs, Colorado

Prepared by
Engineering Solutions & Design, Inc.
9393 W. 110th Street, Ste 500
Overland Park, KS 66210
(800) 298-1851

VERSION 2
December 10, 2018

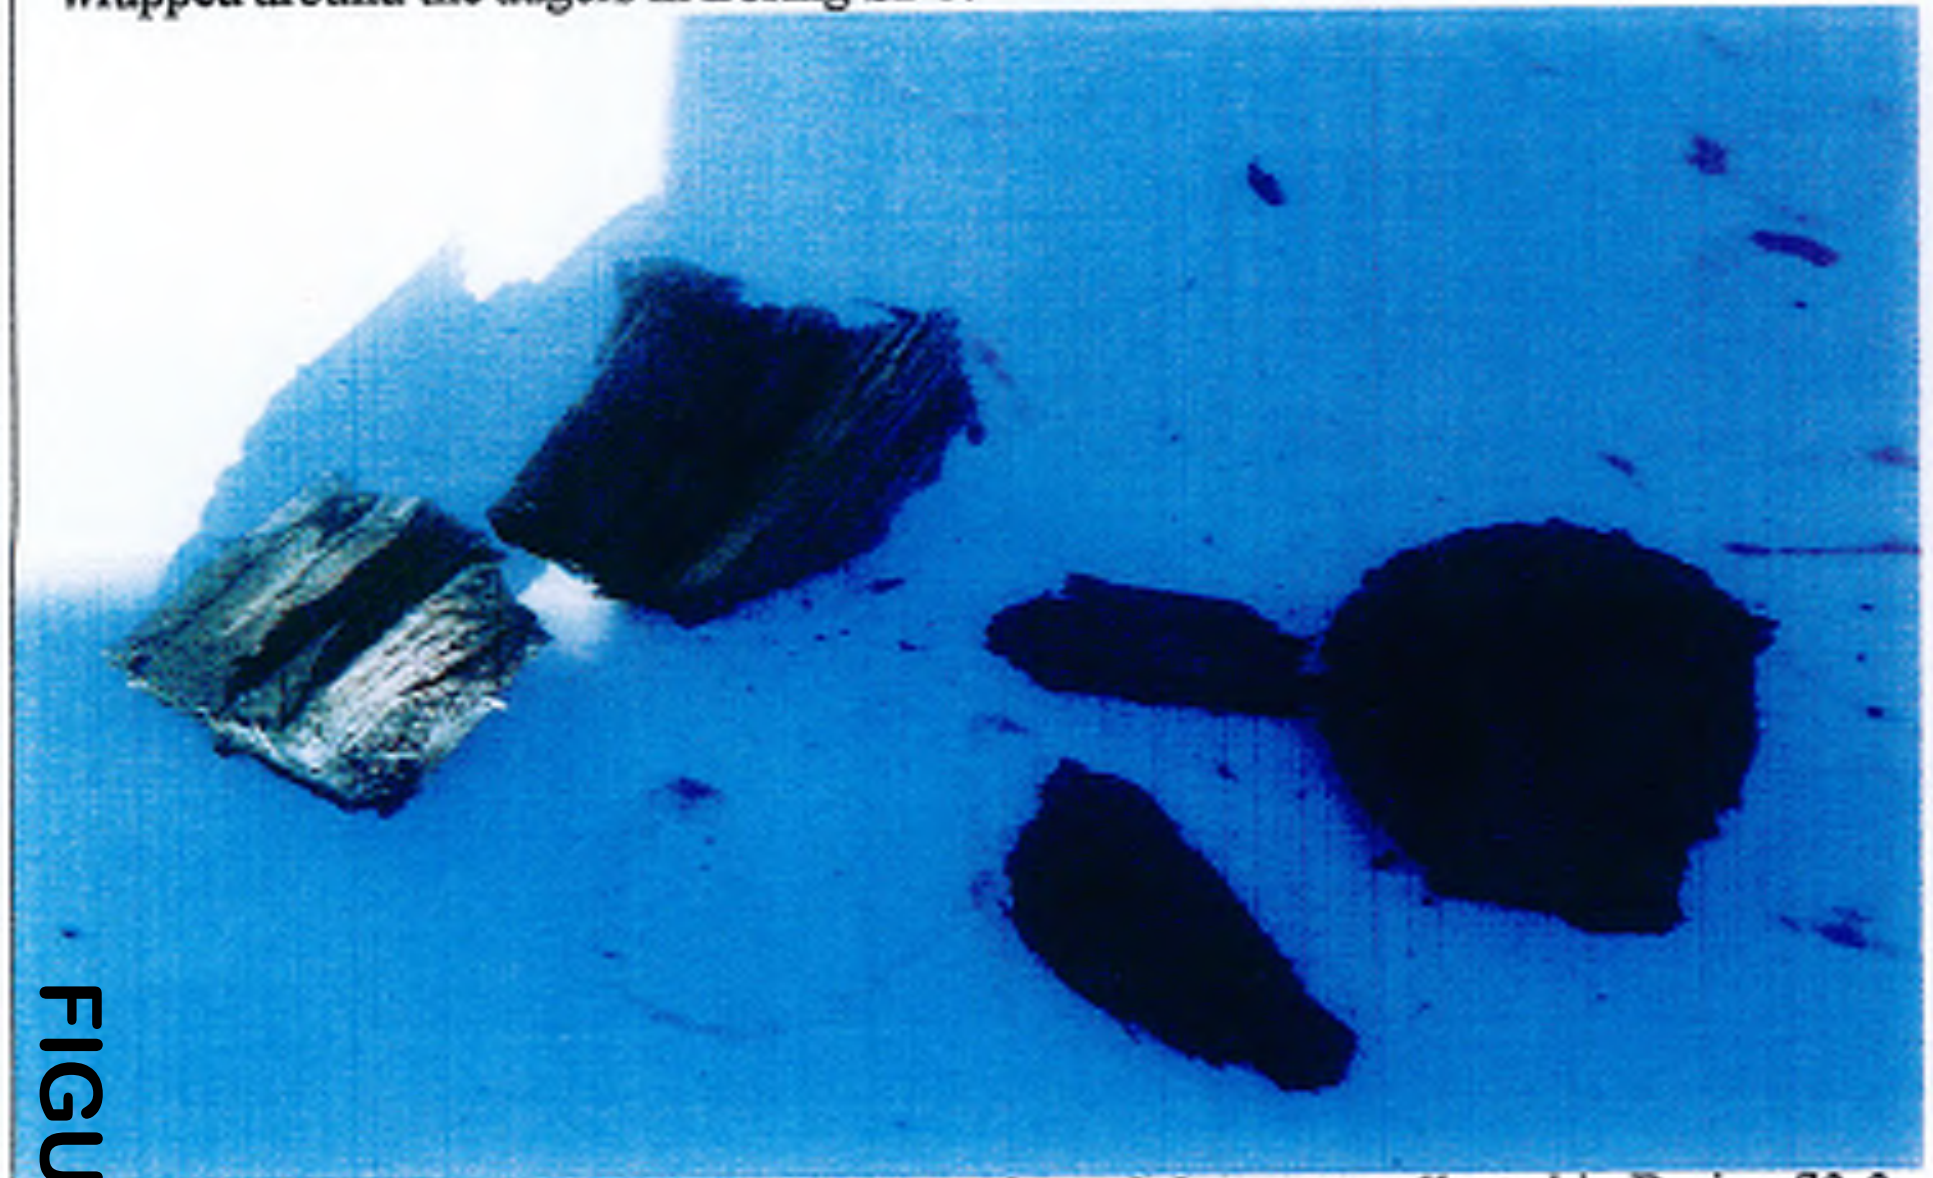
hotograph 19 – Looking at small pieces of wood that were collected in Boring S2-3.

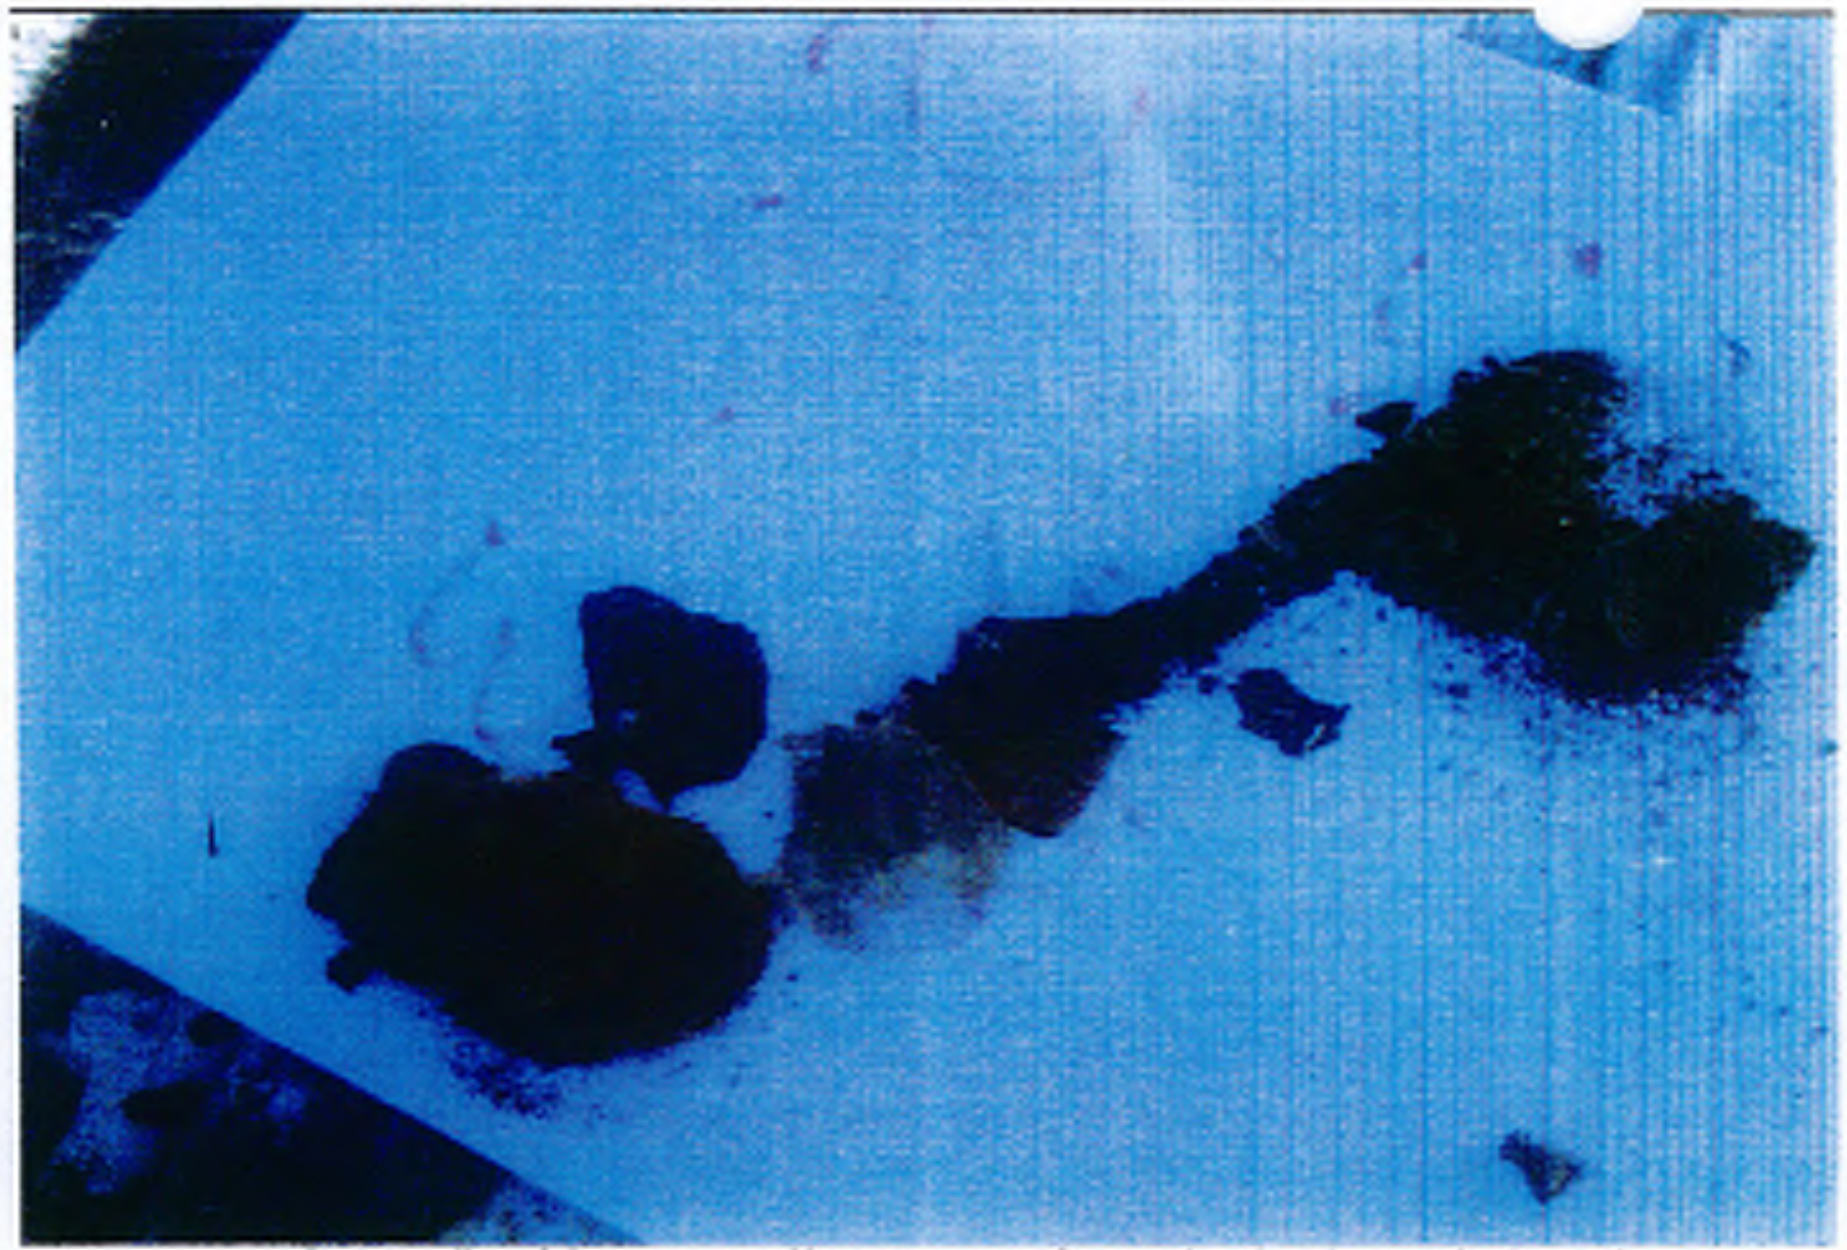
Photograph 22 – Looking at small amounts of wood, plastic, and glass that were collected in Boring S3-3.

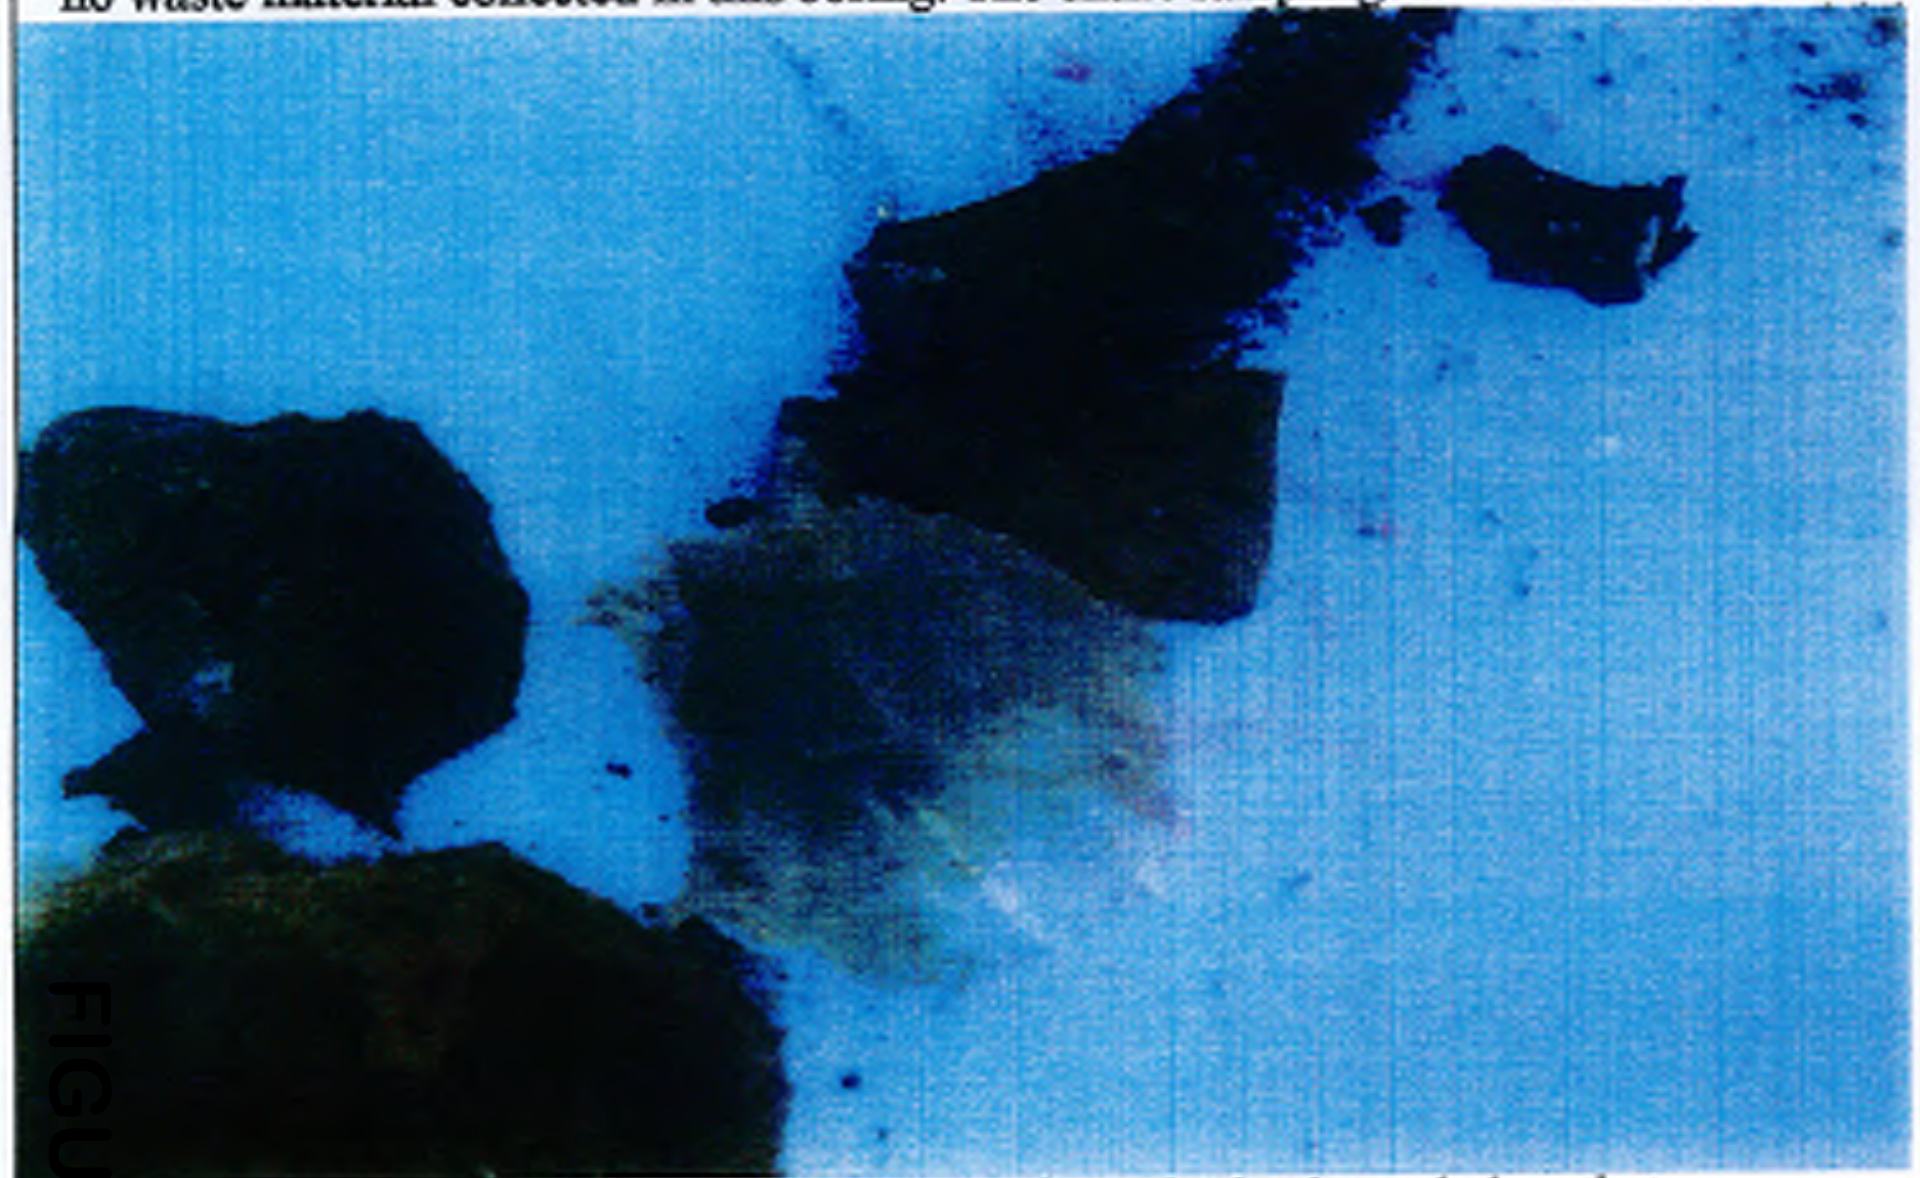
otograph 23 –Looking at small amounts of wood, plastic, and glass that ere collected in Boring S3-3.
