RE: Application for Voluntary Clean-Up
Remediation of Existing Landfill on Property Located in the Northwest Quarter of Section 1, Township 14 South, Range 67 West in Colorado Springs, CO

APPLICATION FOR VOLUNTARY CLEAN-UP

Remediation of Existing Abandoned Landfill Mesa Valley Springs Property Colorado Springs, Colorado

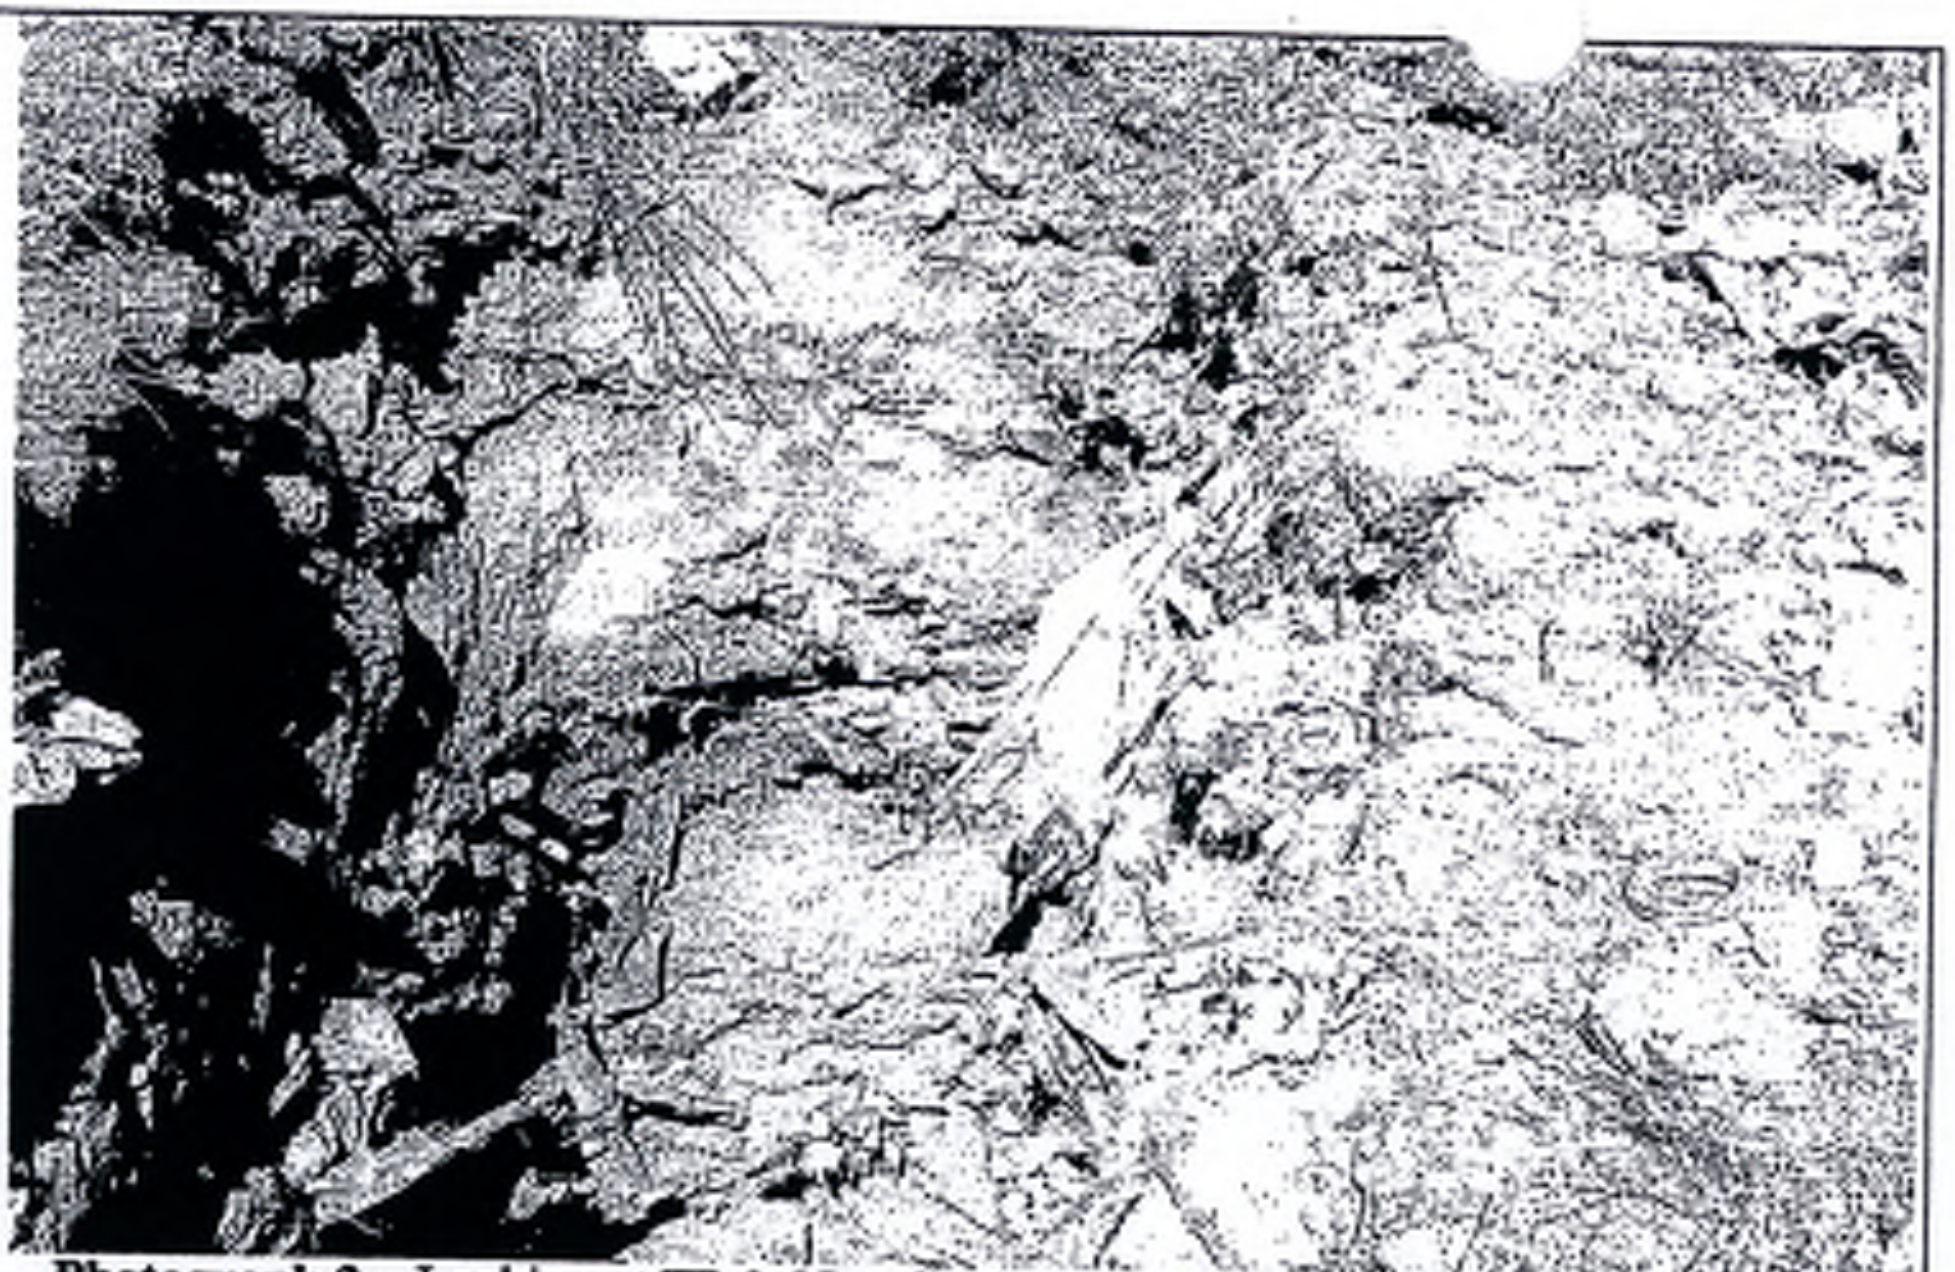
Photograph 1 – Looking at the debris pile from TP-2. Debris was observed throughout the fifteen-foot test pit.

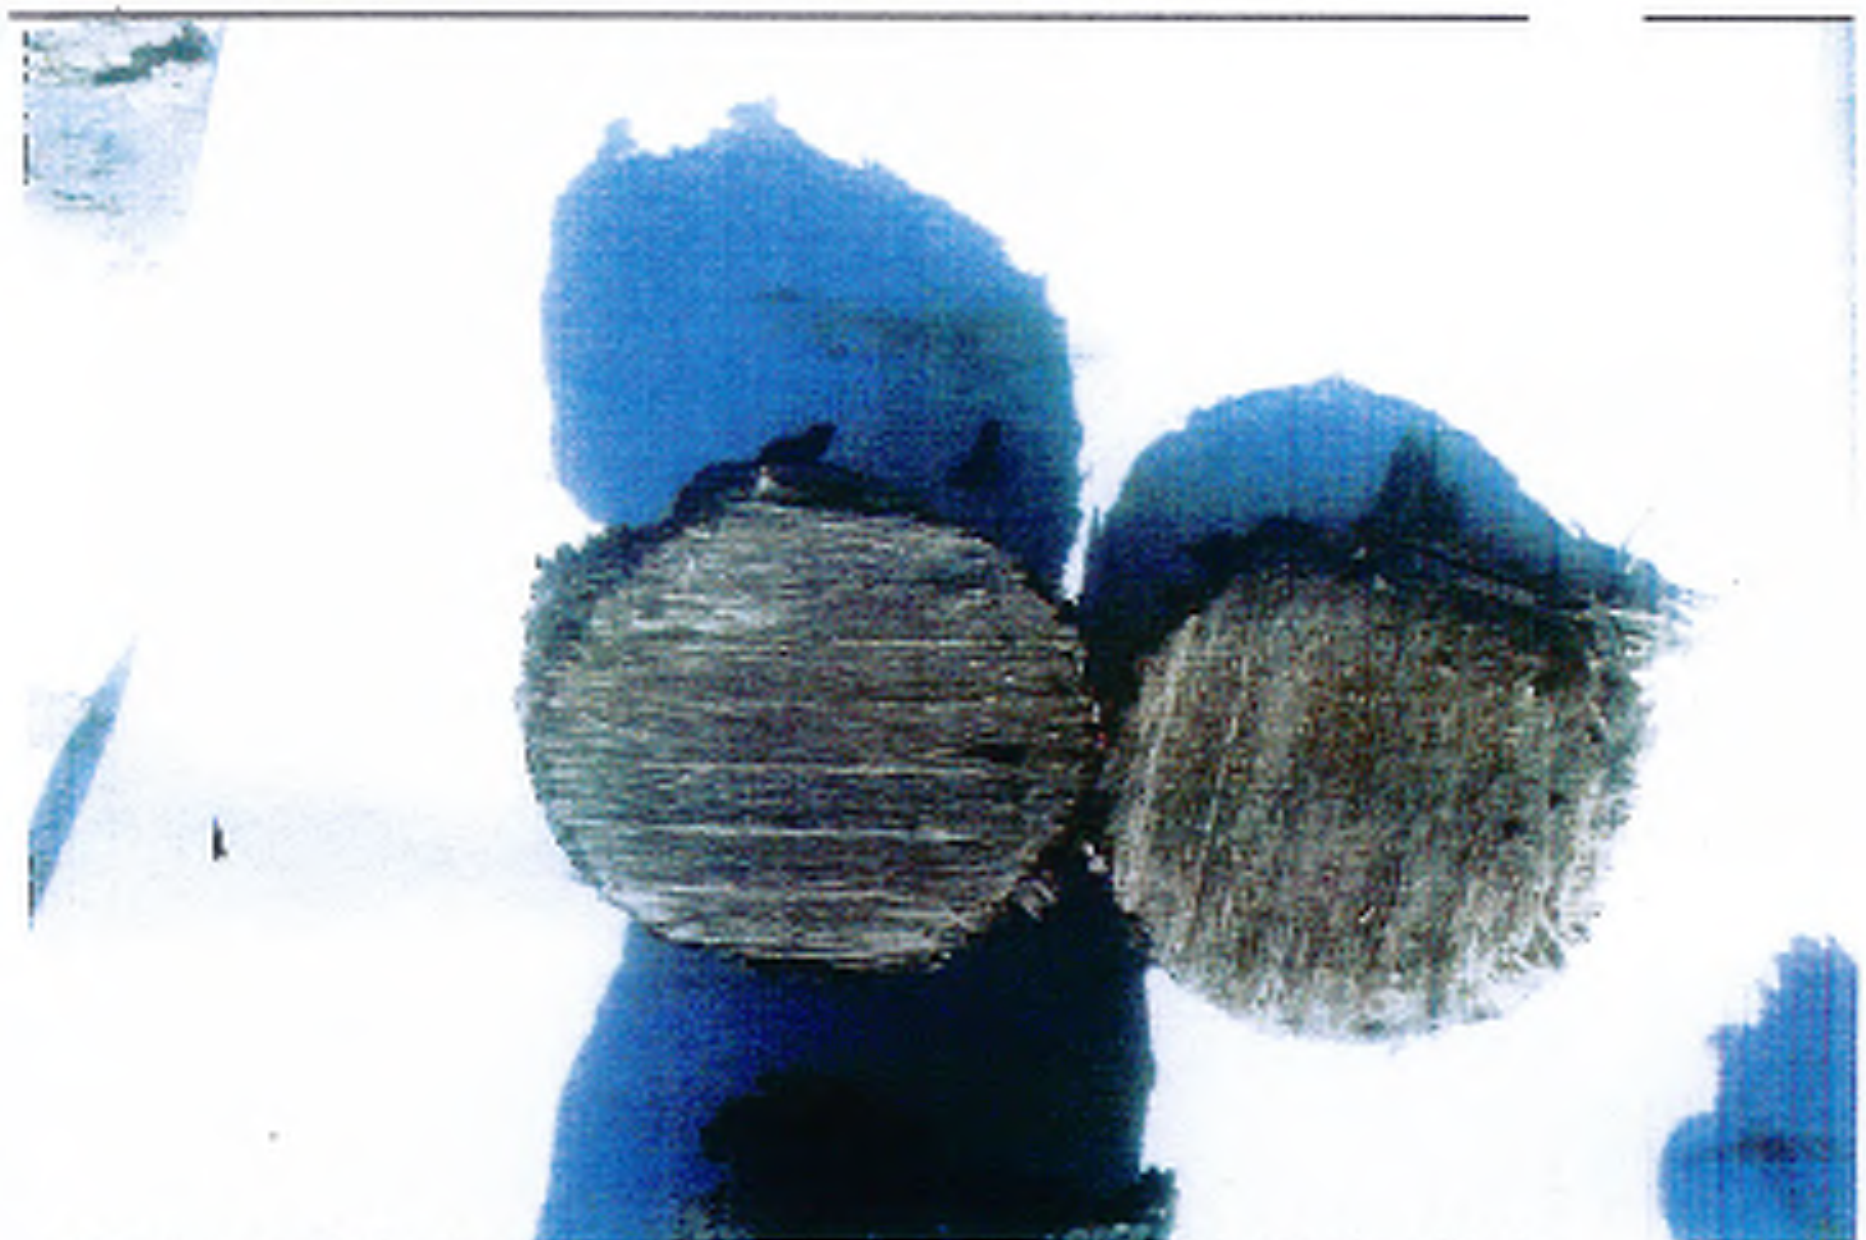
Photograph 5 – Looking at wood and glass that was collected in Boring S1-1.

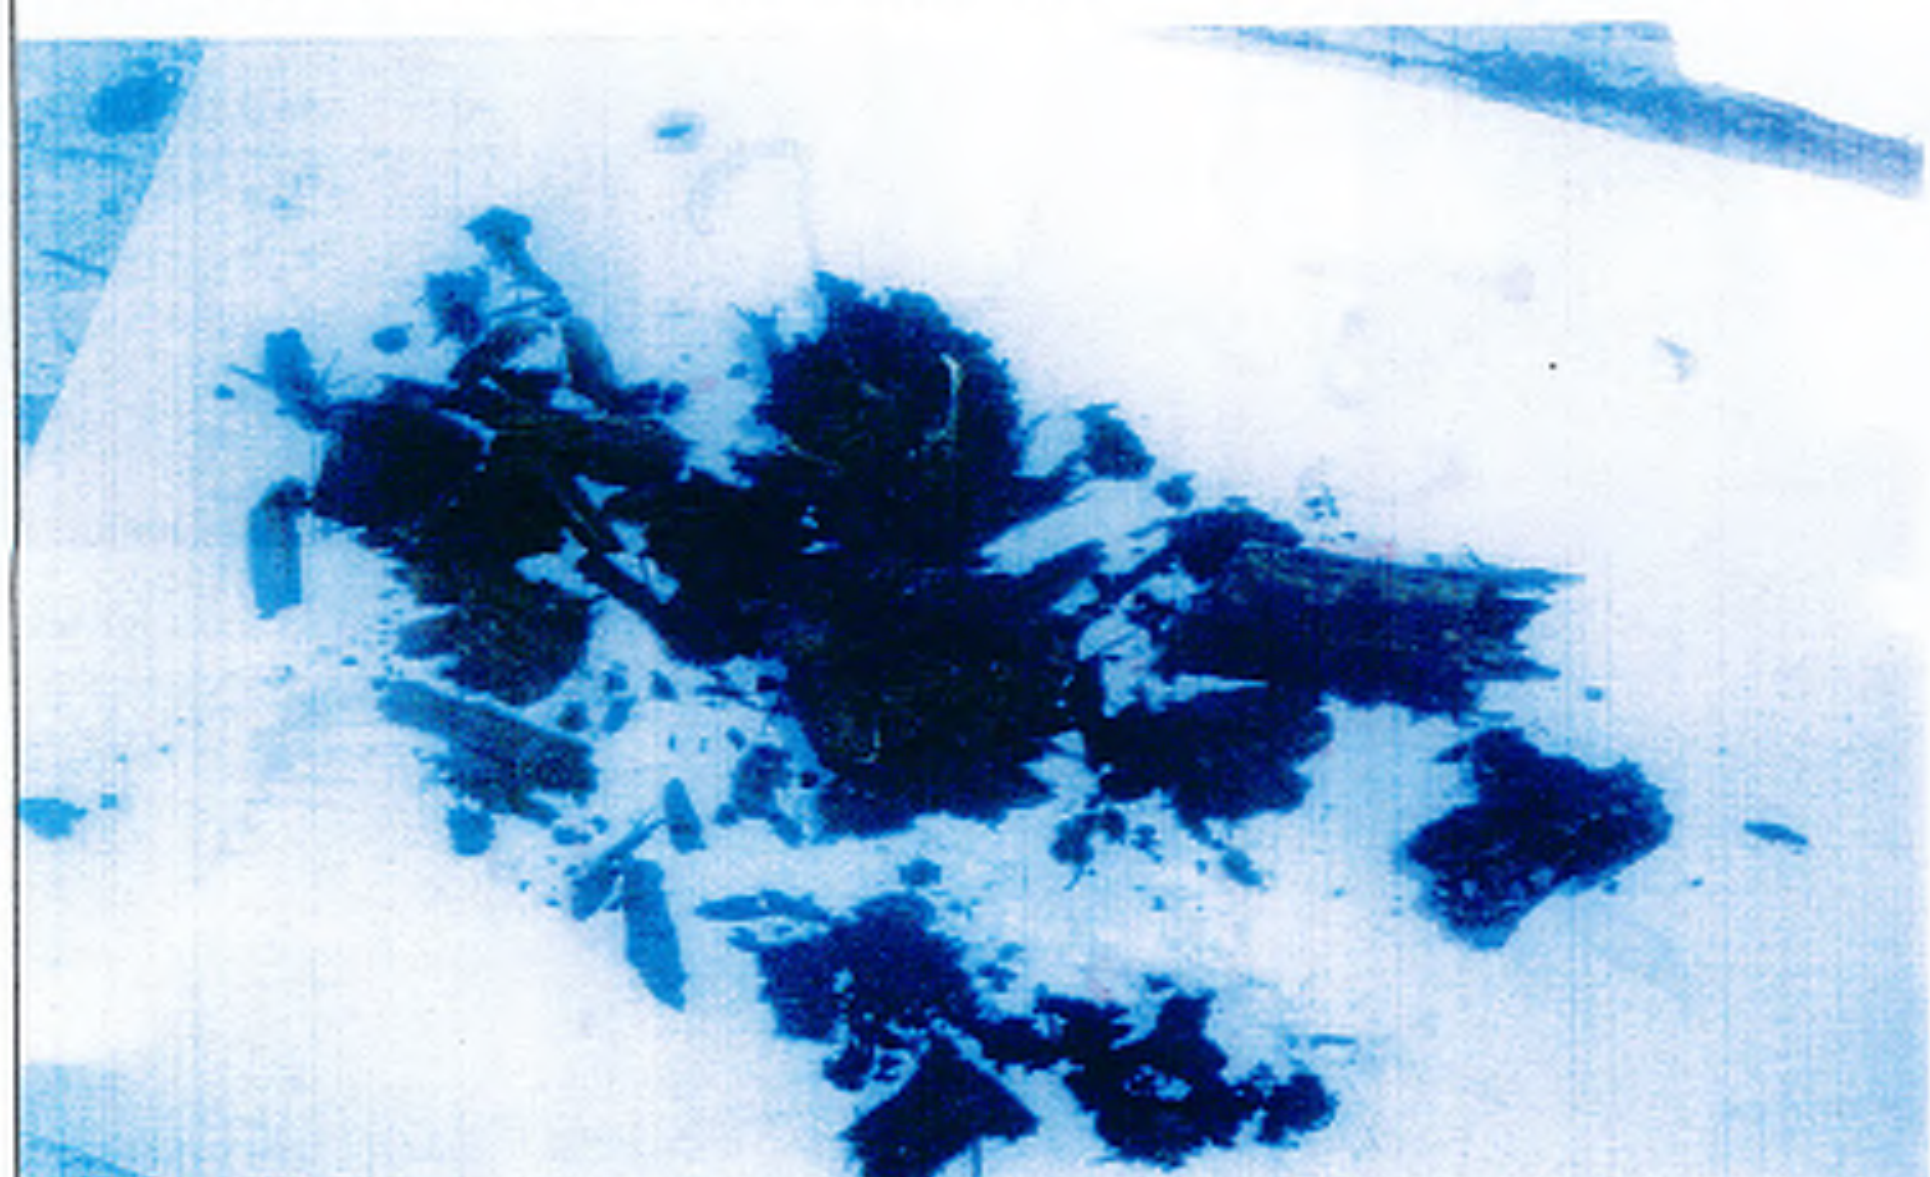
Photograph 6 – Looking at wood that was collected in Boring S1-1.

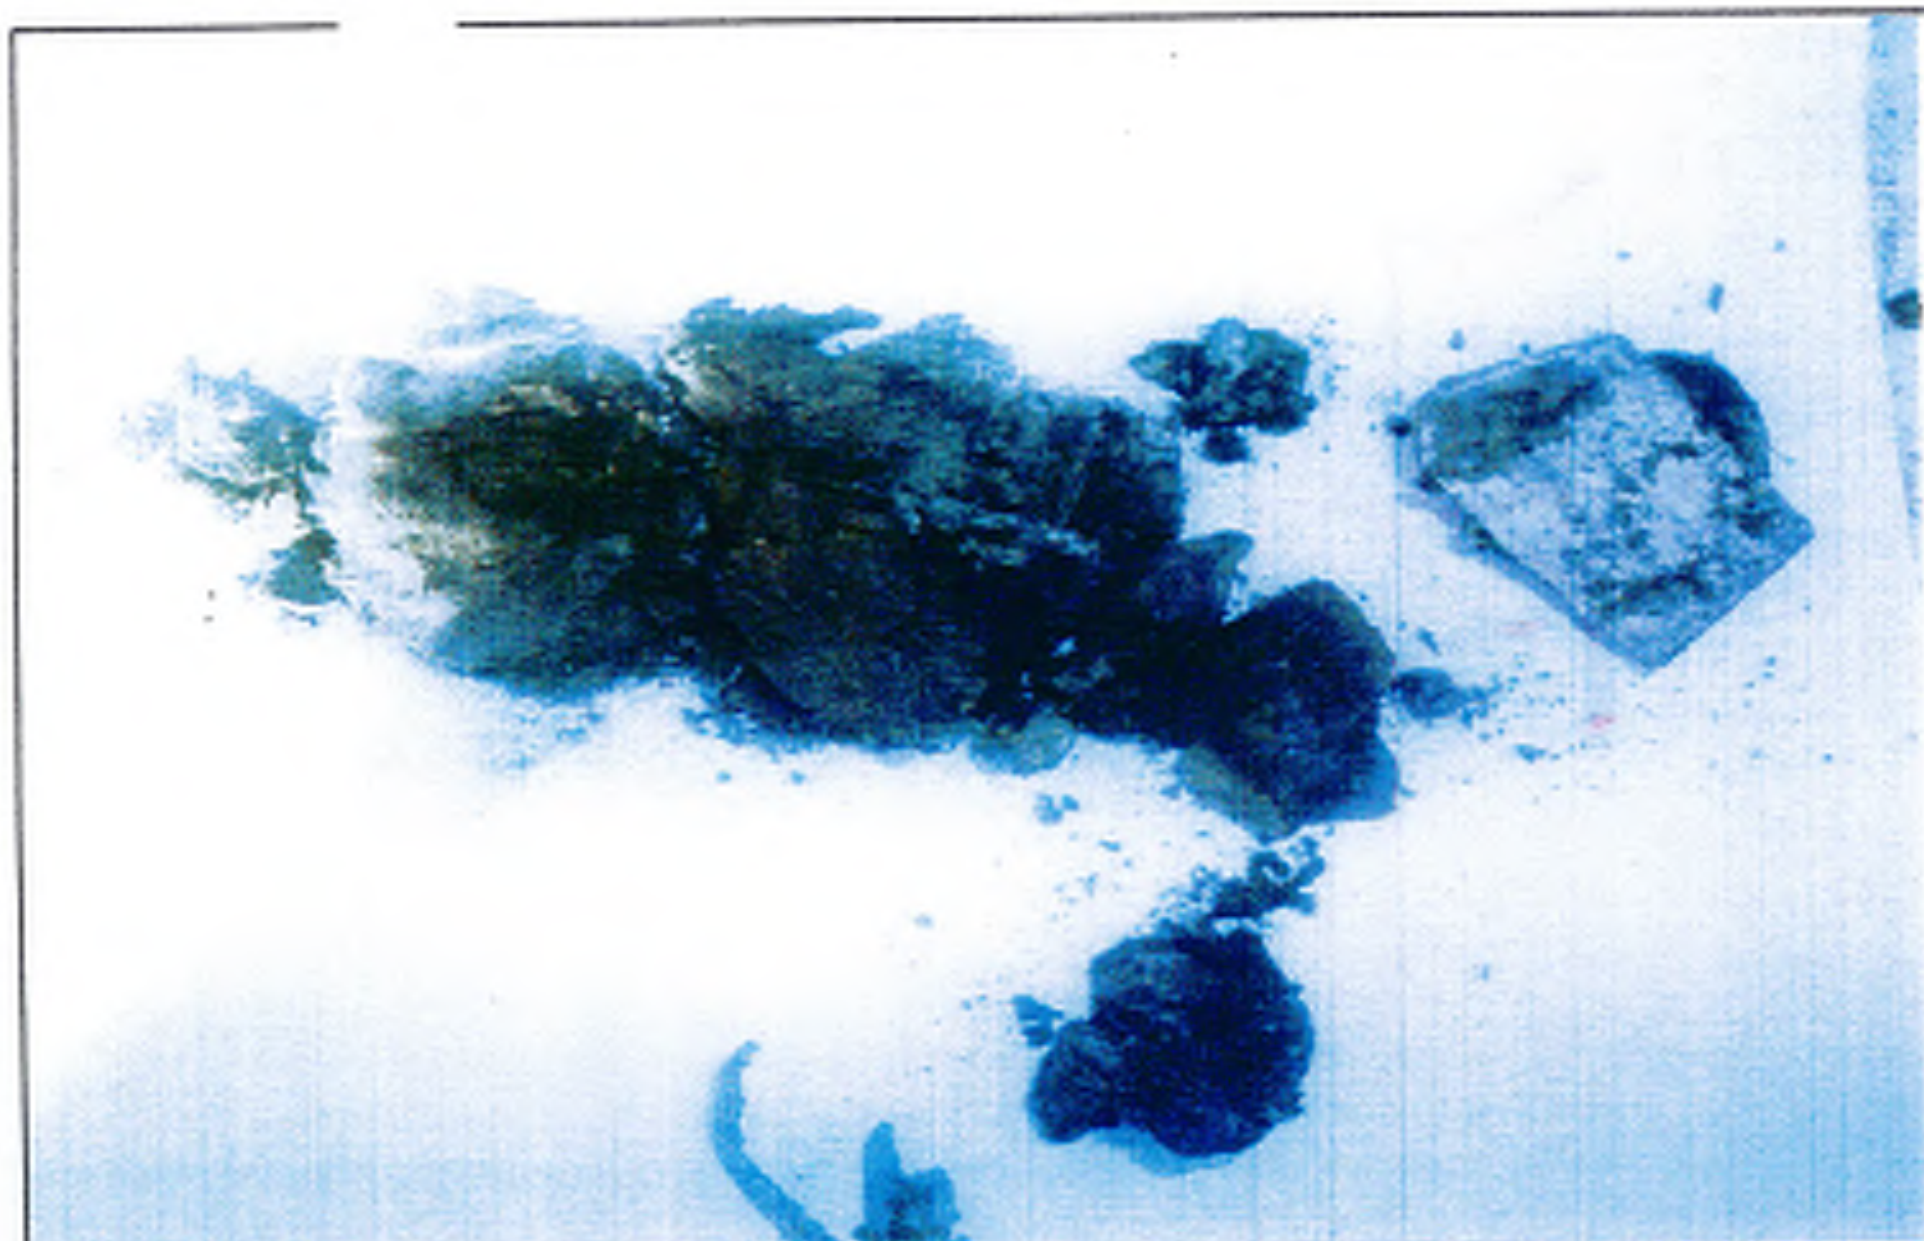
Photograph 8 – Looking at the cuttings from Boring S1-2. The cuttings consisted of water and soil with various types of waste materials within (refer to boring logs).

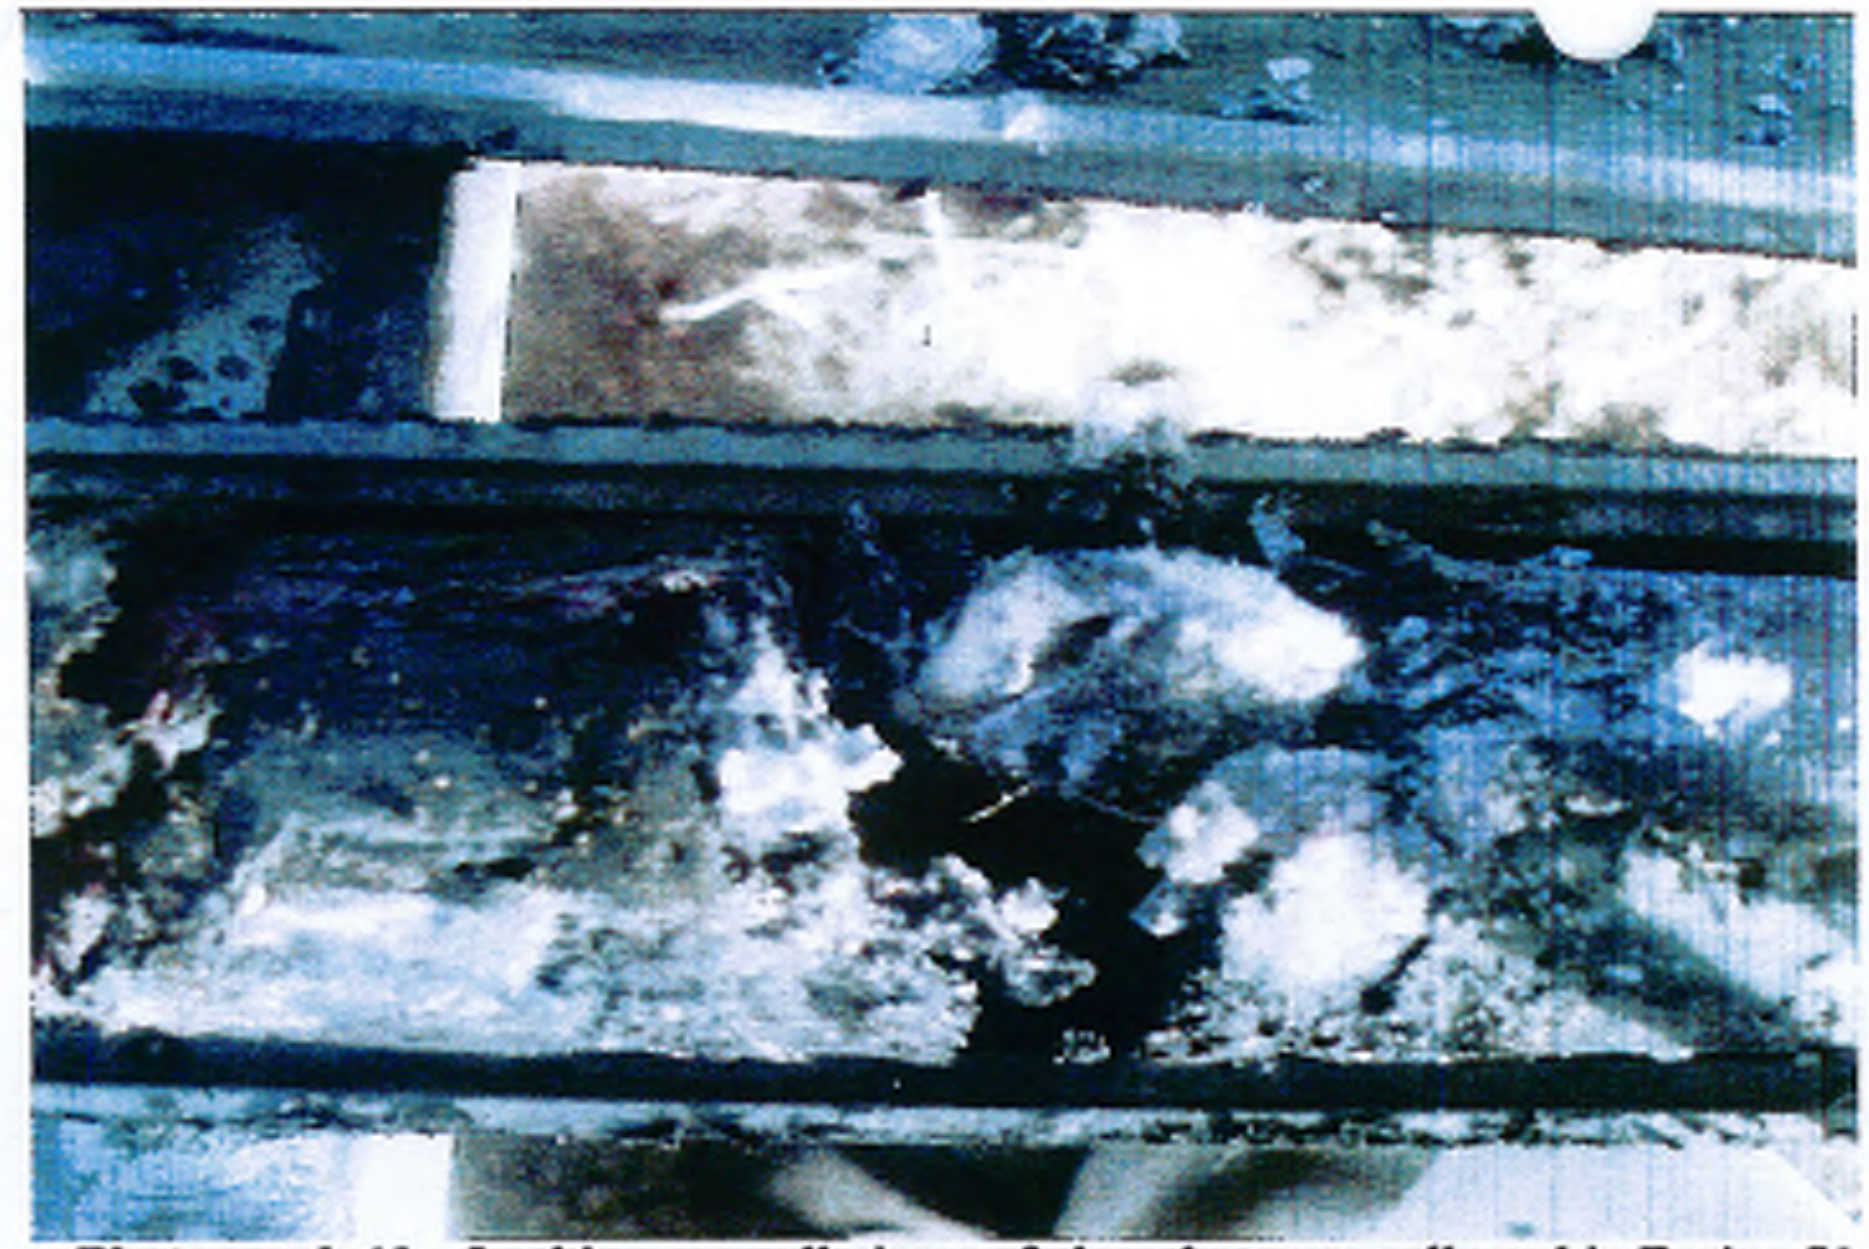
Photograph 9 – Looking at wood and metal that were collected in Boring S1-3.

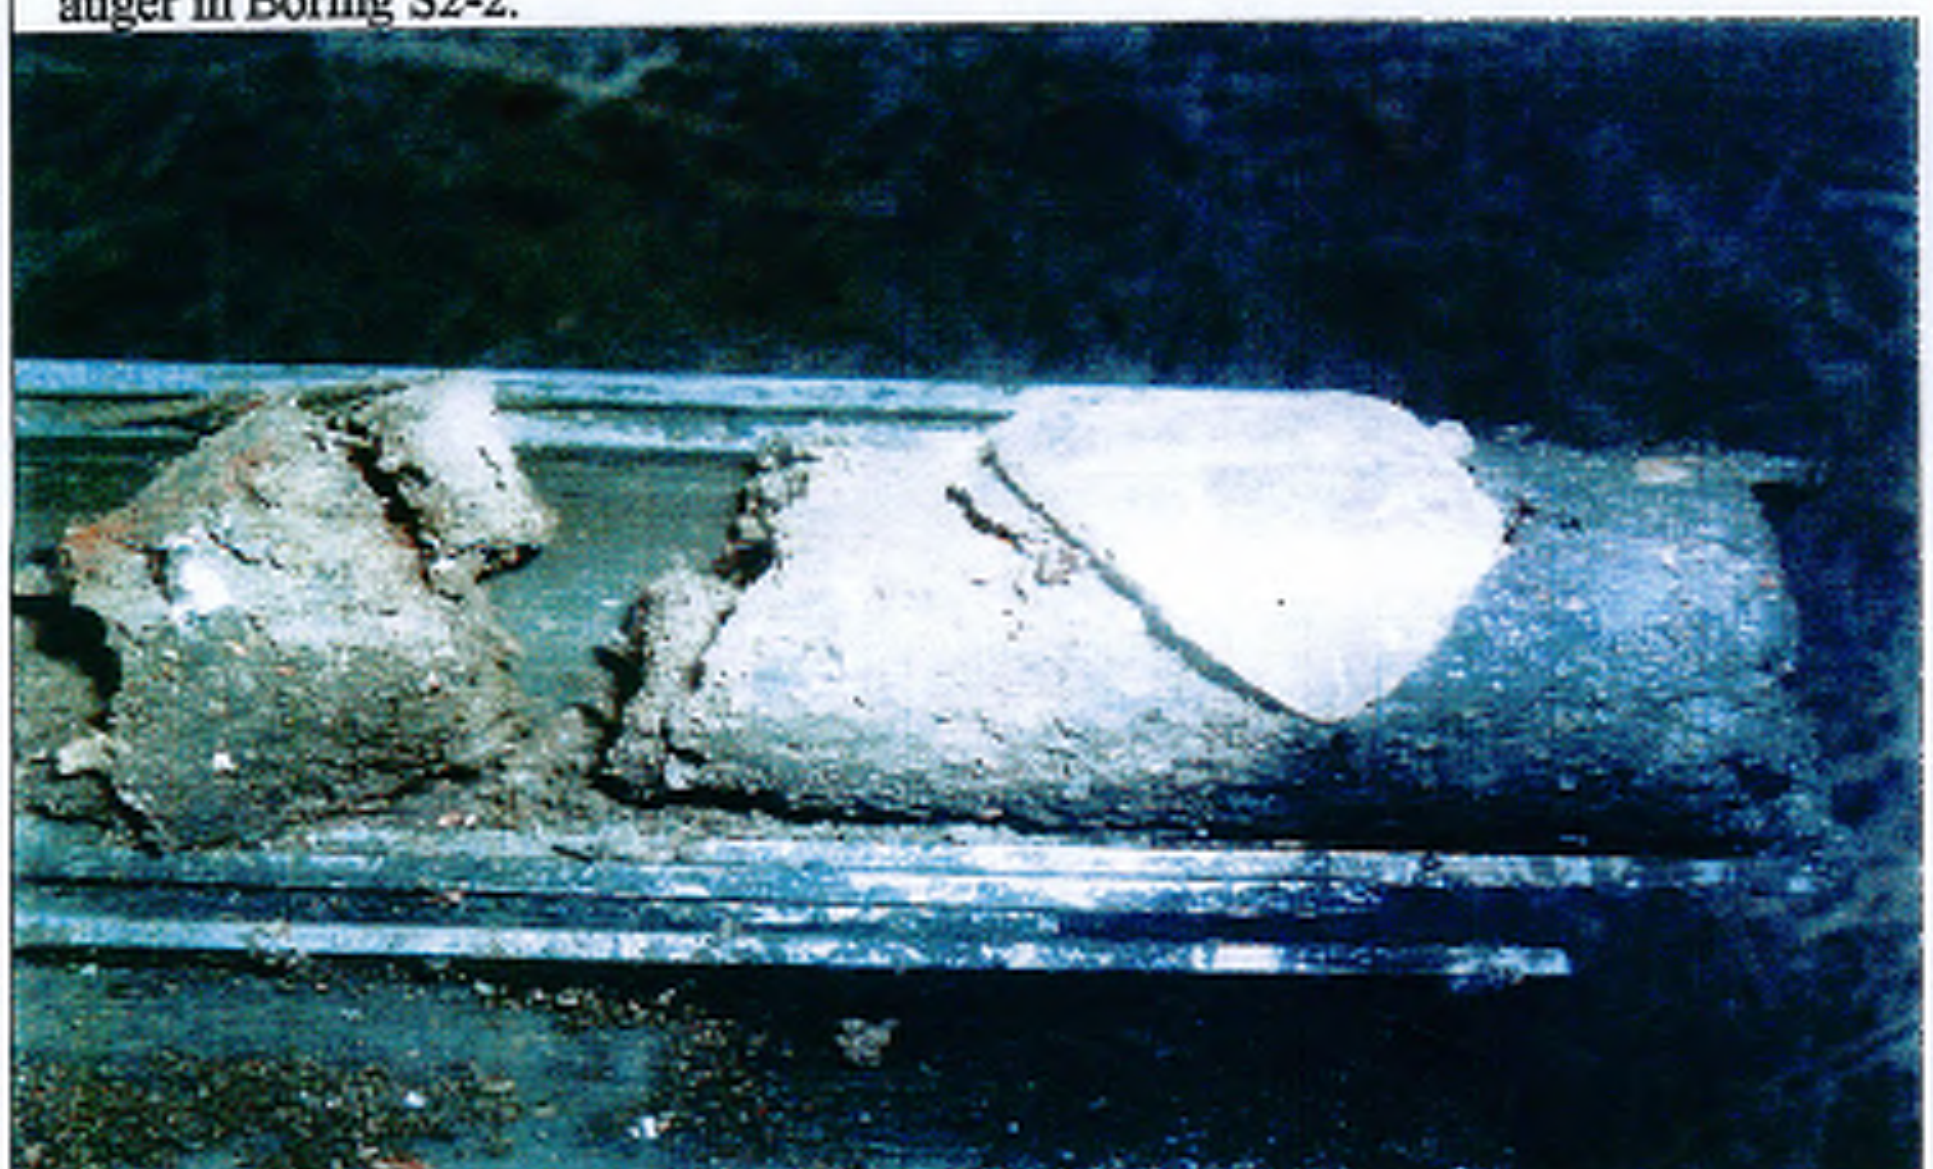
Photograph 14 – Looking at small pieces of glass, wood, and plastic that was collected in Boring S2-2.

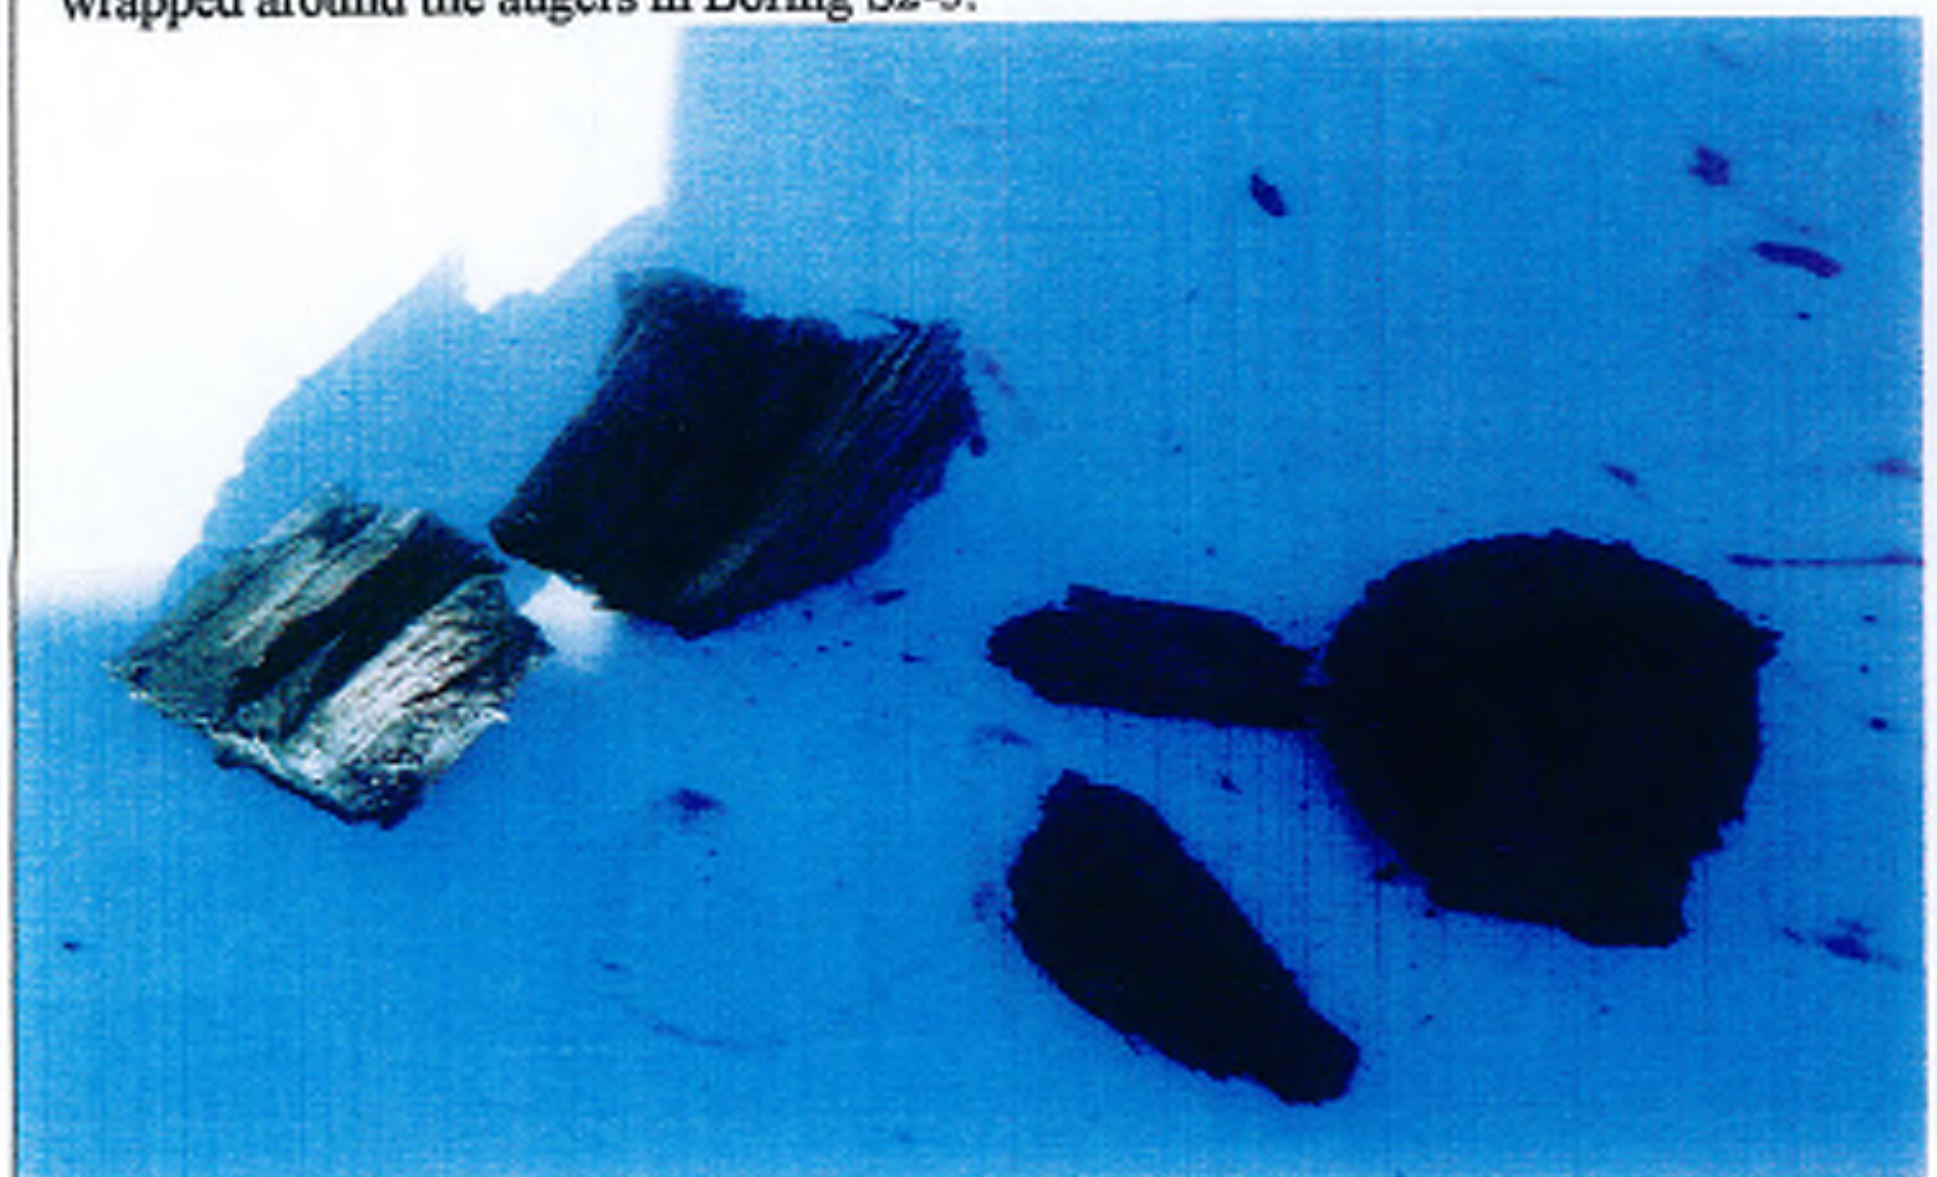
Photograph 18 – Looking at large amounts of plastic that were pulled out of Boring S2-3 during drilling.

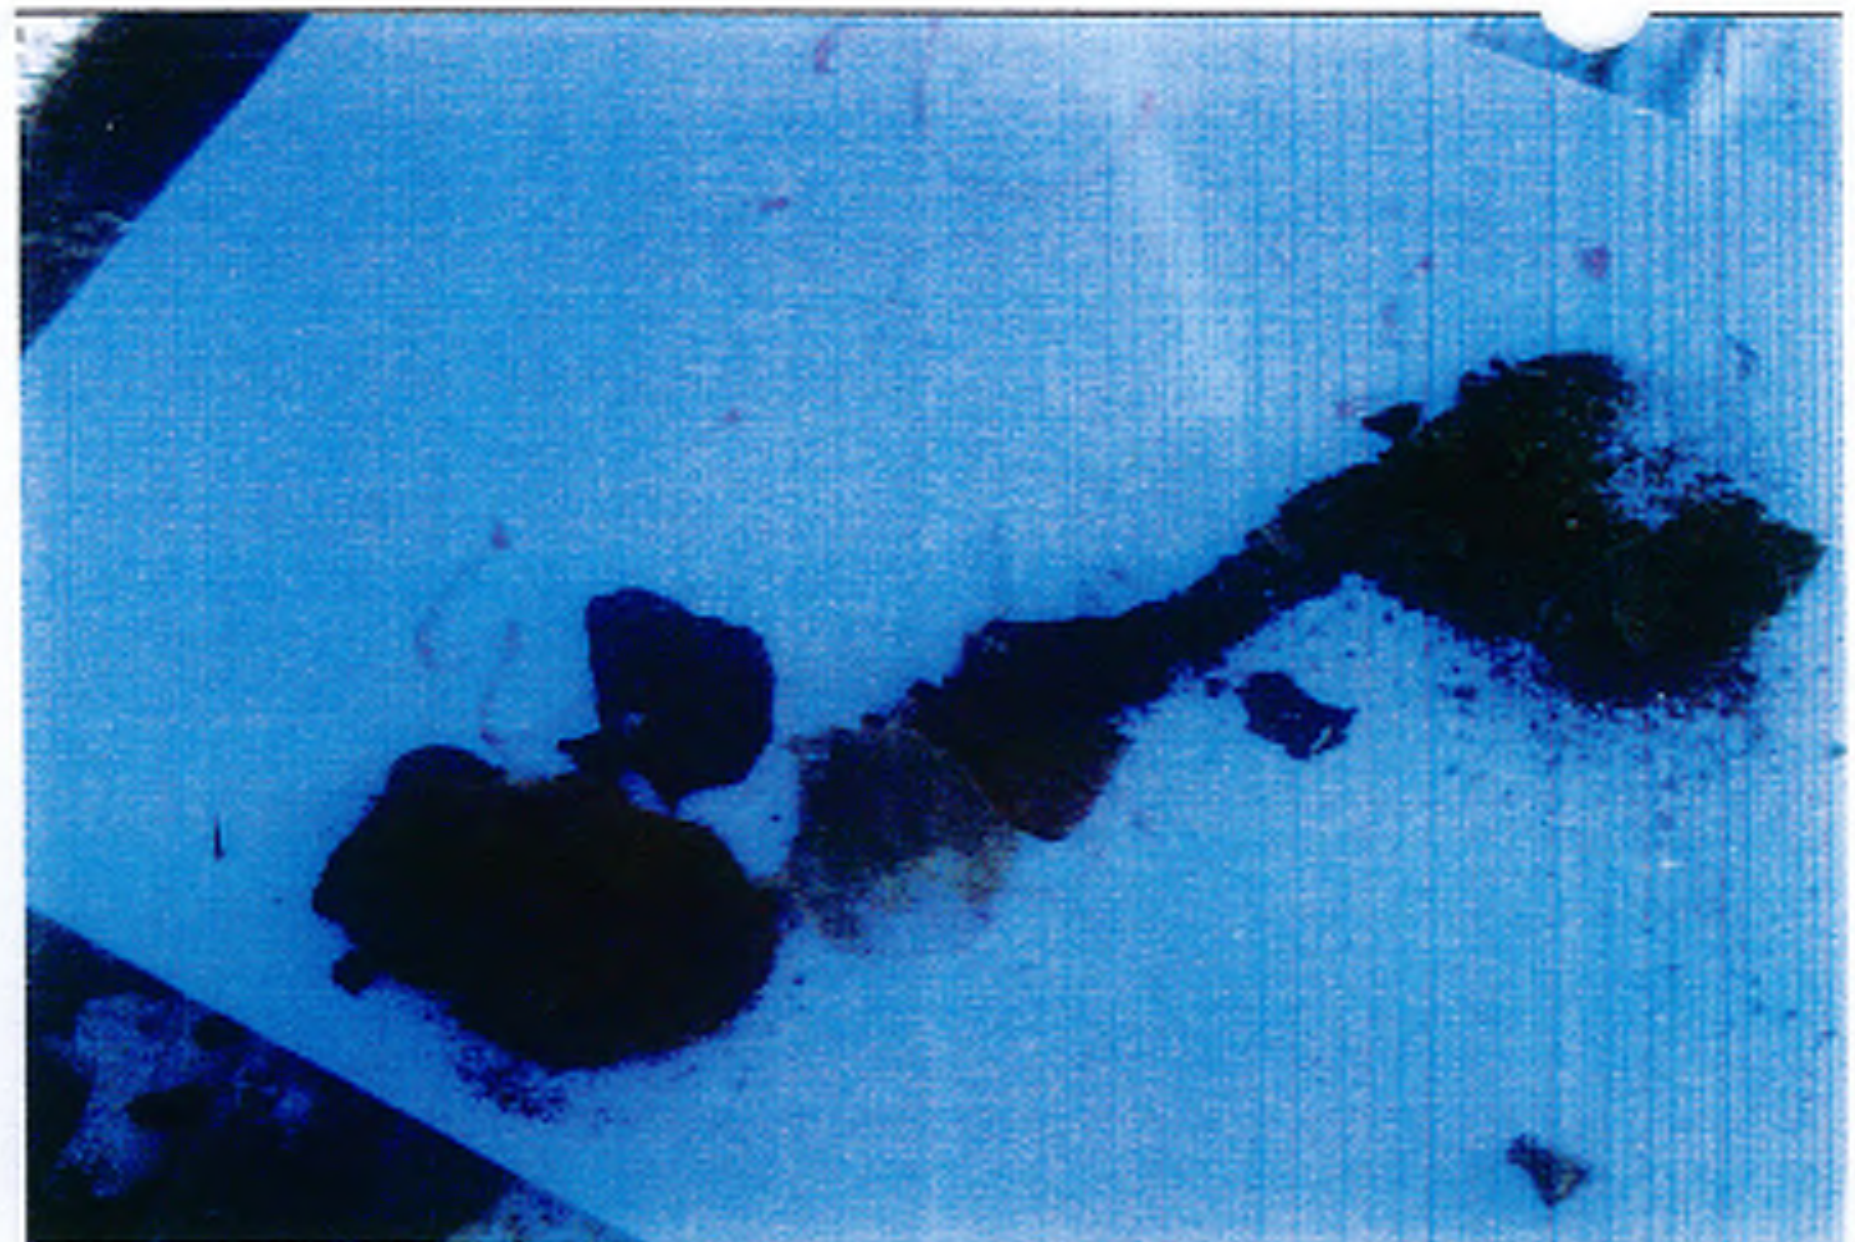
Photograph 21 –Looking at soil cuttings from Boring S3-2. Note that there was no waste material collected in this boring. The entire sampling format was clean.

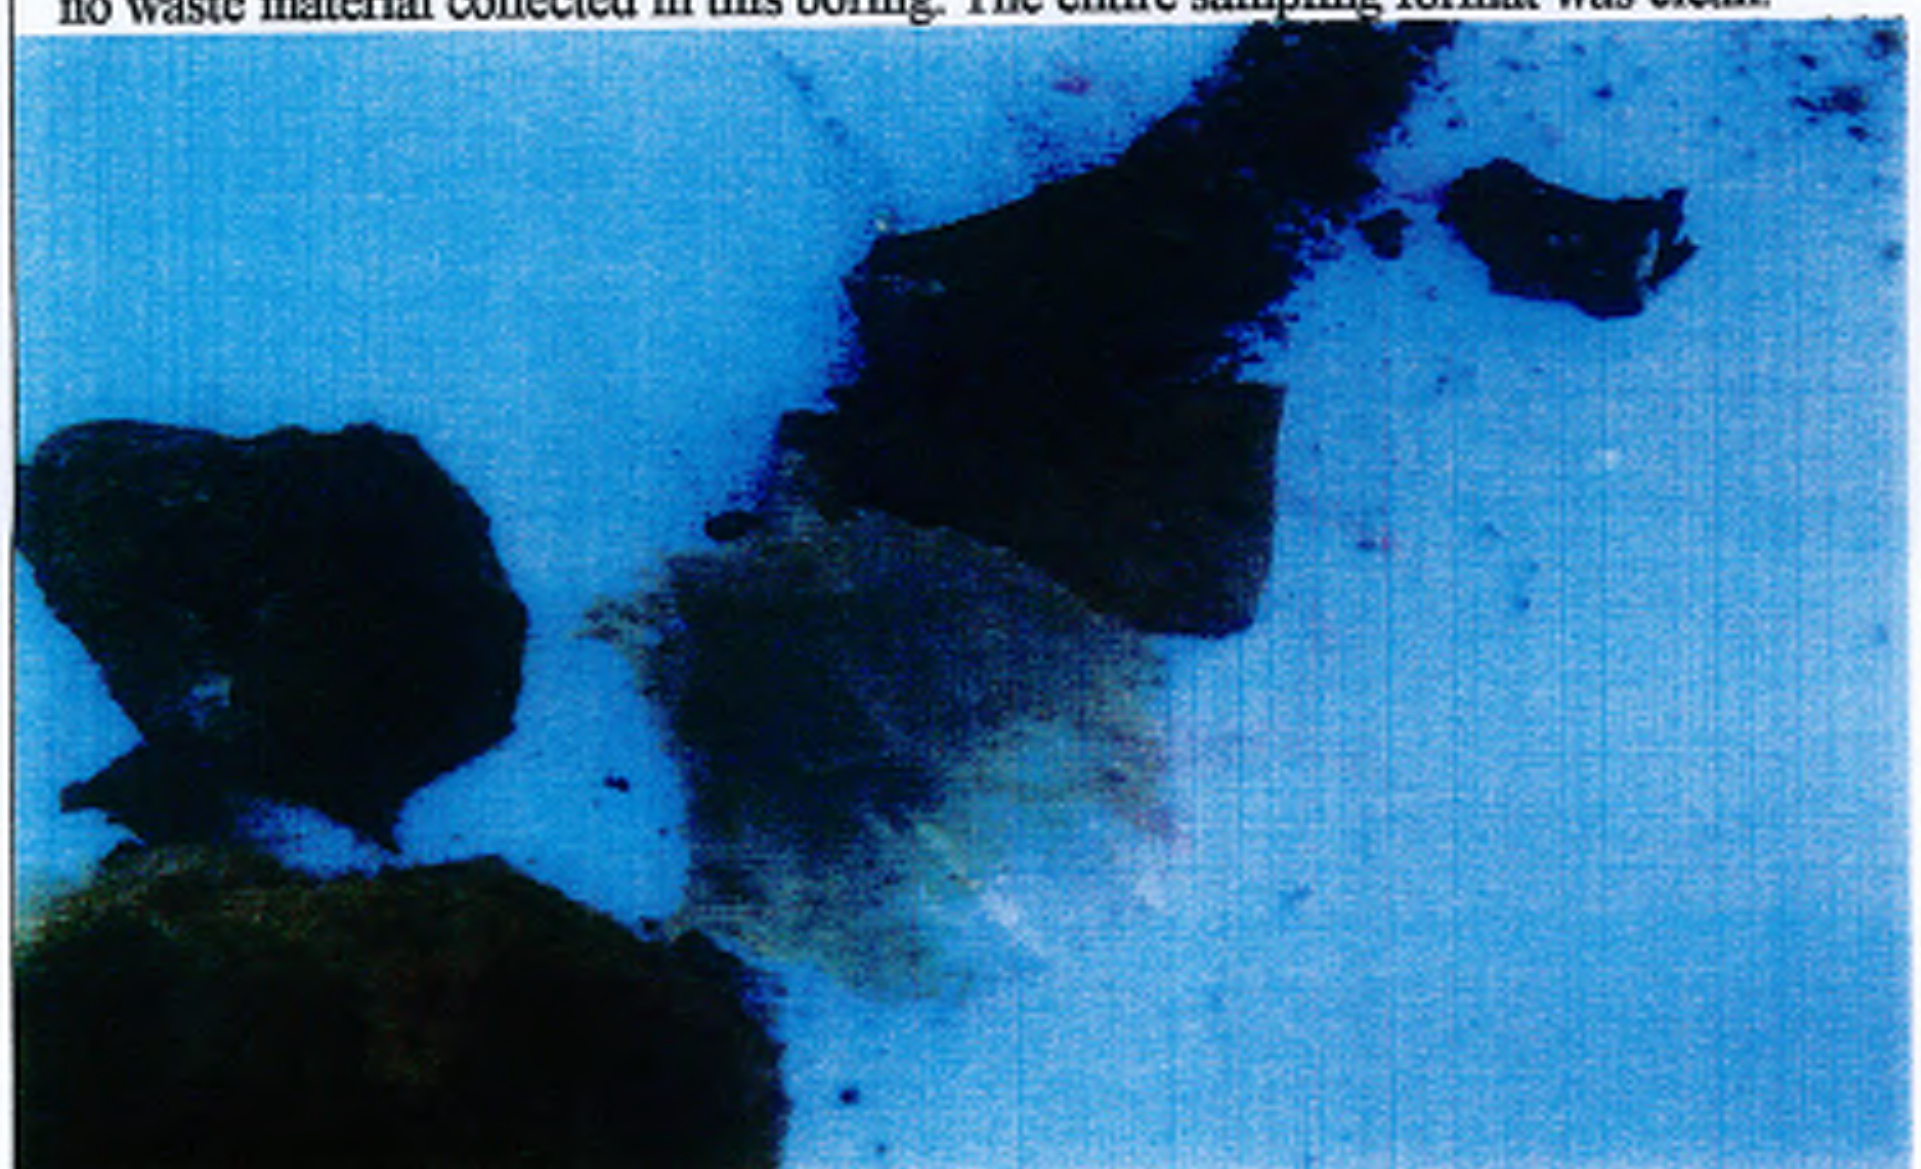
Photograph 22 – Looking at small amounts of wood, plastic, and glass that were collected in Boring S3-3.
