**GEOLOGIC HAZARD INVESTIGATION
VILLAGES AT WATERVIEW NORTH
SOUTH POWERS BOULEVARD AND BRADLEY ROAD
EL PASO COUNTY, COLORADO**

May 15, 2020
Revised: October 1, 2020
Revised: July 15, 2022

Entech Job No. 200599
AAprojects/2020/200599 city geohaz-rev

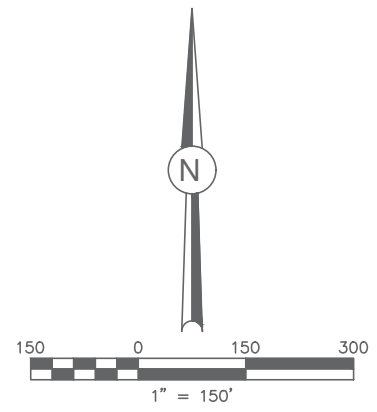
DRAWN
L.L.
CHECKED
DATE
7/11/22
SCALE
AS SHOWN
JOB NO.
200599
FIGURE No.
7

Detailed mapping has been performed on this site to produce an Engineering Geology Map Figure 7. This map shows the location of various geologic conditions of which the developers should be cognizant during the planning, design and construction stages of the project. Hazards include areas of collapsible soils/hydrocompaction, highly expansive soils, potential seasonal shallow groundwater, and shallow bedrock. Minor areas of erosion were also observed. These hazards and the recommended mitigation techniques are as follows:
