GEOLOGIC HAZARD ASSESSMENT PARCEL NOS. 74111-24-137 and 74111-24-206 SUN MOUNTAIN TOWNHOMES WEST UINTAH STREET AND NORTH 21ST STREET COLORADO SPRINGS, COLORADO

Re: Geologic Hazard Assessment

Sun Mountain Townhomes

Entech Job No. 221101

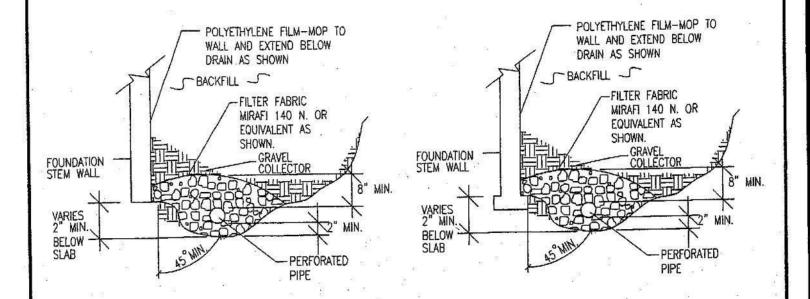
A subsurface drain is recommended for the entire structure. This includes foundation walls between the basement and a crawlspace or garage. Typical drain details are included with this letter.
