Final Report

Gold Hill Mesa Commercial Existing Conditions Survey

City of Colorado Springs Urban Renewal Authority

February 18, 2022

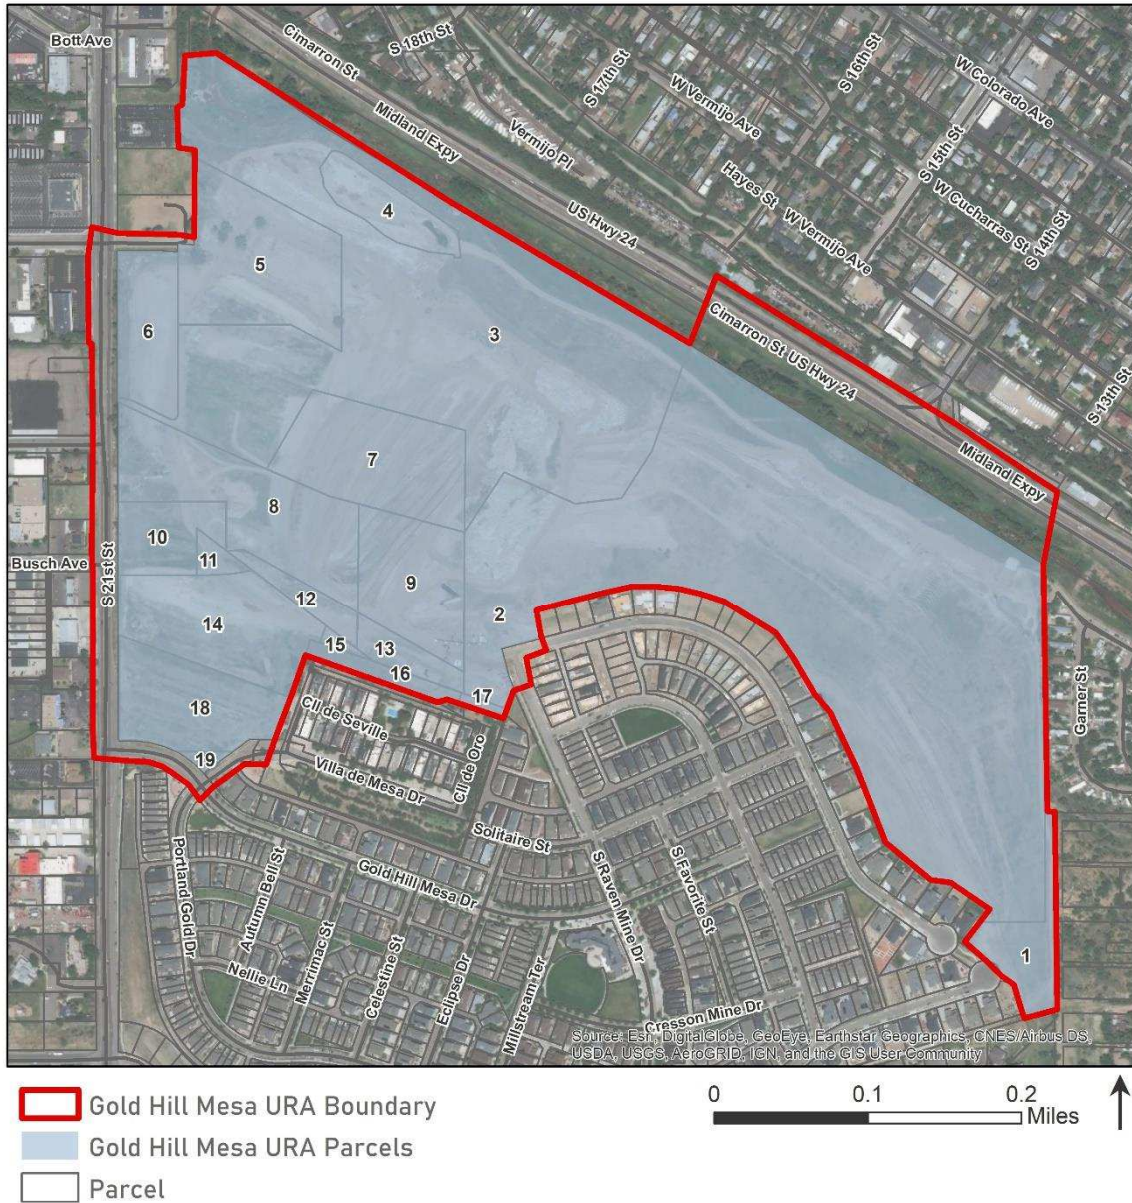
Figure 1. Gold Hill Mesa Proposed URA Boundary and Parcels

The Study Area includes 19 parcels, of which eight parcels are internal and do not have exterior or roadway access. Additionally, parcels range in shape and size with the smallest parcel approximately 0.14 acres. The parcel locations, shape and size are illustrated previously in **Figure 1** and **Table 1**. The lack of access, shape, and small size create impediments for development unless aggregated with adjacent parcels.
