**Geotechnical Evaluation  
Austin Bluffs Tank and Pump Station  
Colorado Springs, Colorado  
Revised**

**Job Number: 25-8003A**

**May 14, 2025**

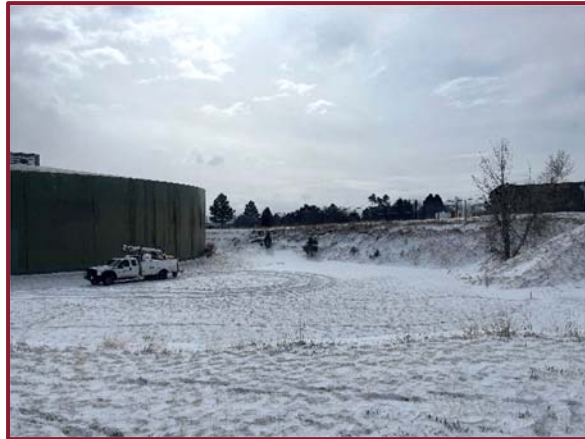
At the time of our exploration, the project site was a relatively flat depression cut out from the upper portion of an irregular, northeast-trending ridge. The area was occupied in large part by an existing, 5-million-gallon, steel tank. and enclosed by chain-link fencing. The flanks of the ridge descended with about 300 feet of relief in the general project area.

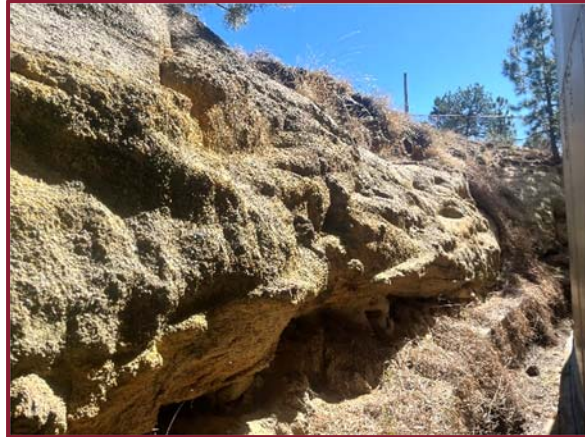
On the southern side of the tank, there was a roughly 10-foot high, shotcrete-covered, approximately 1:1 (horizontal : vertical) descending slope with 2 rows of soil nails or tie back anchors. Relatively steep slopes also descended 10 to 15 feet to west of the tank

and a short distance to the east. The latter exposed sandstone bedrock. Another relatively steep, approximately 30-foot slope ascended northward of the site.

Most slopes in the area stood at angles from about 1:1 to 2:1 (horizontal : vertical) and supported and supported bushes, trees, and other vegetation.
