Appeal of Rejection of Site Plan Submittal without Geohazard Report/Waiver 506 Hawthorne Place Single Family Residence

Appellant: Michael Lowery Resident of Colorado Springs since 1974

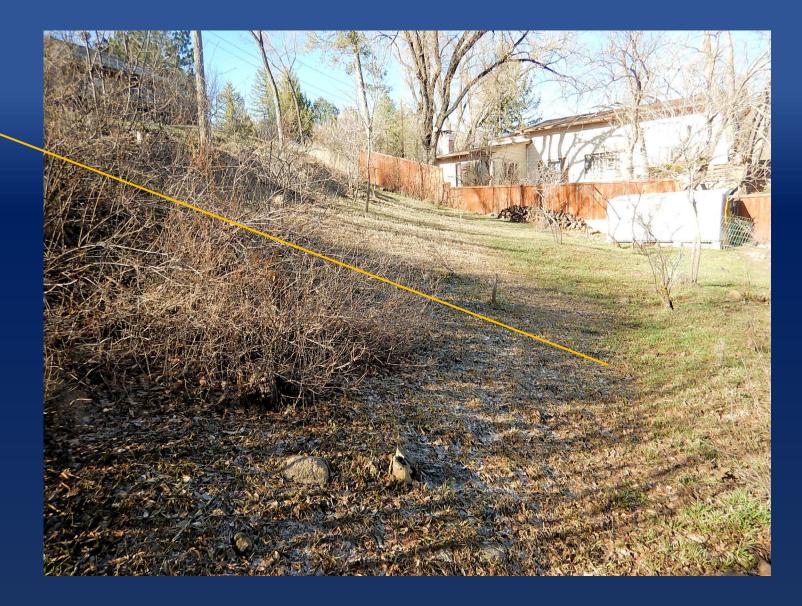
There is a 100-year old irrigation ditch on the 506 lot, on the top of the slope, that has not filled in because of landslides, unstable or creeping soils. Any reasonable engineer would agree.

There are numerous retaining walls in the adjacent neighborhoods in the LSZ that have held without major issues since their construction more than 70 years ago, they can be readily examined by professional engineers as an effective remediation.

Hawthorne Embankment Wash from Embankment After 70 years Wall, water remediation 100 Year foundation **Ditch**

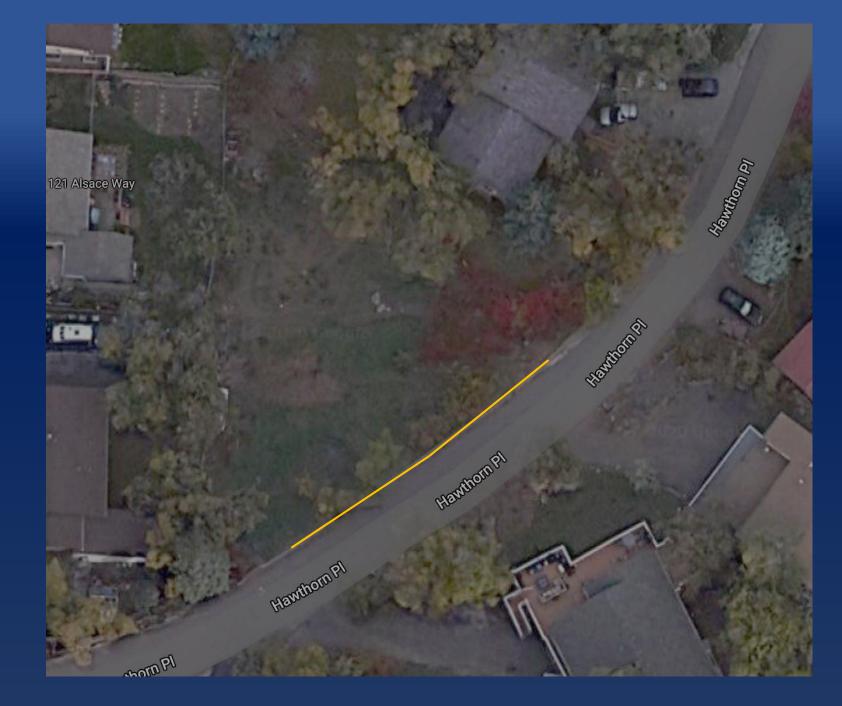
Many well-known foundation designs applicable to unstable soil

Stemwall on rock trench or 5' gravel/rock bed
