**GEOLOGIC HAZARDS EVALUATION AND
PRELIMINARY GEOTECHNICAL INVESTIGATION
OVATION
CHAPEL RIDGE DRIVE AND RHINESTONE DRIVE
COLORADO SPRINGS, COLORADO**

LA PLATA COMMUNITIES
9540 Federal Drive
Colorado Springs, Colorado 80921

CTL|T Project No. CS19669-115

May 2, 2023

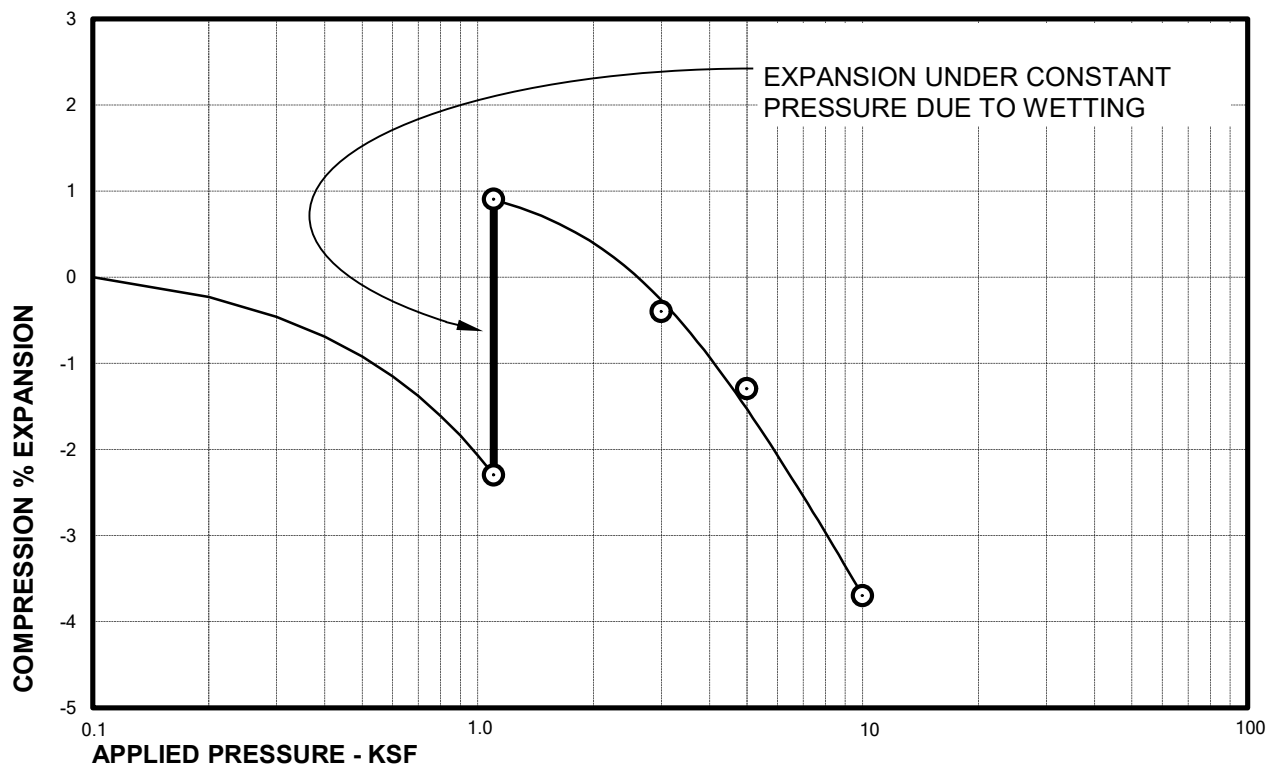
Sample of WEATHERED CLAYSTONE
From TH-1 AT 9 FEET

DRY UNIT WEIGHT= 85 PCF
MOISTURE CONTENT= 34.2 %
