ENTECH
ENGINEERING, INC.

**GEOLOGIC HAZARD INVESTIGATION
VILLAGES AT WATERVIEW NORTH
SOUTH POWERS BOULEVARD AND BRADLEY ROAD
EL PASO COUNTY, COLORADO**

May 15, 2020
Revised: October 1, 2020
Revised: July 15, 2022

Entech Job No. 200599
AAprojects/2020/200599 city geohaz-rev

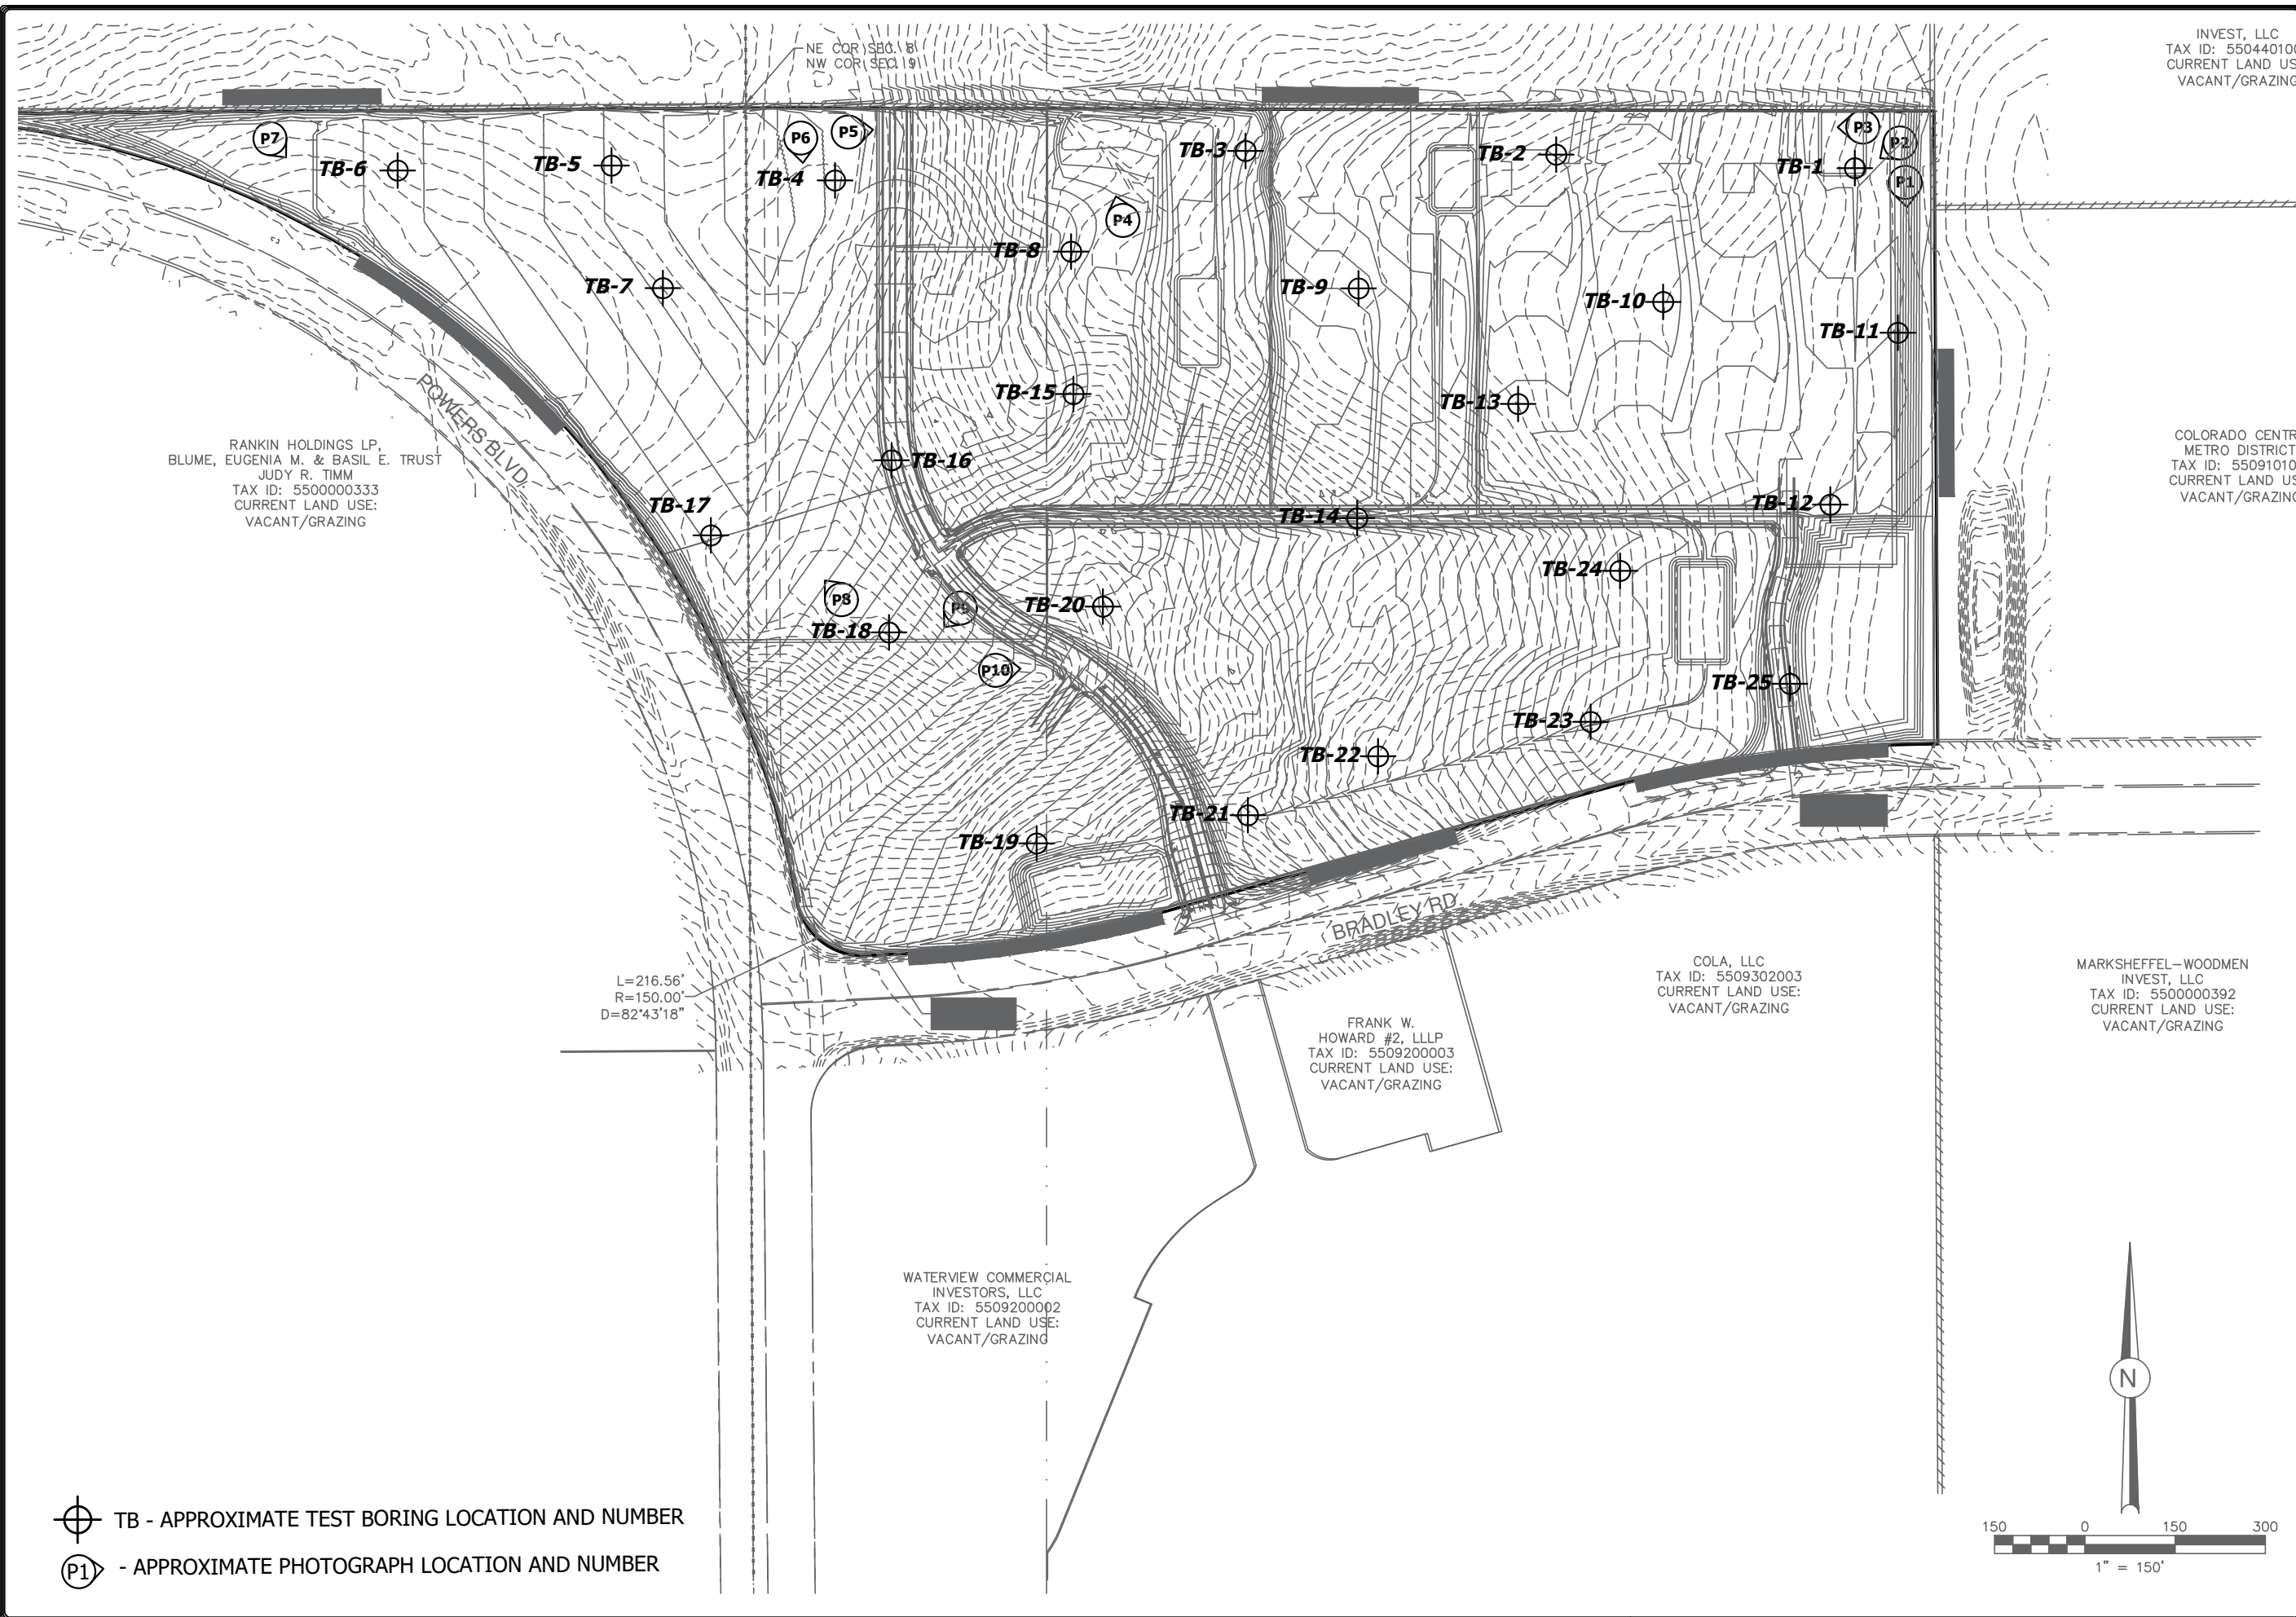
DRAWN L.L.
CHECKED
DATE 7/11/22
SCALE AS SHOWN
JOB NO. 200599
FIGURE No. 3

- TB - APPROXIMATE TEST BORING LOCATION AND NUMBER
- P1 - APPROXIMATE PHOTOGRAPH LOCATION AND NUMBER

SITE MAP/TEST BORING LOCATION MAP
VILLAGES AT WATERVIEW NORTH
POWERS BOULEVARD AND BRADLEY ROAD
EL PASO COUNTY, CO.
FOR: CPR ENTITLEMENTS, LLC

Total acreage involved in the proposed development is approximately 118 acres. The proposed site development consists of a combination of industrial, commercial, and residential development and associated site improvements. The industrial lots will be located in the northwestern portion of the site; the commercial lots will be located in the southwestern portion of the site, and the residential lots will be located in the eastern portions of the site. Twenty-five (25) Test Borings were performed on the site to determine general soil and bedrock characteristics. The locations of the test borings are indicated on the Site Map/Test Boring Location Map, Figure 3. The Preliminary Sketch Plan is presented in Figure 4.

Twenty-five (25) Test Borings were drilled on the site to determine general soil and bedrock characteristics. The locations of the test borings are indicated on the Site Map/Test Boring Location Map, Figure 3. The Test Boring Logs are presented in Appendix B. Results of this testing will be discussed later in this report.

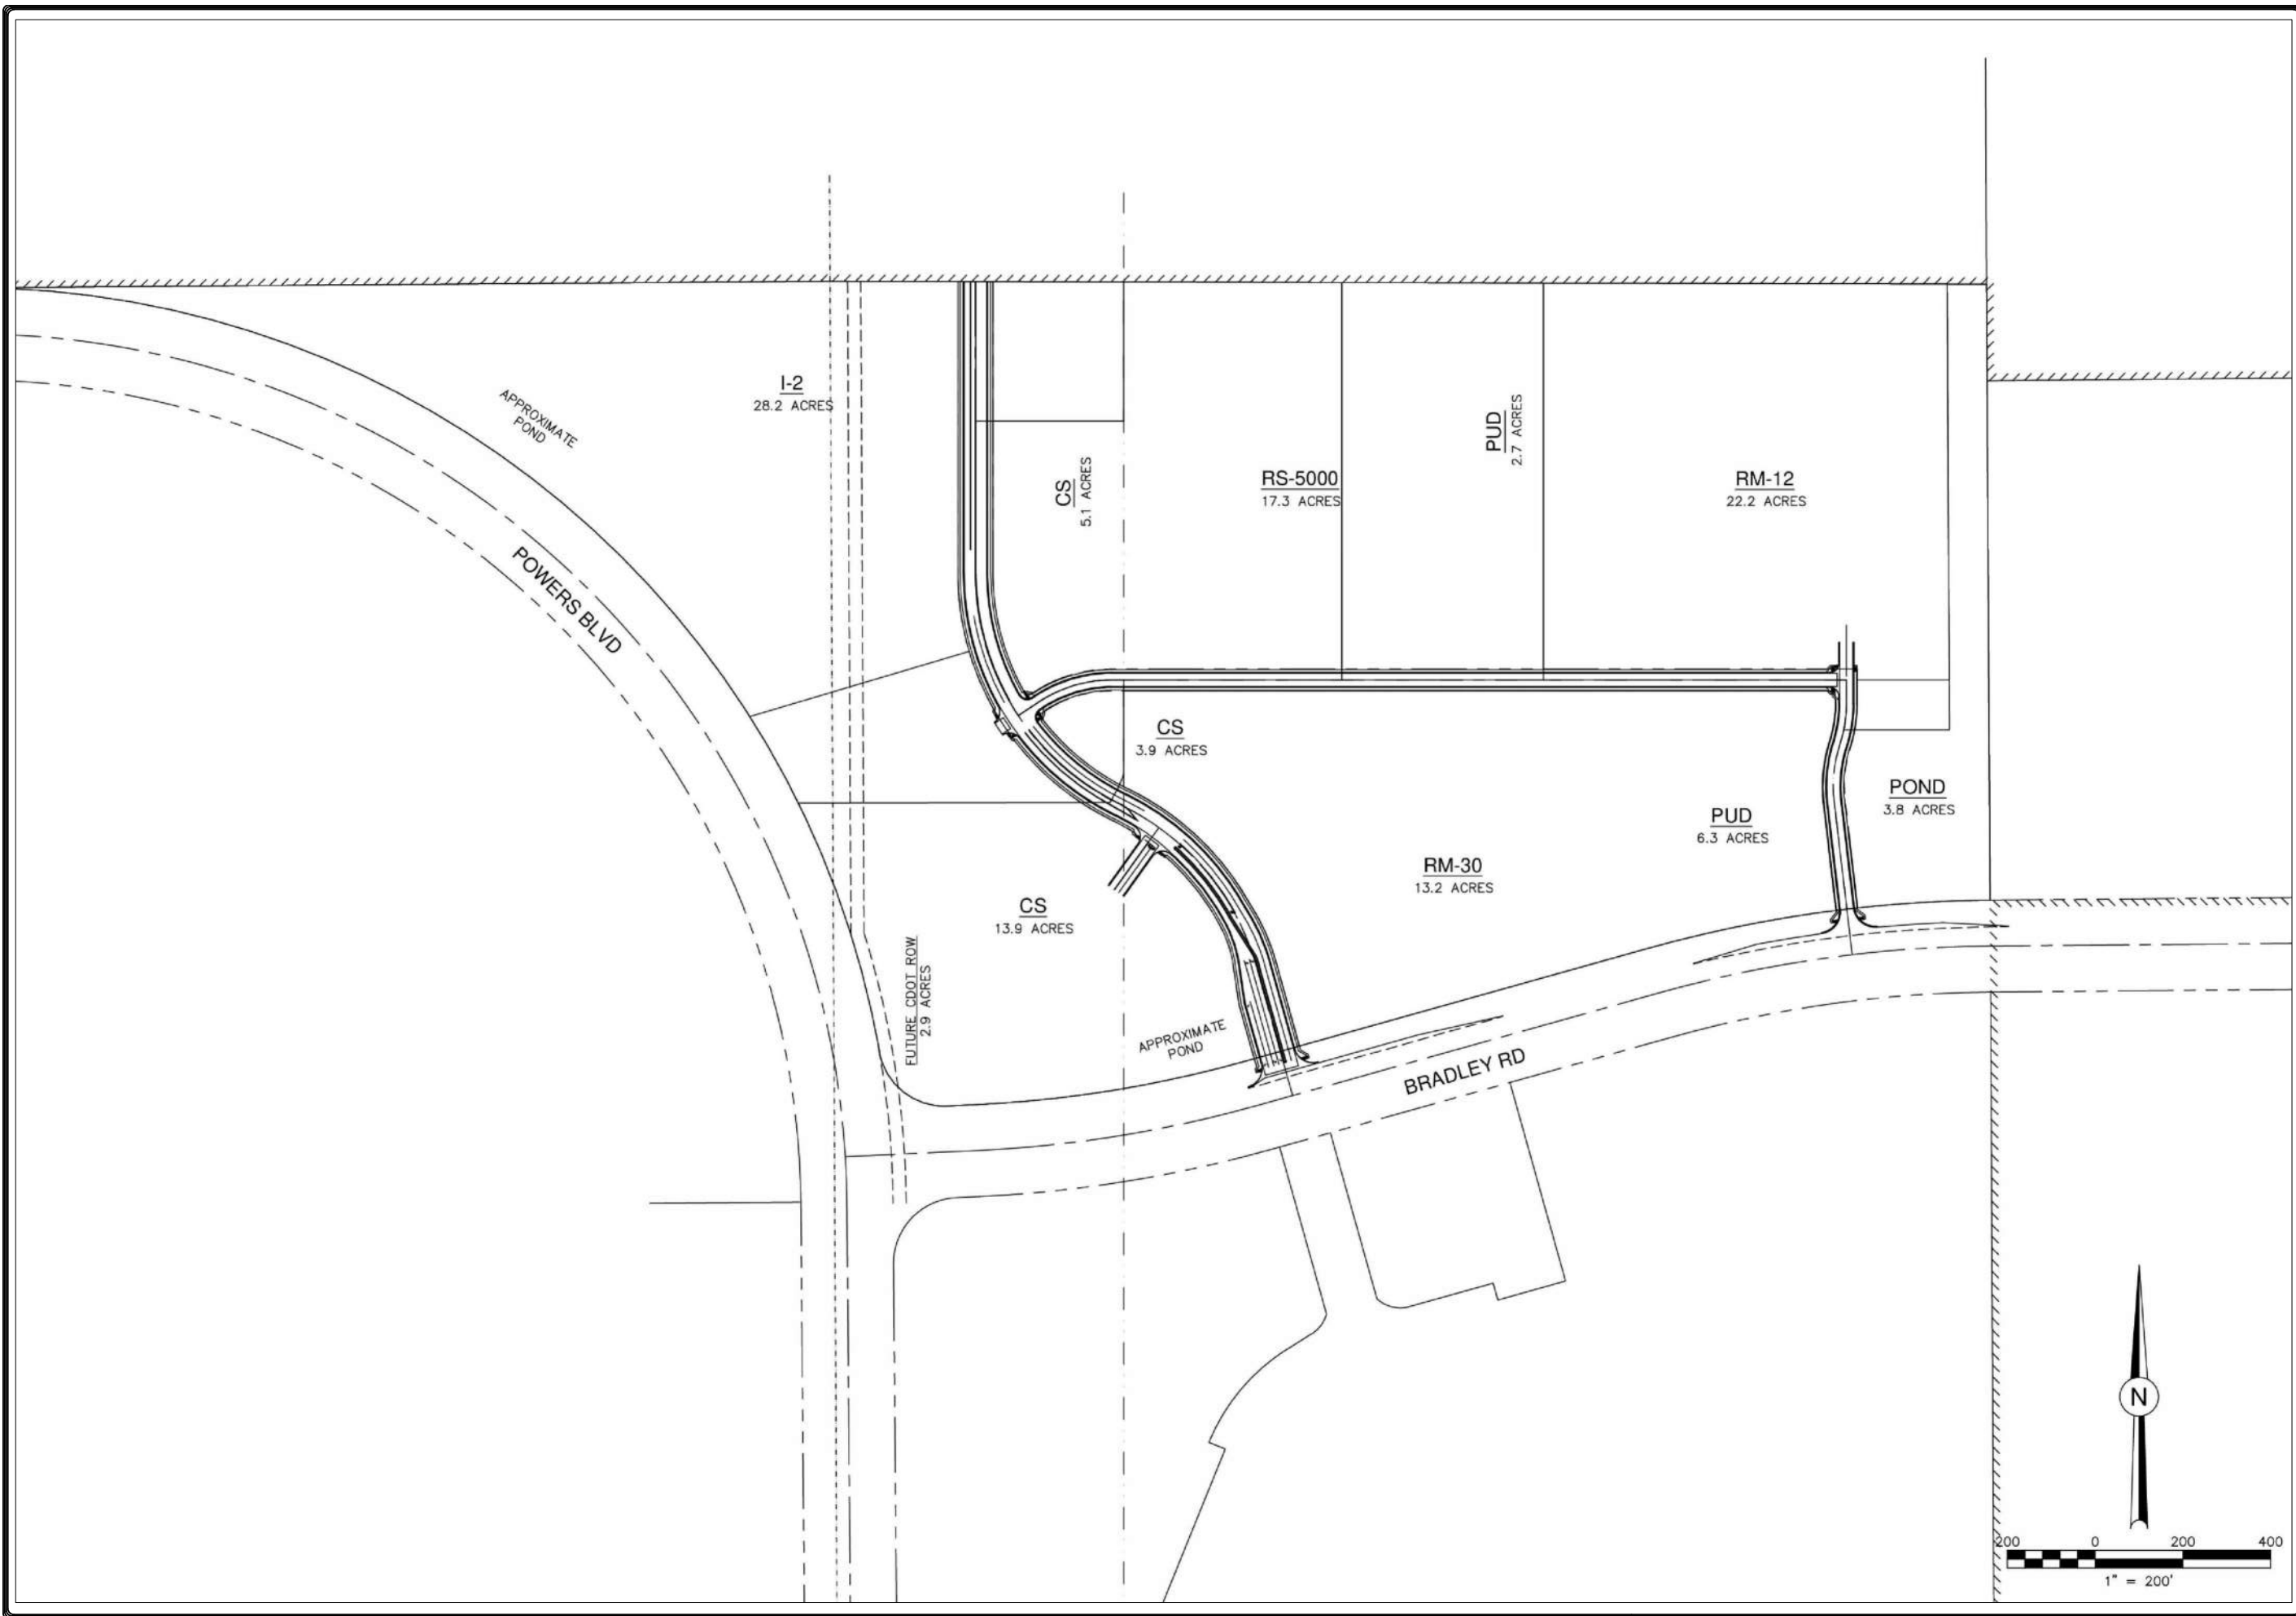
DRAWN L.L.
CHECKED
DATE 7/11/22
SCALE AS SHOWN
JOB NO. 200599
FIGURE No. 4

PROPOSED SKETCH PLAN
VILLAGES AT WATERVIEW NORTH
POWERS BOULEVARD AND BRADLEY ROAD
EL PASO COUNTY, CO.
FOR: CPR ENTITLEMENTS, LLC

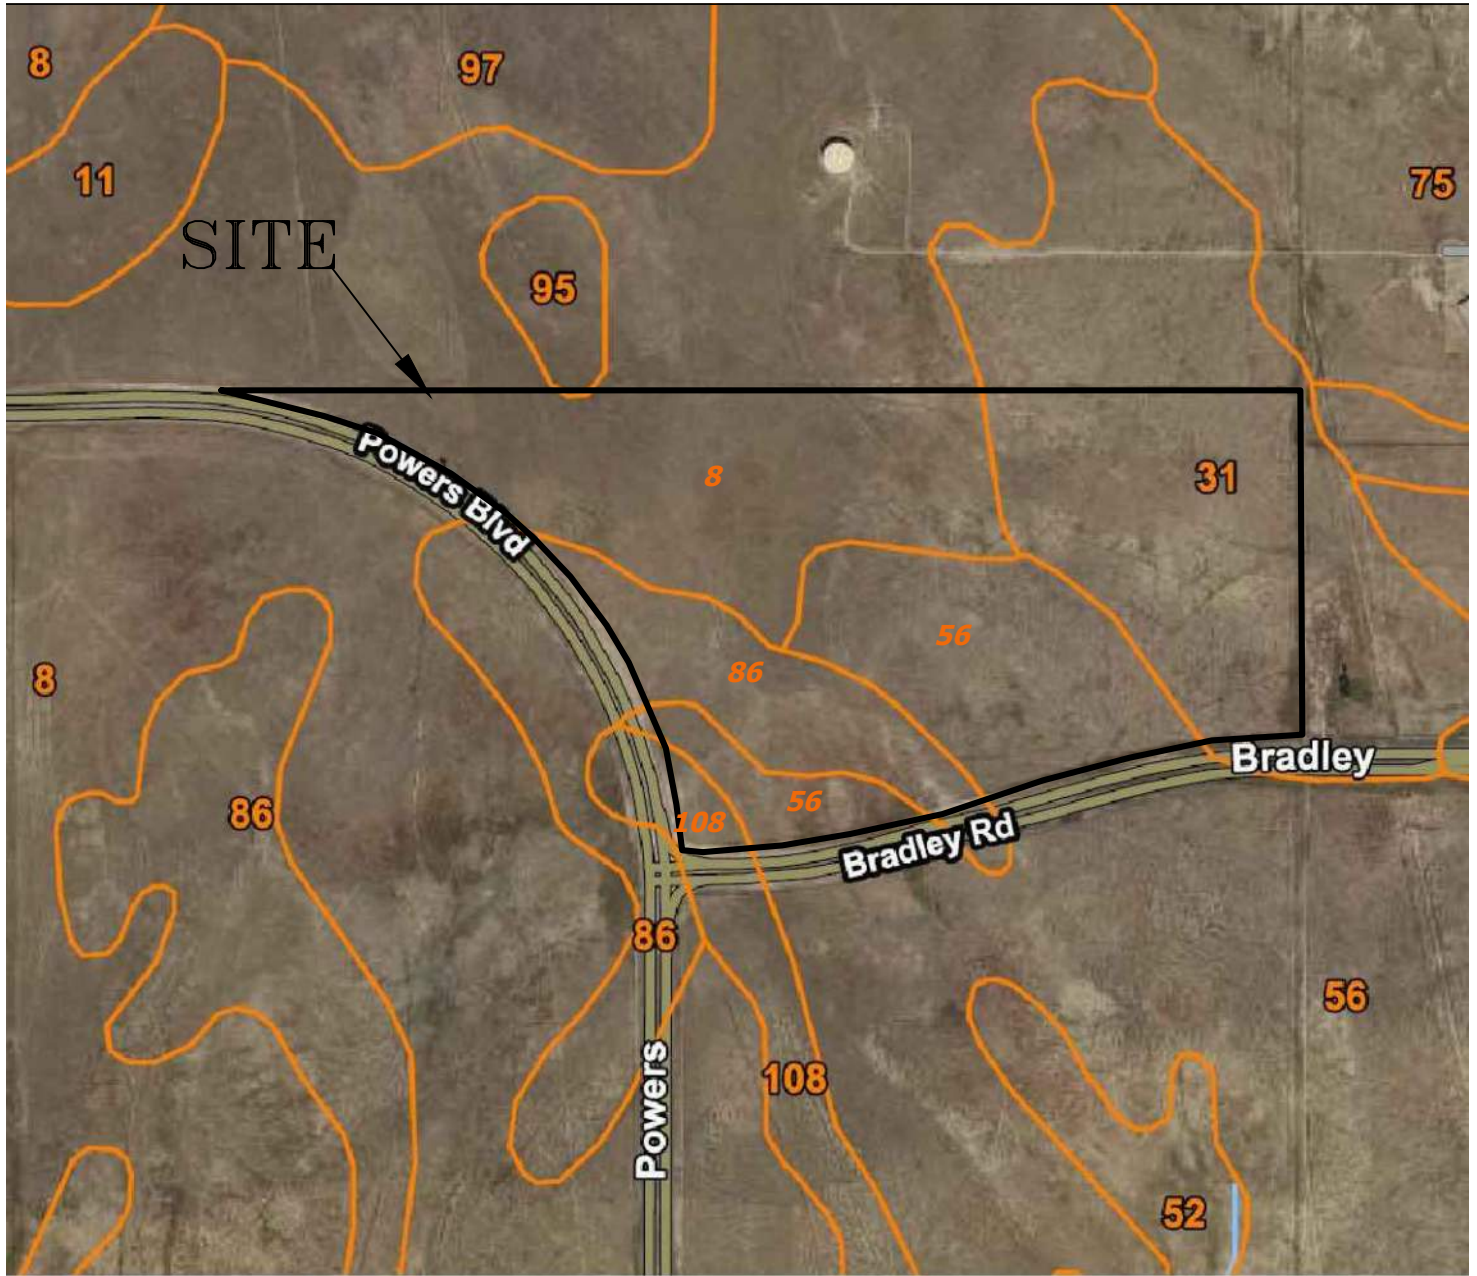
FIG NO.:
 5

SOIL SURVERY MAP
 VILLAGES AT WATERVIEW NORTH
 POWERS BOULEVARD AND BRADLEY ROAD
 EL PASO COUNTY, CO.
 FOR: CPR ENTITLEMENTS, LLC

Complete descriptions of each soil type are presented in Appendix C. The soils have generally been described to have rapid to moderate permeabilities. Possible hazards with soil erosion are present on the site. The erosion potential can be controlled with vegetation. The majority of the soils have been described to have moderate erosion hazards.

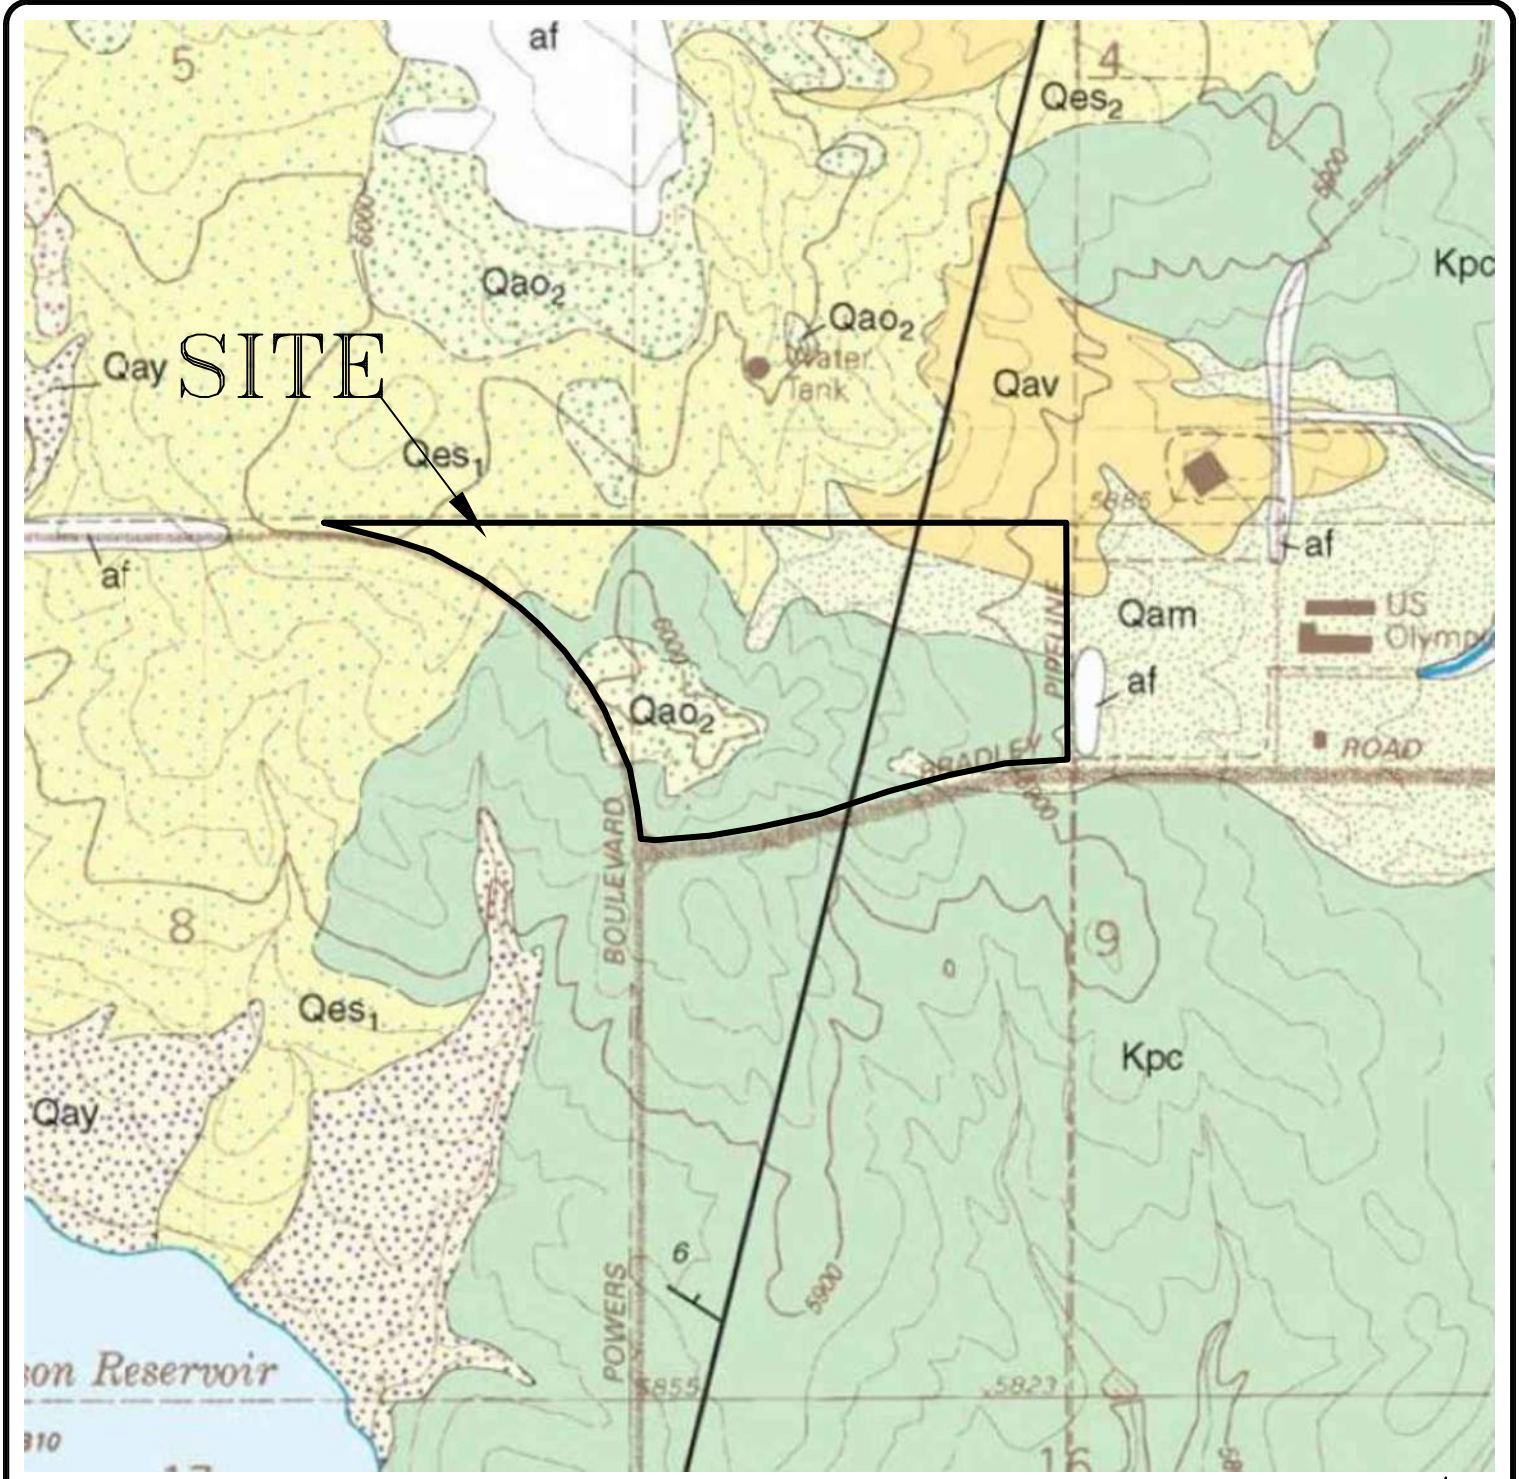
FIG NO.:
6

ELSMERE QUADRANGLE GEOLOGY MAP
WATERVIEW NORTH
POWERS BOULEVARD AND BRADLEY ROAD
EL PASO COUNTY, CO.
FOR: CPR ENTITLEMENTS, LLC

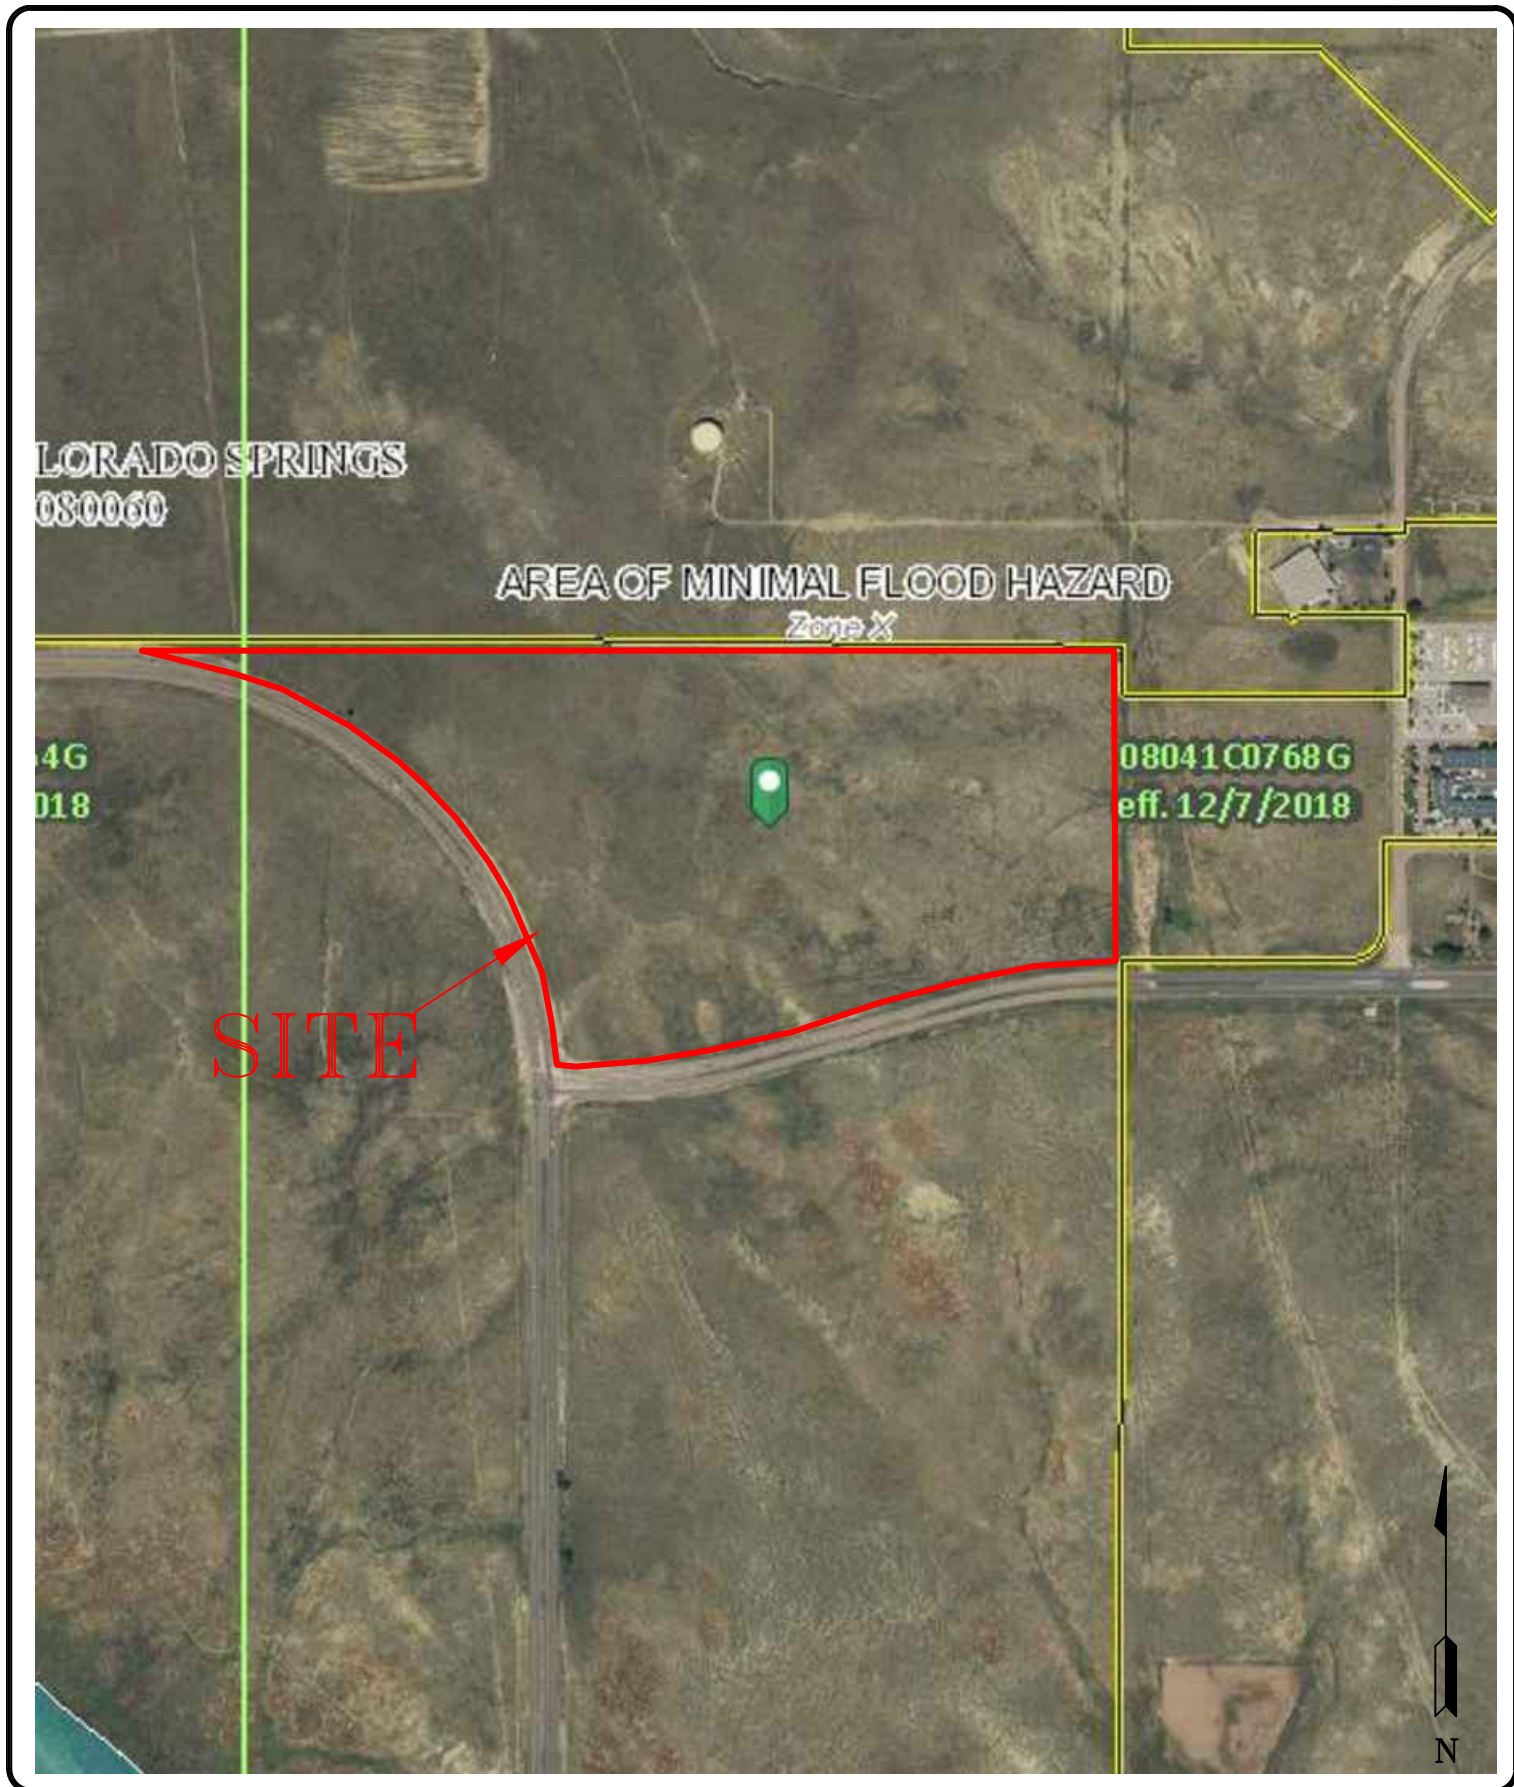
FIG NO.:
8

FLOODPLAIN MAP
WATERVIEW NORTH
POWERS BOULEVARD AND BRADLEY ROAD
EL PASO COUNTY, CO.
FOR: CPR ENTITLEMENTS, LLC

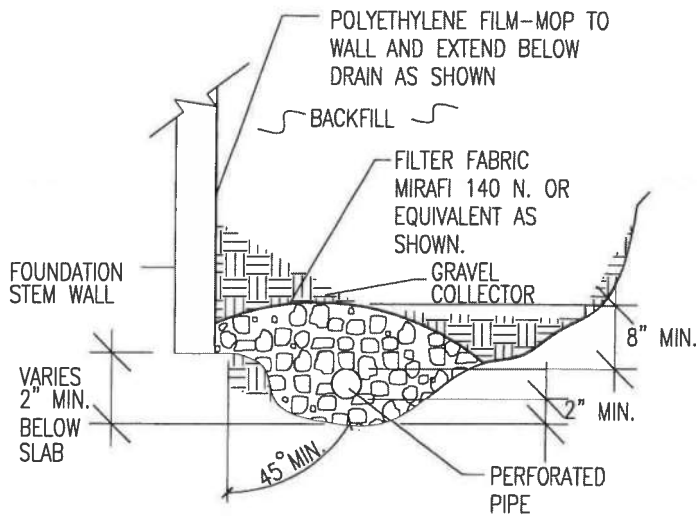
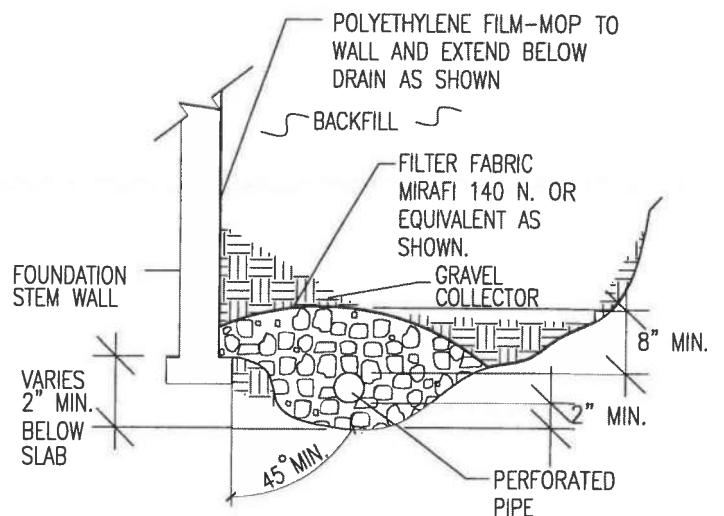
FIG NO.:
9

-GRAVEL SIZE IS RELATED TO DIAMETER OF PIPE PERFORATIONS-85% GRAVEL GREATER THAN 2x PERFORATION DIAMETER.

- Figure 1: Vicinity Map
- Figure 2: USGS Map
- Figure 3: Site Map/Test Boring Location Map
- Figure 4: Proposed Sketch Plan
- Figure 5: Soil Survey Map
- Figure 6: Elsmere Quadrangle Geology Map
- Figure 7: Geology Map/Engineering Geology
- Figure 8: Floodplain Map
- Figure 9: Typical Perimeter Drain Detail
