## GEOLOGIC HAZARD STUDY APPLICATION

Site Location: 2060 Old Ranch Rd, 1455 Kettle Creek Rd, 10515 Kettle Creek Rd

RMG – Rocky Mountain Group was retained to perform a Geologic Hazard Study of the site referenced above. The purpose of this study is to identify/characterize geologic conditions present on the site, and present our opinions of the potential effect of these conditions on the currently proposed development of the site.

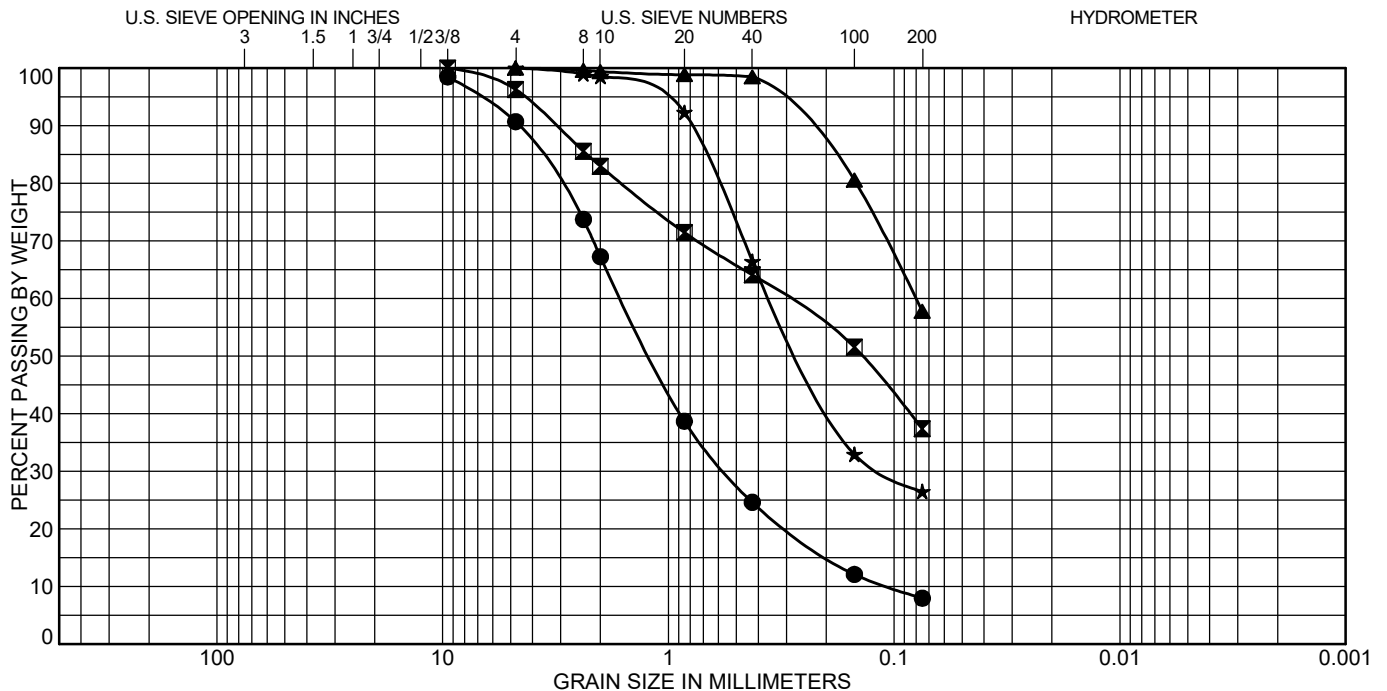
FIGURE No. 7

| COBBLES | GRAVEL | | SAND | | | SILT OR CLAY |
| | coarse | fine | coarse | medium | fine | |

The moisture content for the recovered samples was obtained in the laboratory. Grain-size analysis, Atterberg Limits, and Denver Swell/Consolidation tests were performed on selected samples for purposes of classification and to develop pertinent engineering properties. A Summary of Laboratory Test Results is presented in Figure 6. Soil Classification Data are presented in Figure 7. Swell/Consolidation Test Results are presented in Figures 8 and 9.

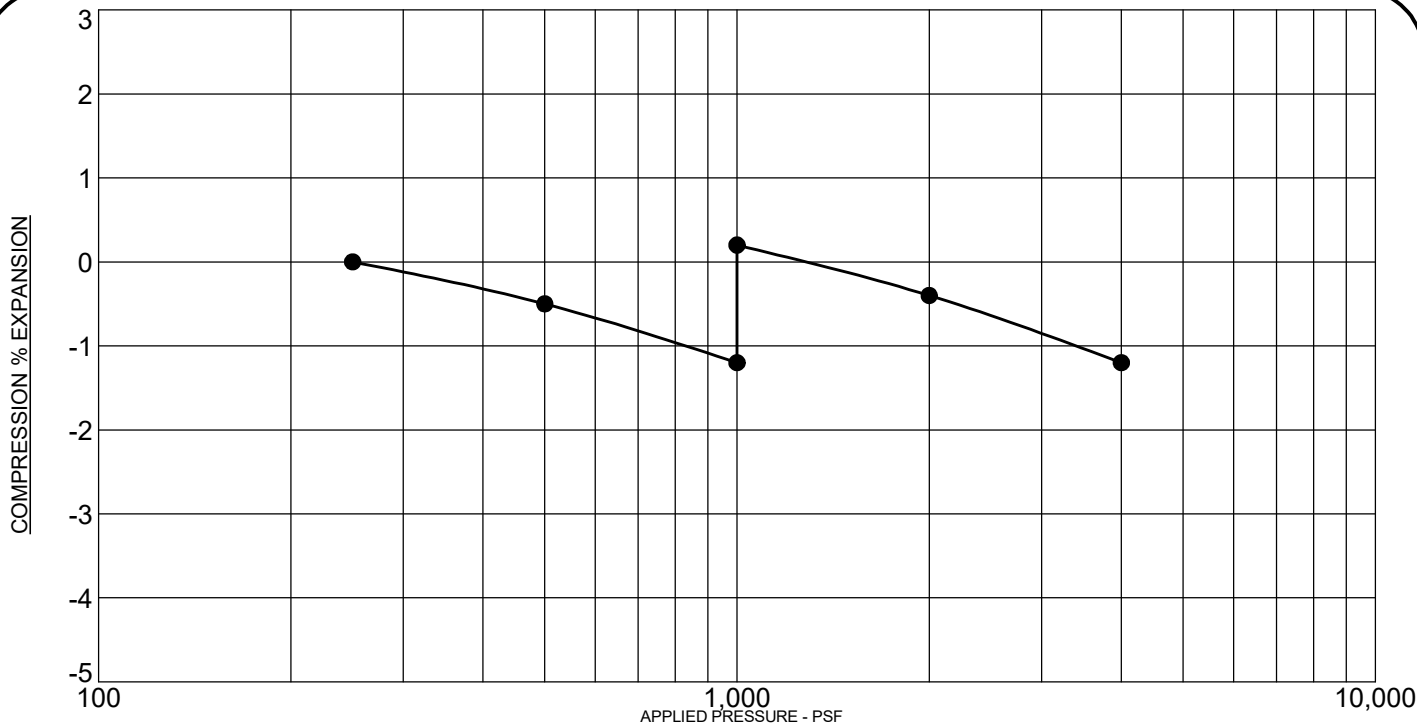
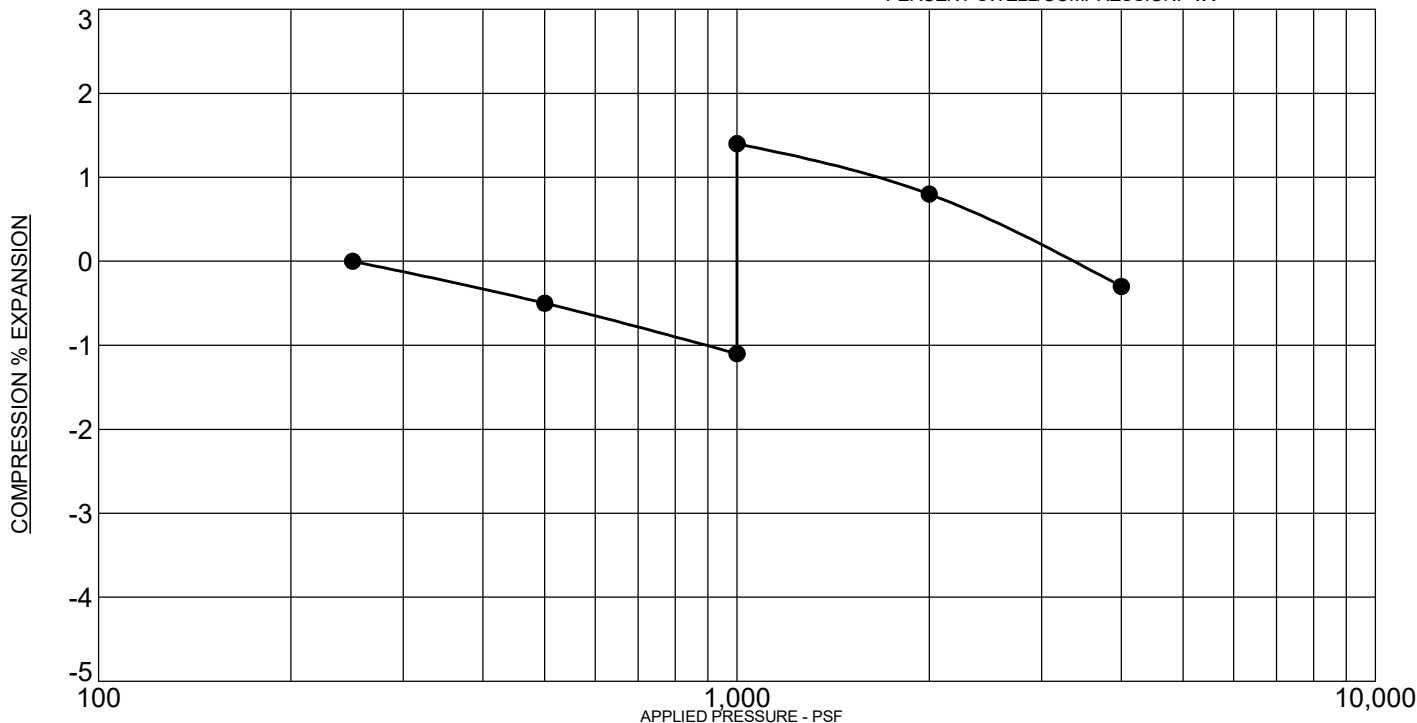
FIGURE No. 8

PROJECT: Kettle Creek Rd, Colorado Springs, Colorado  
 SAMPLE DESCRIPTION: SANDSTONE, CLAYEY  
 NOTE: SAMPLE WAS INUNDATED WITH WATER AT 1,000 PSF

SAMPLE LOCATION: 1 @ 14 FT  
 NATURAL DRY UNIT WEIGHT: 108.4 PCF  
 NATURAL MOISTURE CONTENT: 27.0%  
 PERCENT SWELL/COMPRESSION: 1.4

PROJECT: Kettle Creek Rd, Colorado Springs, Colorado  
 SAMPLE DESCRIPTION: CLAYSTONE, SANDY  
 NOTE: SAMPLE WAS INUNDATED WITH WATER AT 1,000 PSF

SAMPLE LOCATION: 2 @ 14 FT  
 NATURAL DRY UNIT WEIGHT: 102.2 PCF  
 NATURAL MOISTURE CONTENT: 21.5%  
 PERCENT SWELL/COMPRESSION: 2.5

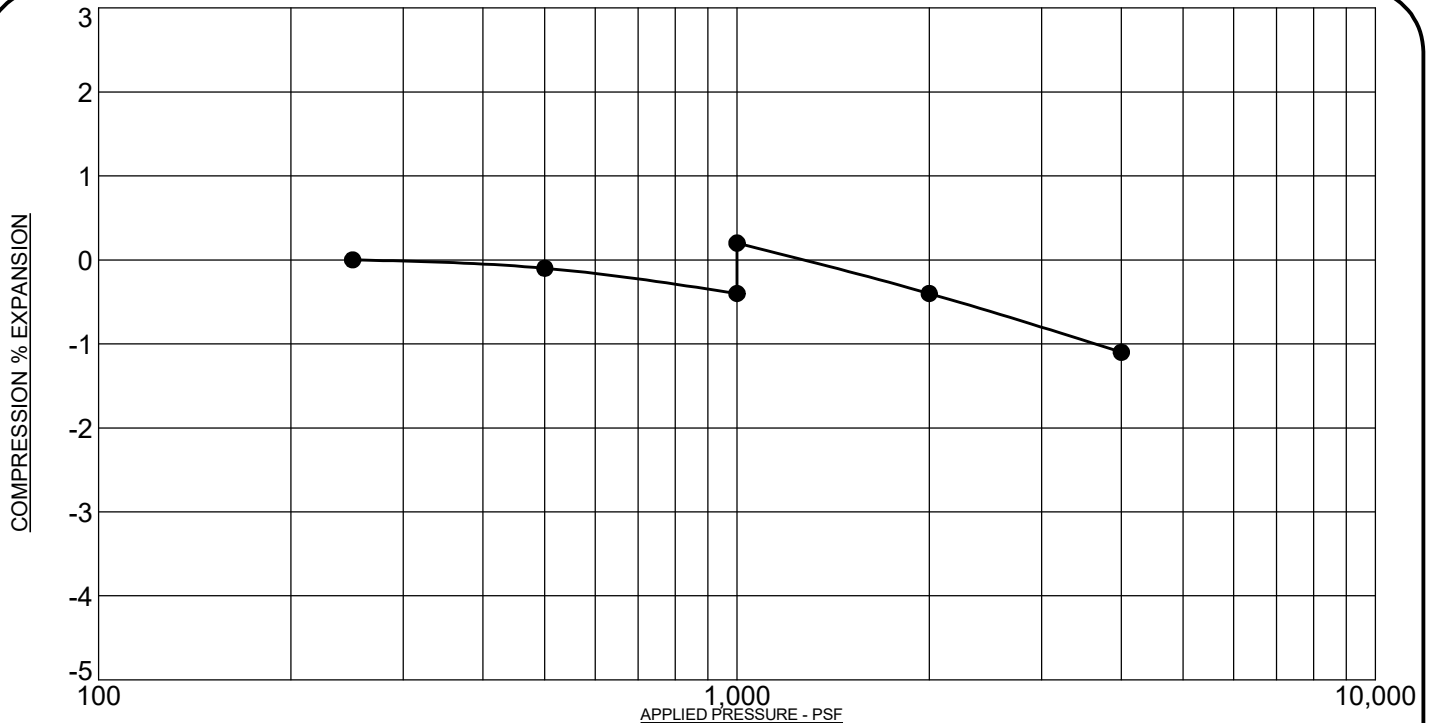
FIGURE No. 9

PROJECT: **Kettle Creek Rd, Colorado Springs, Colorado**  
 SAMPLE DESCRIPTION: **SAND, CLAYEY**  
 NOTE: **SAMPLE WAS INUNDATED WITH WATER AT 1,000 PSF**

SAMPLE LOCATION: **3 @ 9 FT**  
 NATURAL DRY UNIT WEIGHT: **100.2 PCF**  
 NATURAL MOISTURE CONTENT: **26.3%**  
 PERCENT SWELL/COMPRESSION: **0.6**
