**GEOLOGIC HAZARD EVALUATION AND  
GEOTECHNICAL INVESTIGATION  
ARROWSWEST APARTMENTS  
GARDEN OF THE GODS AND 30<sup>TH</sup> STREET  
COLORADO SPRINGS, COLORADO**

WEIDNER APARTMENT HOMES  
9757 NE Juanita Drive, Suite 3  
Kirkland, WA 98034

Attention: Mr. David Avenell  
CTL|T Project No. CS19280-120

September 14, 2020

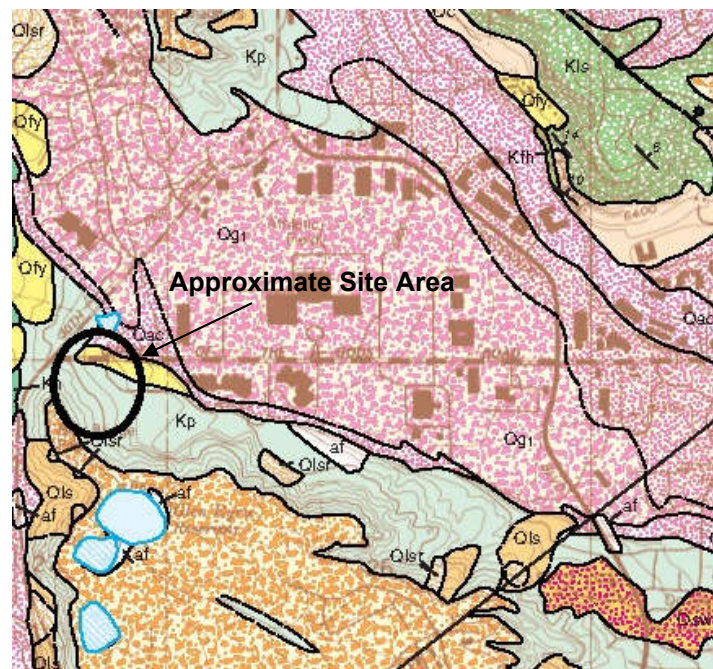
Geologic Map

Based on geologic mapping by Thorson and others (Thorson, 2001), the site is mapped predominantly as Kp, Pierre Shale For-

mation. The Pierre Shale is an Upper Cretaceous aged marine shale interbedded with bentonite, sandstone, and siltstone beds. This formation typically weathers near the ground surface to materials classified by engineering terms of clay, weathered claystone, and claystone as well as shale. The bedding within the Pierre Shale Formation in

Geologic conditions were evaluated through the review of published geologic maps, field reconnaissance, and our subsurface investigations. Information from these sources was used to produce our interpretation of site geology, as shown in Fig. 2. A list of references is included at the end of this report.

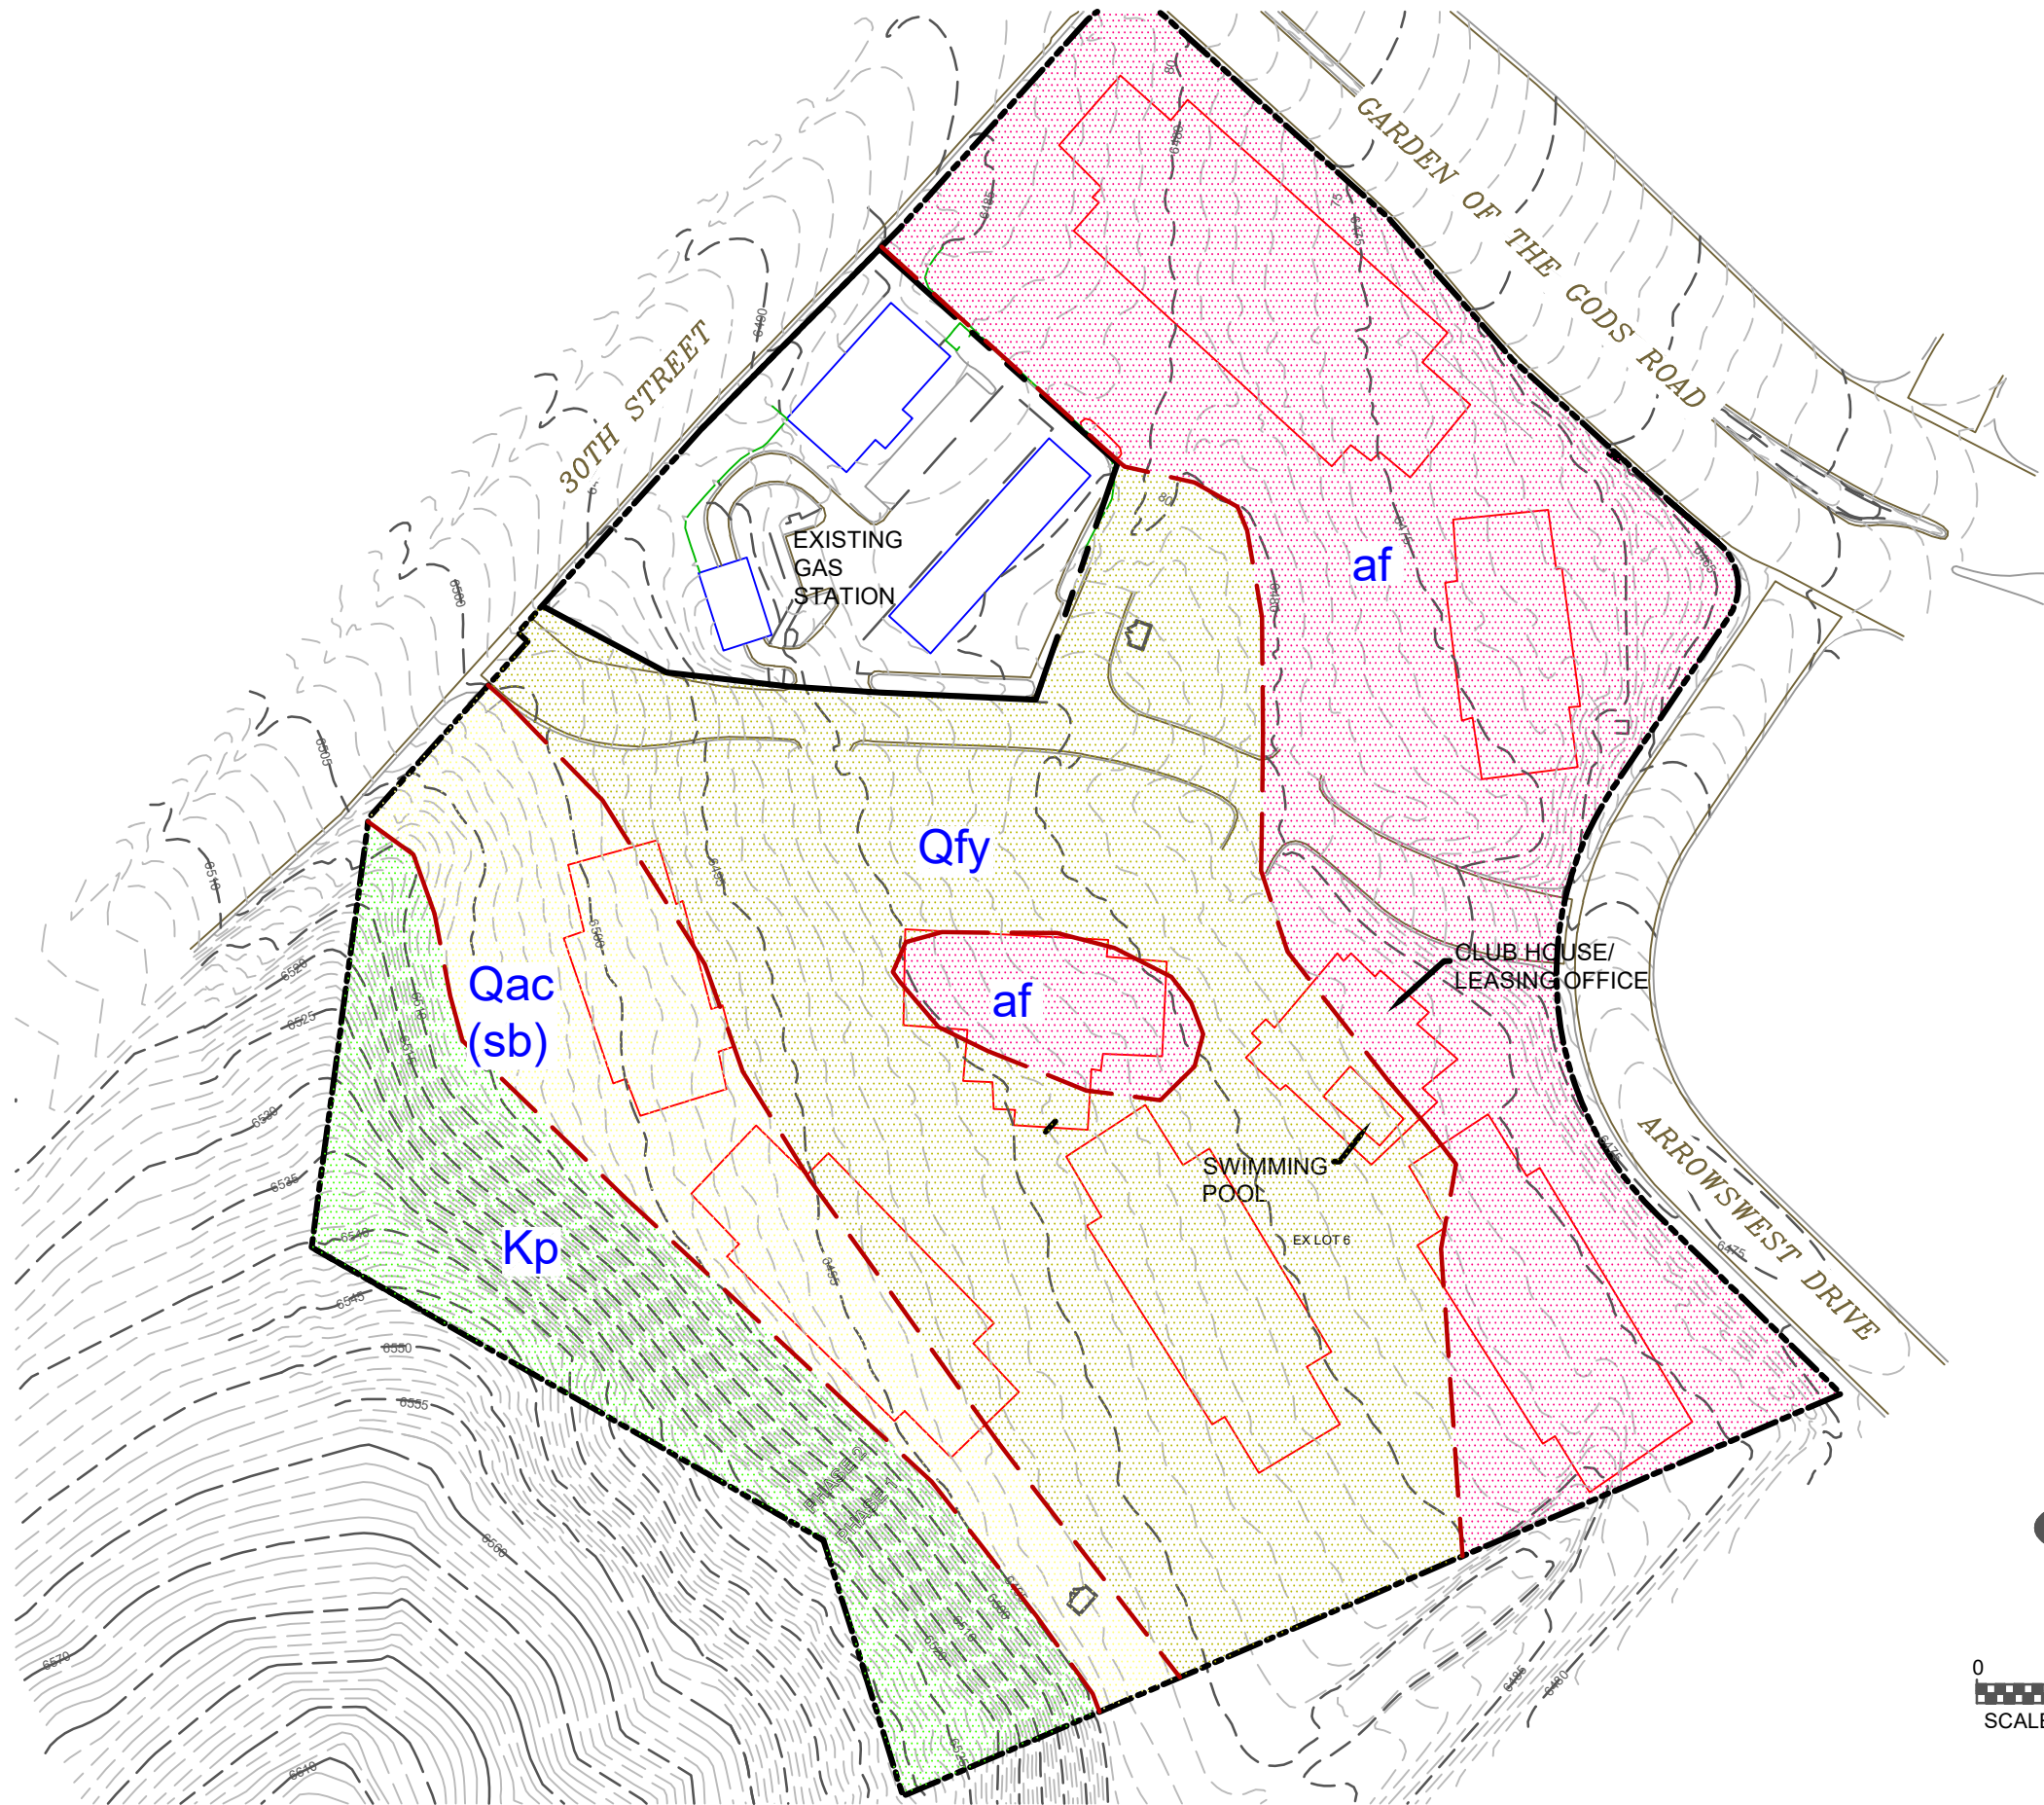
NOTES: THE CONTACTS BETWEEN GEOLOGIC UNITS WAS BASED ON A SUBJECTIVE INTERPOLATION OF CONDITION FOUND IN TEST HOLES REVISED OF AVAILABLE MAPPING, A SITE RECONNAISSANCE AND OUR EXPERIENCE. LOCAL VARIATIONS SHOULD BE EXPECTED.

Holocene-age, undivided alluvium and colluvium is also mapped at the far north end of the site. The conditions encountered in our borings generally match the mapped units. However, we found surficial alluvial deposits overlying the Pierre Shale formation and also large areas of the site have experienced previous grading activity and are overlain with fill material that was placed as part of the site development activities in late 1983 and early 1984. Colluvium derived from in-place weathering of bedrock deposited by gravity and sheetwash was found near the toe of the slope in the southwest portion of the site.

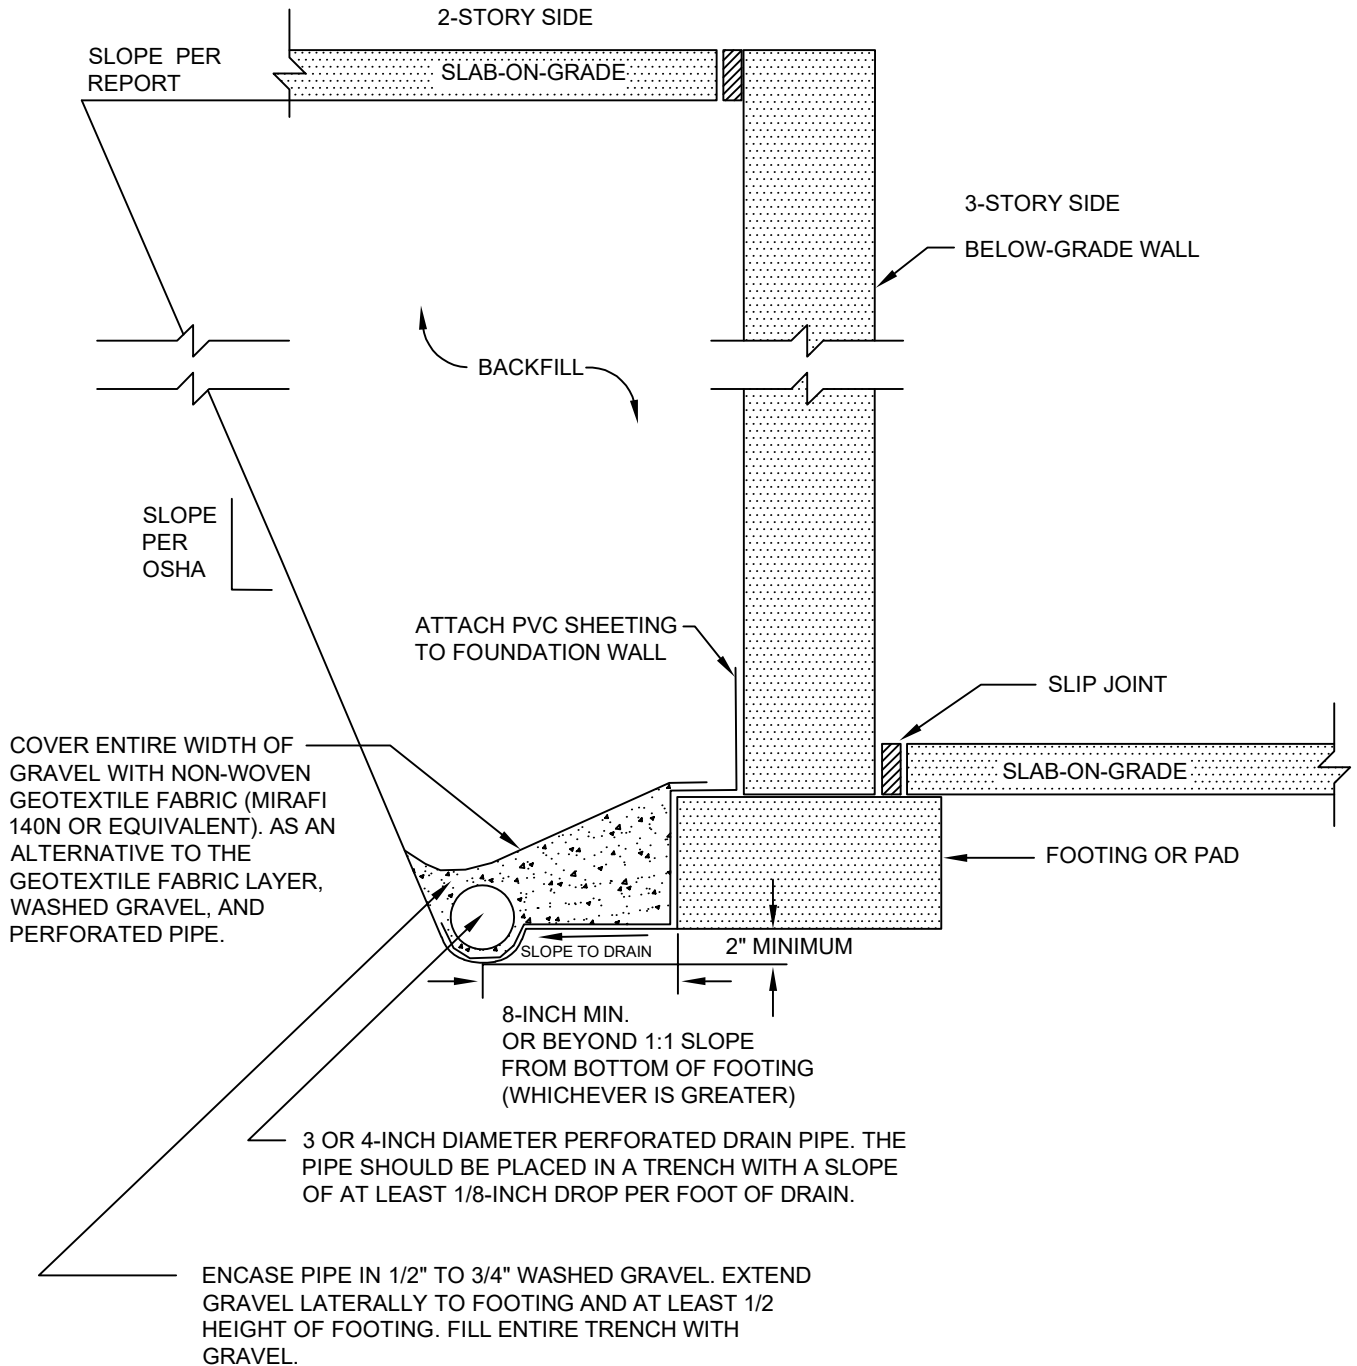
## 2-3 Story Split Foundation Wall Drain

THE BOTTOM OF THE DRAIN SHOULD BE AT LEAST 2 INCHES BELOW BOTTOM OF FOOTING AT THE HIGHEST POINT AND SLOPE DOWNWARD TO A POSITIVE GRAVITY OUTLET OR TO A SUMP WHERE WATER CAN BE REMOVED BY PUMPING. SUMP MAY BE DISCHARGED TO UNDERDRAIN SYSTEM, DOWN GRADIENT OF THE FOUNDATION DRAIN CONNECTION.

deep sub-excavations are performed into the bedrock. Perimeter drains for structures with below-grade areas are recommended. Drains near the toe of the slopes may be appropriate to help mitigate groundwater.

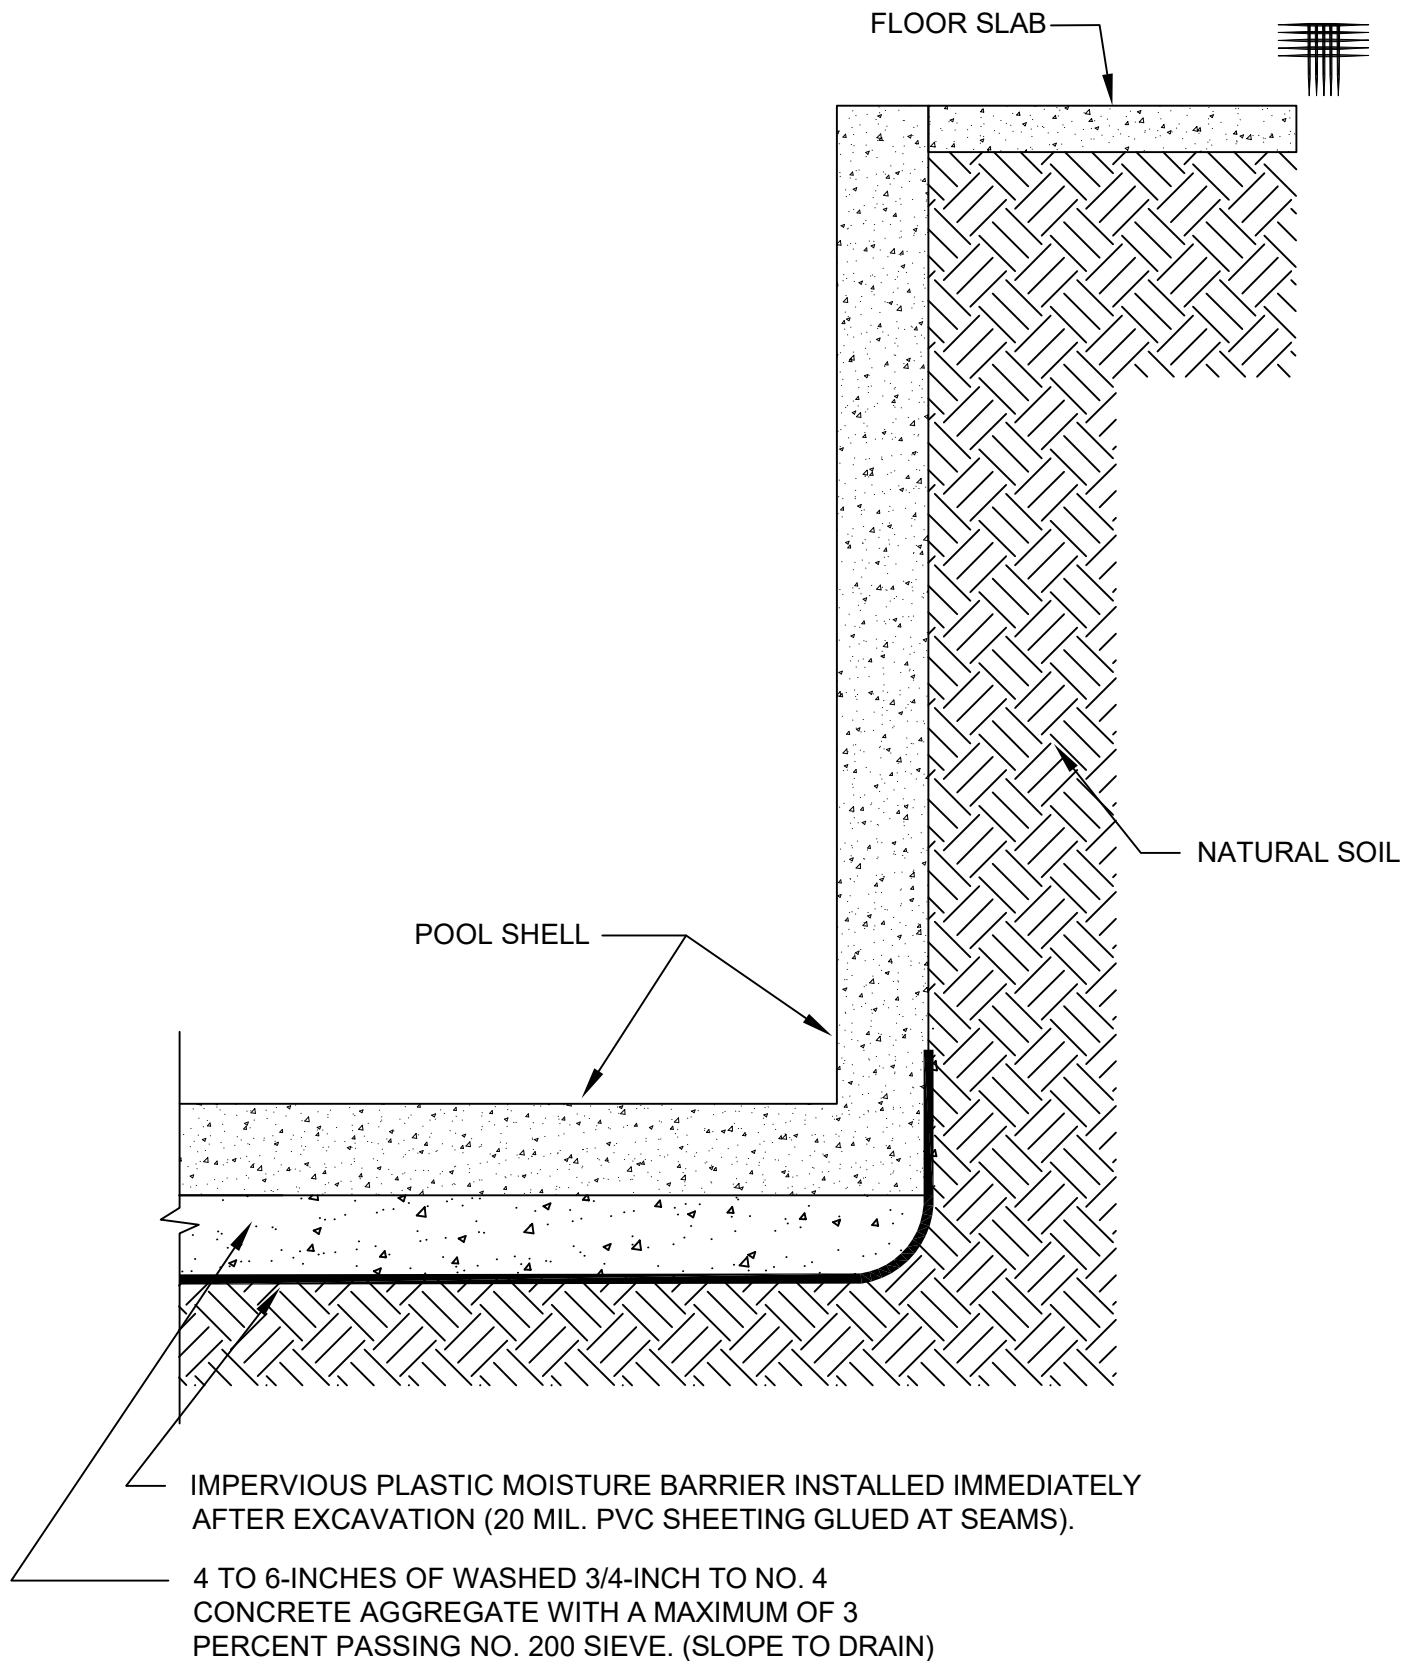
IMPERVIOUS PLASTIC MOISTURE BARRIER INSTALLED IMMEDIATELY AFTER EXCAVATION (20 MIL. PVC SHEETING GLUED AT SEAMS).

4 TO 6-INCHES OF WASHED 3/4-INCH TO NO. 4 CONCRETE AGGREGATE WITH A MAXIMUM OF 3 PERCENT PASSING NO. 200 SIEVE. (SLOPE TO DRAIN)

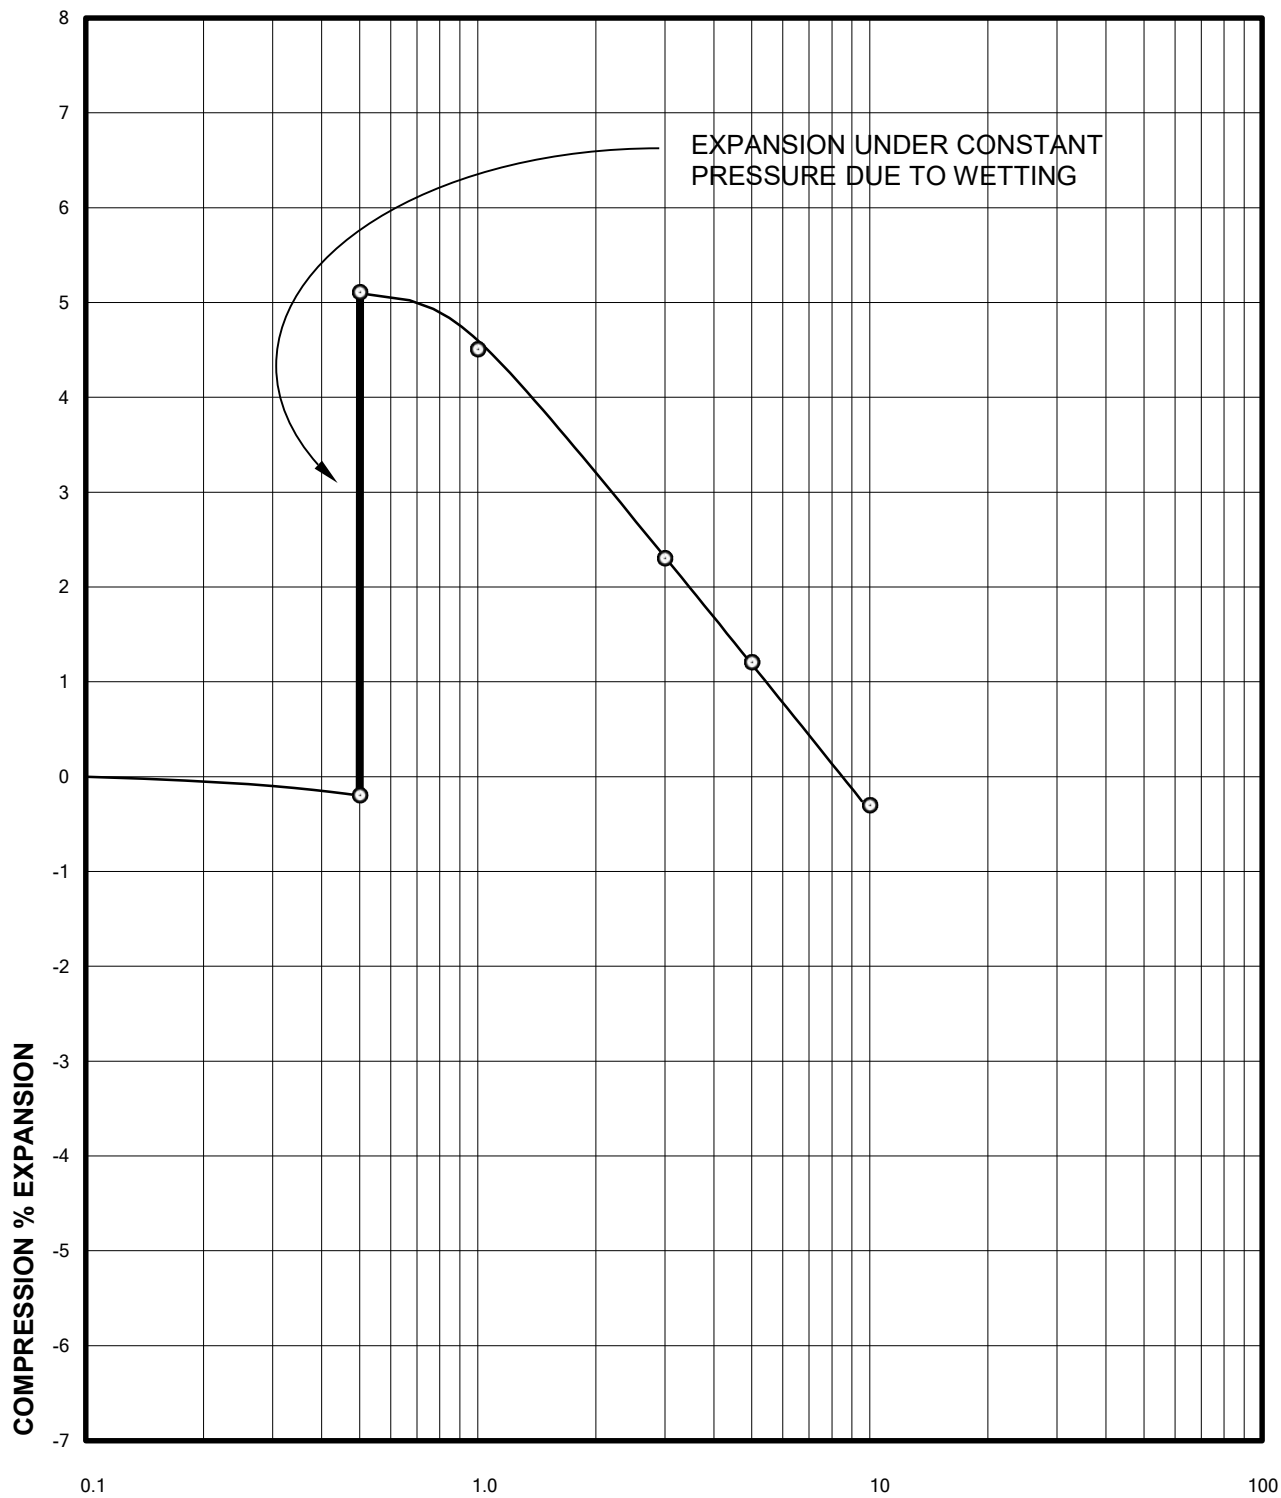
FIG. B-1

**APPLIED PRESSURE - KSF**  
Sample of CLAY, SLIGHTLY SANDY (CL)  
From TH-6 AT 4 FEET

DRY UNIT WEIGHT= 109 PCF  
MOISTURE CONTENT= 20.9 %

Soil samples obtained during drilling were returned to our laboratory and visually classified. Laboratory testing was then assigned to representative samples and included moisture content and dry density, swell-consolidation, Atterberg limits, sieve analysis (percent passing the No. 200 sieve), and water-soluble sulfate concentration tests. The swell test samples were wetted under applied loads that approximated the overburden pressure (the weight of overlying soil). Results of the laboratory tests are presented in Appendix B and summarized in Table B-1.

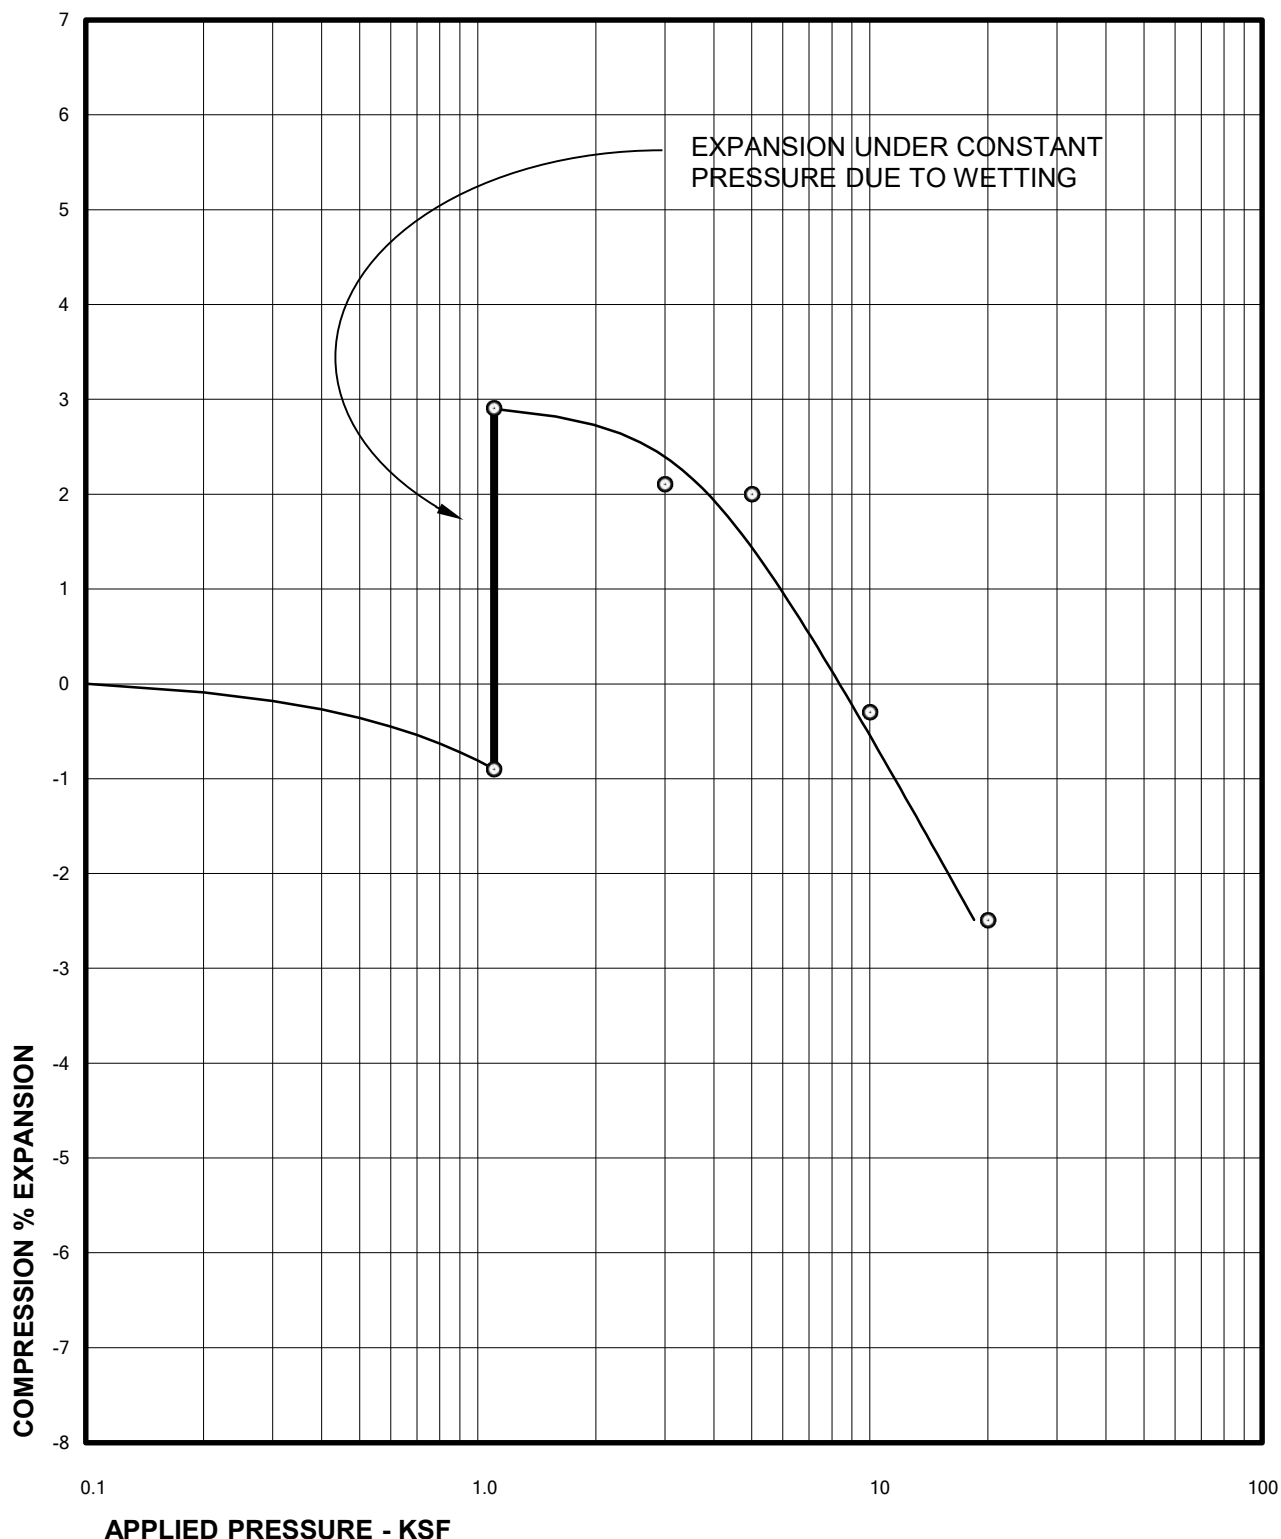
FIG. B-4

Sample of CLAYSTONE  
From TH-8 AT 9 FEET

DRY UNIT WEIGHT= 129 PCF  
MOISTURE CONTENT= 10.9 %

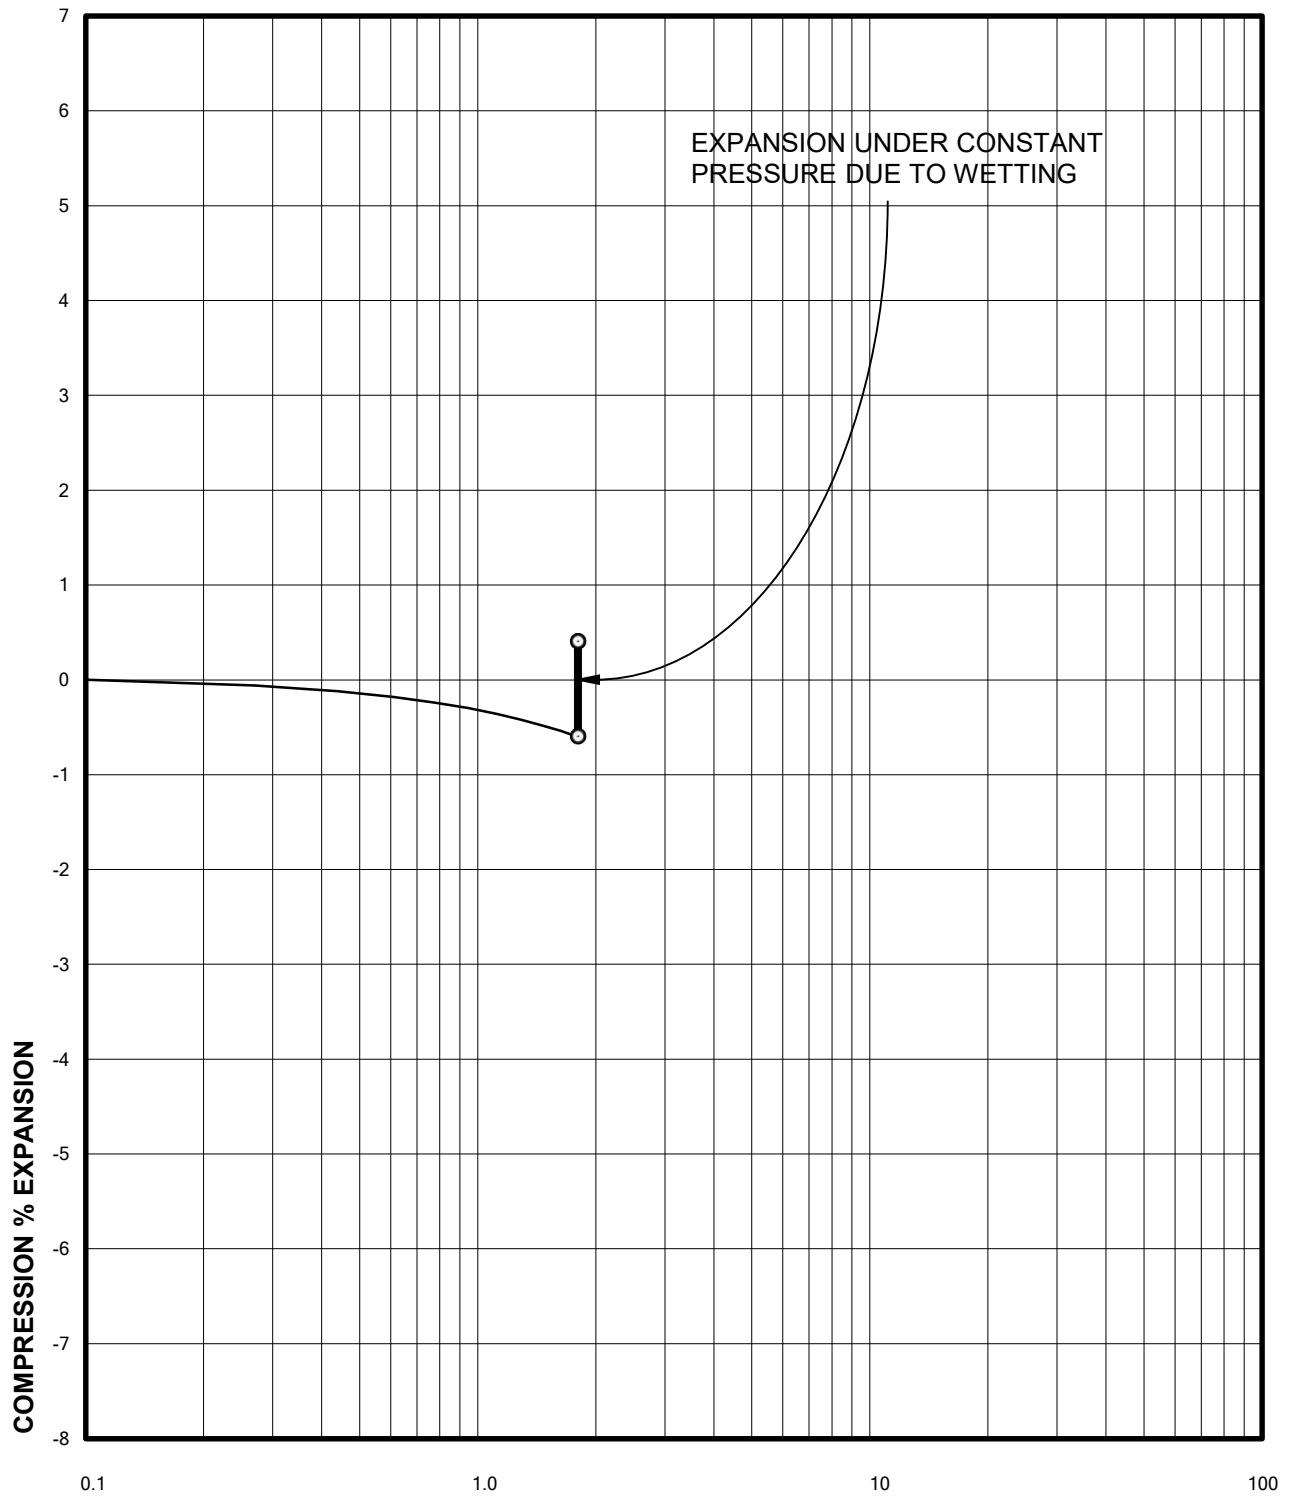
FIG. B-5

Sample of CLAYSTONE  
From TH-9 AT 14 FEET

DRY UNIT WEIGHT= 128 PCF  
MOISTURE CONTENT= 11.5 %

## Swell Consolidation Test Results

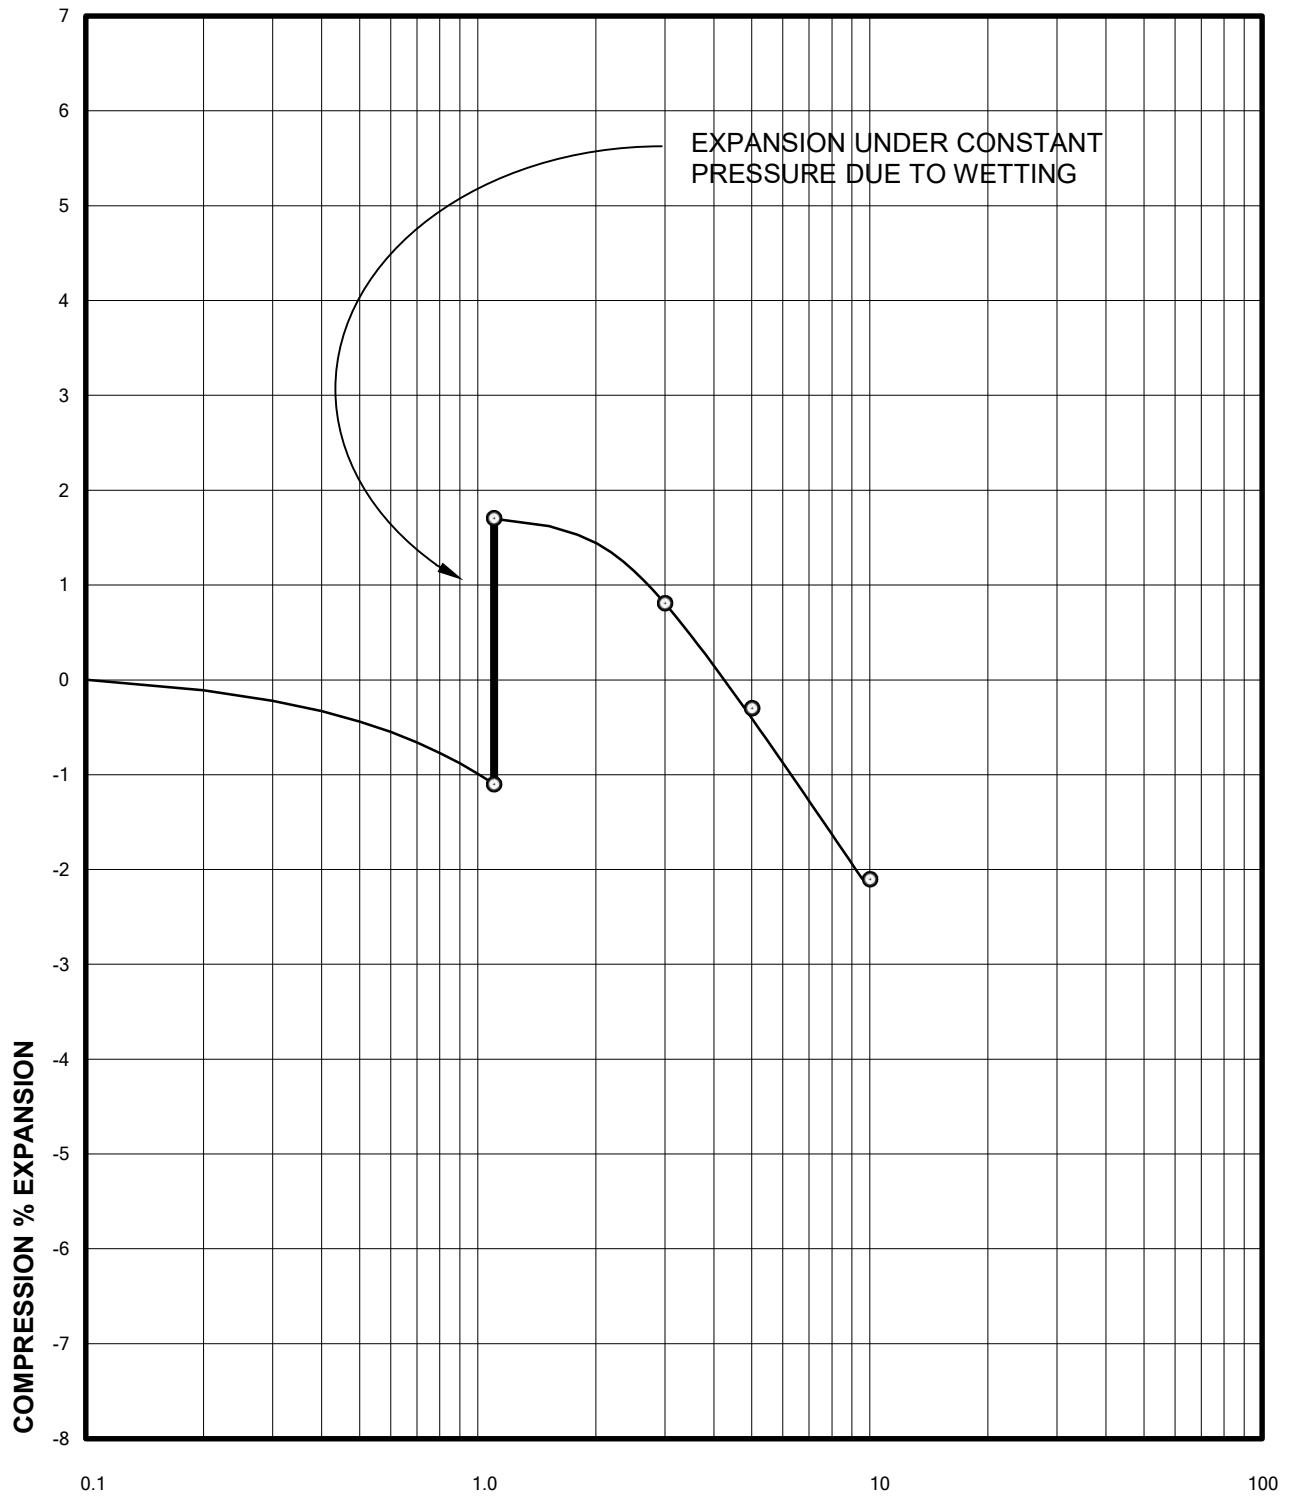
FIG. B-7

**APPLIED PRESSURE - KSF**  
Sample of CLAY, SANDY (CL)  
From TH-12 AT 9 FEET

DRY UNIT WEIGHT= 112 PCF  
MOISTURE CONTENT= 17.4 %

## Swell Consolidation Test Results

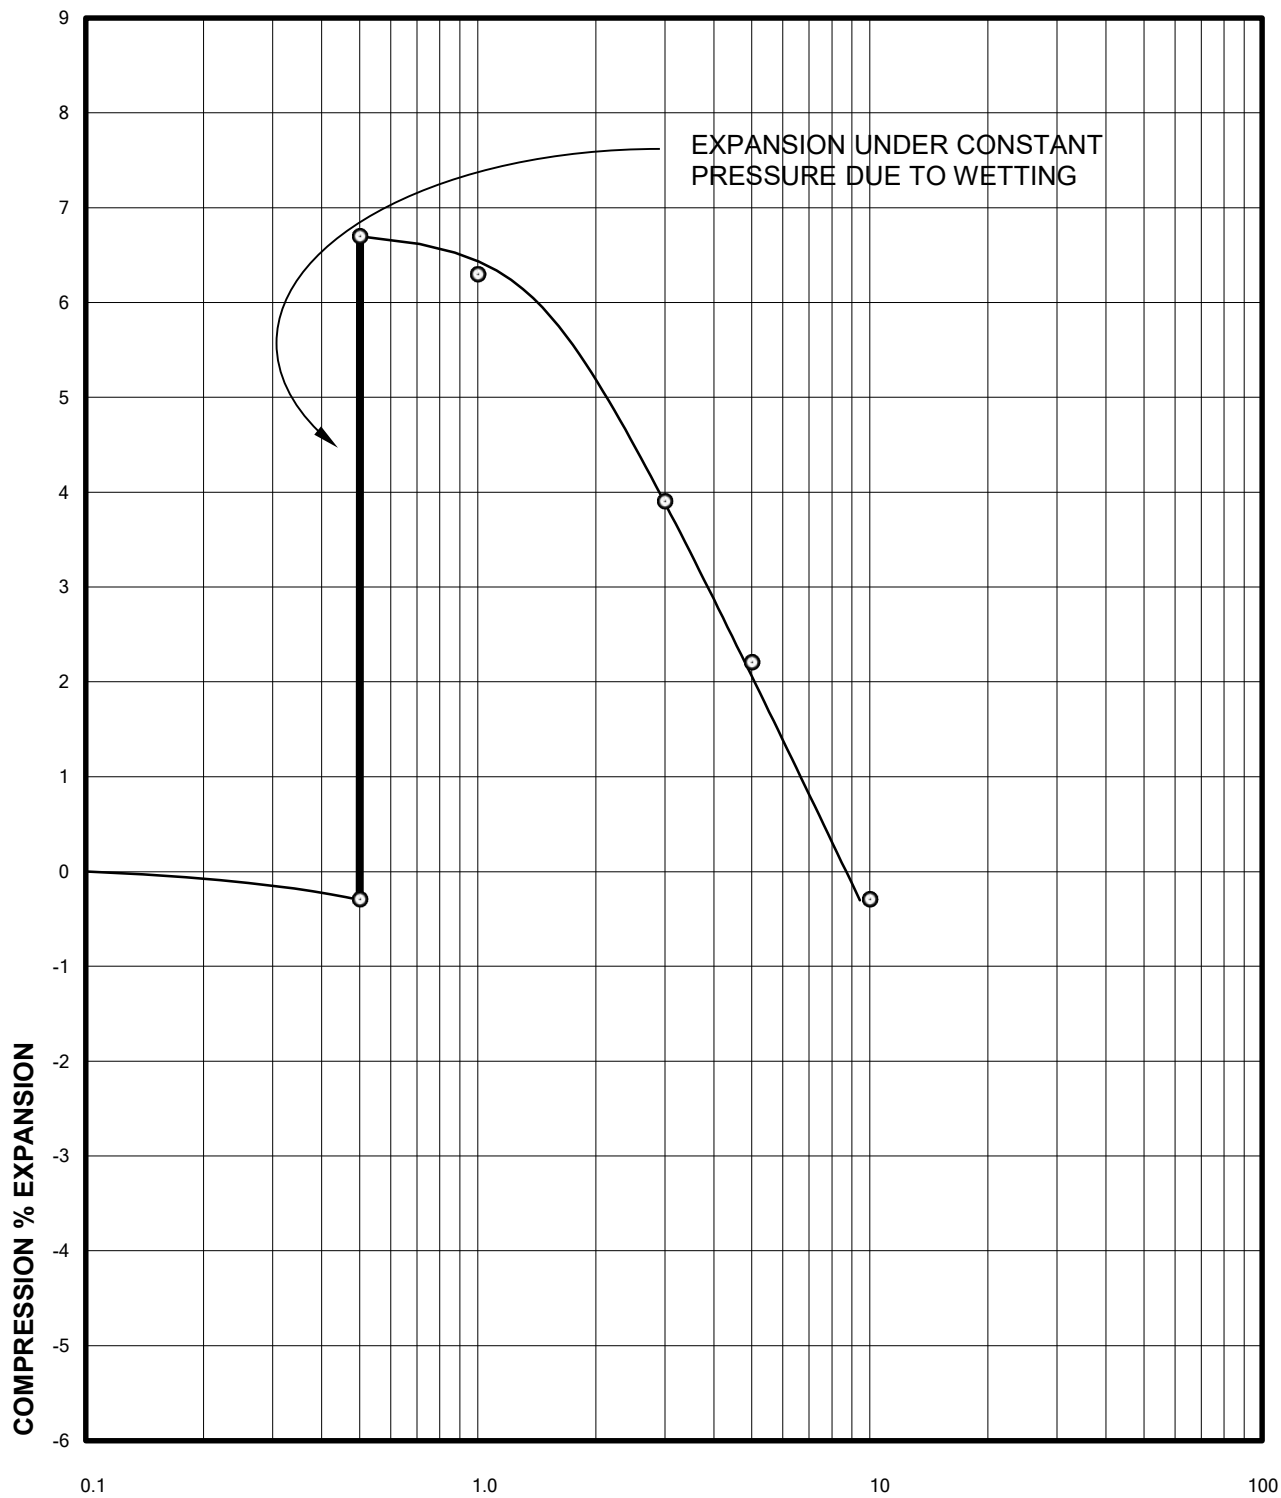
FIG. B-8

**APPLIED PRESSURE - KSF**  
Sample of CLAY, SLIGHTLY SANDY (CL)  
From TH-14 AT 4 FEET

DRY UNIT WEIGHT= 108 PCF  
MOISTURE CONTENT= 14.2 %

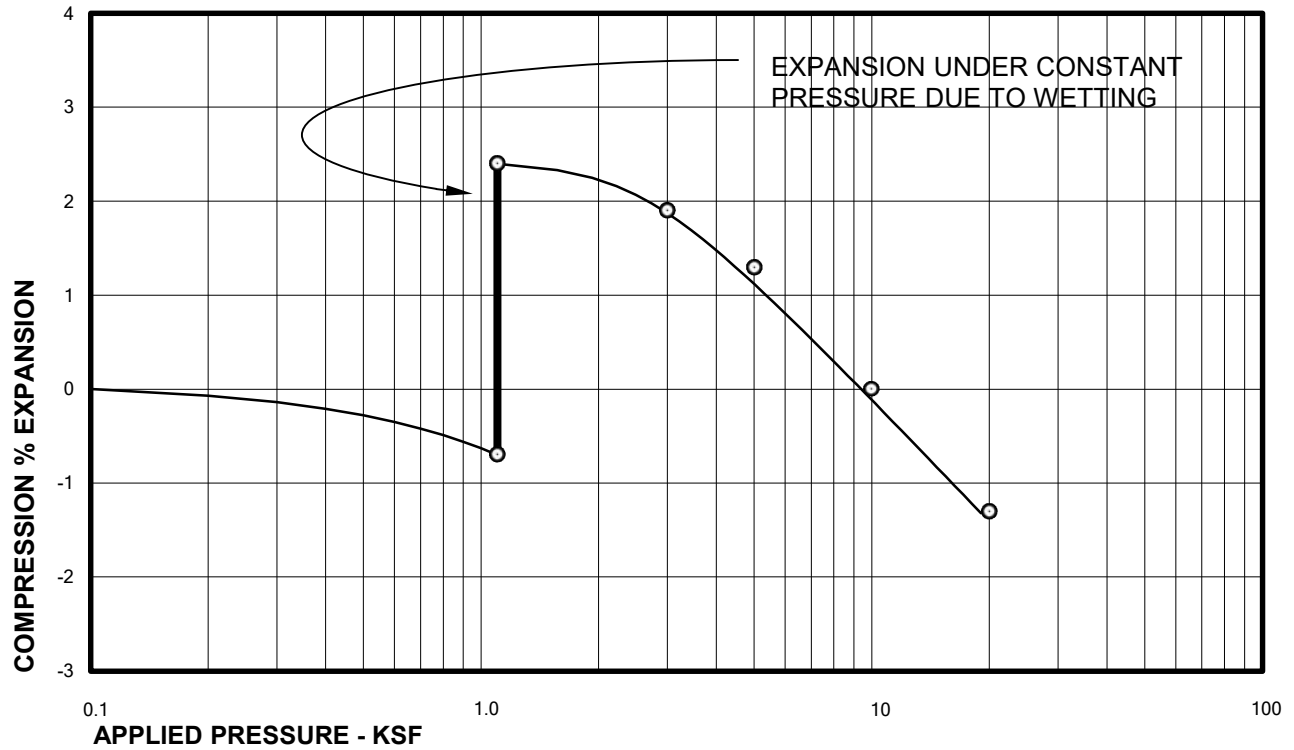
Sample of CLAYSTONE  
From TH-16 AT 9 FEET

DRY UNIT WEIGHT= 121 PCF  
MOISTURE CONTENT= 14.0 %

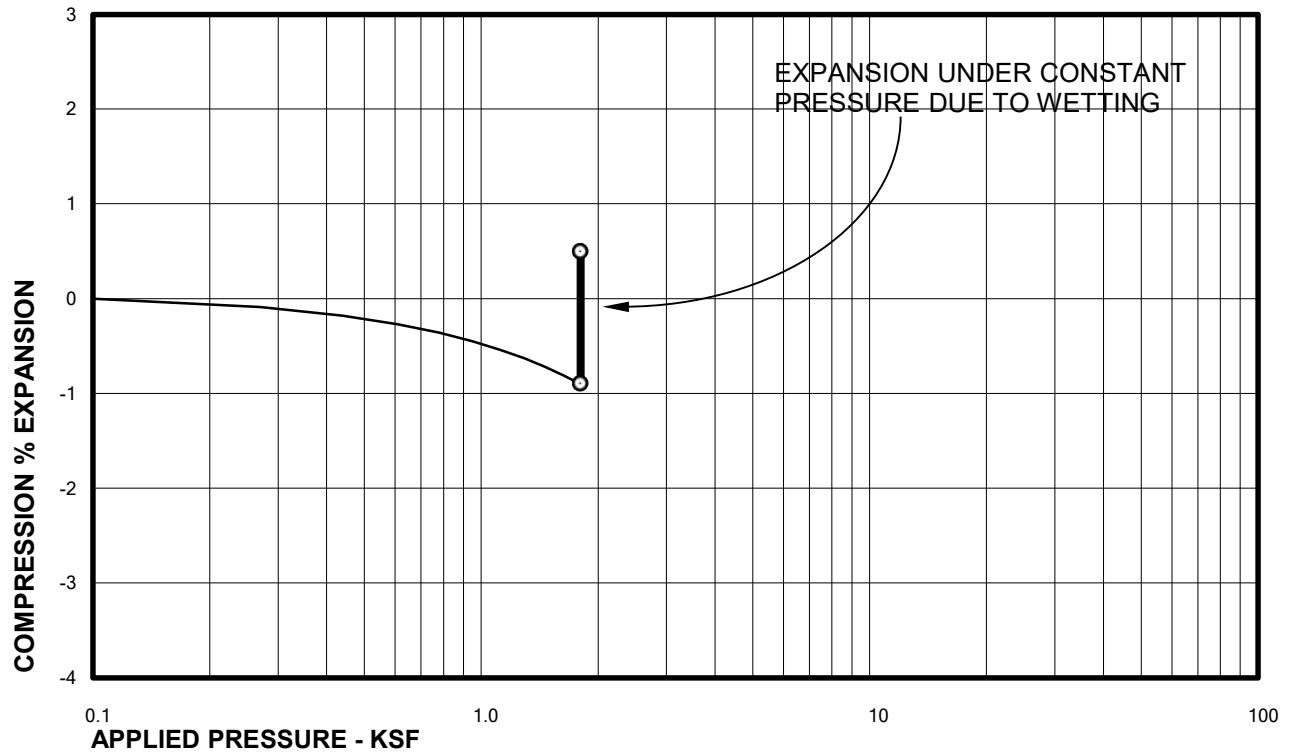
Sample of CLAYSTONE  
From TH-16 AT 14 FEET

DRY UNIT WEIGHT= 122 PCF  
MOISTURE CONTENT= 14.1 %

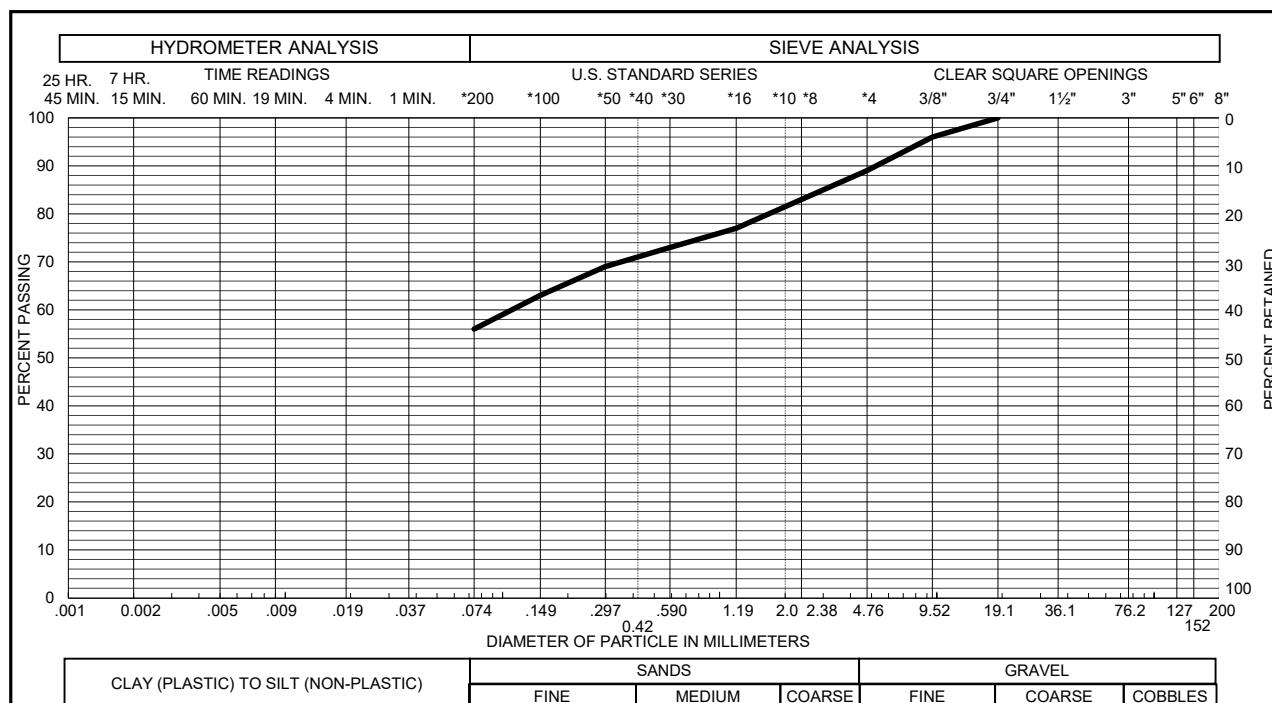
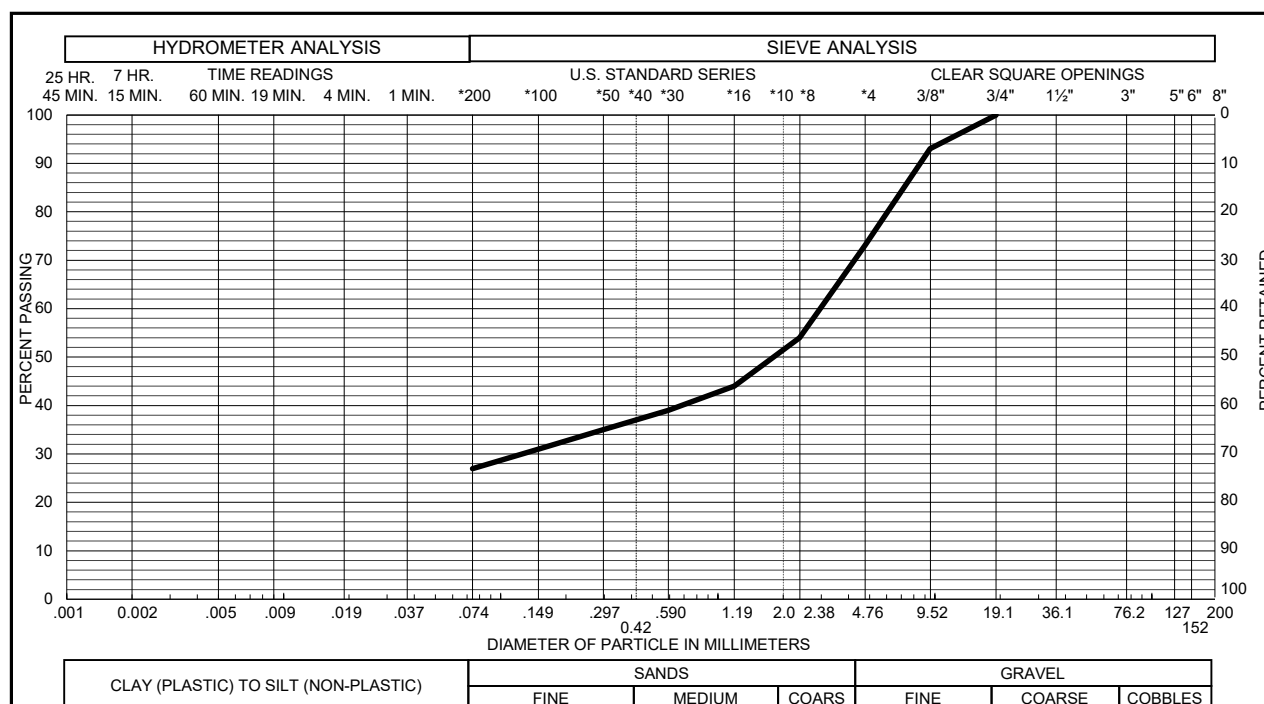
FIG. B-12

Sample of FILL, CLAY, VERY SANDY (CL) GRAVEL 11 % SAND 33 %  
From TH - 4 AT 4 FEET SILT & CLAY 56 % LIQUID LIMIT   
PLASTICITY INDEX

Sample of SAND, CLAYEY, GRAVELLY (SC) GRAVEL 27 % SAND 46 %  
From TH - 17 AT 4 FEET SILT & CLAY 27 % LIQUID LIMIT   
PLASTICITY INDEX

## Gradation Test Results
