**GEOLOGIC HAZARD EVALUATION AND  
GEOTECHNICAL INVESTIGATION  
ARROWSWEST APARTMENTS  
GARDEN OF THE GODS AND 30<sup>TH</sup> STREET  
COLORADO SPRINGS, COLORADO**

WEIDNER APARTMENT HOMES  
9757 NE Juanita Drive, Suite 3  
Kirkland, WA 98034

Attention: Mr. David Avenell  
CTL|T Project No. CS19280-120

September 14, 2020

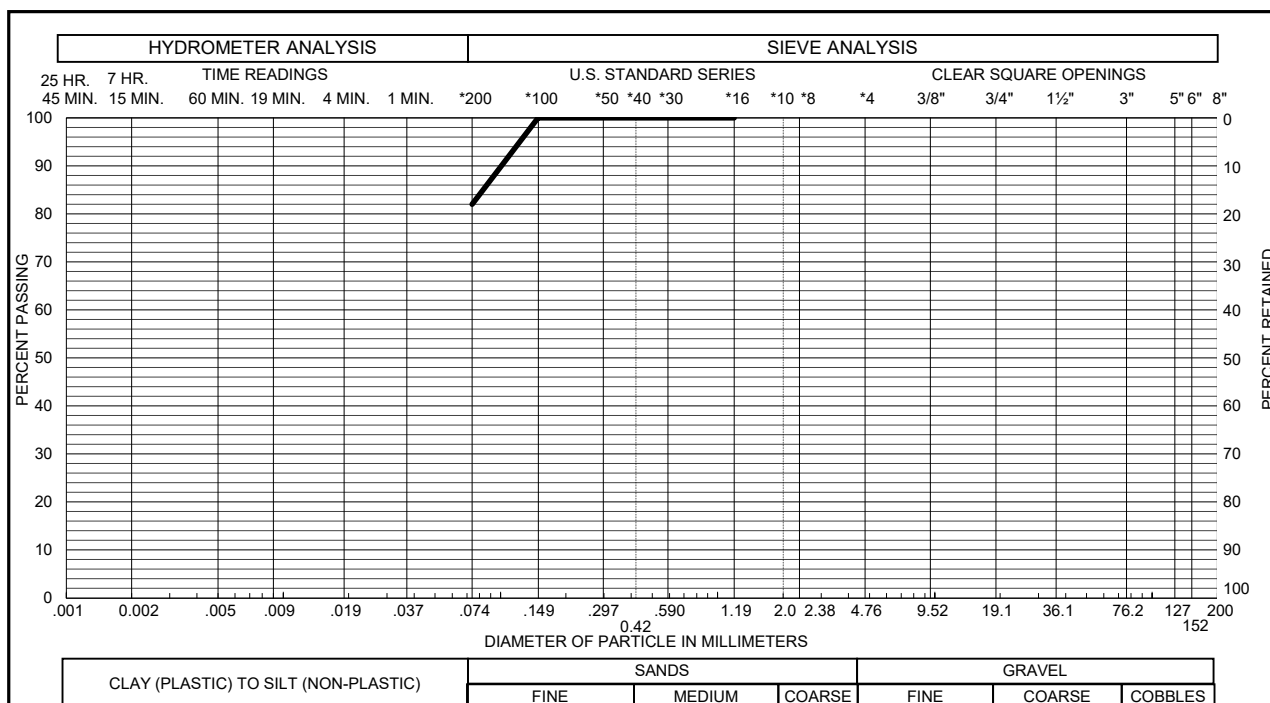
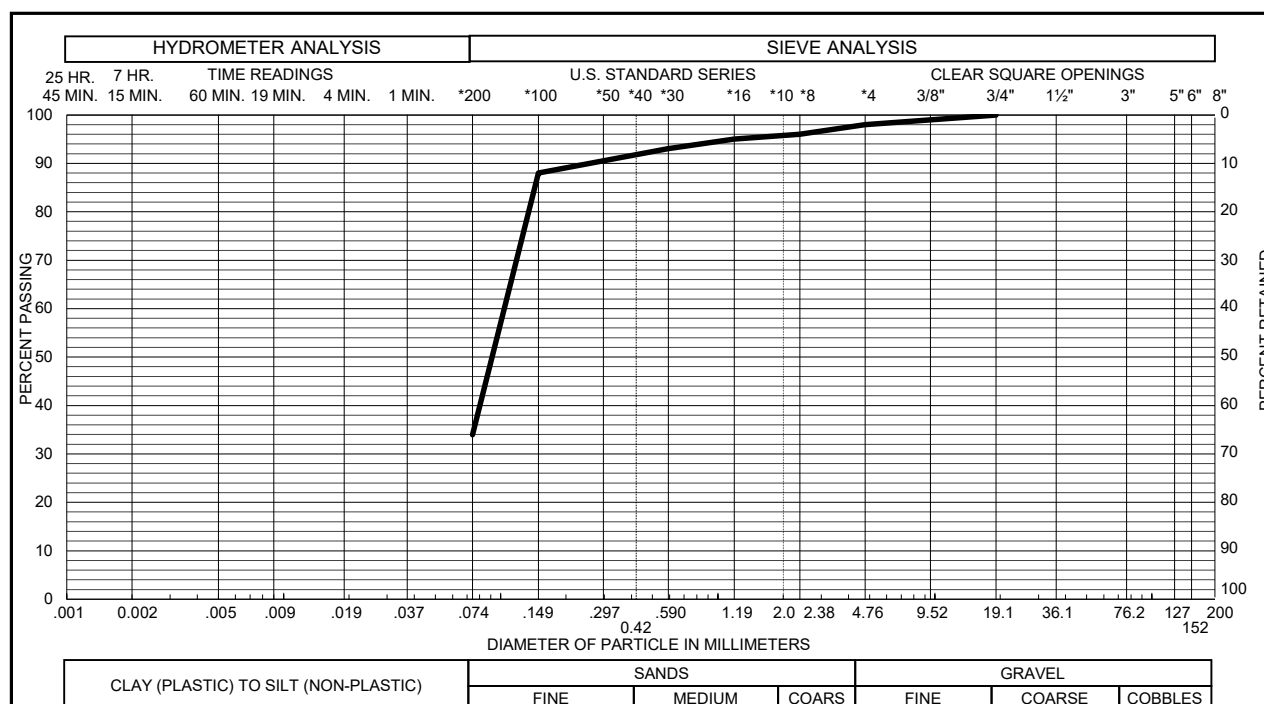
Sample of FILL, CLAY, SANDY GRAVEL 0 % SAND 18 %  
From TH - 19 AT 4 FEET SILT & CLAY 82 % LIQUID LIMIT         
PLASTICITY INDEX

Sample of CLAY, SANDY (CH) GRAVEL 2 % SAND 64 %  
From S - 4 AT 0-4 FEET SILT & CLAY 34 % LIQUID LIMIT         
PLASTICITY INDEX

## Gradation Test Results

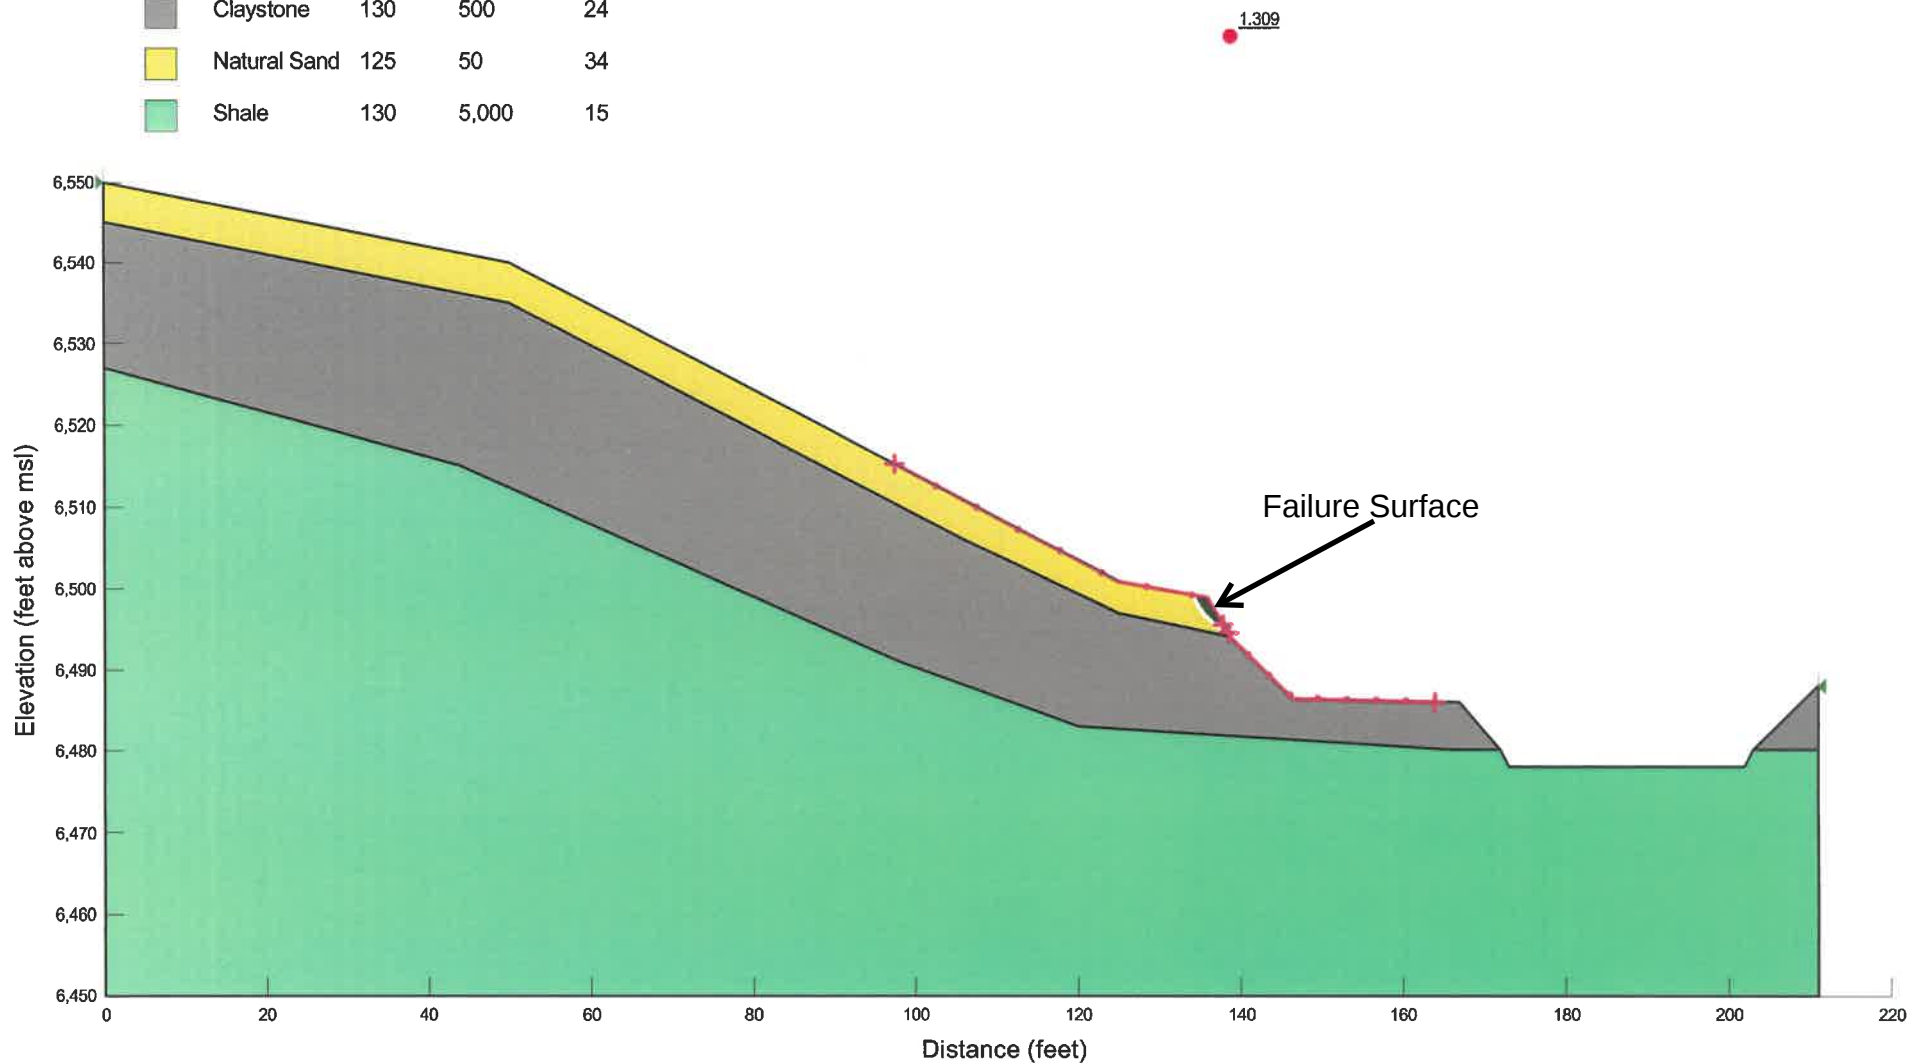
FIG. C-1

DURING CONSTRUCTION - 10 FT DEEP SUB-EXCAVATION

We performed a slope stability analysis considering the excavated condition of the slope during sub-excavation and the final slope condition with the an apartment building constructed. Although not expected to be present near the surface within the slope, groundwater was modeled in the slope above the bedrock to evaluate impacts of an increased groundwater level. Factors of safety of 1.15 and 1.5 are usually considered appropriate by Geotechnical Engineers for temporary and permanent slopes, respectively. The results of our slope stability analysis indicate adequate factors of safety (i.e., about 1.3 for the temporary construction slope and 1.7 for the permanent slope condition). The results of our slope stability analyses are presented in Appendix C. This slope stability evaluation is limited to the specific portion of the site. Based on the results of our analysis and our site reconnaissance, we believe slope stability during and after construction will be stable. Once site grading plans and finish floor elevations are available, we should be contacted to review the plans and determine if additional analysis is required.

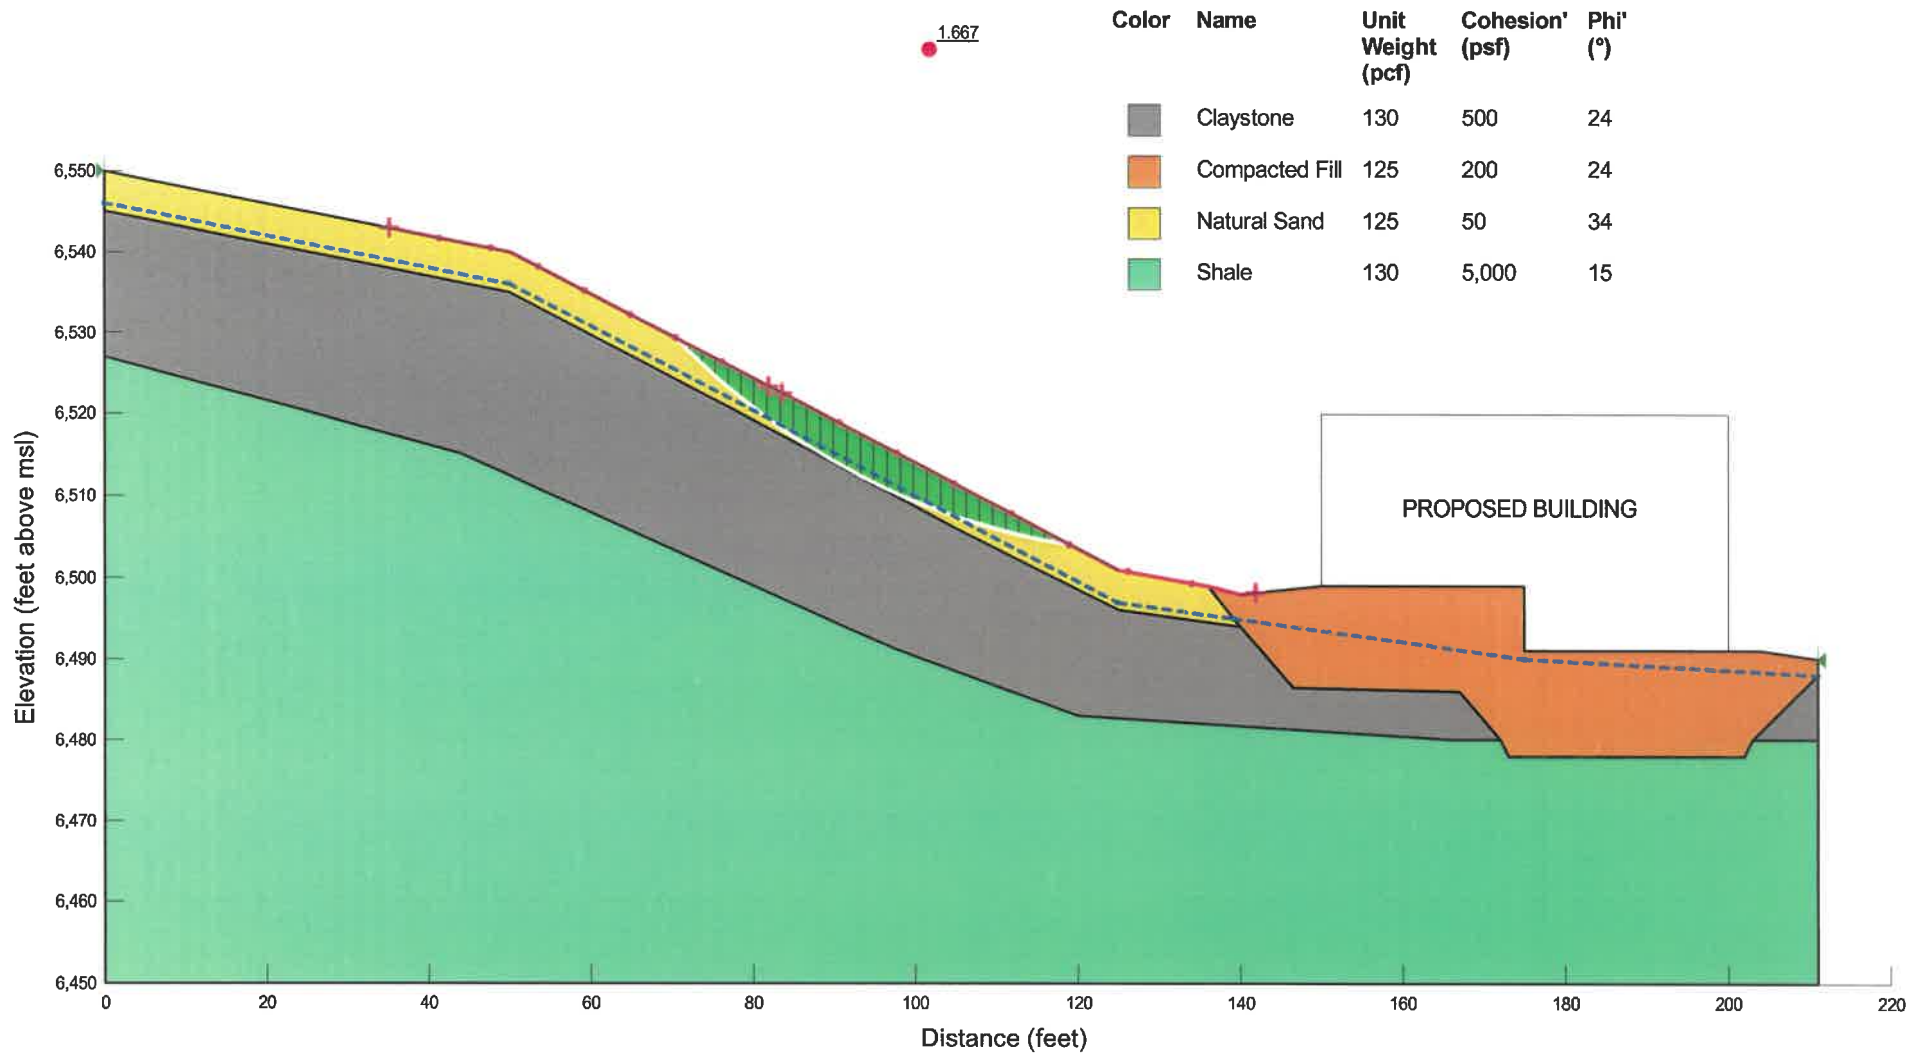
PERMANANT CONDITION WITH PROPOSED BUILDING

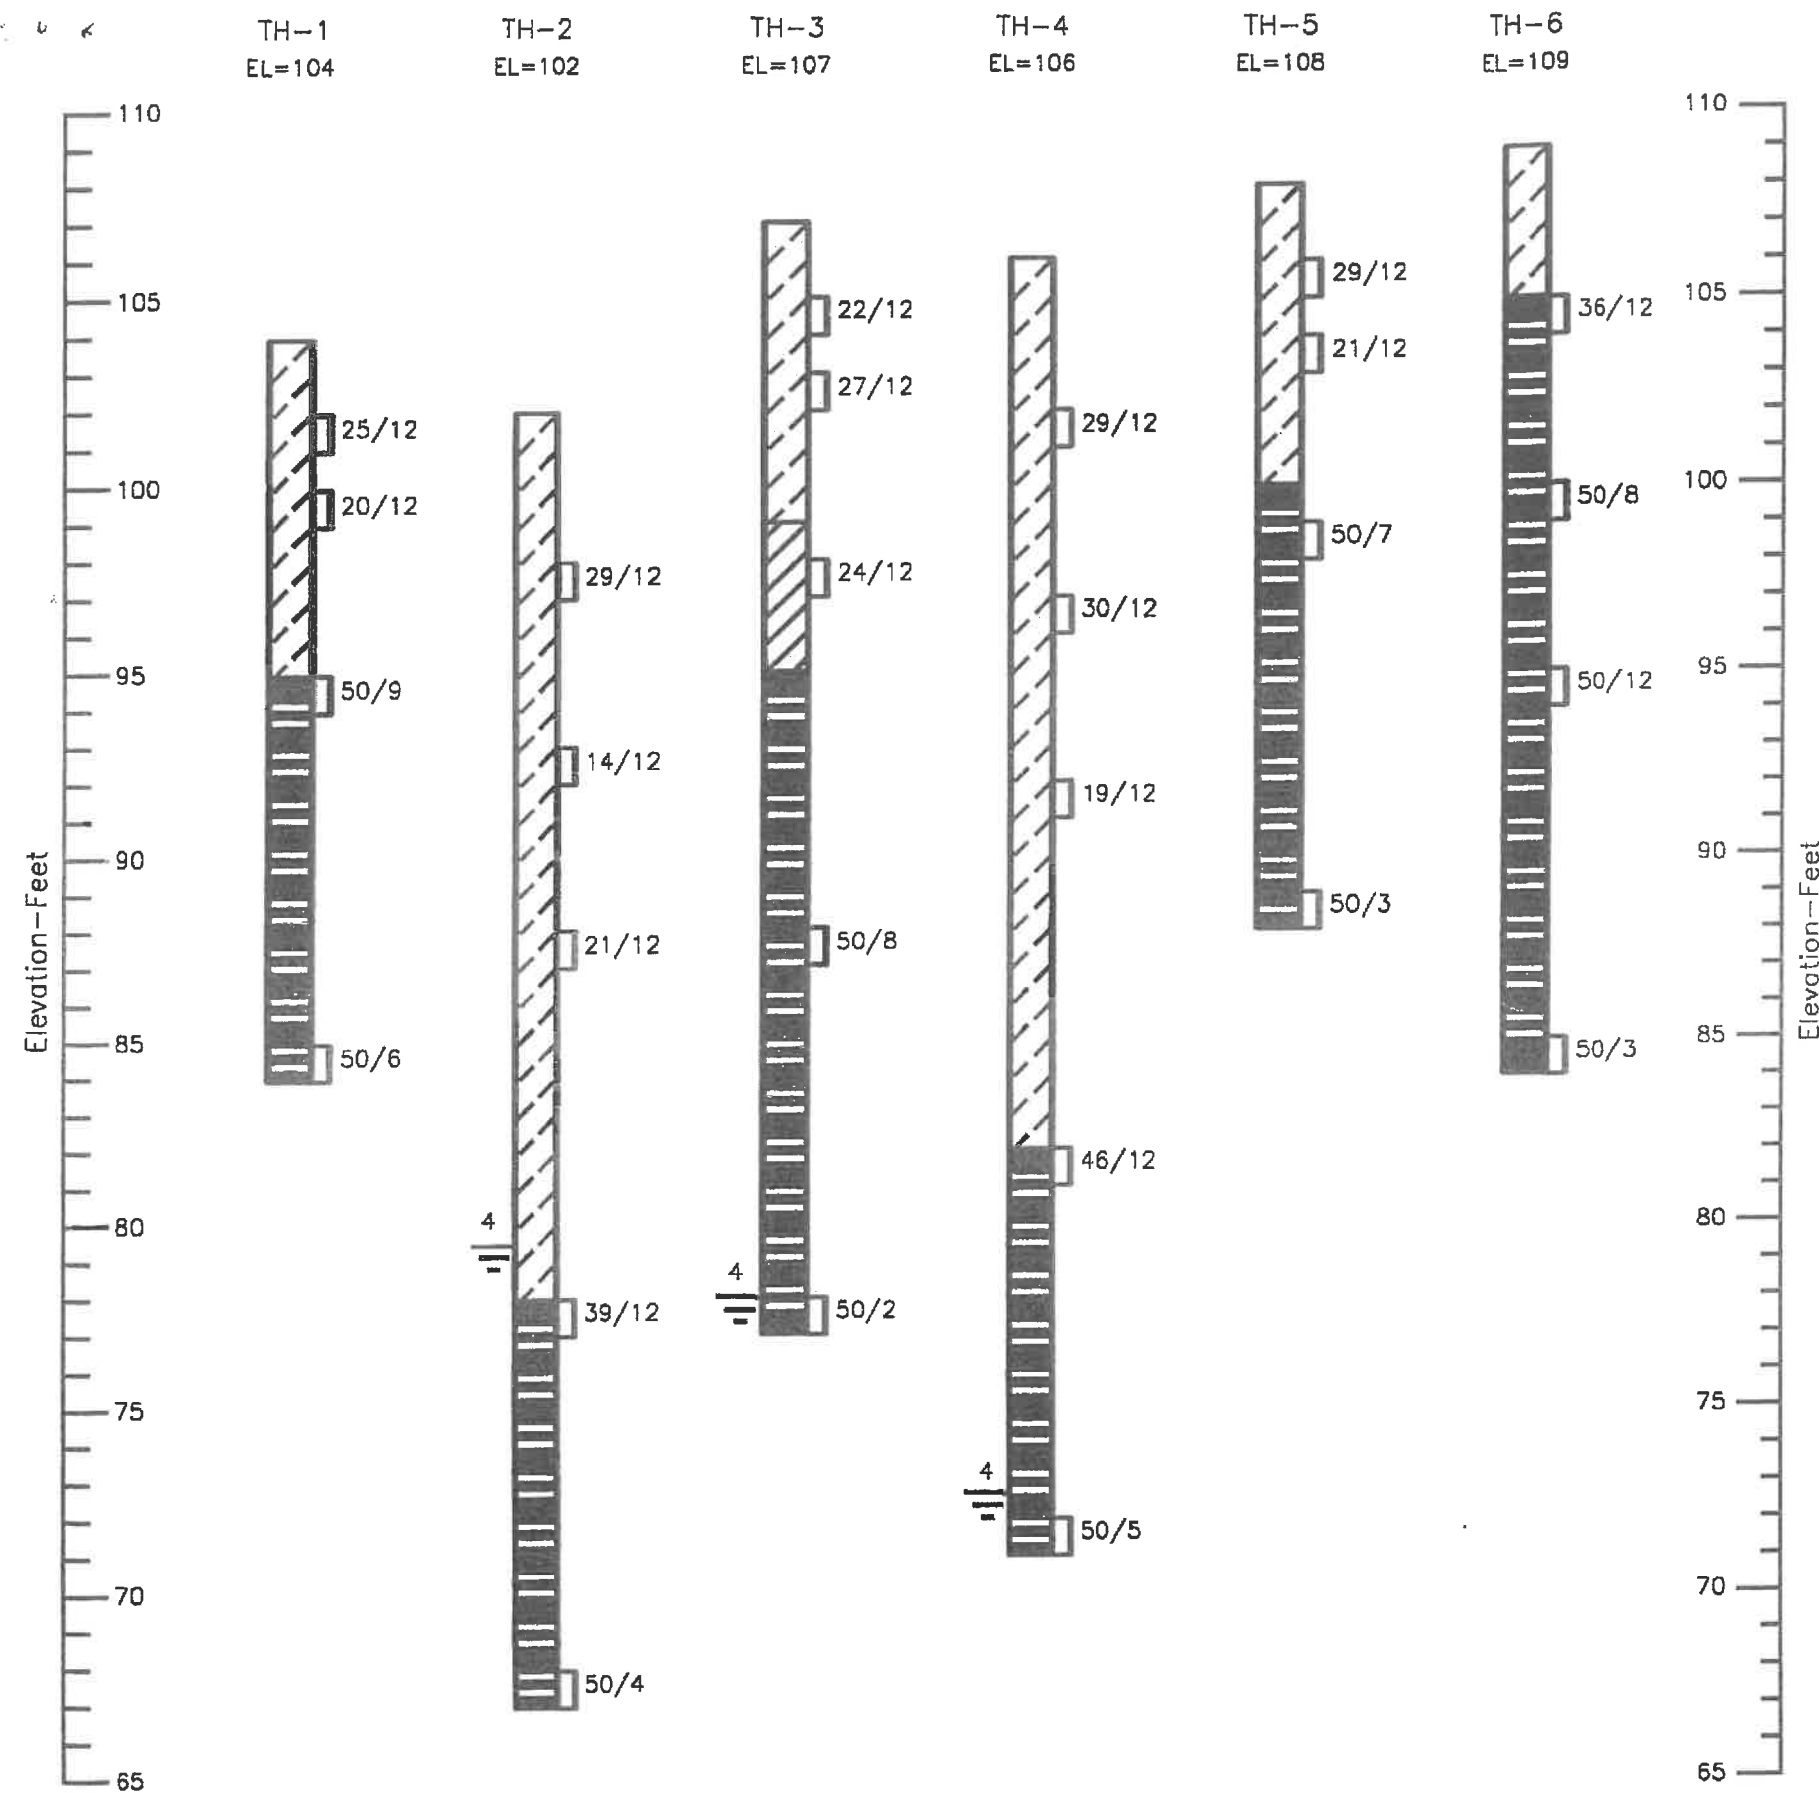
Clay, sandy, very stiff, moist, brown (CL).

1. The borings were drilled November 16, 1998 using a 4-inch diameter, continuous-flight, truck-mounted, power auger.
2. The borings are subject to the explanations, limitations, and conclusions as contained in the report.
3. The elevations shown are approximate and were determined using a hand level and the benchmark shown on Fig. 1.

CLT|Thompson has been involved with the overall Arrowswest Development since 1981. Numerous previous investigations have been completed at this site and in the general vicinity of this site. In January 1999, CLT | Thompson, Inc. prepared a Geologic Hazards Investigation (CTL Job No. CS-9300, report dated January 1999) that

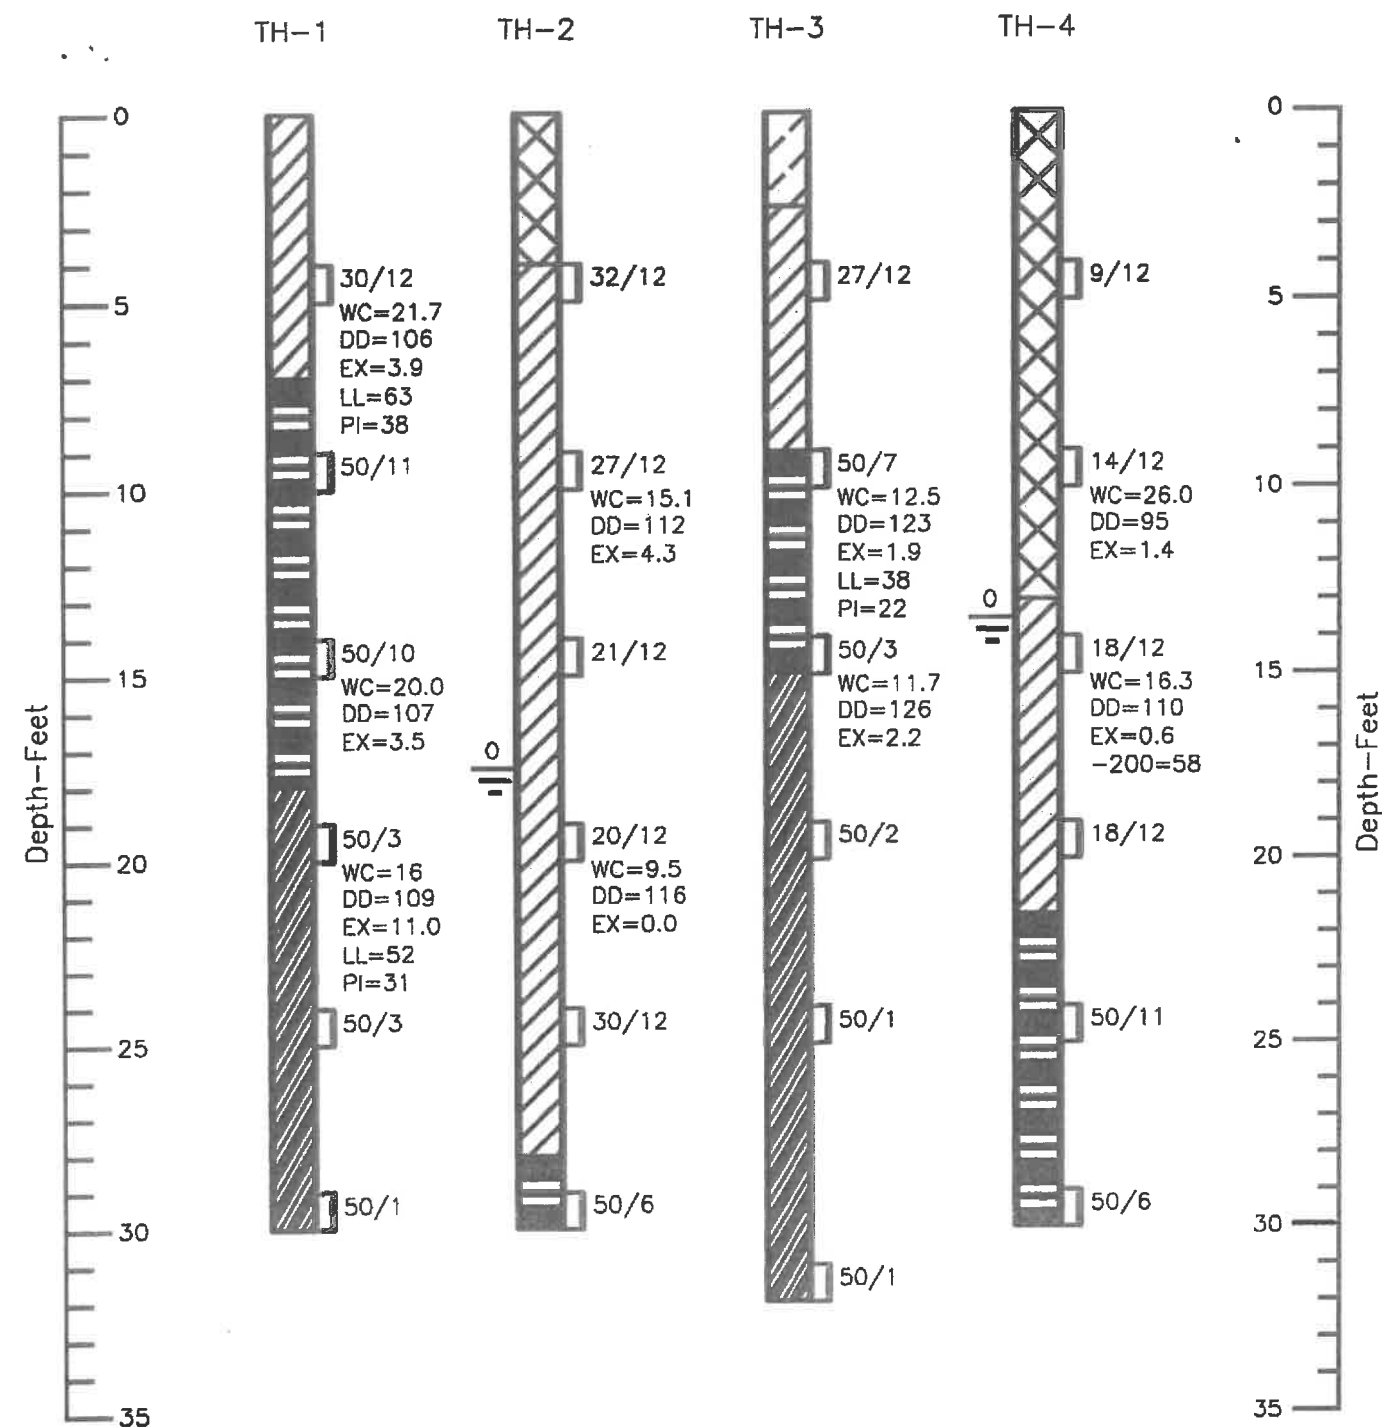
- Fill, sandy clay and clayey sand, stiff, slightly moist to moist, olive to reddish brown.
- Clay, sandy, slightly moist to moist, olive brown.
- Bedrock. Weathered claystone, sandy, medium hard, steeply dipping bedding, slightly moist, gray to olive brown.
- Bedrock. Claystone, sandy, hard to very hard, steeply dipping bedding, slightly moist, gray.
- Bedrock. Shale, very hard, steeply dipping bedding, slightly moist, dark gray.
- Drive Sample. The symbol 30/12 indicates that 30 blows of a 140-pound hammer falling 30 inches were required to drive a 2.5-inch O.D. sampler 12 inches.

1. The borings were drilled March 31 and April 5, 2000 using a 4-inch diameter, continuous-flight, truck-mounted, power auger.
2. The borings are subject to the explanations, limitations, and conclusions as contained in the report.
3. WC - Indicates natural moisture content (%)  
DD - Indicates dry density (pcf)  
EX - Indicates percent expansion when sample wetted under a surcharge pressure of 1000 psf  
-200 - Indicates the percent passing the No. 200 sieve.  
LL - Indicates liquid limit (%).  
PI - Indicates plasticity index (%).

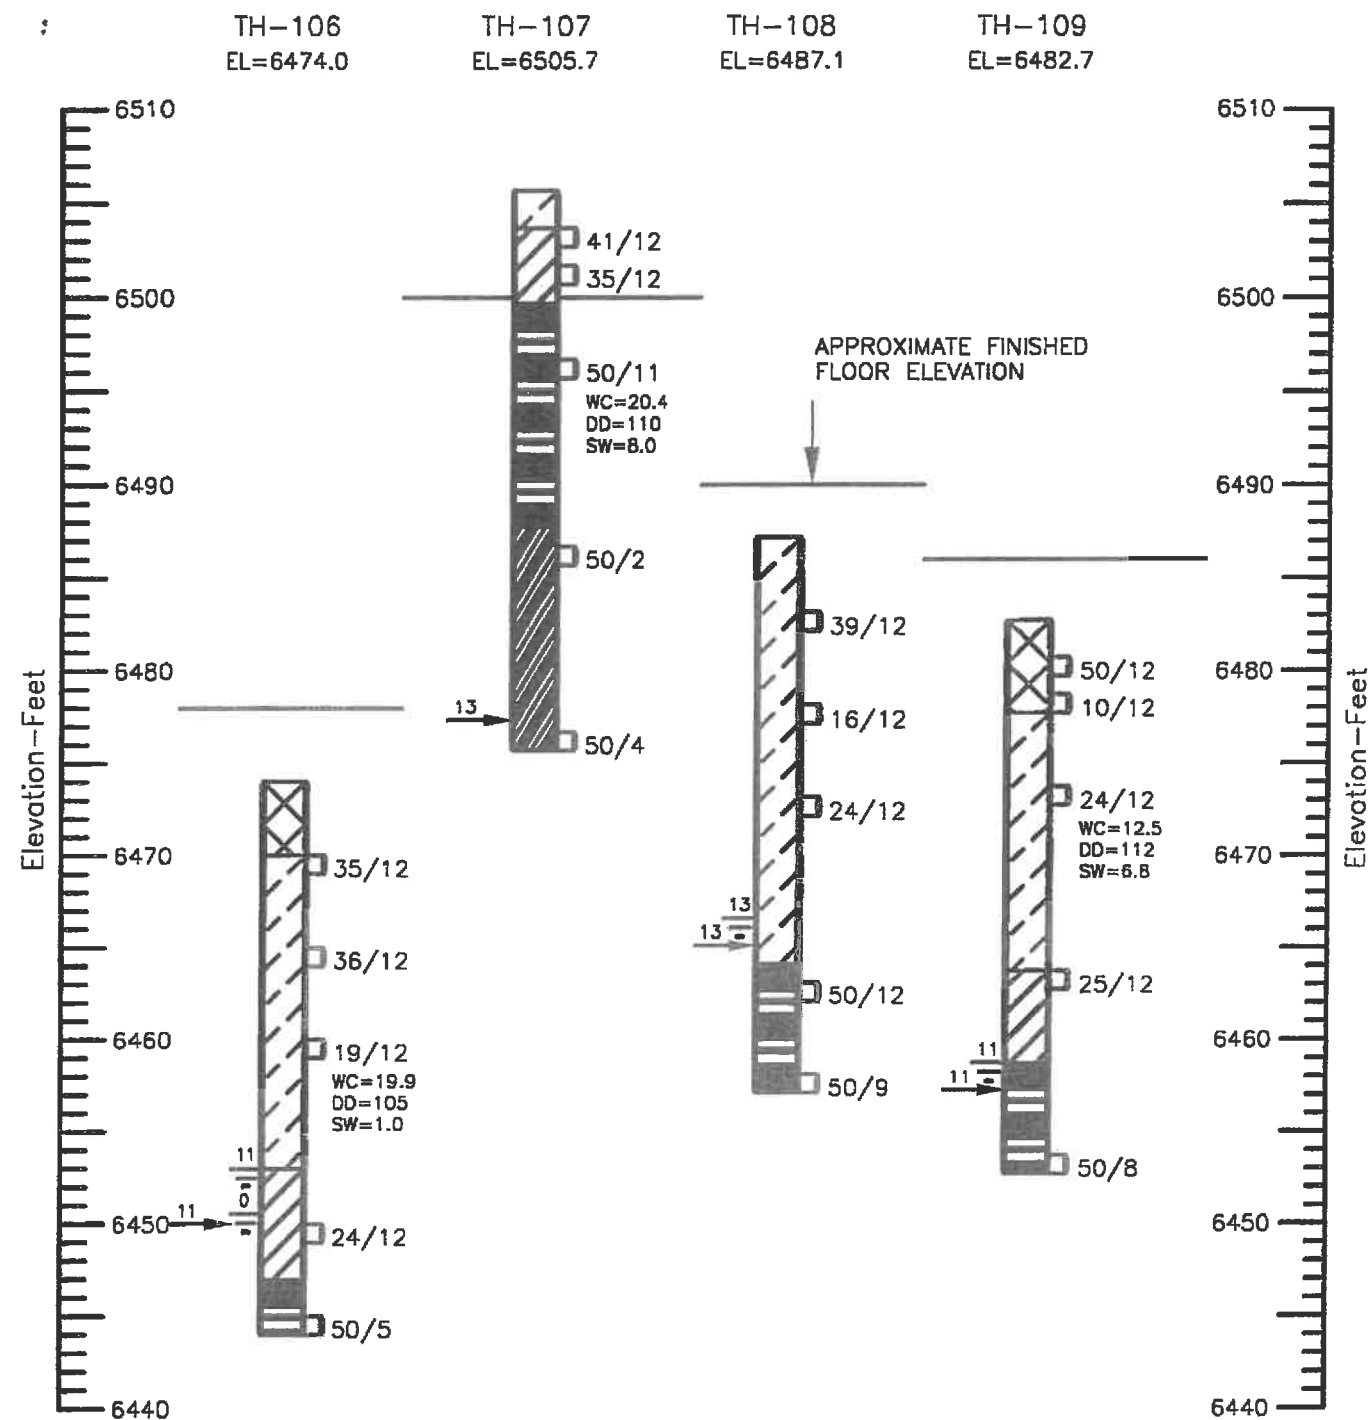
- Fill, sand, clayey and clay, sandy, slightly gravelly to gravelly, medium dense to dense (sand) and very stiff (clay), slightly moist to moist, brown and olive.

1. The borings were drilled February 19 and 21, 2002 using a 4-inch diameter, continuous-flight, truck-mounted, power auger.
2. The borings are subject to the explanations, limitations, and conclusions as contained in the report.
3. The elevations shown are approximate and were provided by Classic Consulting Engineers and Surveyors, LLC.
4. WC - Indicates natural moisture content (%).  
DD - Indicates dry density (pcf).  
SW - Indicates percent swell when sample wetted under an applied pressure of 1000 psf.
