2029 North Nevada Avenue
Solazzi Residence
TN: 6406123007

We are representing the owners of 2029 North Nevada to repair the damaged existing front porch/deck. The existing foundation has failed, and the porch/deck is sinking into the ground which is also causing roof damage.

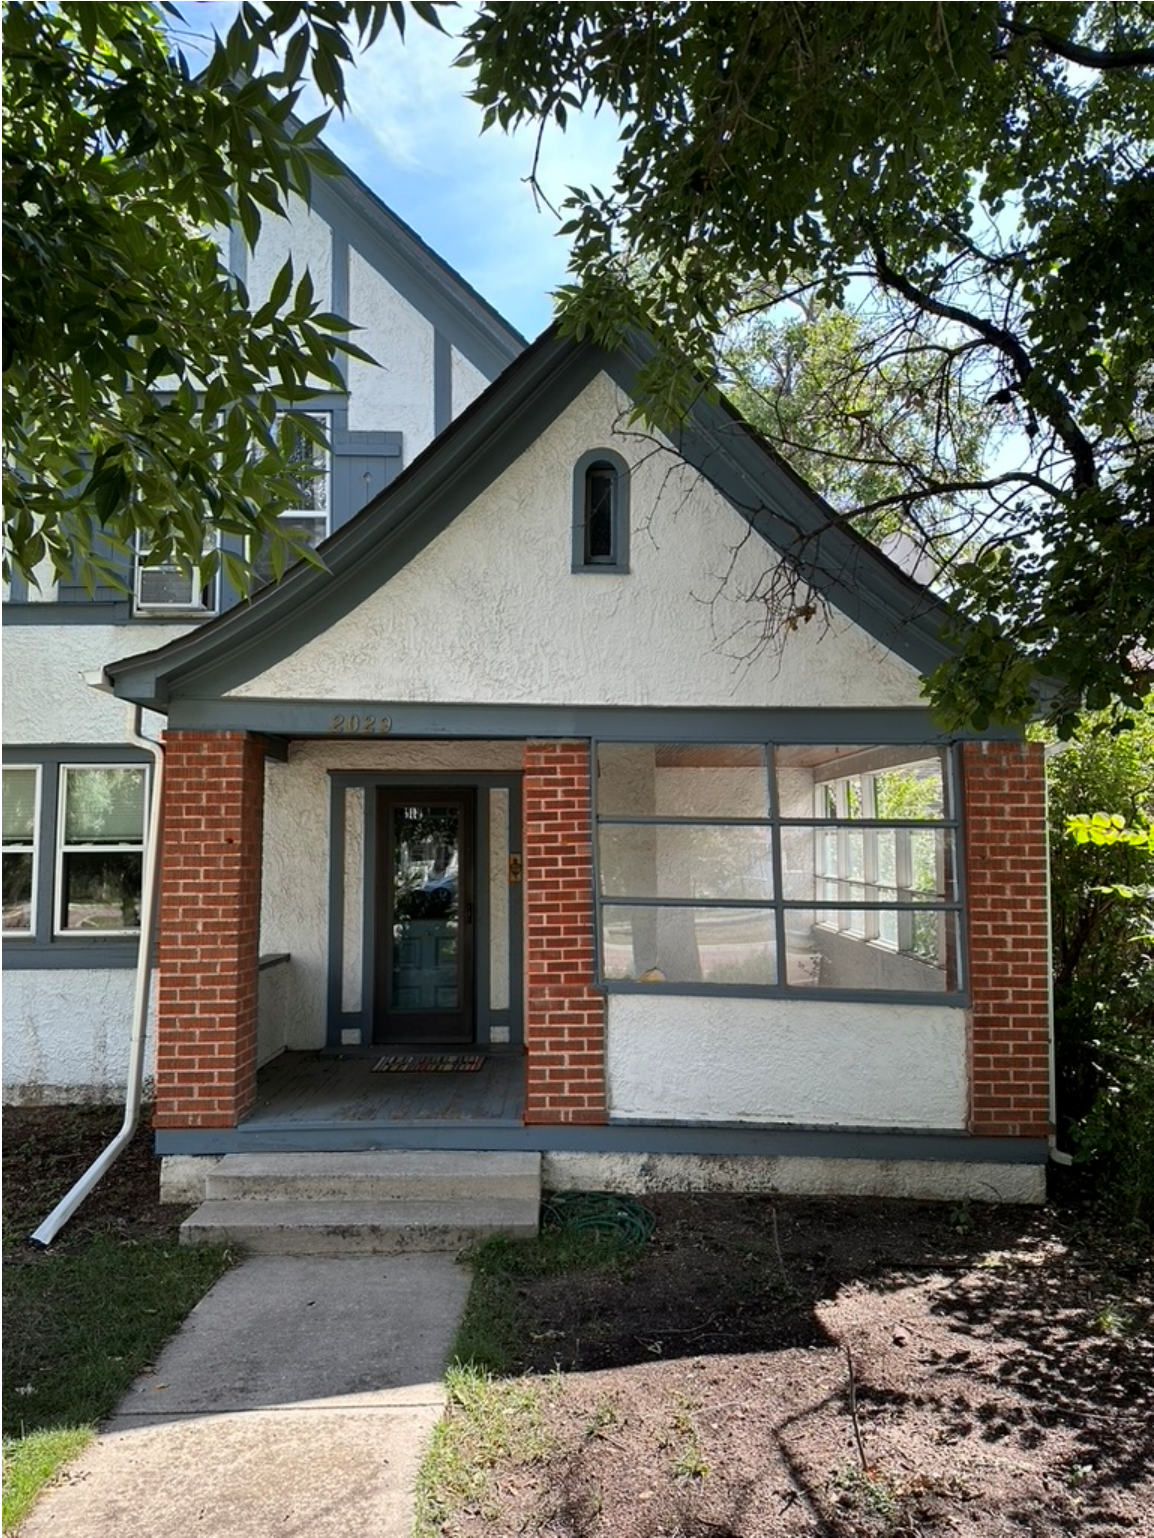
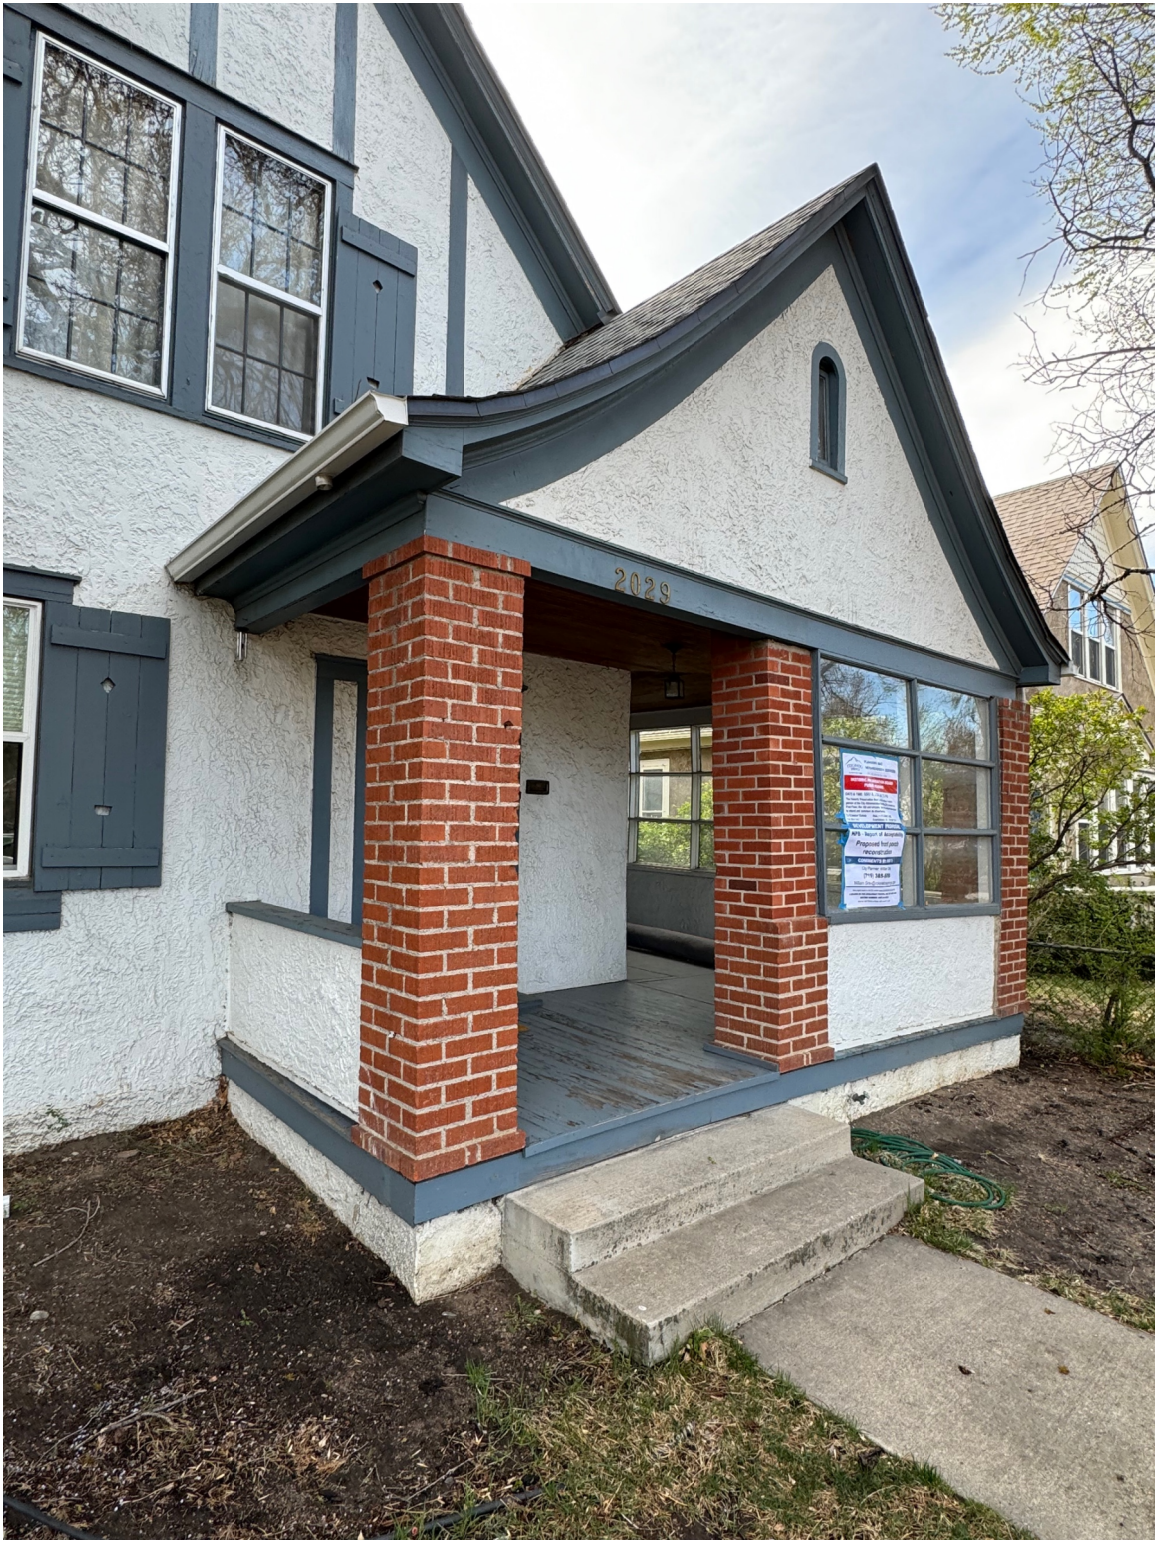
Existing house and porch

The owner is requesting to have the structure rebuilt in its existing location with no additional square footage added to it. The existing brick has begun to crack due to the weight of the roof pushing down on the structure, also the existing framing and side structures to the porch are breaking and cracking.

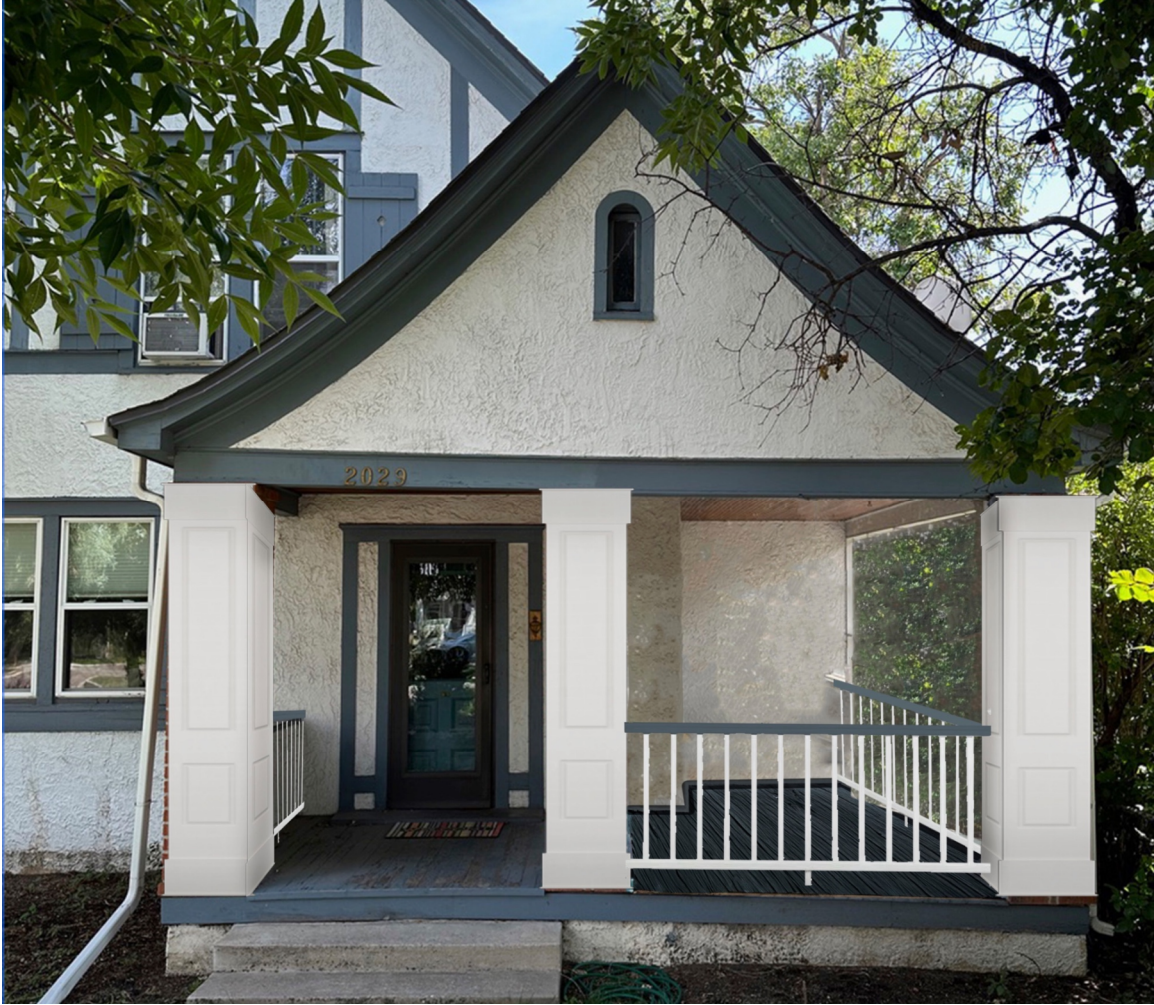
Proposed New Porch and Deck

The existing brick columns are the only brick on the entire house, and we feel the wood columns proposed would be more in keeping with the Historic North End as well as the existing house (examples shown below of similar homes along Nevada), the owners would like a more open and inviting porch and we feel the handrail being open is also more inviting than the closed off stucco low wall. The handrail would be wood also matching the other homes shown in the photos. The columns and handrail would be painted white with a blue handrail to match the trim on the existing house. As shown in the other photos, white is the common choice for the columns and handrails in the neighborhood.

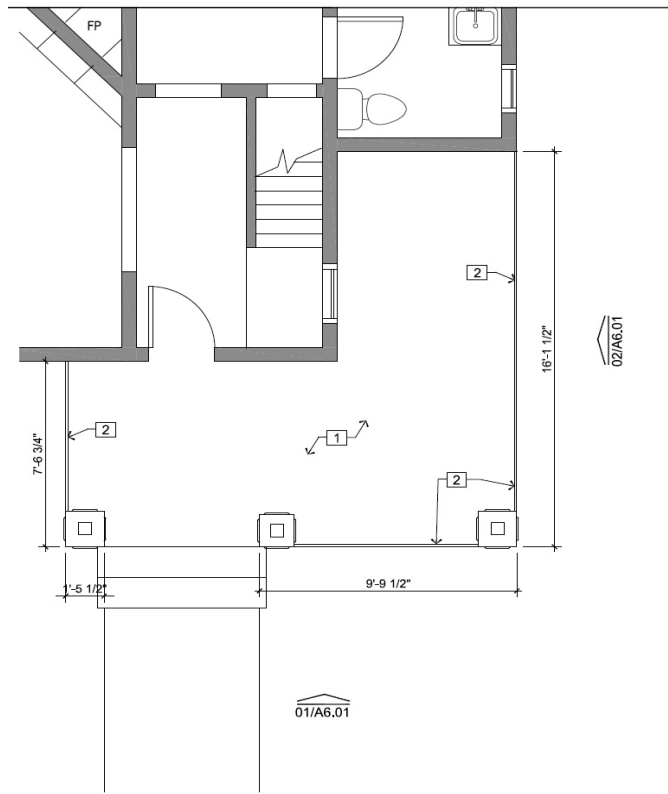
Floor Plan of Existing Porch

CONSTRUCTION PLAN

3/8" = 1'-0"

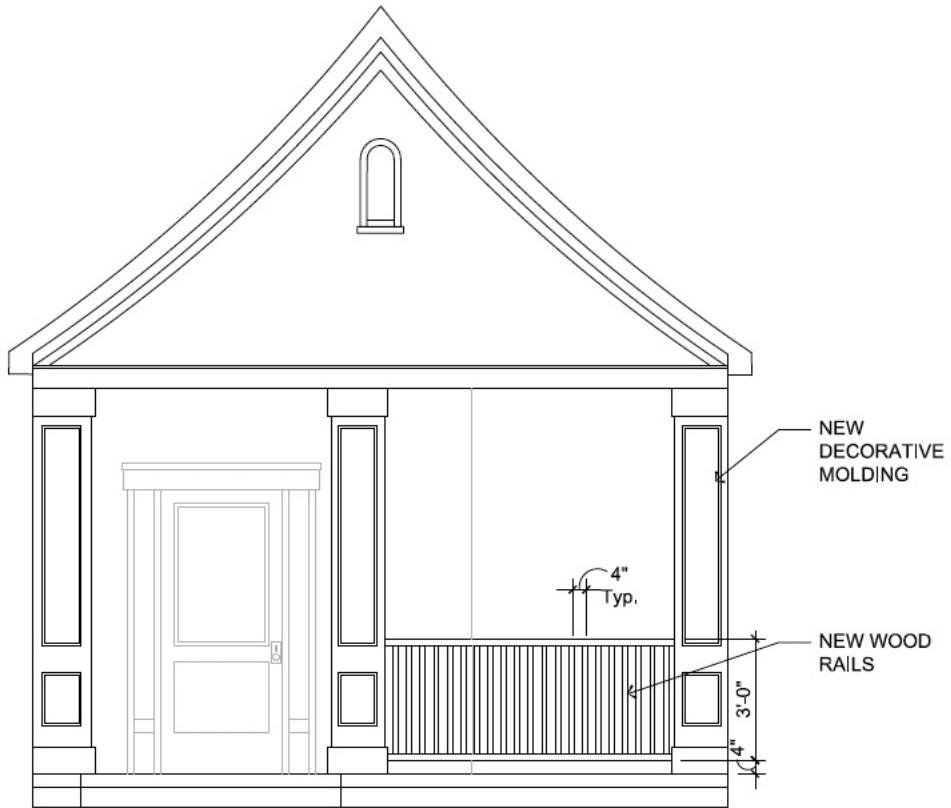
Proposed Columns and Handrail for Porch

01 FRONT ELEVATION

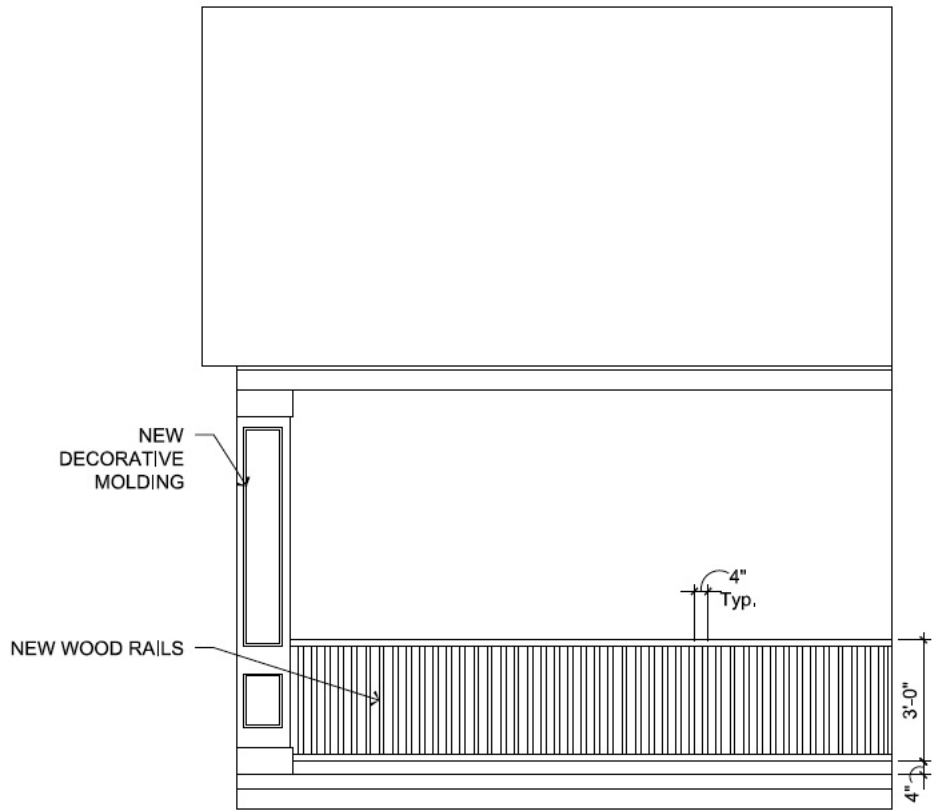
02

SIDE ELEVATION

3/8" = 1'-0"
