Appeal of an Administrative Decision to City Planning Commission

Project Name: Nonuse Variance for Fence Height
Site Address: 21 Marland Rd
Tax Schedule Number: 7436404006
Type of Application being appealed: Non-use Variance
Include all file numbers associated with application: AR NV 20-00678
Project Planner's Name: Alex Osborne
Administrative Decision Date or Date of Notice and Order: 12/15/2020

This appeal under City Code 7.5.906.A.4 involves the disputed ordinances: City Code 7.4.102A (Fences) and 7.3.105A (Accessory Structures). The applicant requested a nonuse variance for a 7' 6" fence height from top of fence to finish grade at the bottom of the retaining wall within 3' of the fence, where 6' is required.

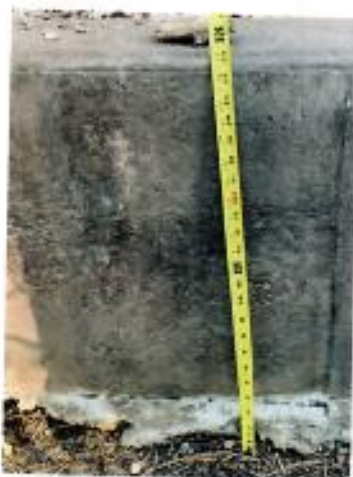
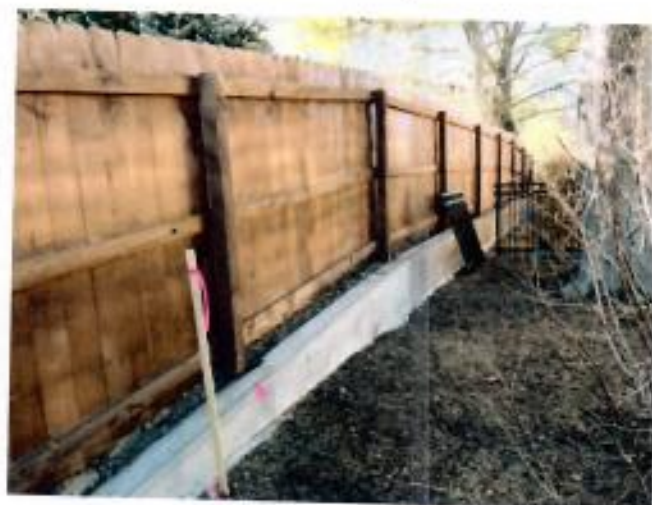
At its highest, the retaining wall is 22" to 23"—not 18" as drawn. The cedar fence measures 6' to 6' 3". This results in much of the wall/fence being well over 7' 6". Measurements were taken when city code enforcement visited the site and should be on record. We remember Tom with City Code saying the fence was close to 8' in places. The length of the retaining wall is 60 feet long—20 feet more than applicant represented in site plan.

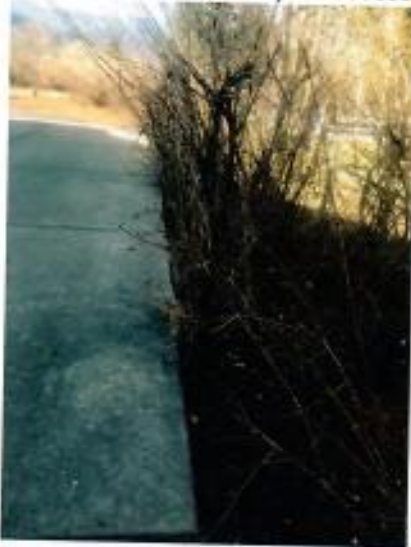
Driveway and easement between 17 and 15 Marland is similar to concrete driveway of 21 Marland prior to retaining wall added in October 2018.

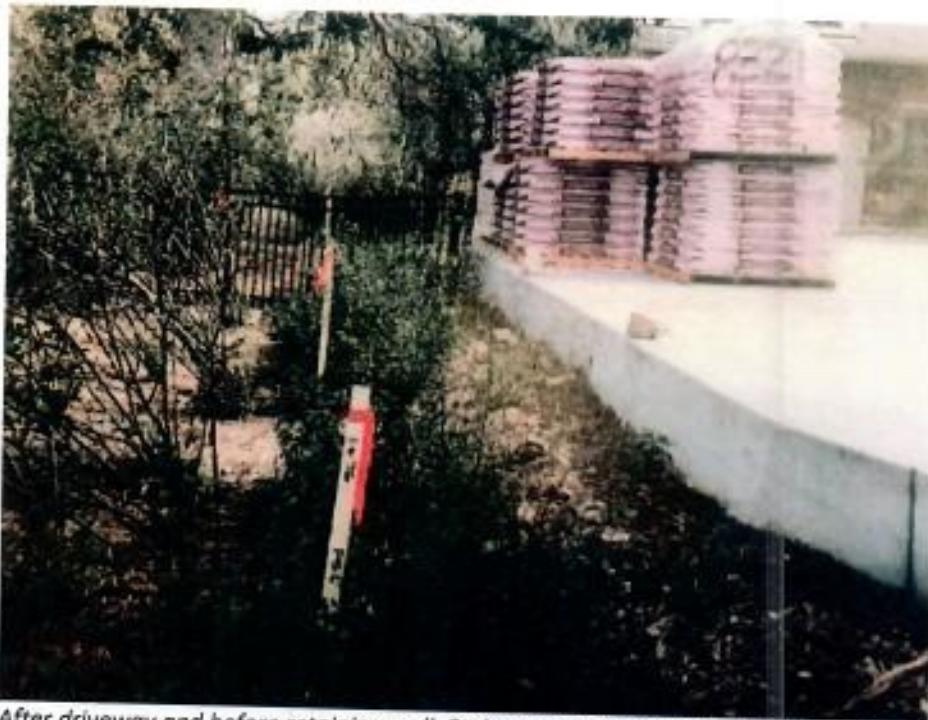
After driveway and before retaining wall. Stakes represent property line inches from where retaining wall was erected.

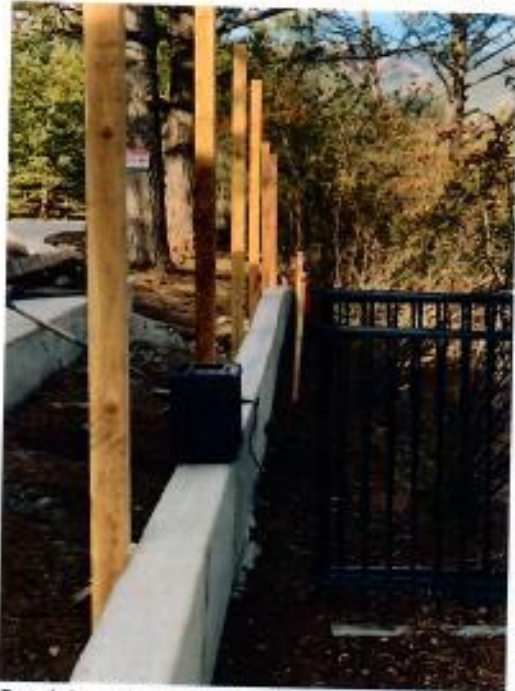
Retaining Wall and filler dirt added in October 2018, six months after driveway. No engineer report stating retaining wall was needed for stabilization prior to October 2018.

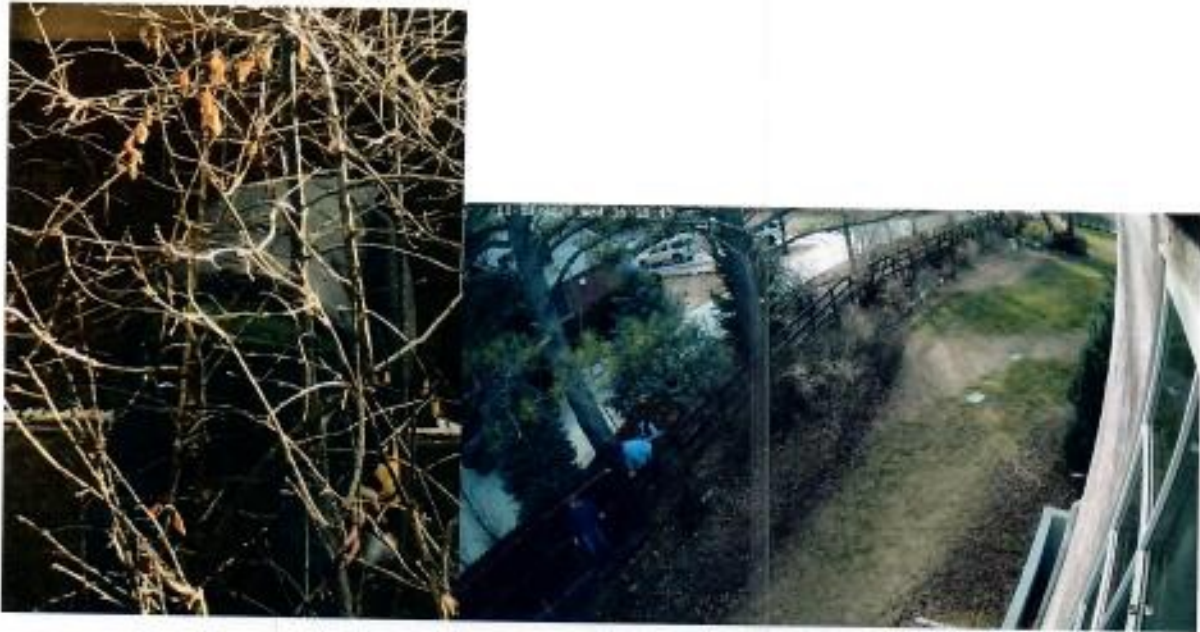
Driveway access is addressed above. In regards to security, a six-foot fence would provide adequate security for both neighbors. A 3-foot setback would not impact fence security. Both homes have security surveillance systems. The lots are over one acre and a six-foot fence is adequate for others who live on Marland Rd. (see letter from Dan League, 15 Marland, attached). While appellants cannot address the applicant's accusations in his application due to a settlement agreement, the fence existed at the time of these alleged incidents. Additionally, the current almost 8-foot fence did not prevent a worker from entering appellants' yard without permission or others crossing the fence while appellants were out of state.

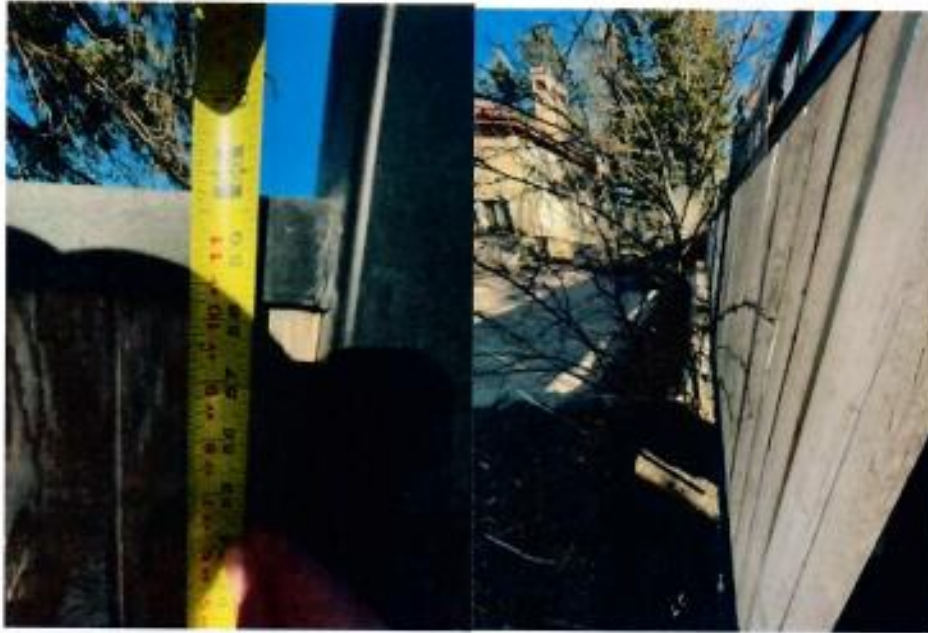
5 Marland Rd’s wood fence is 5 foot. According to City Code 7.4.102.A.4, “an additional twelve inches (12”) of height is permitted for fence posts, poles, and finials when spaced eight feet (8’) or more from each other.” The retaining wall positioned so only 5 Marland can view is stone and harmonious to the neighborhood and does not adversely impact other neighbors or the community. We believe 5 Marland may have obtained a variance to position the fence closer to the retaining wall; portions of the fence are set back farther than other portions.

5 Marland's retaining wall

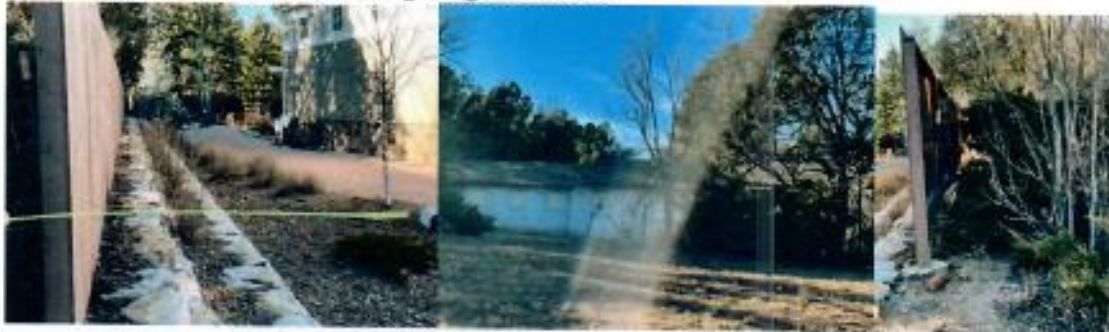
28 Marland has a 6-foot cedar fence. The "stepped-up" retaining wall facing the homeowner is attractive stone harmonious to the neighborhood. Between the first "step" of the retaining wall, the cedar fence is roughly 5 feet setback from the first step. This fence was built to hide the abandoned house at 34 Marland, which City Code enforcement is familiar with (red tagged for years). According to the homeowner at 28 Marland, the cedar fence is also temporary until someone buys the abandoned house. The retaining wall/fence in no way adversely impacts the dilapidated house next to it or the neighborhood the way the retaining wall at 21 Marland does to its neighbor and surrounding neighborhood.

28 Marland's Retaining wall to hide abandoned house.

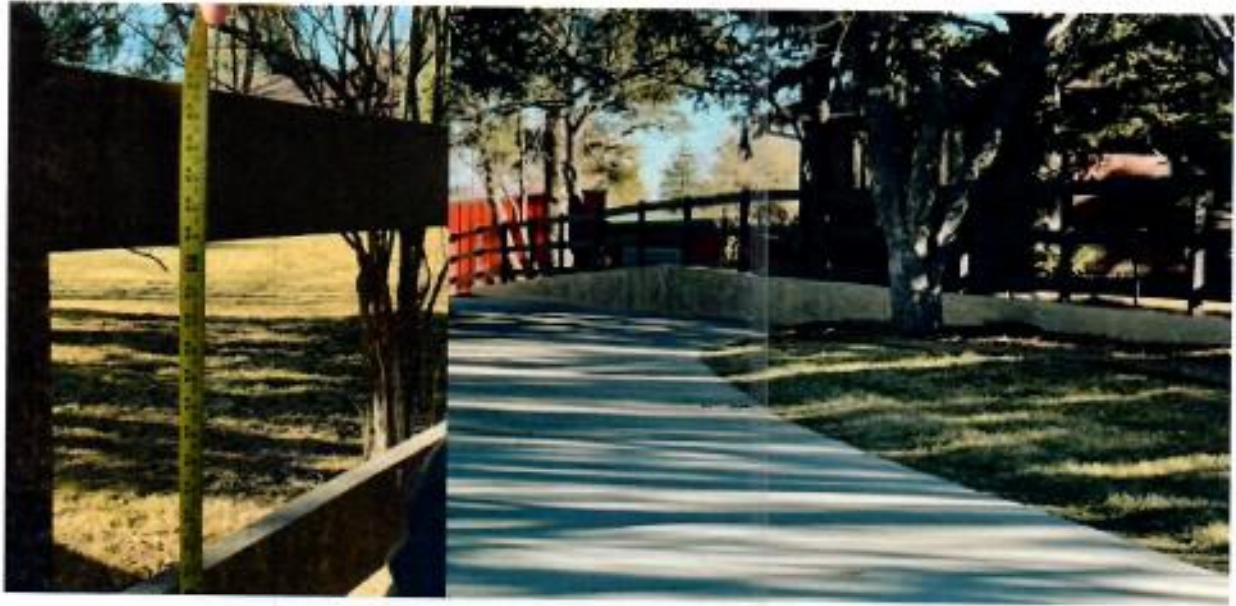
The cement retaining wall between 29 Marland (built in 1972) and 35 Marland (built in 1952) may have been used for comparison. Not sure what City Code was at the time this was built, but the split-rail fence is less than 5 feet tall.

Retaining wall/fence between 29 and 35 Marland

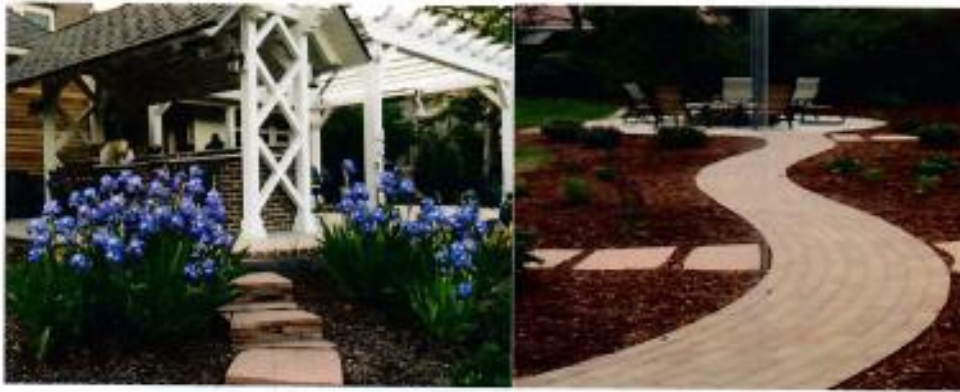
Appellants' yard prior to retaining wall/fence

The wall built in October 2018 is already crumbling and eroding. A structural engineer is scheduled will be consulted. The cedar fence is poorly built and will require lifetime maintenance that applicant will be unable to do without trespassing. A three-foot setback will allow applicant to access the fence.

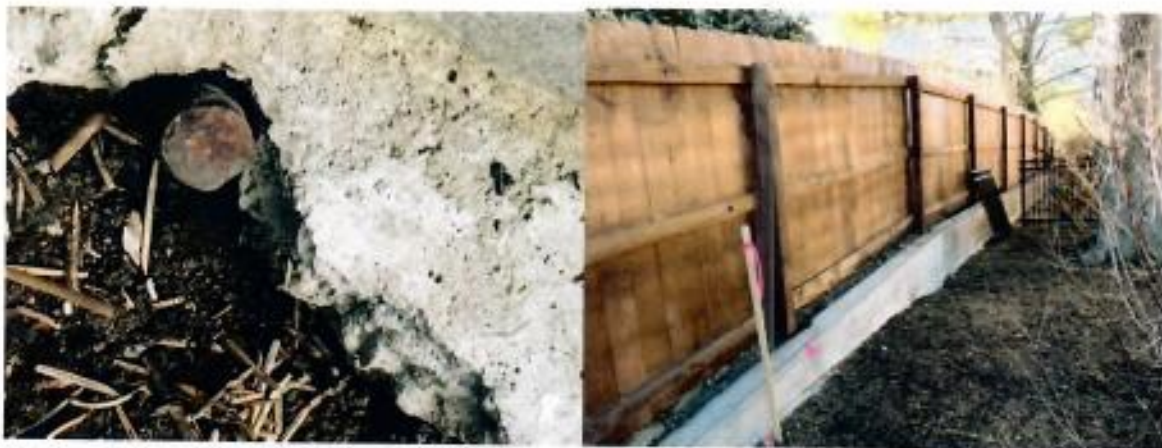
Retaining wall falling apart is inches from property line

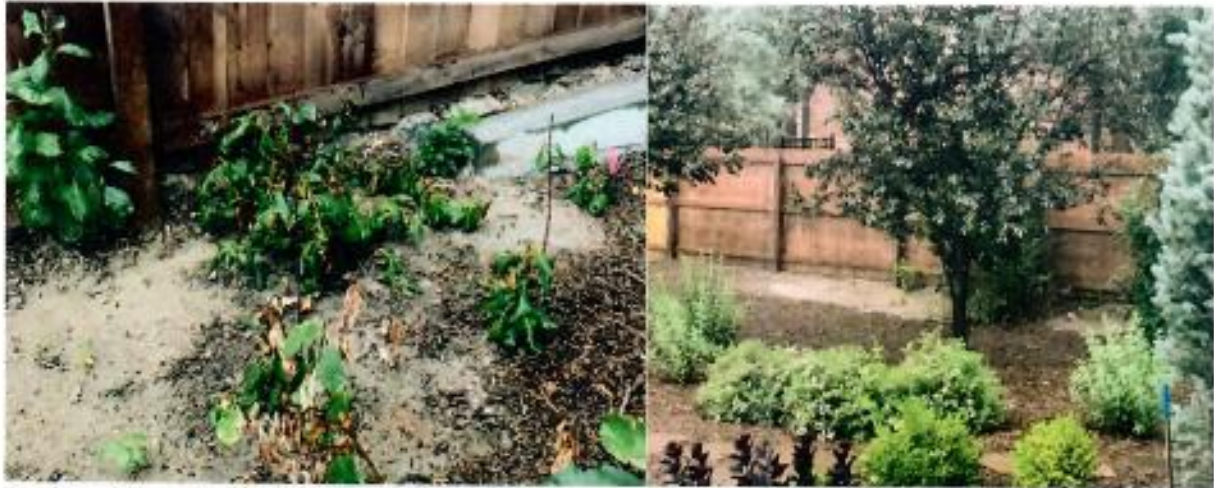
Furthermore, the design of the 60-foot east-west retaining wall has created significant runoff on both sides, harming the appellants' property. Refer to letter and photos sent to Alex

Ongoing damage to appellants' property caused by stormwater runoff

Osborne dated December 7, 2020. According to the Record-of-Decision, City Engineering says, "although lot-to-lot drainage is a concern, it is a private matter that City Engineering does not have jurisdiction or funding to correct." Appellants are therefore seeking a structural engineer's review.

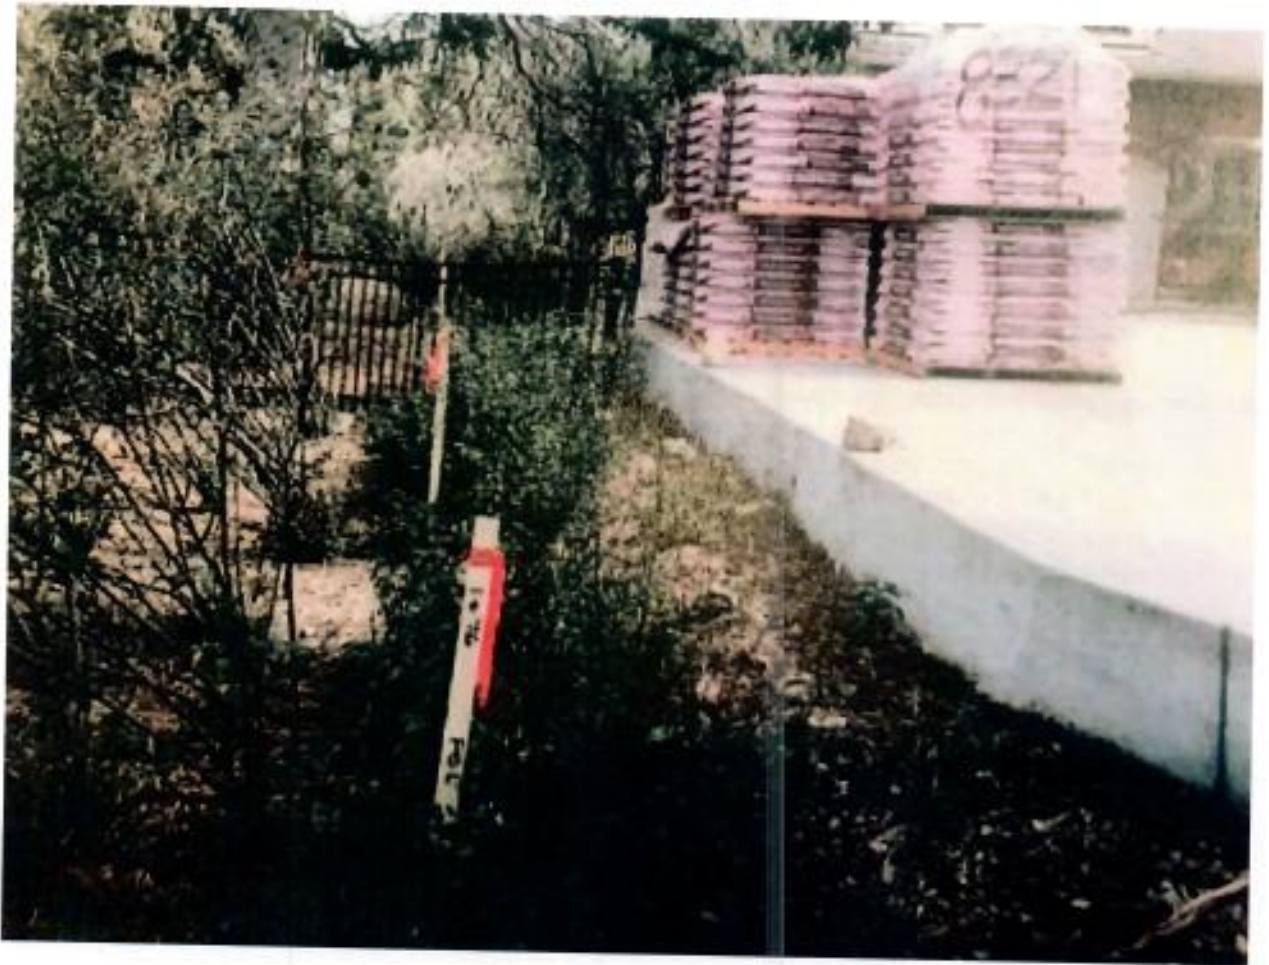
Following is Photo A taken by the Surofcchek's landscaper *after* the driveway was poured and *before* the retaining wall was built. This photo clearly shows that the north-south slope is insignificant. For the 20+ years the former owners of 21 Marland lived there, as well as the 8 years we lived in our house sans the retaining wall, there has never been an issue with runoff--even during severe storms. The builder of 21 Marland was also the builder and former owner of 17 Marland and he would be happy to talk to you.

Photo A: Topography Before Retaining Wall

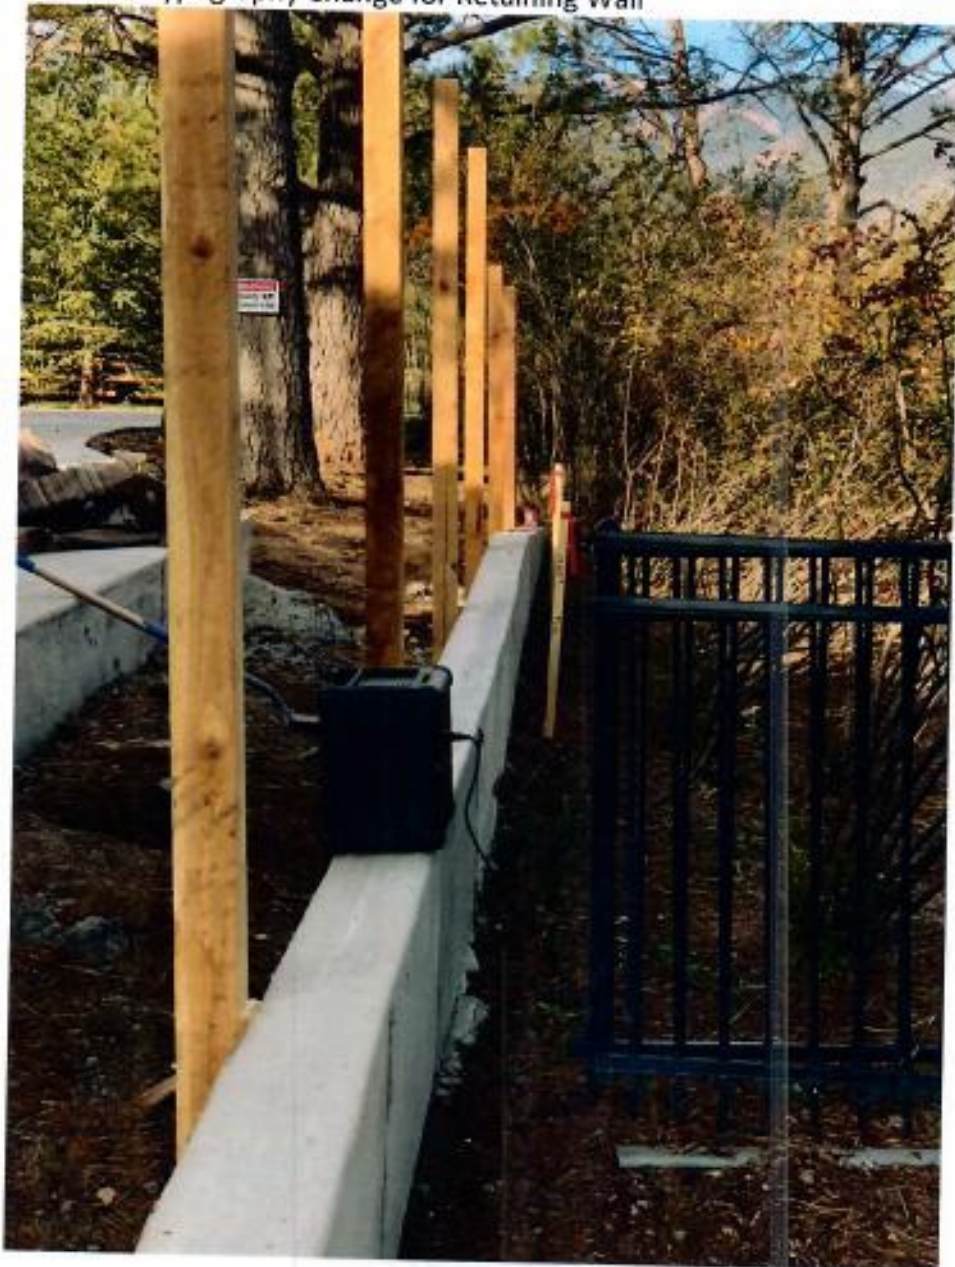
Photo B: Typography Change for Retaining Wall

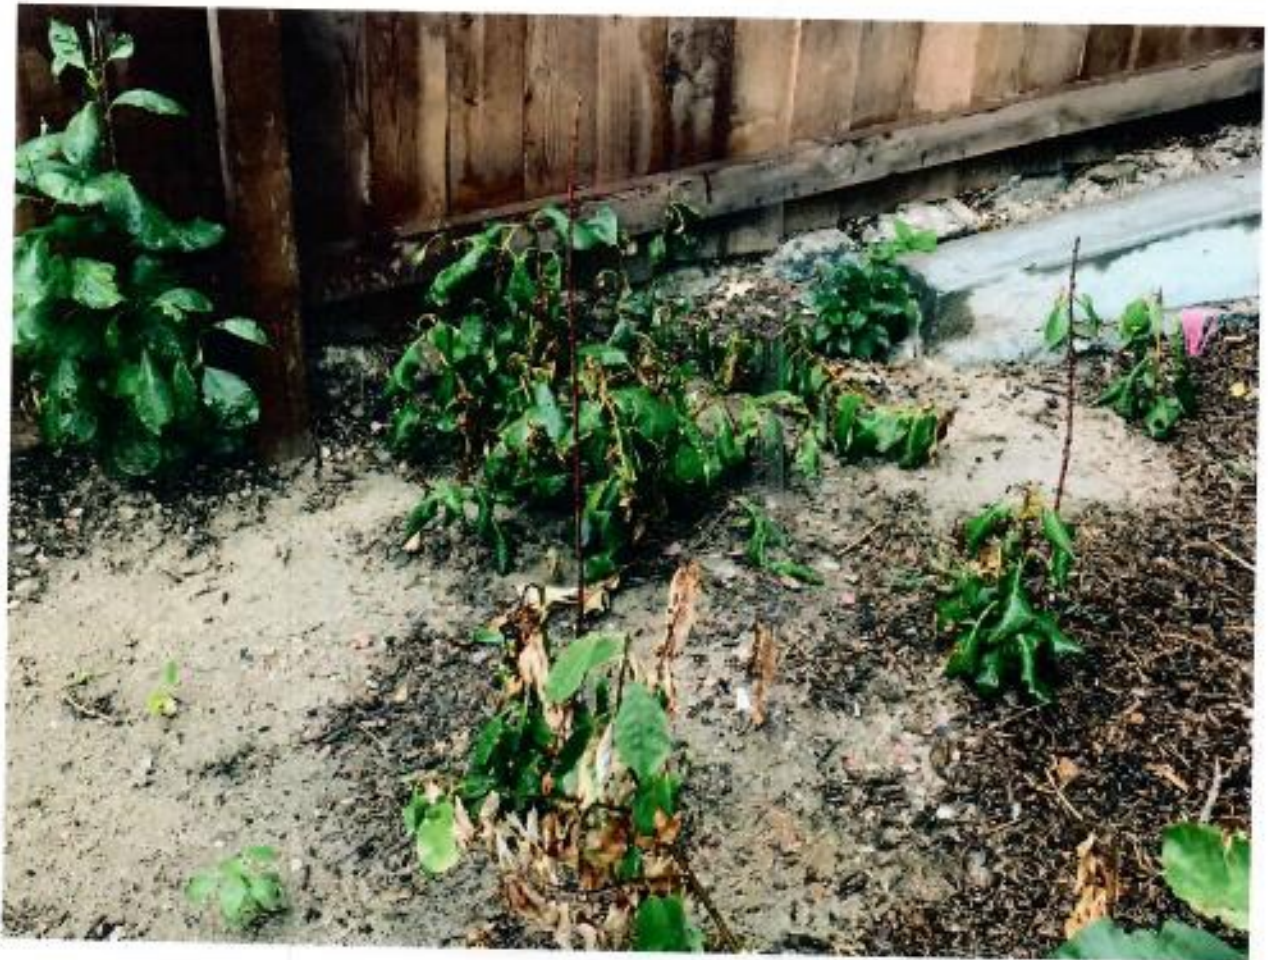
Photo D: Runoff at End of Retaining Wall

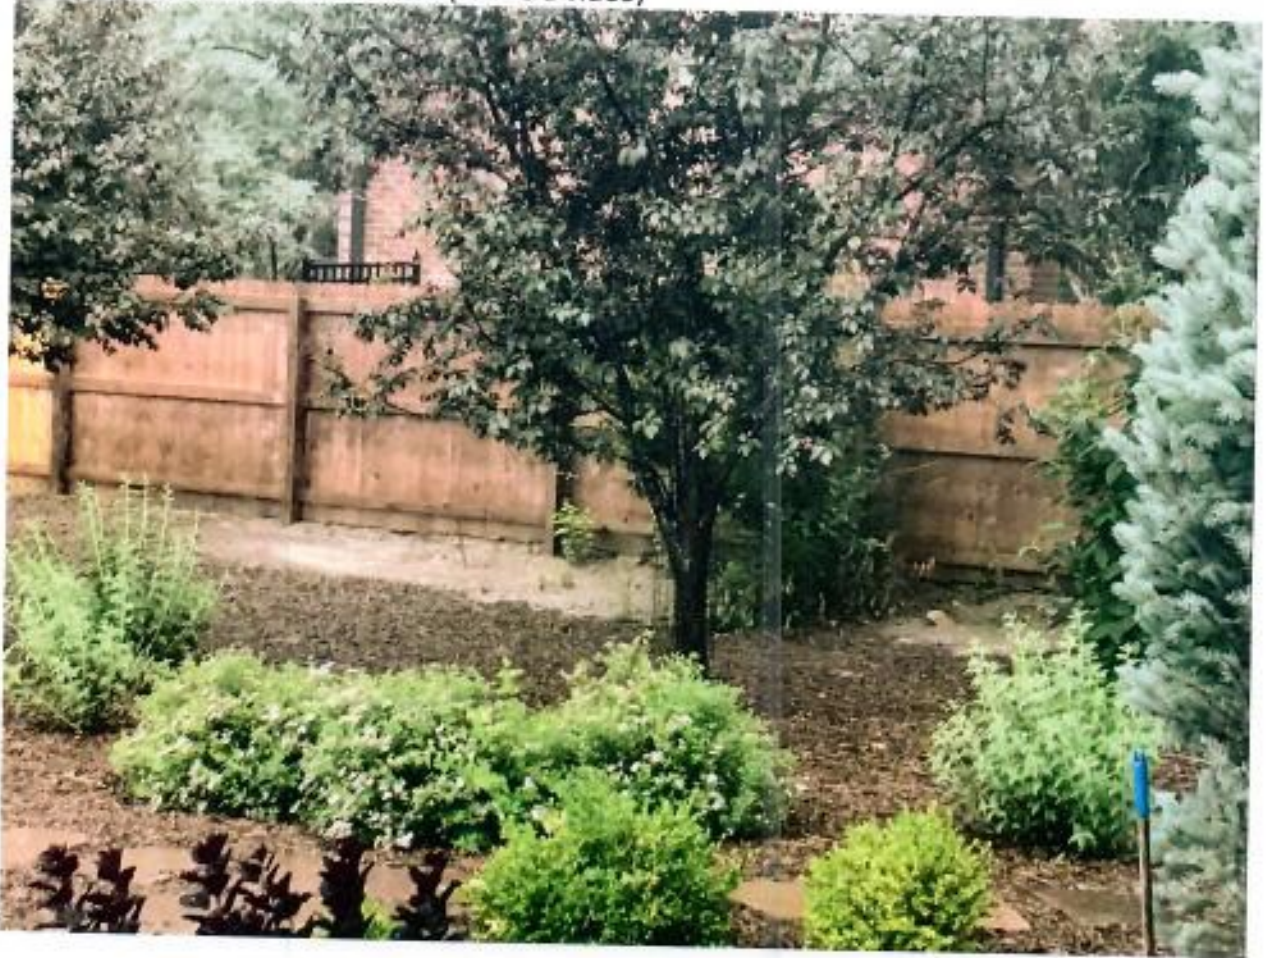
Photo E: Runoff Becomes a River (I have a video)

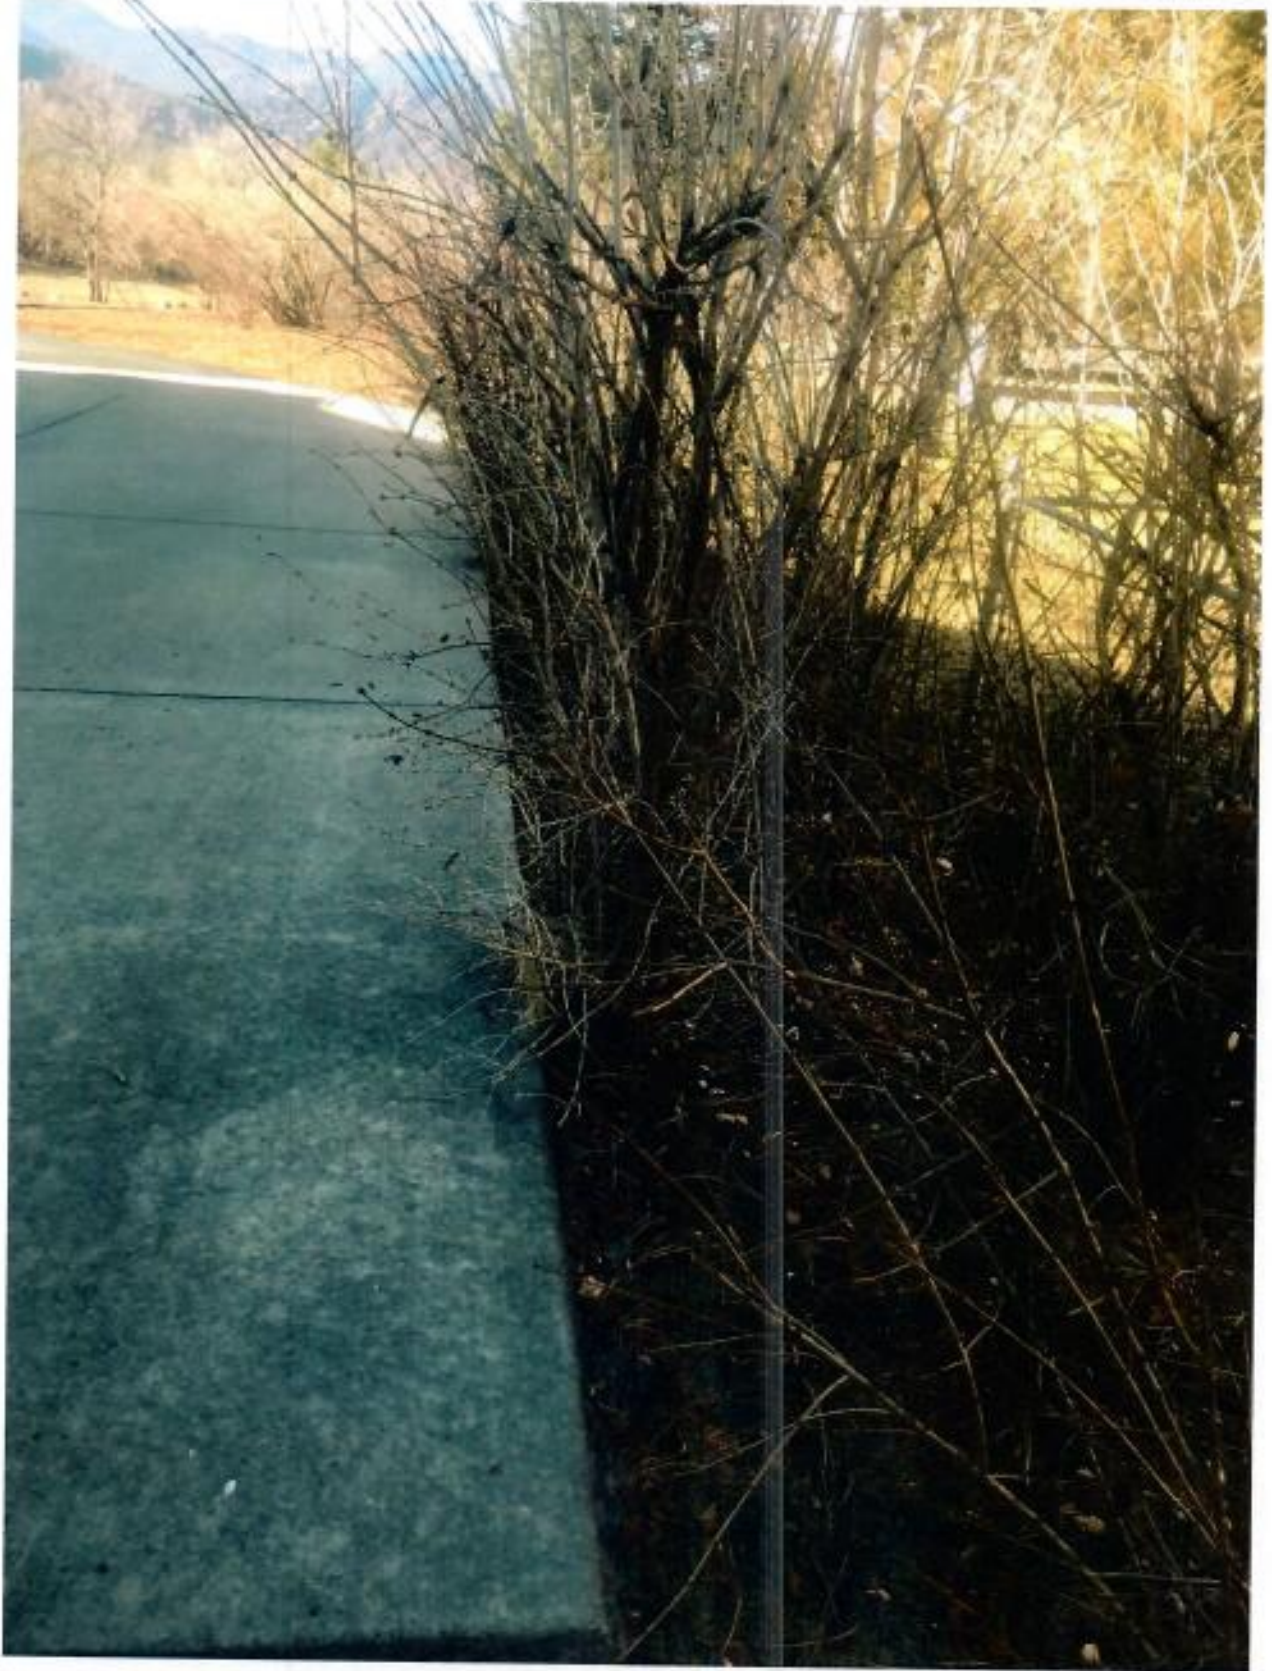
Finally, I am including Photo E of our driveway garage entrance at 17 Marland which is quite similar to the Surofcchek's. There is a slight downward slope toward our neighbor at 15 Marland but it's so slight I cannot get a good photo. Our neighbor who has lived at 15 Marland for 43 years will also attest to the fact we have never had a run off/erosion issue.

Photo F: 17 Marland Drive: No Retaining Wall Needed
